**STAFF RECOMMENDATION**  
**1112 Forrest Avenue**  
**October 17, 2012**

**Re: Review of Structural Integrity of  
Residence for Remodeling  
1112 Forrest Avenue  
Nashville, TN 37206  
AJDS Project No. 12-0826-000**

Re: Structural Observations of Framing  
Residence, 1112 Forrest Ave., Nashville

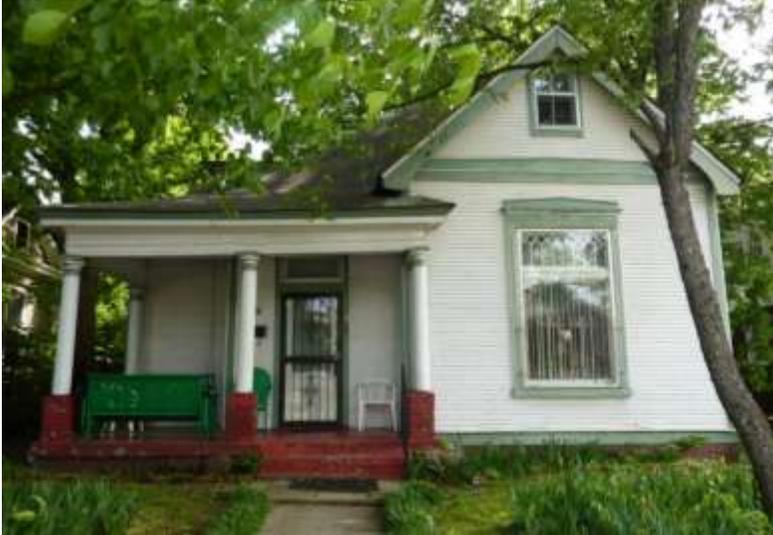
1112 Forrest Avenue before restoration and preparation for the approved addition began.

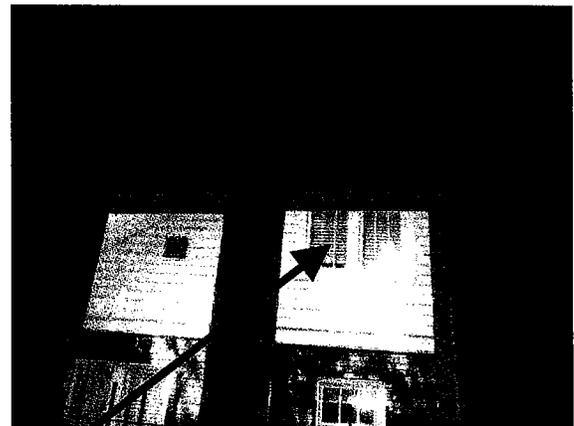
4. We noted that no headers were installed above exterior windows or interior and exterior doors. Properly sized headers will need to be installed above all of these.

None of exterior windows or doors or interior doors have headers above them to support ceiling joists or rafters

7. The correct size headers should be installed above all of the windows and doors.
8. Since the second floor is presently only supported by too small of ceiling joists and not true floor joists, all of the second floor joists would need to also be replaced with 2x10s spaced at 16-inch centers. Unfortunately increasing the depth of the floor joists would reduce the ceiling height so the second floor would not be feasibly usable.

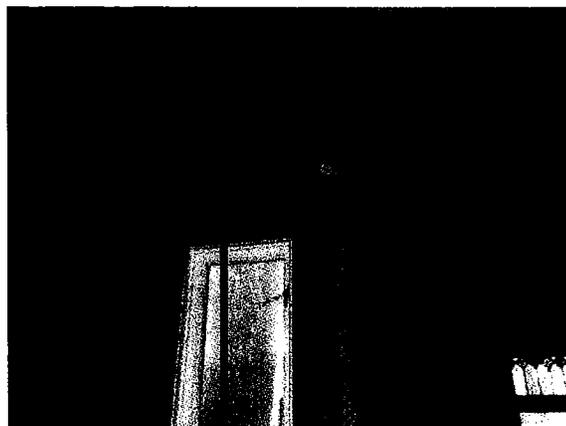
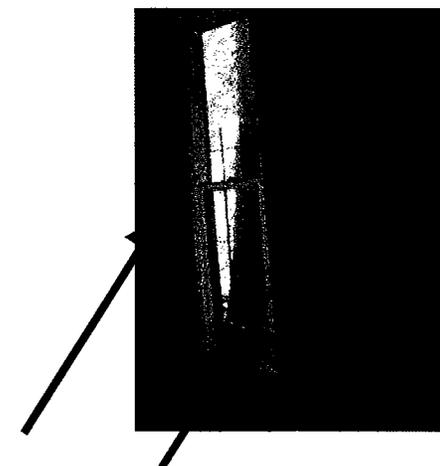
No header above window and studs at each side of window are termite damaged.

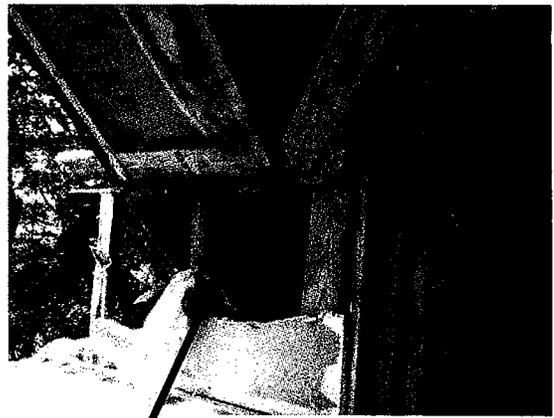
The various knee walls throughout the attic have placed unwanted loads on the ceiling joists, typical.
