METROPOLITAN GOVERNMENT OF NASHVILLE AND DAVIDSON COUNTY

STAFF RECOMMENDATION
1818 Wildwood Avenue
August 21, 2013

Application: Demolition
District: Belmont-Hillsboro Neighborhood Conservation Zoning Overlay
Council District: 18
Map and Parcel Number: 11704013600
Applicant: Manuel Zeitlin, architect
Project Lead: Robin Zeigler, robin.zeigler@nashville.gov

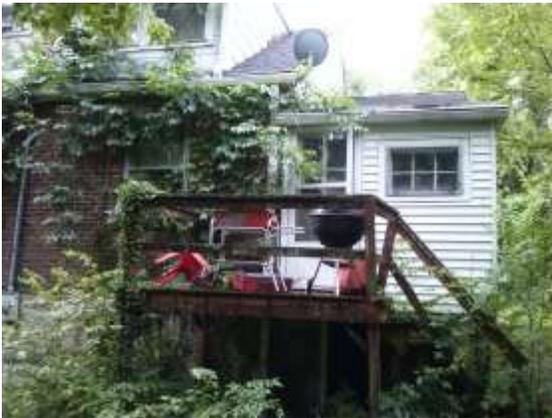
Figure 1: rear corner addition

The brick of the home is compromised by allowing plant life to scale the foundation and walls. (See figure 1.) The negative slope of the front yard caused the porch to fail. It was never repaired creating water damage near the front door. (See figure 2.)

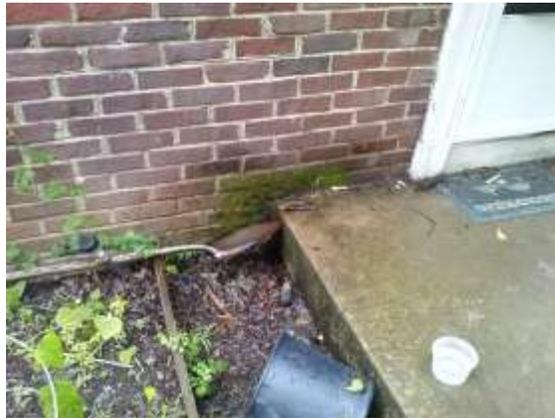
Figure 2: left of front door

The primary concern with the current condition is the negative front yard slope which has allowed water to push against the front foundation. Keith Garman, PhD, PE, PG, with Garman Engineering Company states that there are two possible solutions. One to construct a front retaining wall and reconstruct the basement retaining walls and two, to raise the height of the foundation walls. Either scenario will also require repairs to the front porch, subfloor framing, floors, walls and ceilings. The applicant has an estimate of \$115,000 to add the retaining wall and repair the damage caused from the deferred maintenance, rear additions, and negative slope. (The full engineers report was provided to the Commission at the July 2013 meeting. There have been no alterations to that report which can be found online, www.nashville.gov/Historical-Commission/About/Historic-Zoning-Commission/Meeting-Information/2013.aspx, as a part of the July record for this case.)

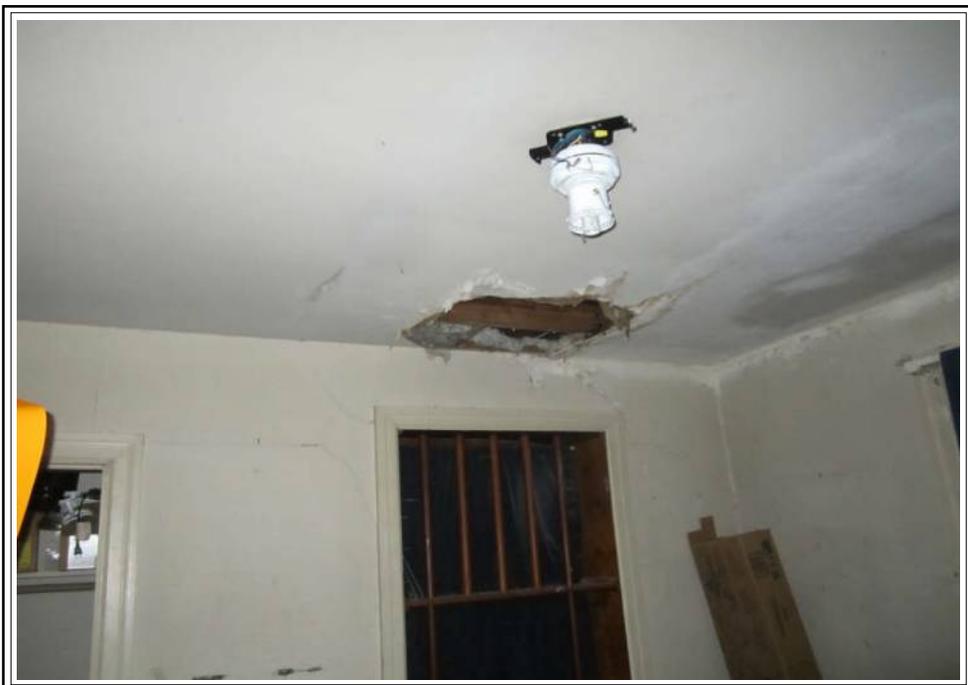
Ceiling Damage

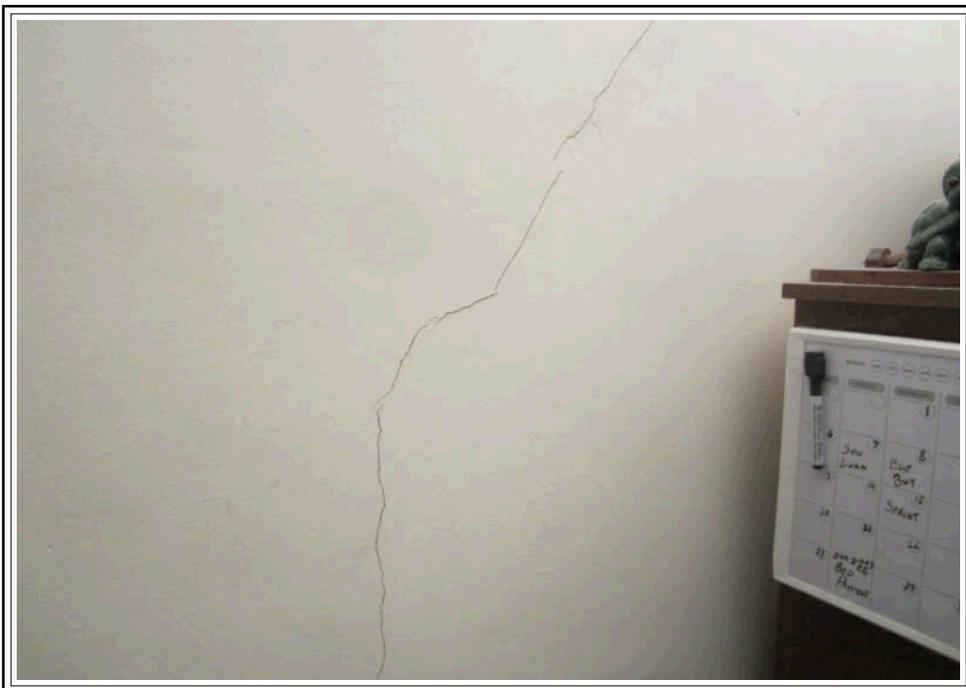
Interior Settlement Crack in Plaster Wall

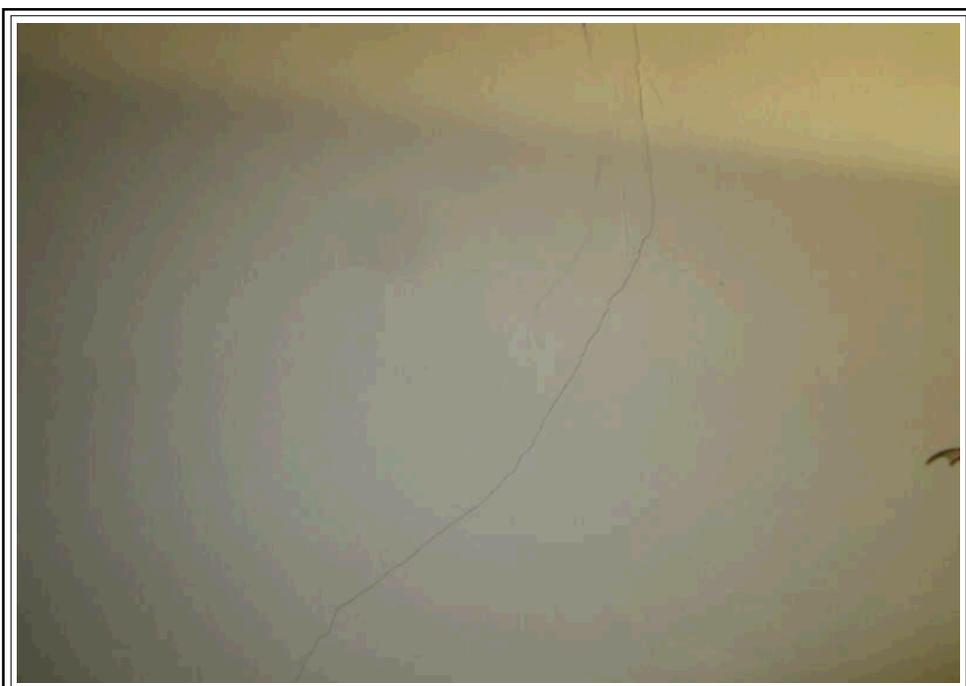
Interior Settlement Crack in Plaster Wall

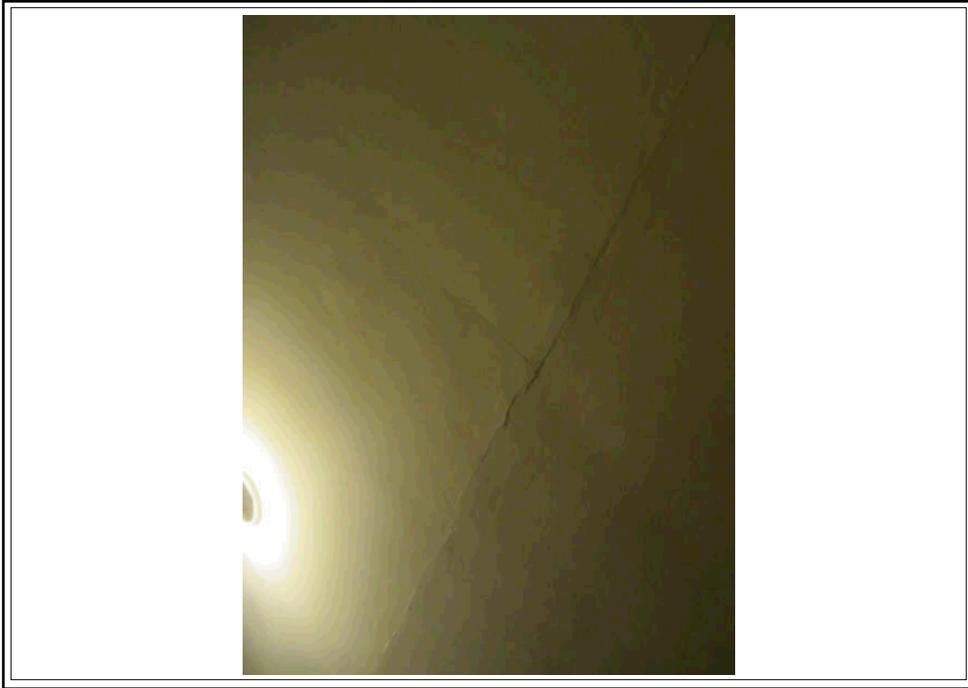
Typical Previous Repair Area
Settlement Cracks on interior areas

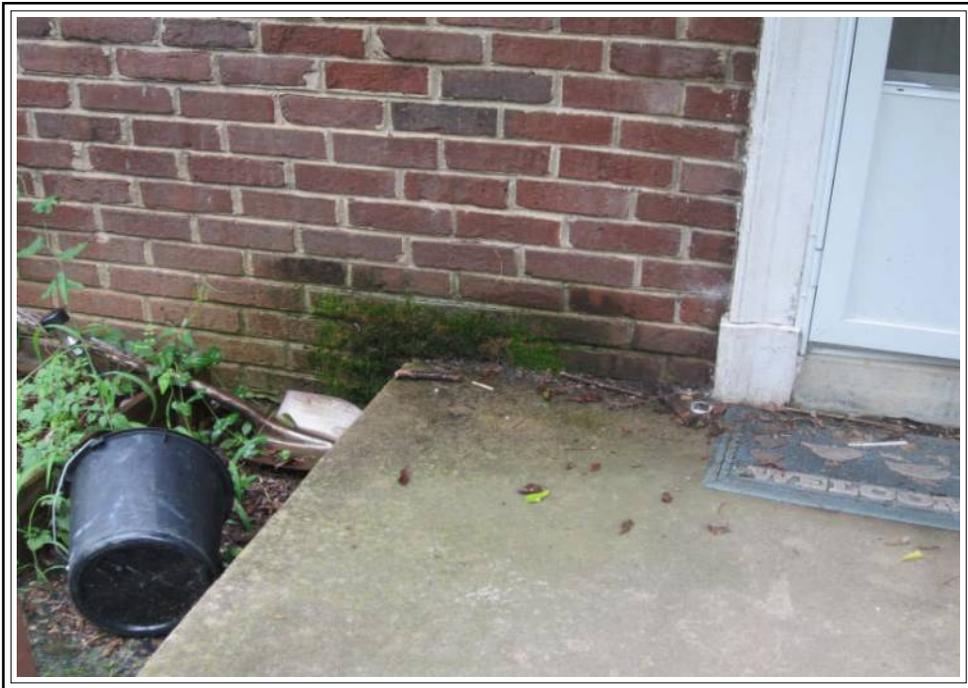
Settlement with water issue

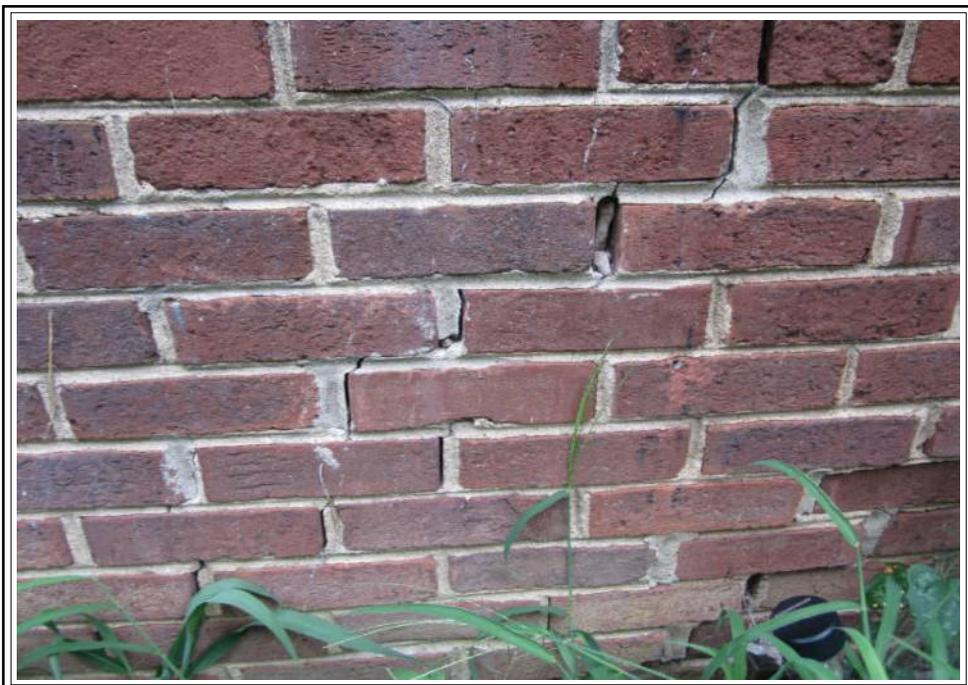
Settlement Cracks
Numerous Areas on Exterior

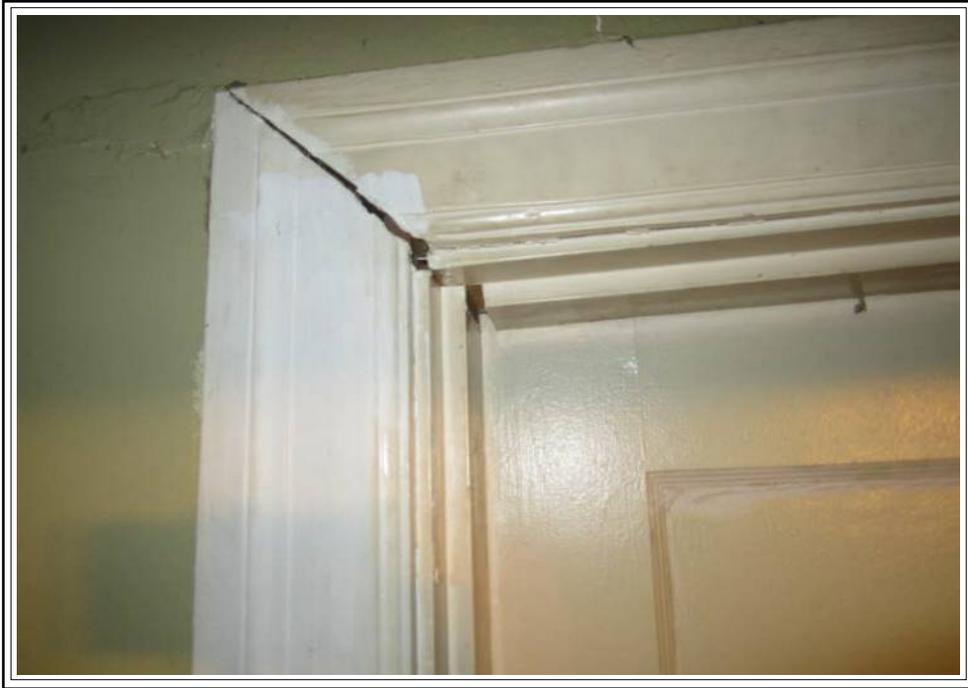
Settlement Separation on Interior Door Facing

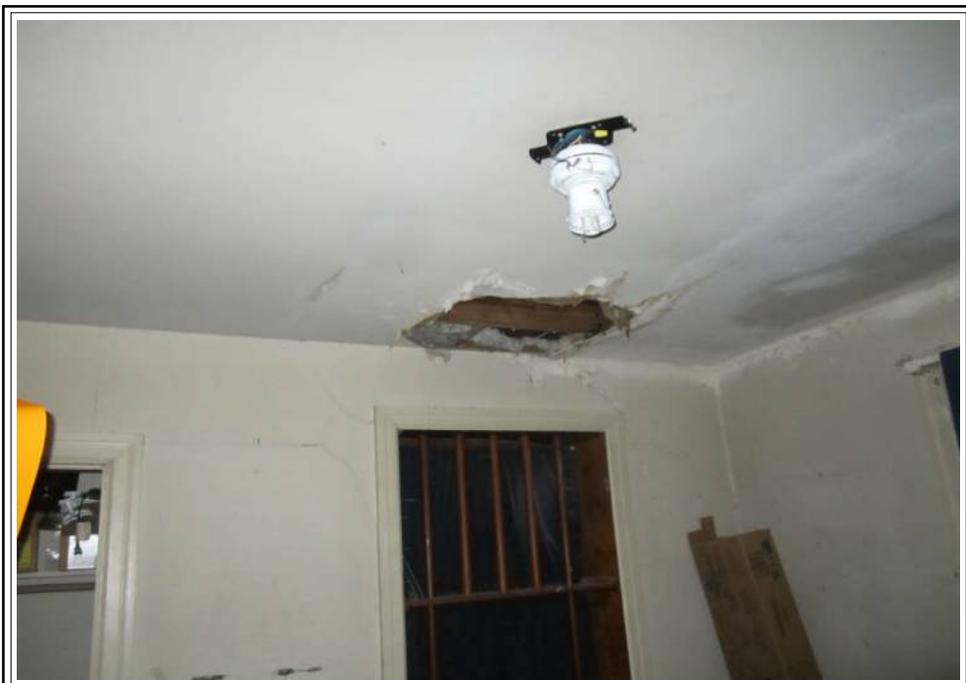
Ceiling Damage
