STAFF RECOMMENDATION
2200 Grantland Avenue
March 16, 2016

Application: Demolition
District: Woodland in Waverly Historic Preservation Zoning Overlay
Council District: 17
Map and Parcel Number: 10514010500
Applicant: Michelle Stephens
Project Lead: Paul Hoffman, paul.hoffman@nashville.gov

RE: **Residential Structural Observations & Reporting**
2200 Grantland Avenue, Nashville, TN
SE&I Project No.: 15-1276

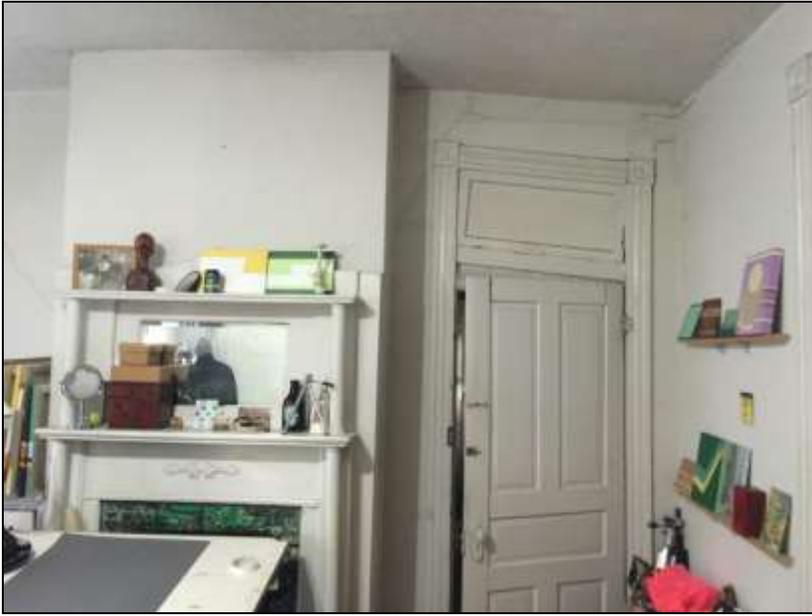
Figure 2. The transom above this door is racked, showing several inches of settling

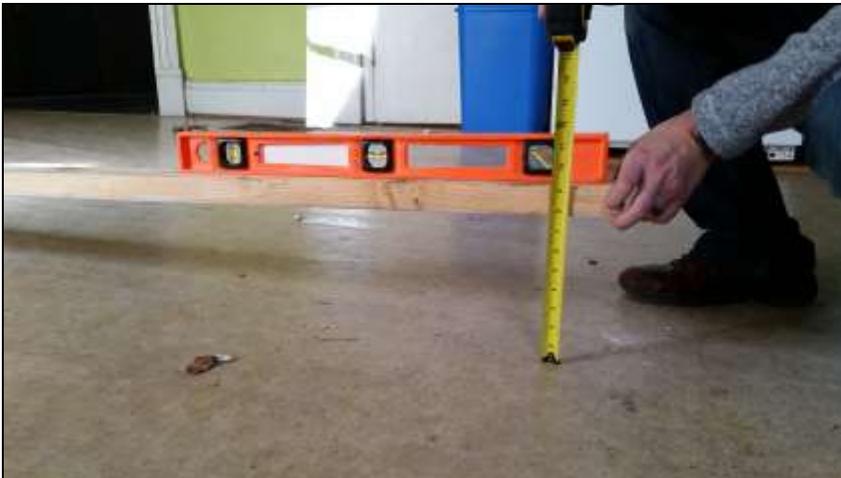
Figure 3. This portion of the house shows eight inches (8") of fall in a short span

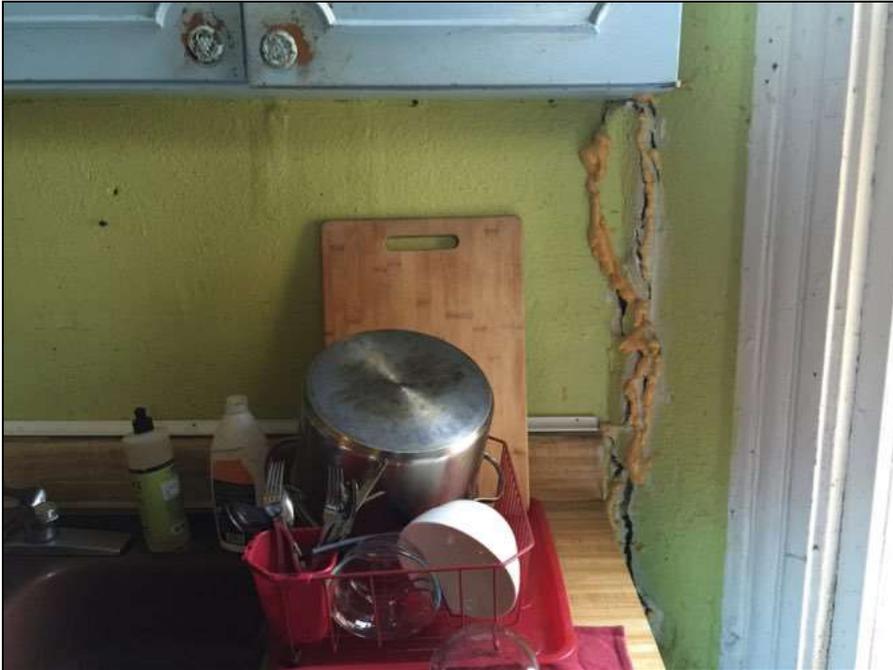
Figure 4. The walls meeting in this corner of the kitchen have separated, evidenced by the spray foam applied to fill the crack

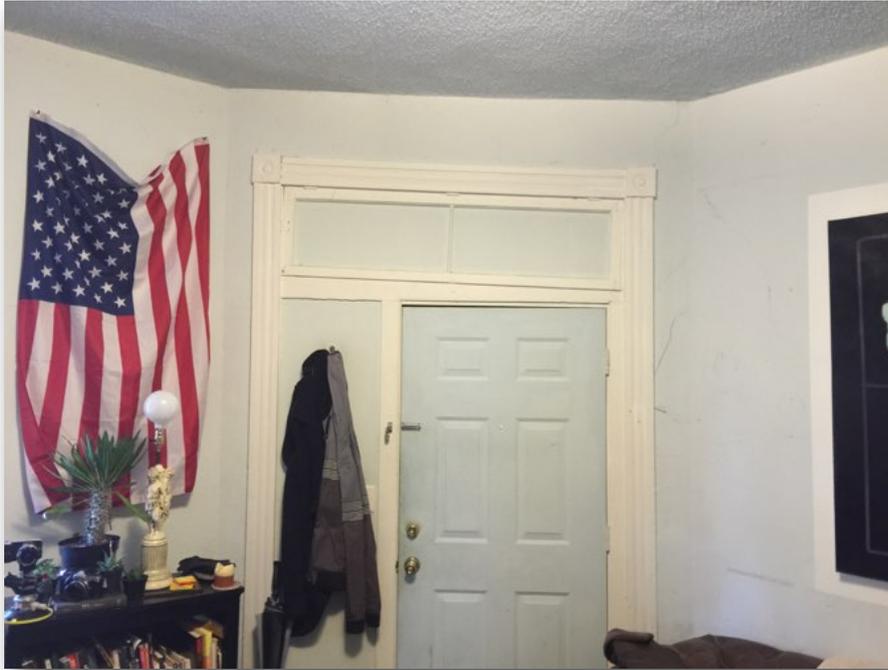
Photo 3: Front entry door unit is racked significantly as the floor has sloped along the exterior wall.

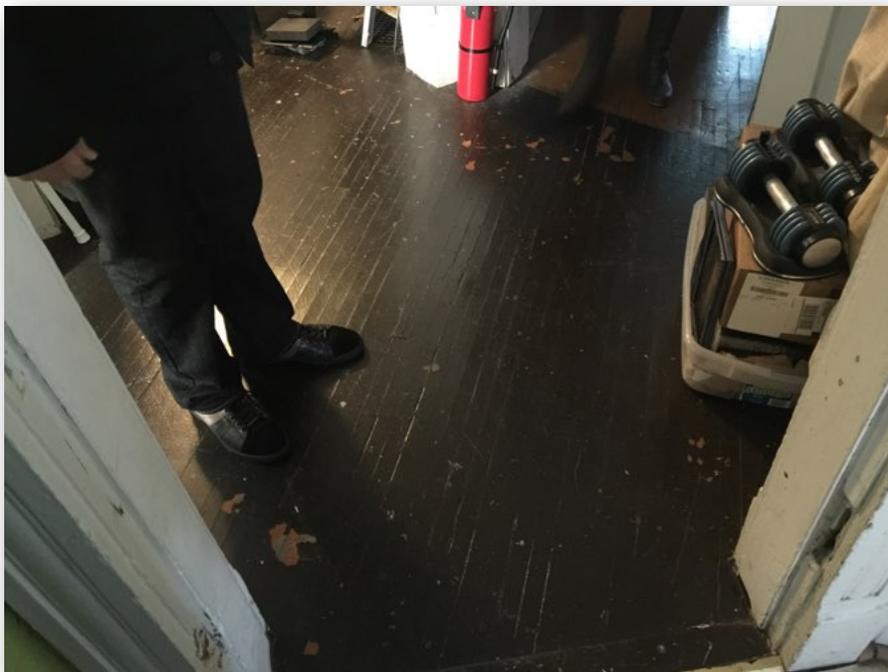
Photo 4: Floor of the small hall area. Floor was observed to slope approximately 2" to 3" from the persons feet to the box on the right.

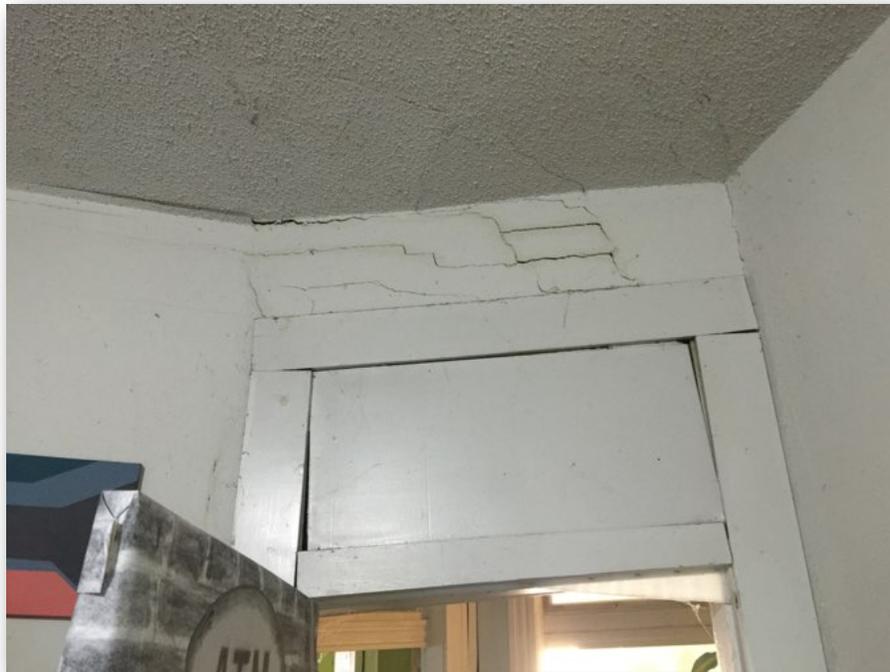
Photo 6: Door opening to middle left room at small hall area. Door frame is racked significantly and plaster is cracked above the door opening.

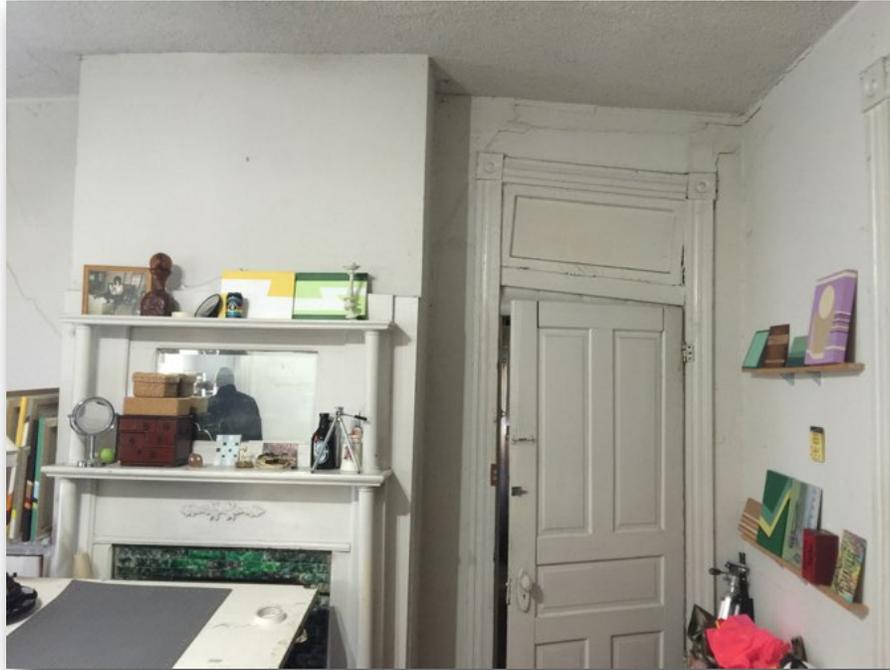
Photo 7: Back wall of middle left room with masonry fireplace in middle of wall. Door frame is racked significantly as floor is sloping away from the fireplace area.

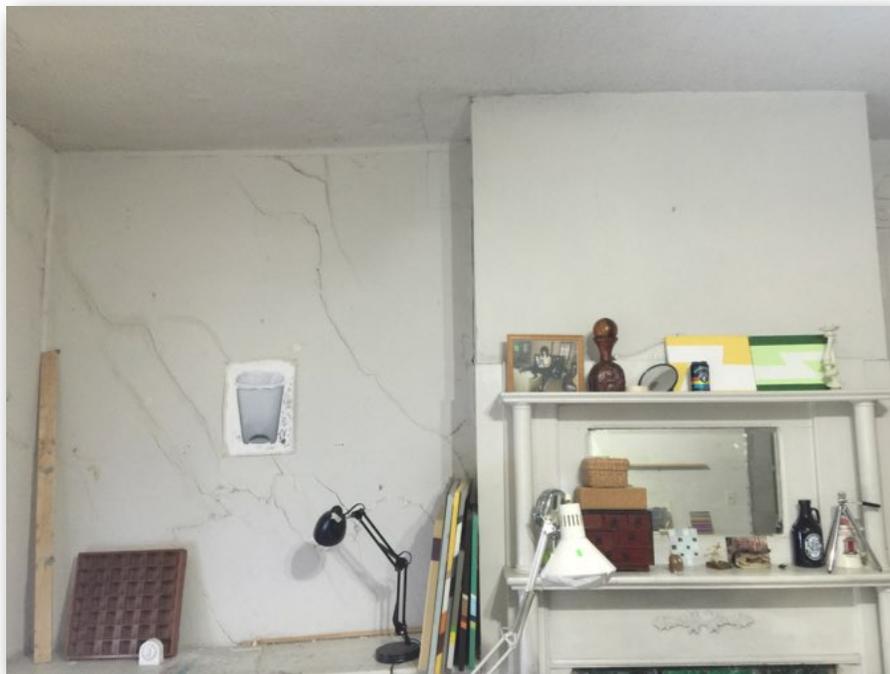
Photo 8: Wall to left of fireplace has diagonal cracking in the plaster as the wall is racked.

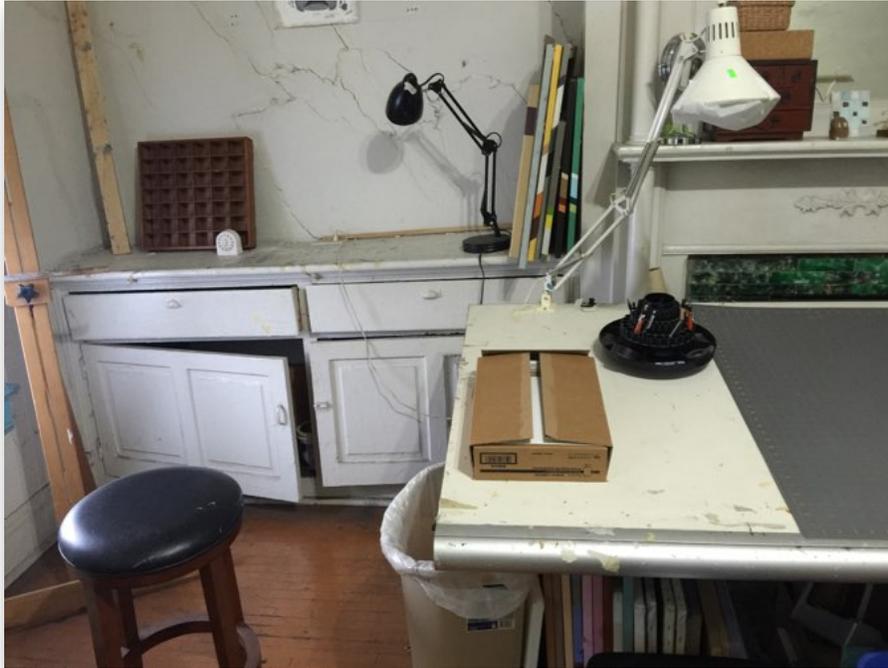
Photo 9: The cabinets to the left of the fireplace are sloping to the exterior wall with the floor.

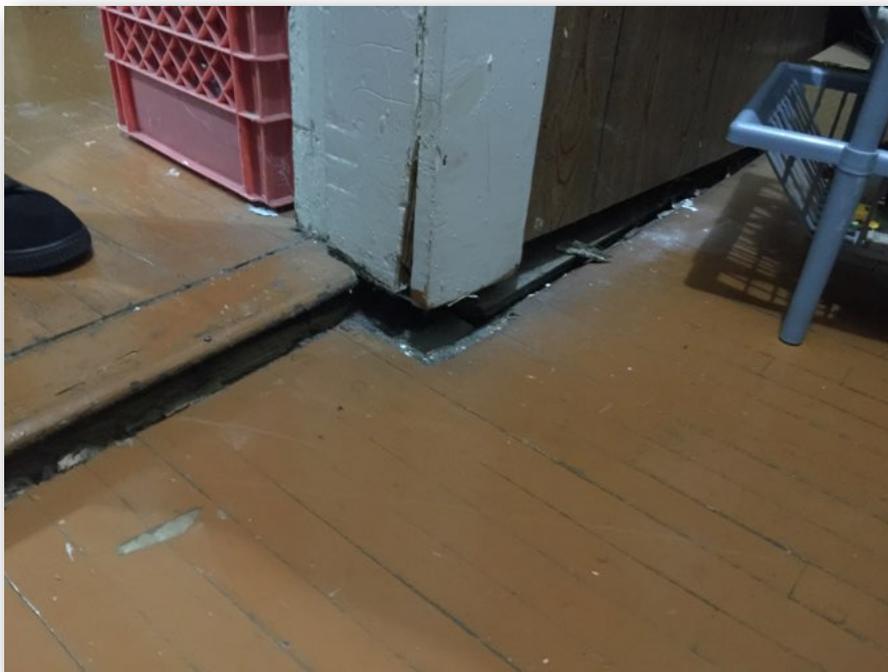
Photo 10: The floor is falling away from the interior right wall of the middle left room. This door opening is between the room and closet located to the right of the room. The closet appears to be an enclosed former hallway area.

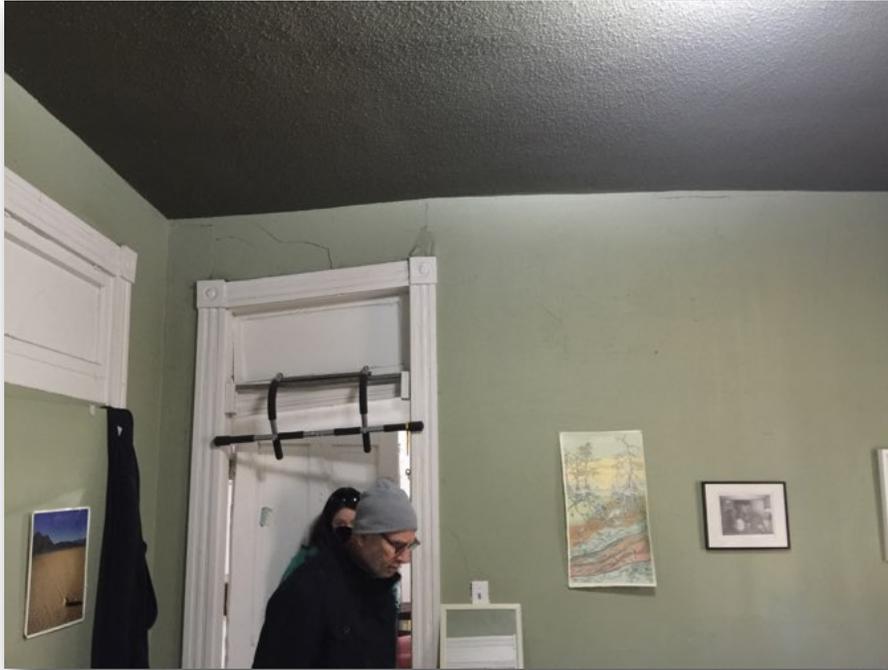
Photo 11: Front wall of back left room. Opposite side of wall shown in Photo 7. The amount of slope away from the fireplace area is dramatic in this photo.

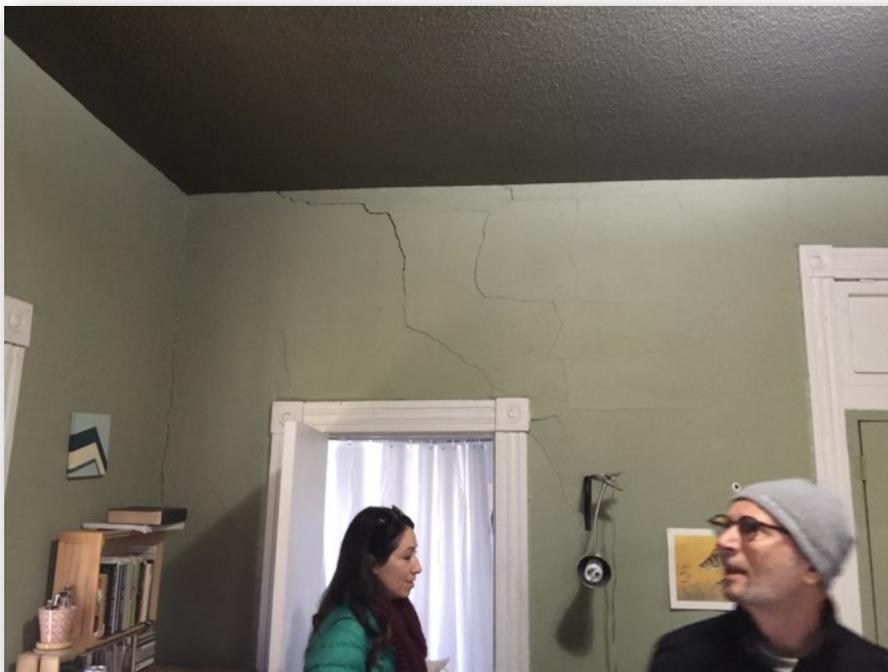
Photo 12: Right wall of back left room. Door opening to adjacent bathroom. Door frame is racked and the plaster is cracking.

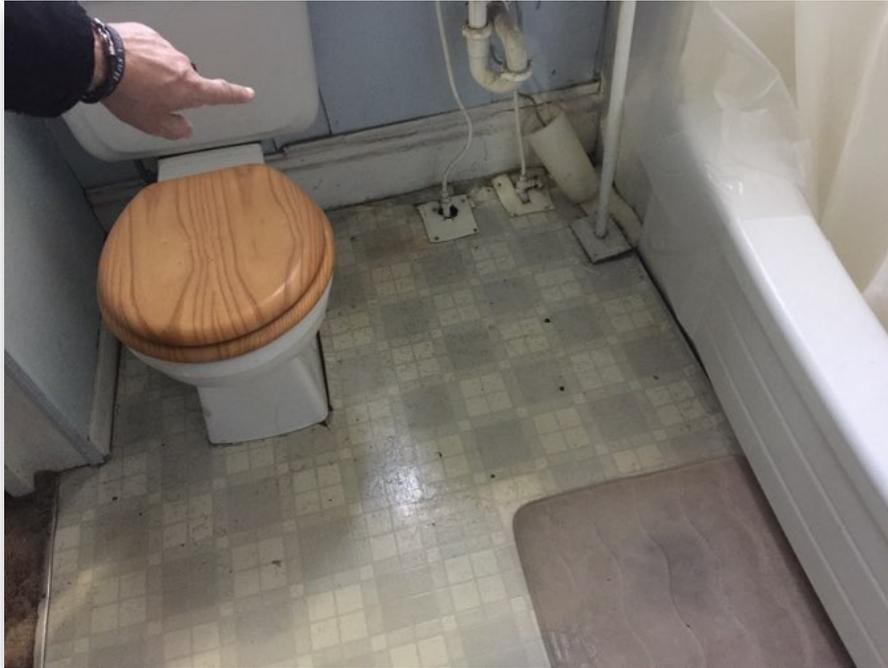
Photo 13: View looking toward back wall of adjacent bathroom. Does not do justice to show the significant left-to-right slope and the gap along the bottom of the cast iron tub.

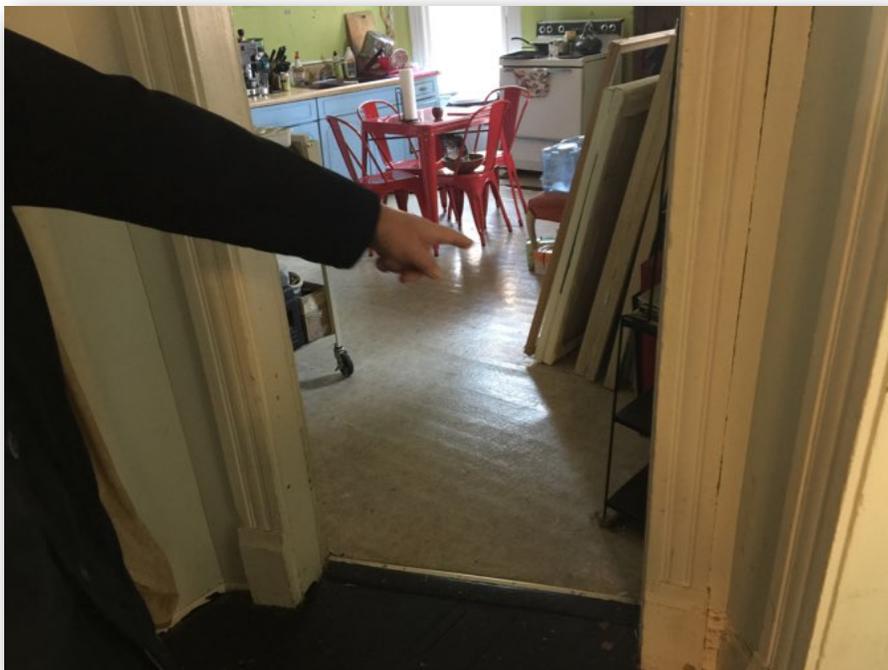
Photo 14: View from small central hall area into kitchen area, which is the middle right room of the house. The photo does not show the significant front-to-back slope of the room. The room is estimated to be sloping approximately 6" to 8" across the room.

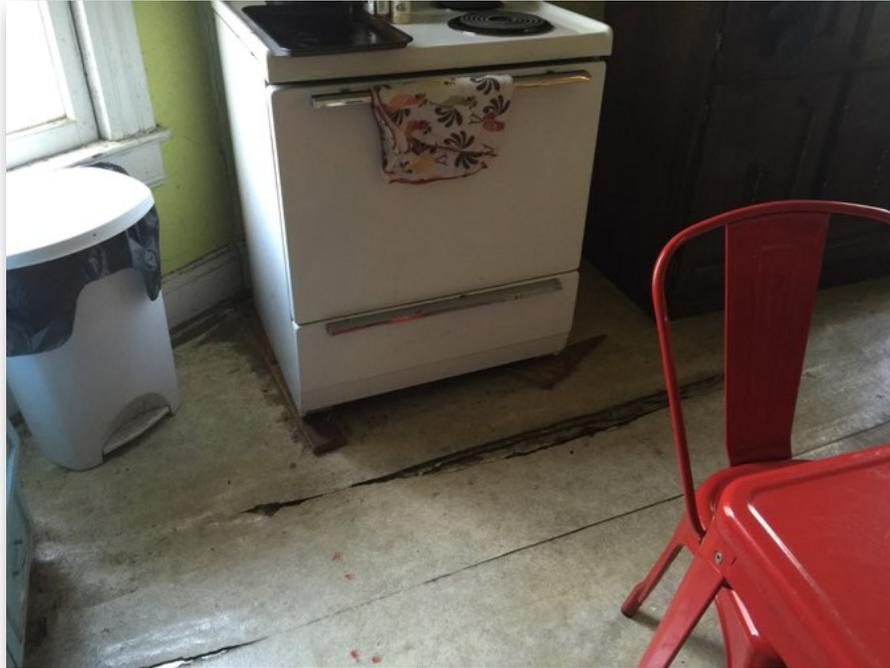
Photo 15: Kitchen floor slope is significant enough that the range has been shimmed with 2x4s and plywood to create a relatively level cooking surface.

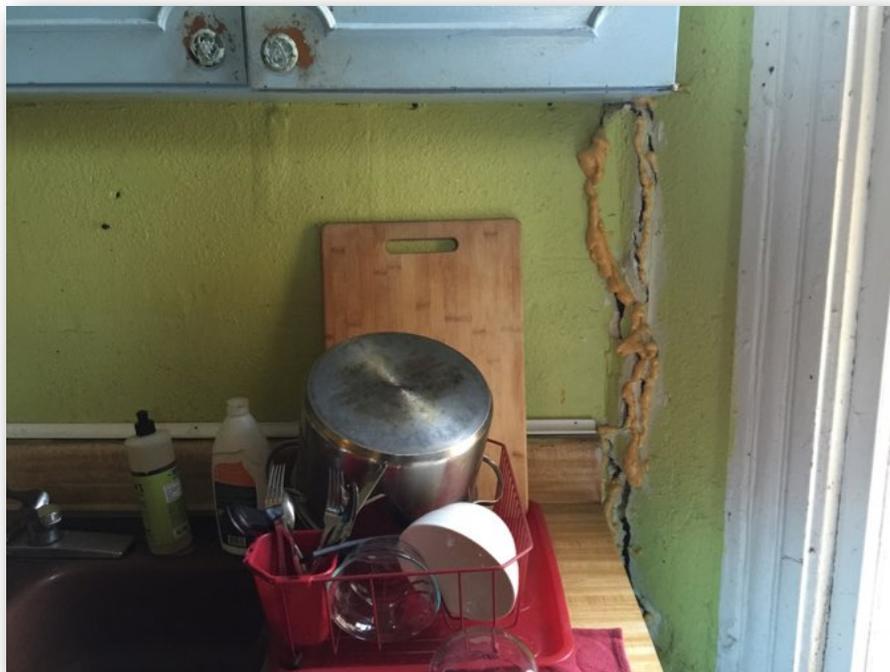
Photo 16: View into back right corner of kitchen at back edge of bay area. Wall is cracked significantly and daylight can be seen through the crack. Attempts have been made to fill the space with foam insulation.

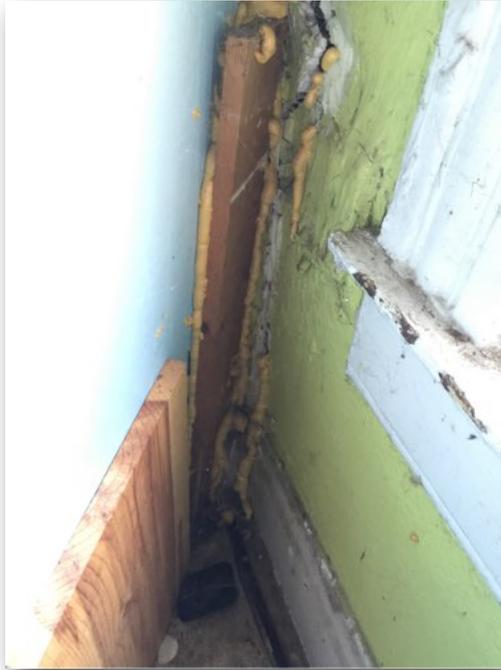
Photo 17: View along side of base cabinet. Gap in the wall has been filled with wood scraps and foam insulation.

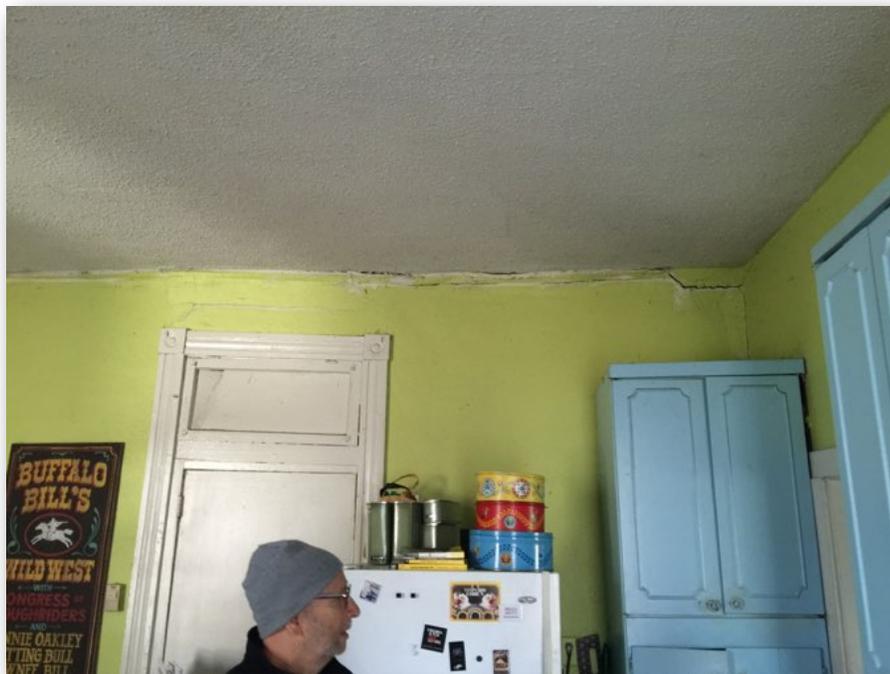
Photo 18: View along left wall of kitchen. Significant cracking between ceiling and top of wall due to slope of floor and settlement of the interior first floor structure.

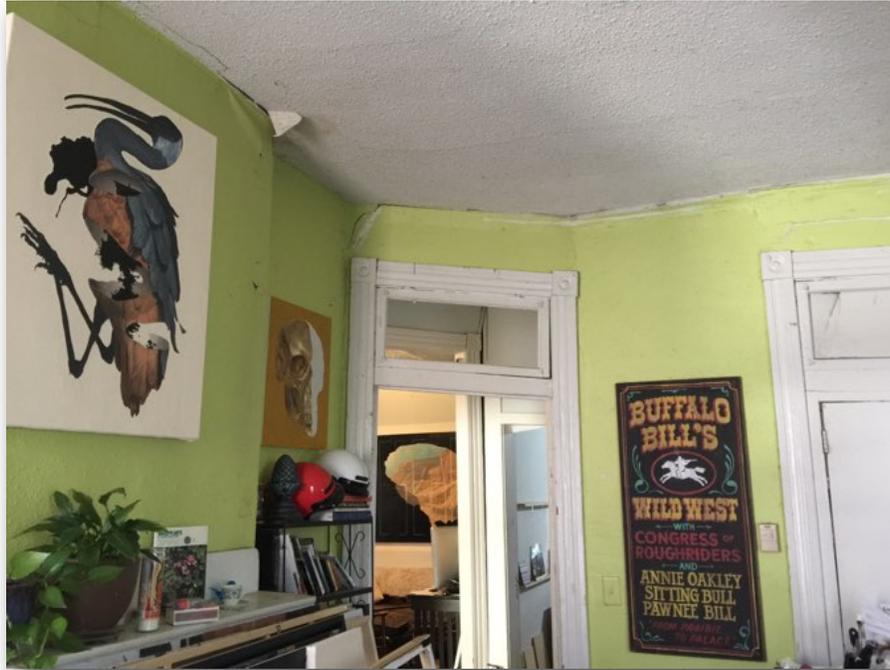
Photo 10: View of kitchen door to central hall area at front left corner of room. Door frame is racked significantly.

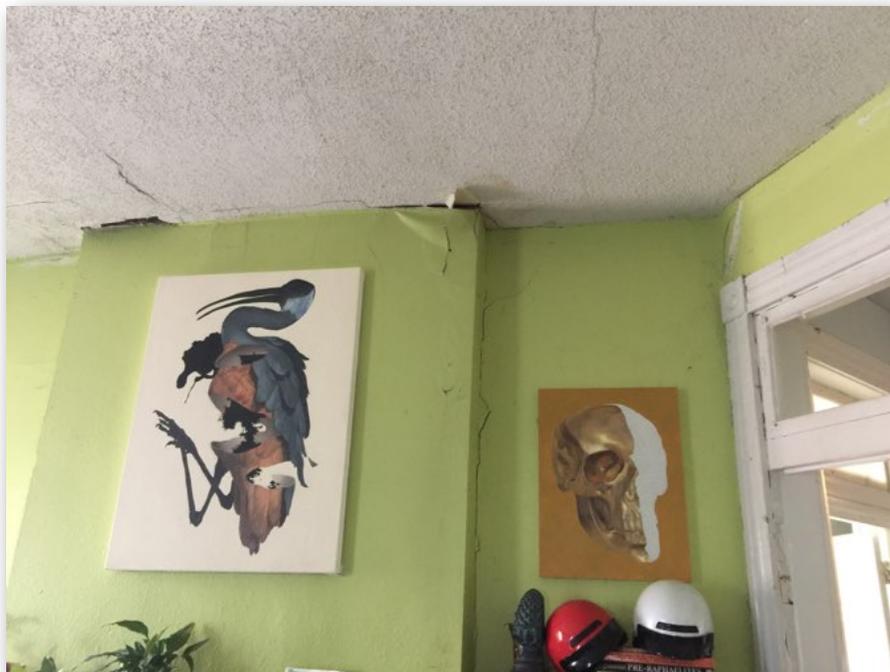
Photo 20: View along front wall of kitchen along back side of fireplace in front right room. Significant cracks between ceiling and wall and along sides of fireplace.

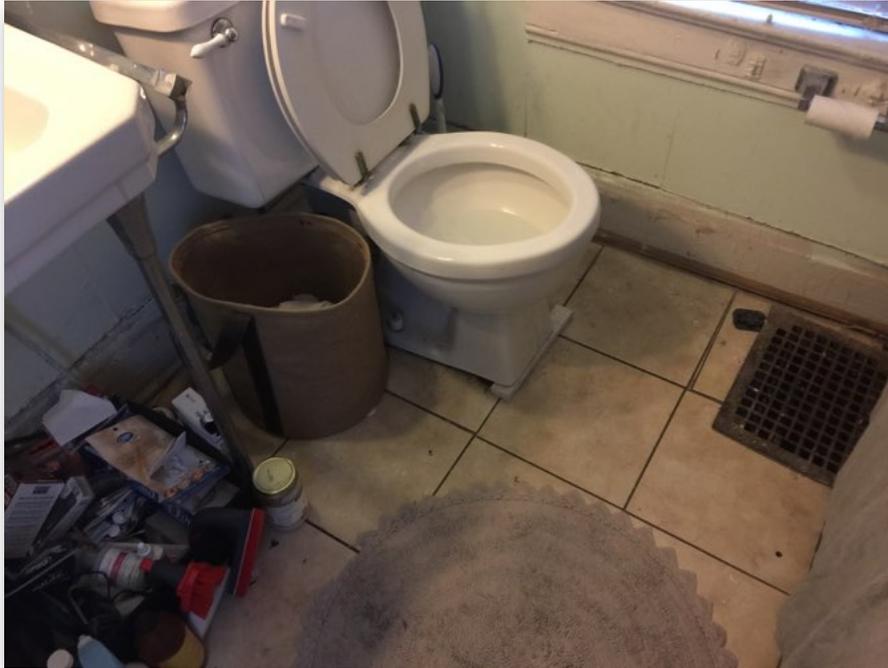
Photo 21: Bathroom at back right corner of the house, behind the kitchen area. The commode has been shimmed with a scrap of wood to level the commode.

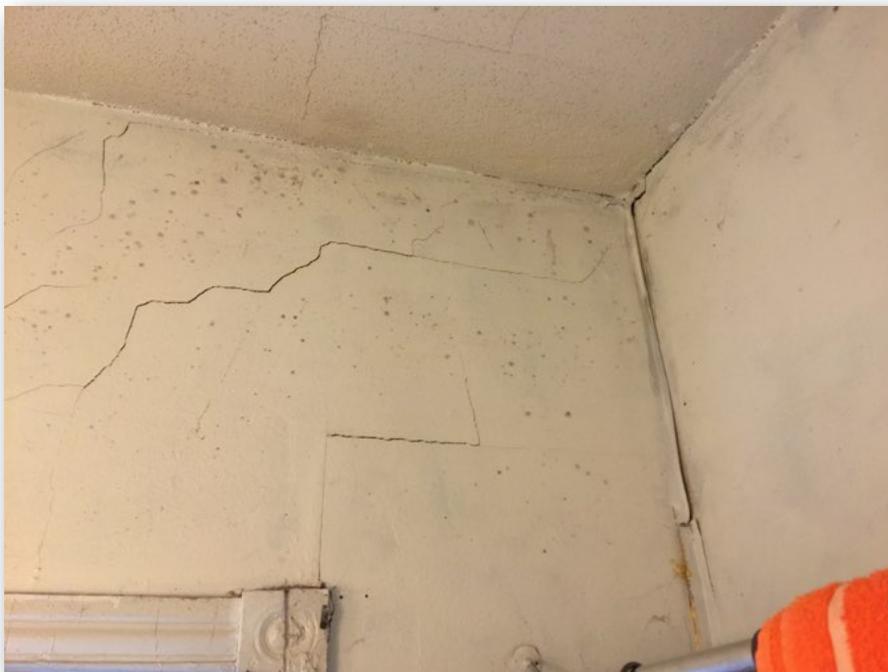
Photo 22: View along right wall of bathroom at corner shared with back right of kitchen. The plaster is cracking significantly above the window opening and along the corner.

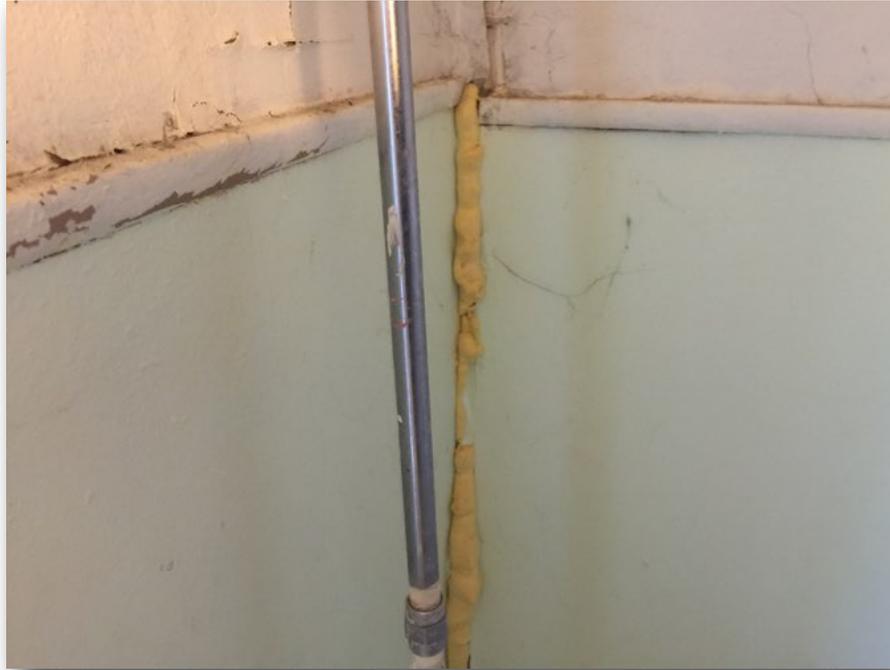
Photo 23: Large gaps along corner cracks in front right corner of bathroom in shower area. Gaps filled with foam insulation.

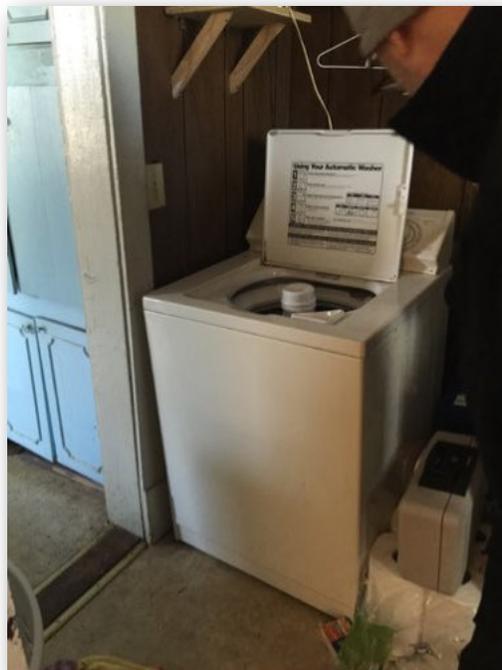
Photo 24: Laundry area behind back left corner of kitchen and left of the bathroom above. The washer is shimmed with wood scraps to level the appliance.

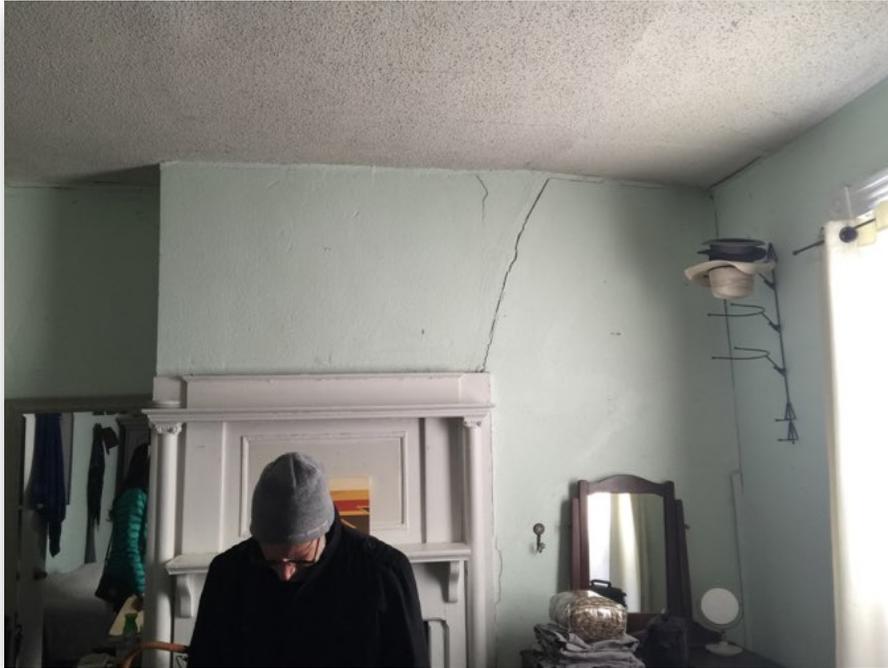
Photo 25: View of rear wall of front right room. Opposite side of wall shown in Photo 20 above. Significant plaster cracks and slope away from fireplace toward right exterior wall.

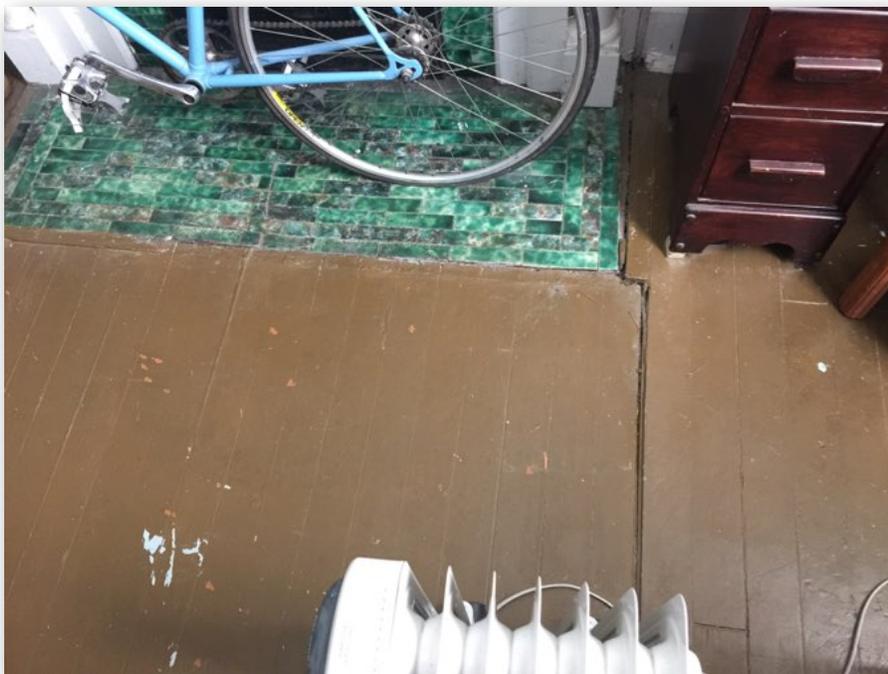
Photo 26: Significant slope at right side of fireplace and separation in hardwood floor planks.

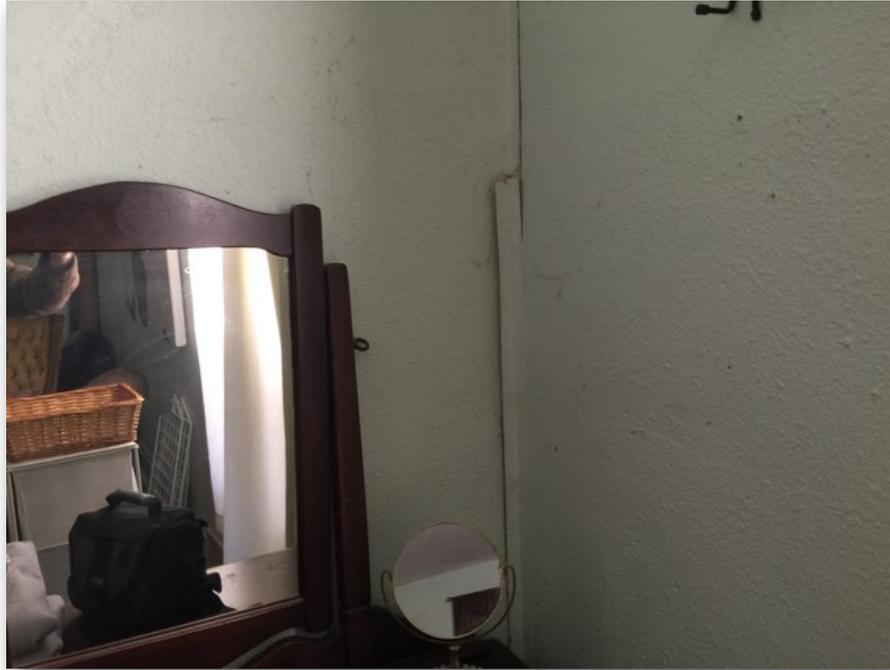
Photo 27: Significant cracking at back right corner of the front right room along exterior wall.

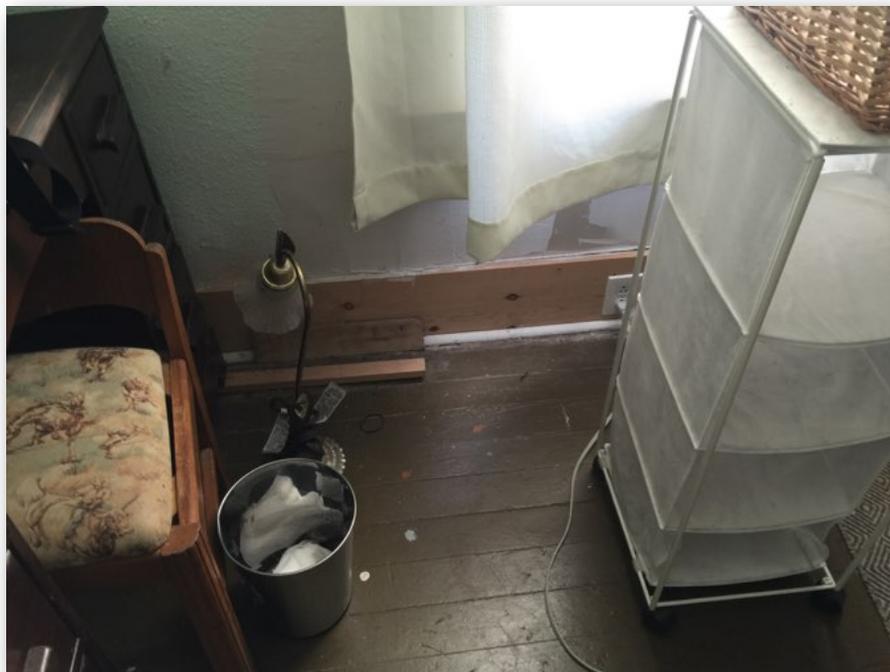
Photo 28: Base molding has been replaced with wood to cover gap between wall and floor.

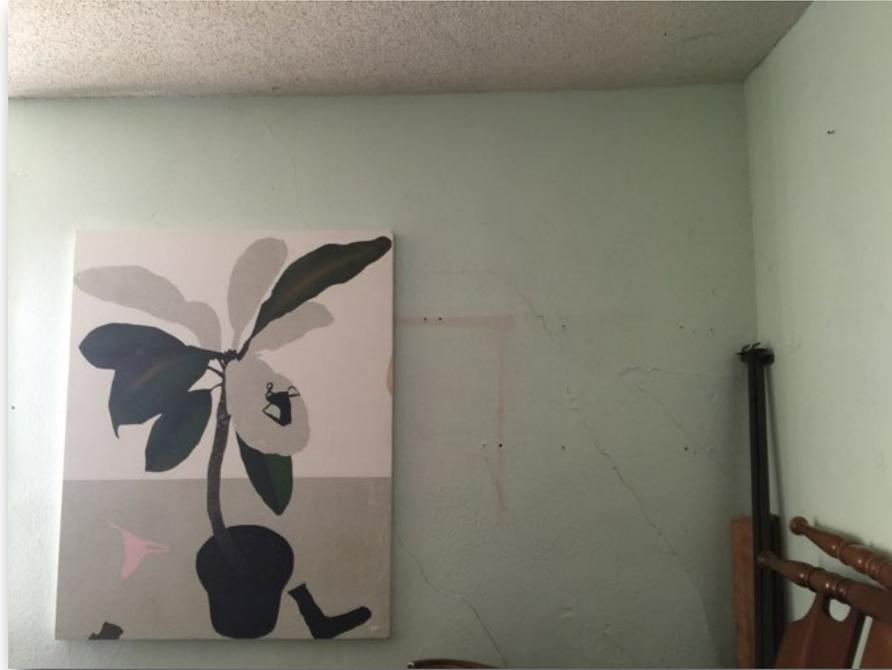
Photo 29: Right wall from front right room. Diagonal cracks through plaster finishes near front right corner.

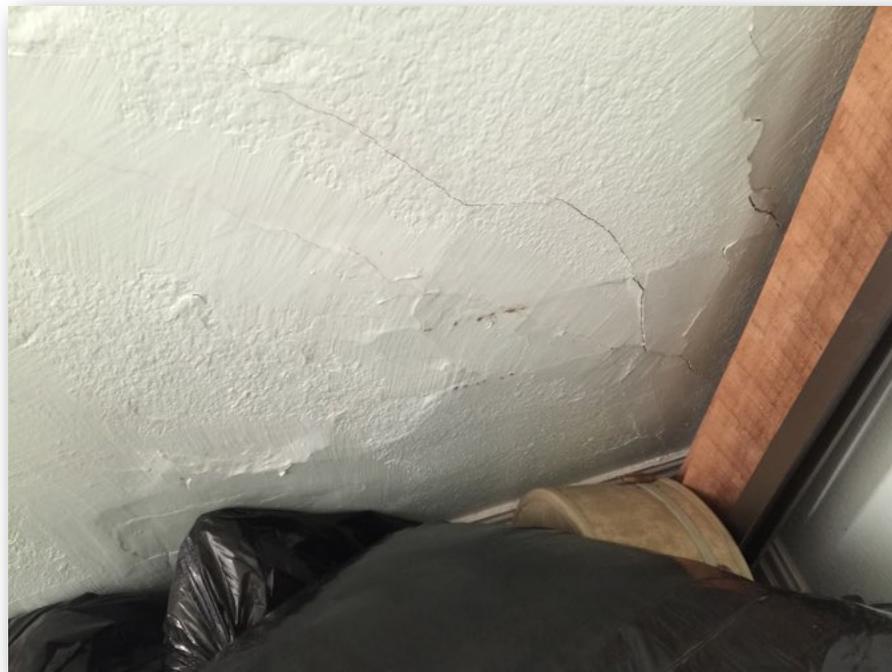
Photo 30: More cracks near bottom of wall.

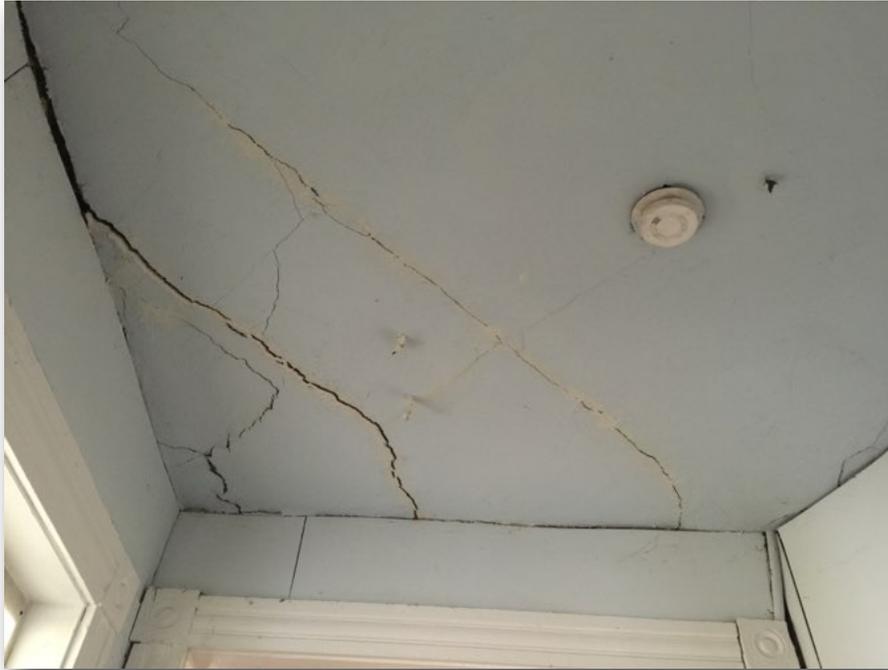
Photo 31: Ceiling of small hallway area leading to the individual rooms. Significant cracks through plaster and along wall/ceiling intersections.

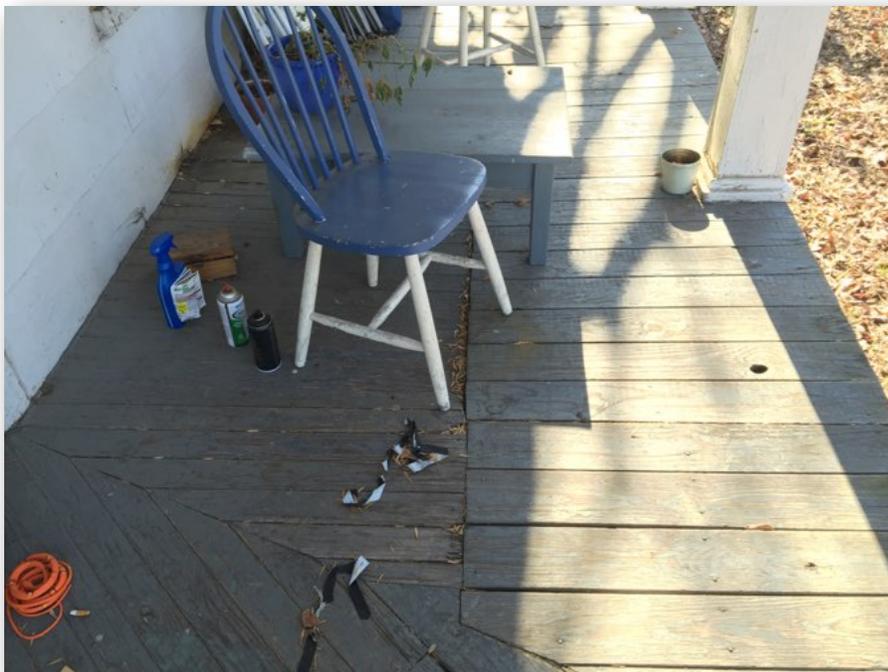
Photo 32: Porch along front wall, deck appears to be deteriorating and many boards need to be replaced.

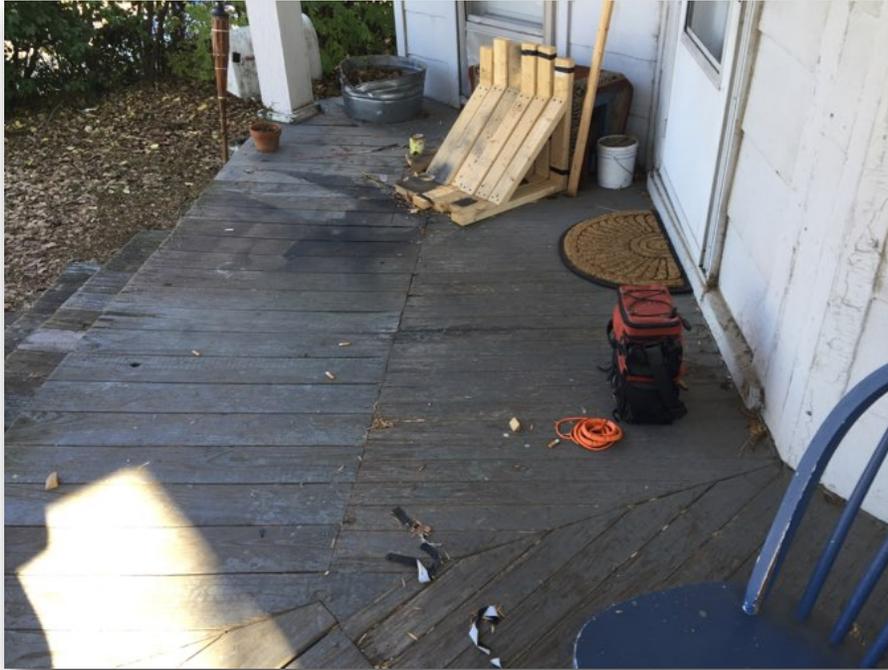
Photo 33: Porch along left side of house. Boards appear to have been replaced halfway into the deck.

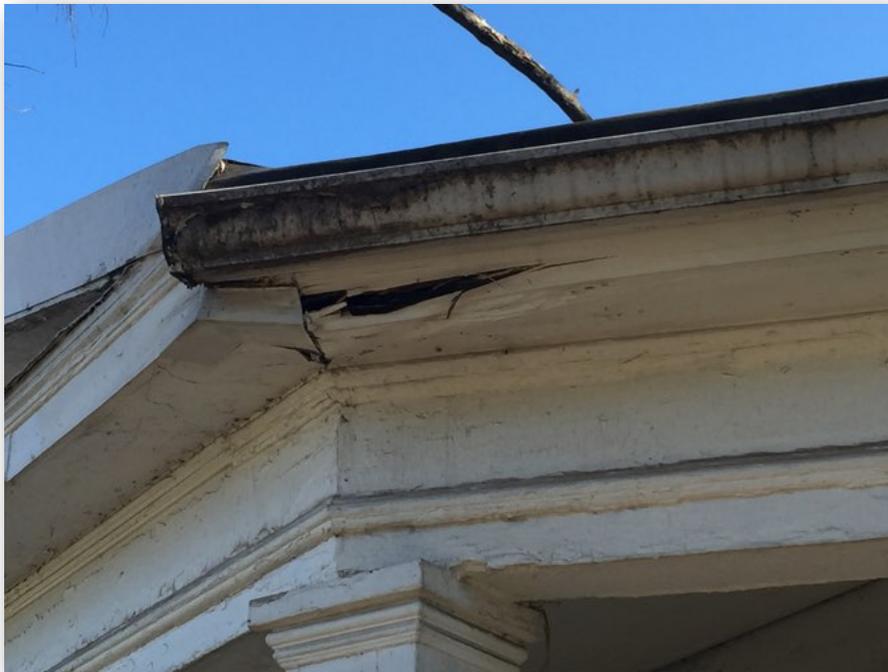
Photo 34: Eave of roof is deteriorated and rotting.

Item	Description	Cost Estimate	Notes
Demolition	Remove existing cedar pole foundation and wood underpinning, remove from site, temporarily level and support structure with steel I-beams	20,000.00	
Footings	Hand dig 200 linear feet 18"x 12"/ pour new concrete footing	7,500.00	
Foundation	Install 200 linear feet of new split faced concrete block foundation on newly poured footings	7,500.00	
Abatement	Abate existing asbestos shingle siding, existing plaster walls with lead based paint, repair existing wood siding	30,000.00	
Roofing	Remove multiple layers of existing asphalt shingles, repair decking, install new asphalt roofing. Flash existing chimneys	25,000.00	
Renovation	1627 square feet renovation @ \$135 per sq. ft. includes framing, plumbing, electric, heating and air, drywall, flooring, cabinetry, painting, insulation, new windows	220,000.00	
Cornice Repair	Repair water damaged cornice and roof overhang	8,500.00

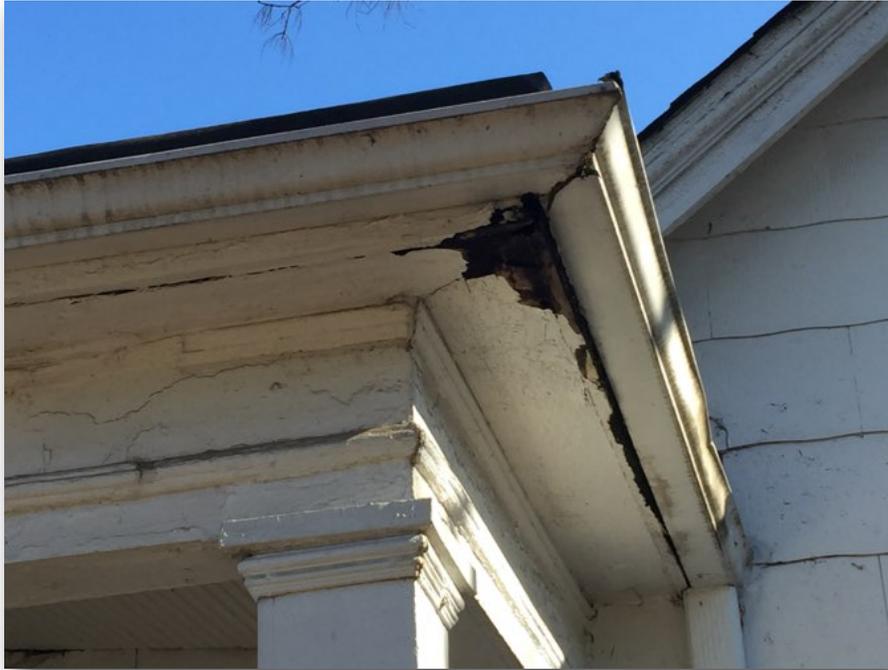
Photo 35: Soffit along side of porch roof is deteriorated and rotting.

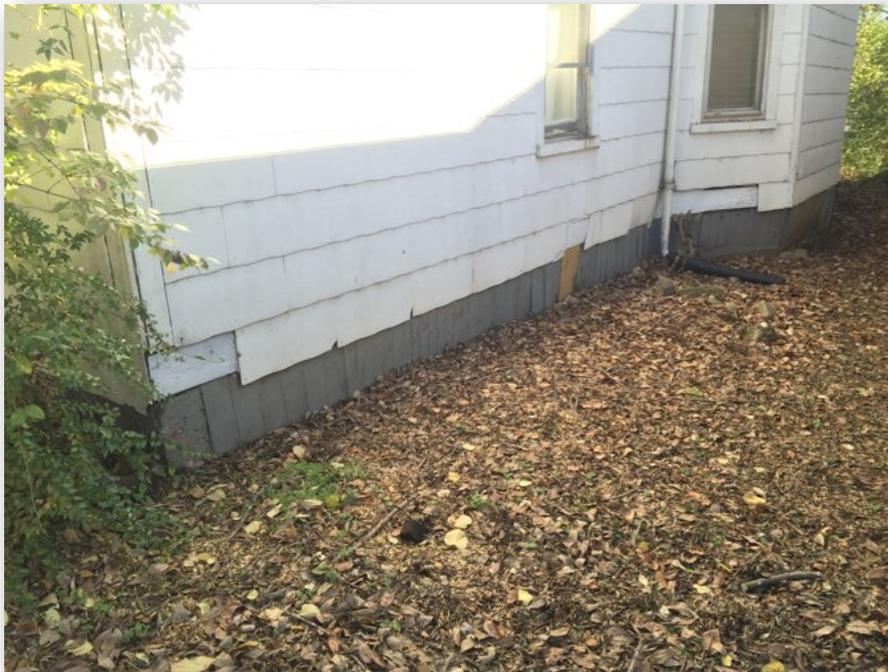
Photo 36: The exterior of the crawlspace is finished with wood board or vertical siding. There is no continuous foundation wall.

The house will require significant repair in order to restore its structural integrity. The interior of the home would have to be completely gutted to expose the wood-frame structure for further evaluation. The entire first floor will likely need to be reframed due to the extensive termite damage and slope in the floor structure. The existing cedar post foundation system is deteriorated to the point it is no longer adequate and must be removed and replaced with a conventional concrete masonry unit block foundation wall and pier system.

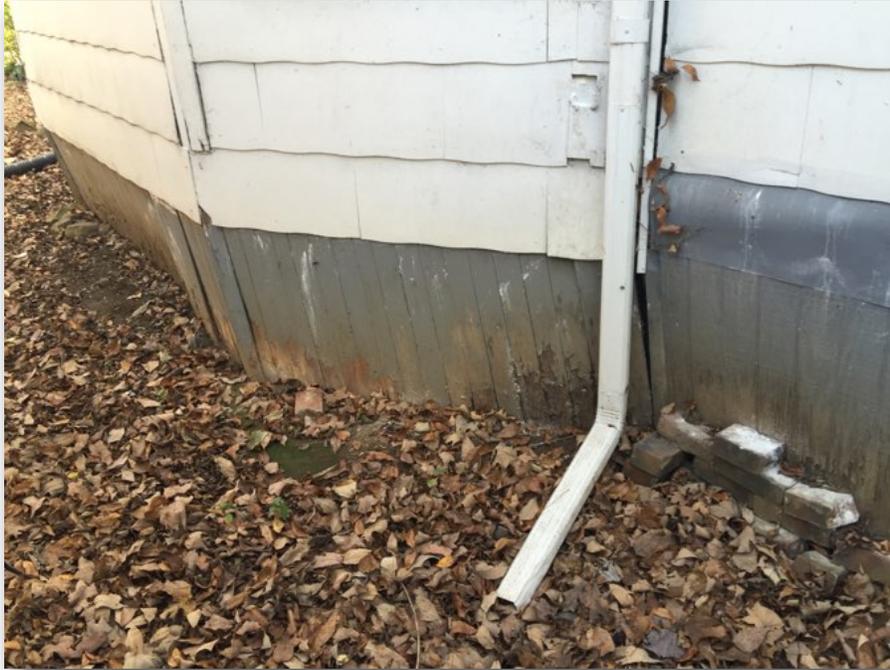
Photo 37: The bay along the right side of the kitchen appears to be shifting outward causing the perimeter skirting to lean. The corner behind the downspout is where the daylight was visible from the kitchen.
