STAFF RECOMMENDATION
2200 Grantland Avenue
March 16, 2016

Application: Demolition
District: Woodland in Waverly Historic Preservation Zoning Overlay
Council District: 17
Map and Parcel Number: 10514010500
Applicant: Michelle Stephens
Project Lead: Paul Hoffman, paul.hoffman@nashville.gov

RE: **Residential Structural Observations & Reporting**
2200 Grantland Avenue, Nashville, TN
SE&I Project No.: 15-1276

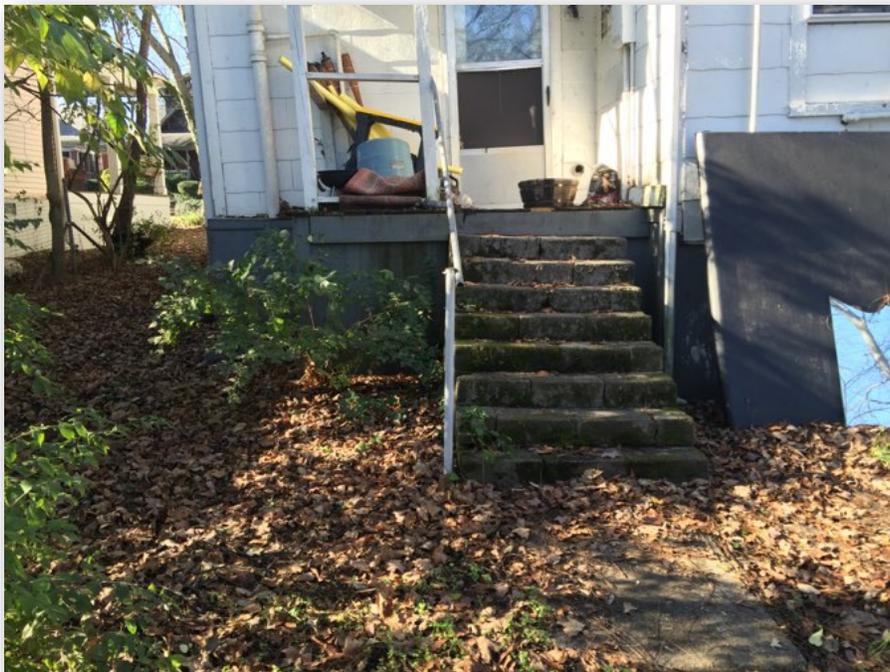
Photo 38: Steps to rear porch have settled and are sloped to one side.

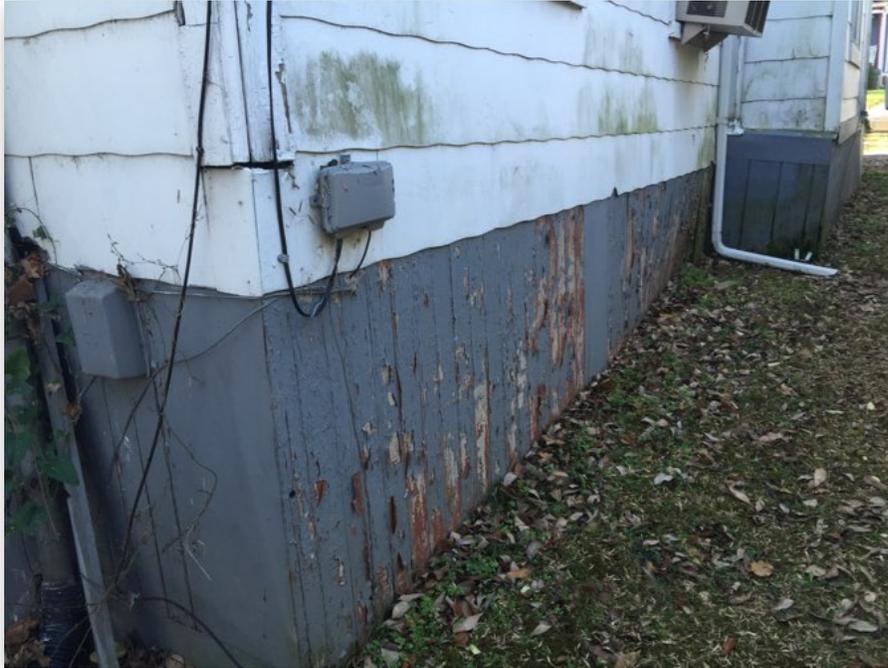
Photo 39: Skirting along left side of house along middle room is deteriorated.

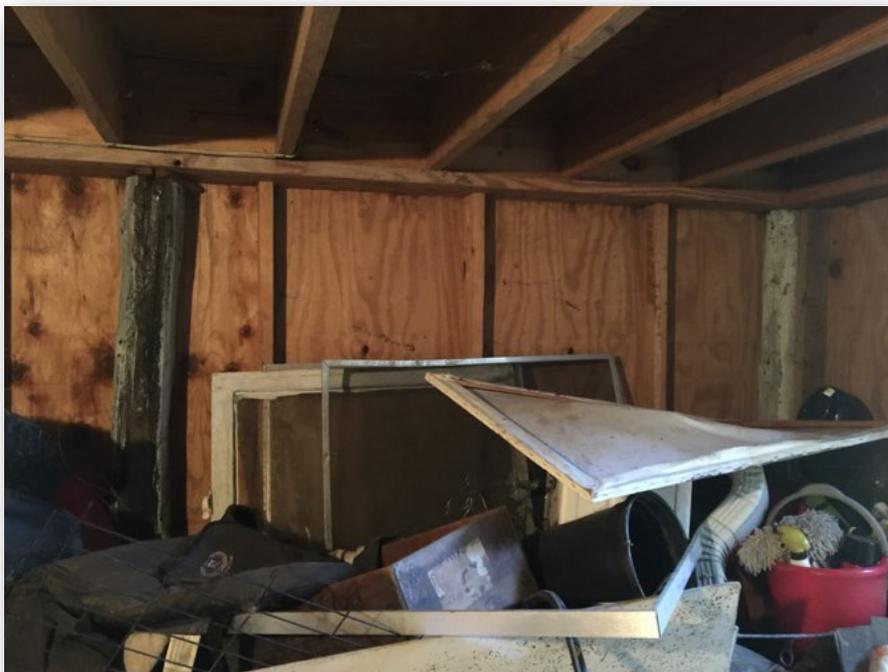
Photo 40: Perimeter skirt wall construction appears to be non-pressure treated lumber. Note location of what appears to be the original cedar posts along the wall.

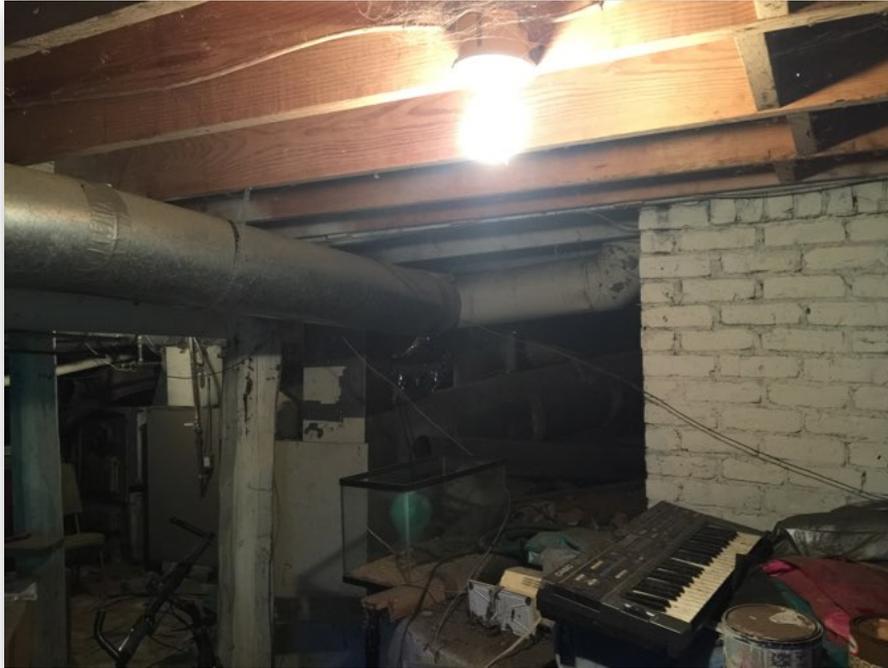
Photo 41: Brick masonry chimney between left middle and left rear rooms. Note newer floor framing below back left room. White painted framing beyond is sloping significantly away from the chimney.

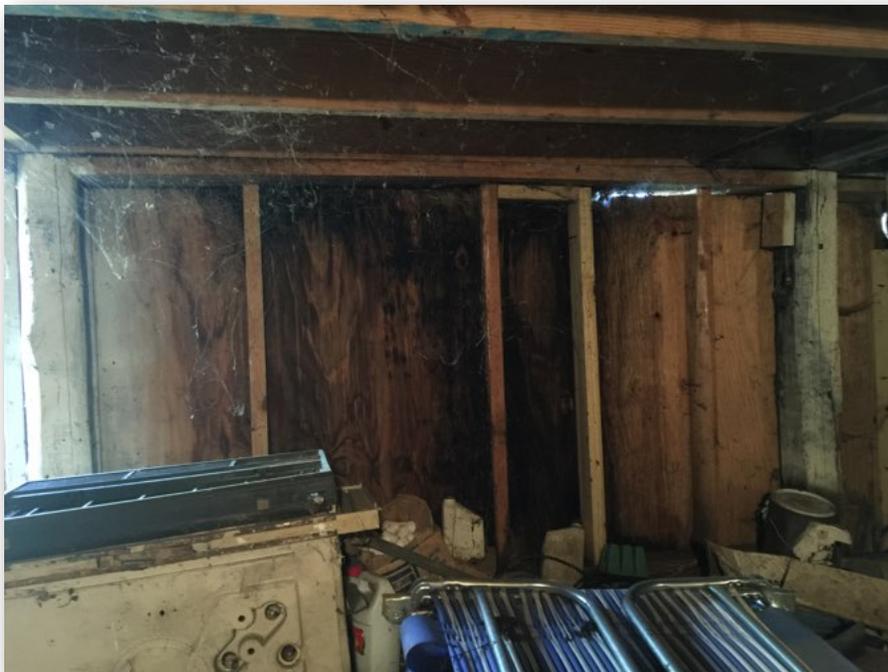
Photo 42: Water damaged and deteriorated sheathing and framing of skirt wall along back wall of house.

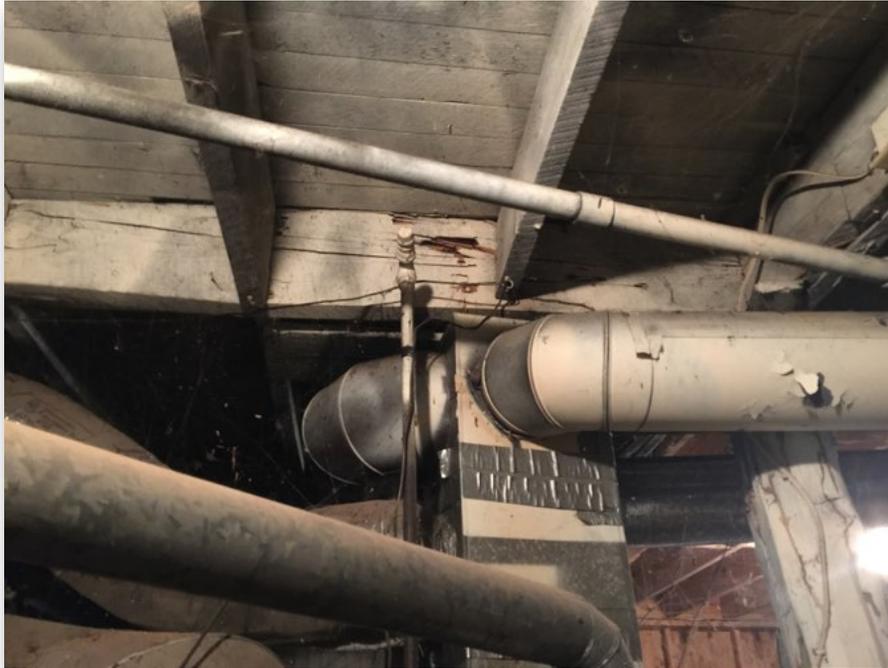
The slope in the floor framing is clearly visible around the masonry chimney structures. There appears to be a main beam extending front-to-back, along the side of the chimney, that contains significant termite damage. The beam appears to be crushing and deflecting significantly. In one area the beam appears to be bearing directly on top of an older furnace appliance in the cellar area. The framing below the bathroom areas appears to have several notches and possible evidence of previous water damage. The cellar space appears to have been excavated very close to the right exterior wall of the house. The excavation appears to have undermined the original cedar posts that were supporting the floor framing at the bay. The bottom of the posts are no longer bearing on soil and appear to be hanging from the bottom of the floor framing.

Photo 43: Main support beam located below right wall of left rooms. The brick chimney in Photo 41 is located behind this equipment. The beam is heavily damaged by termite activity and is currently bearing over this piece of equipment.

Termite Repair	Repair termite damaged floor system framing	10,000.00	
Subtotal		328,500.00	
Contractors fee	15%	47,775.00

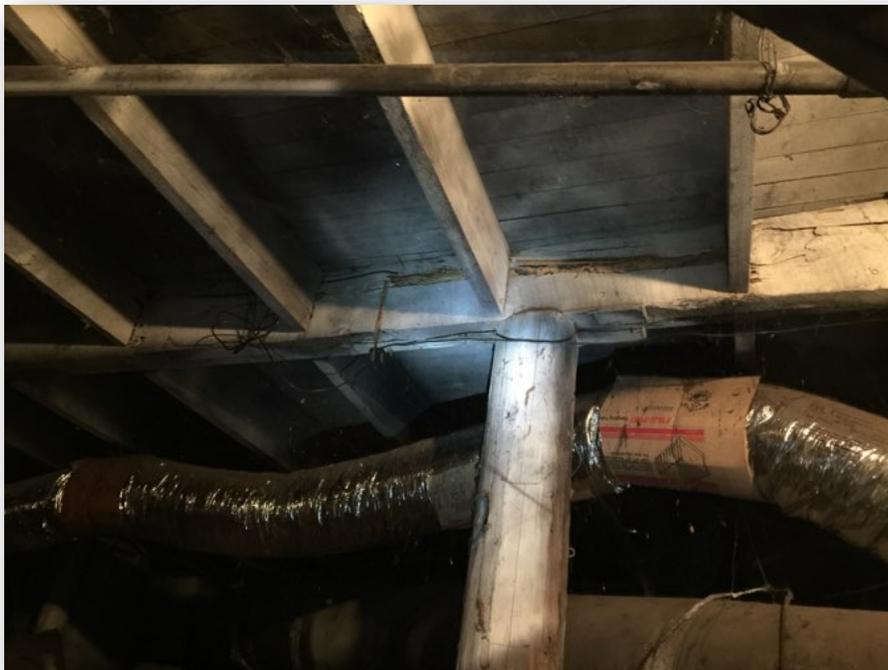
Photo 44: Same beam, closer to front of house. Heavily damaged by termite activity. Beam crushing over support post. There is no ledger board to support joists along beam.

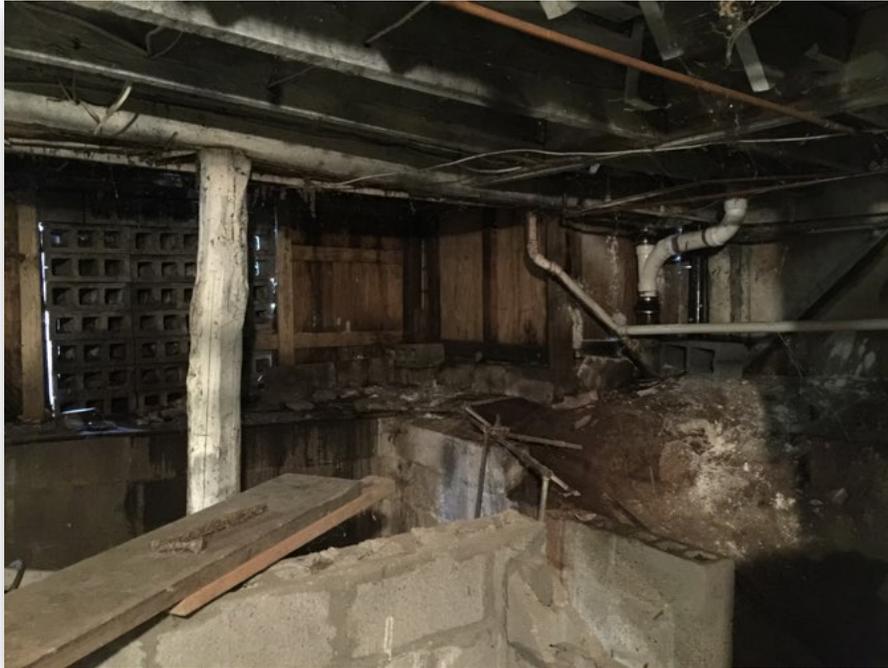
Photo 45: View into back right corner of crawlspace/cellar area. Note plumbing to right is the bathroom at back right corner of house.

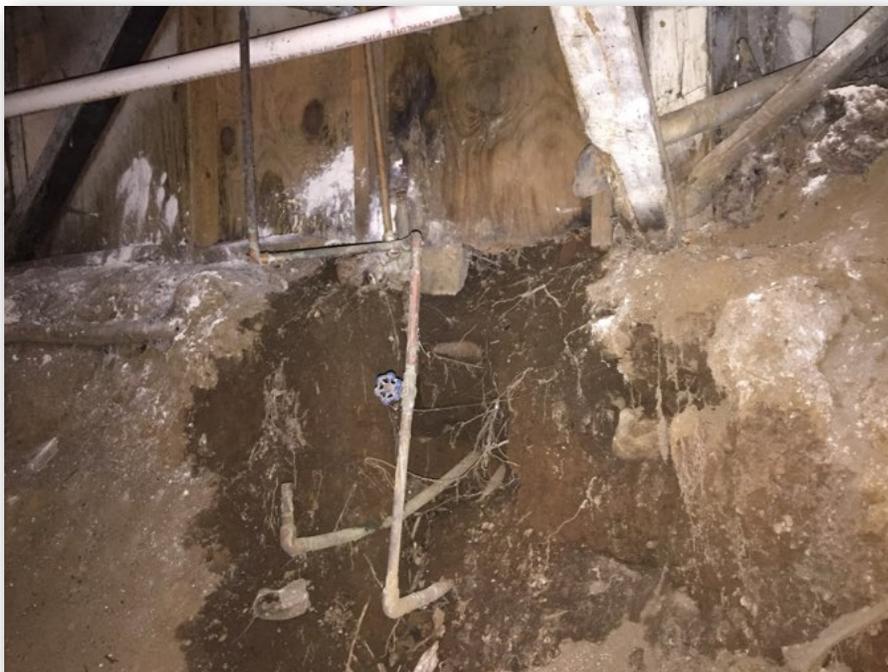
Photo 46: Erosion of soil below right side of bathroom and back right corner of kitchen area. Post has no bearing on soil at this corner and may explain the significant slope of the kitchen floor.

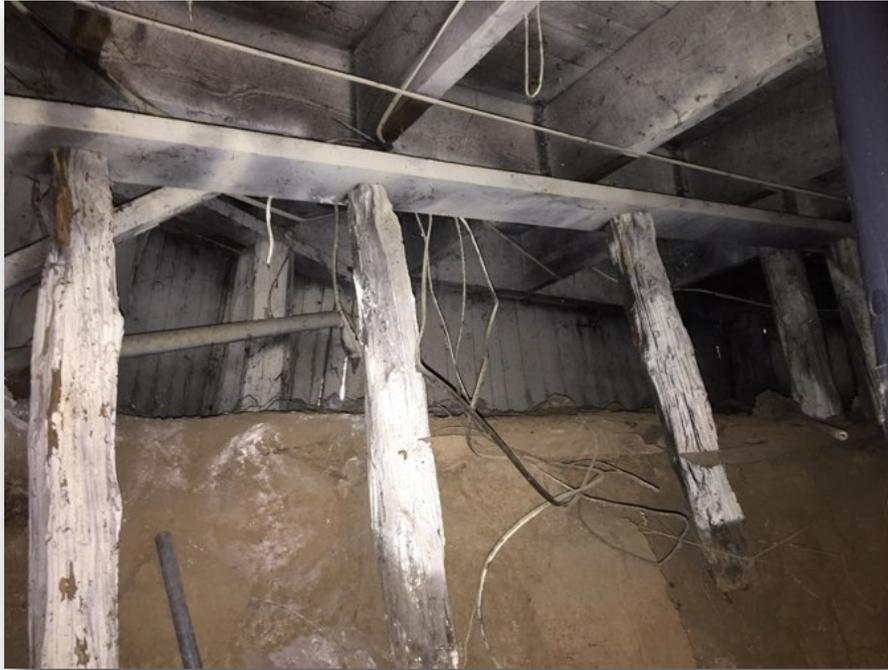
Photo 47: Support posts below right side of kitchen, bay area beyond post line. Posts no longer have bearing over soil as the soil has eroded significantly.
