STAFF RECOMMENDATION
3726 Richland Avenue
April 20, 2016

Application: Demolition; Reconstruction
District: Richland-West End Neighborhood Conservation Zoning Overlay
Council District: 24
Map and Parcel Number: 10409007300
Applicant: Gary and Lou Ann Brown
Project Lead: Paul Hoffman, paul.hoffman@nashville.gov

Description of Project: Demolition of a contributing building and reconstruction to the specifications and details of the existing building.

Structural Condition Assessment of 3726 Richland Ave., Nashville, Tennessee

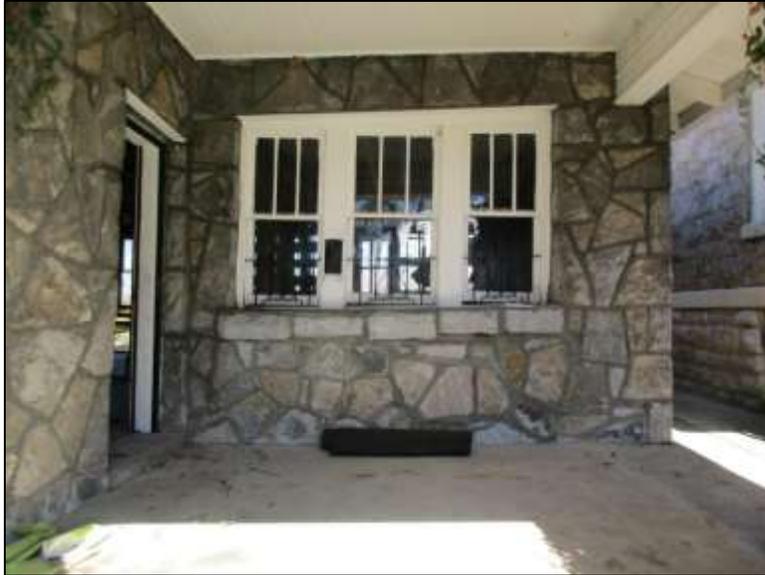
Figure 2. The window lintel and sill at the front porch reveal considerable settling

Demolition: There is settling apparent on first view of the building's front facade. The front porch shows a fall of two to three inches (2-3") over its twelve feet (12') from right to left. At an unknown date, the deterioration of the foundation wall was observed and remediation attempted with a new concrete block wall. This was laid adjacent to the front stone wall to a height of approximately seven feet (7') to support the stone wall. The new wall may have kept the stone behind it from fully collapsing. The engineer for the project observes that it also hid the problem, preventing the necessary repair:

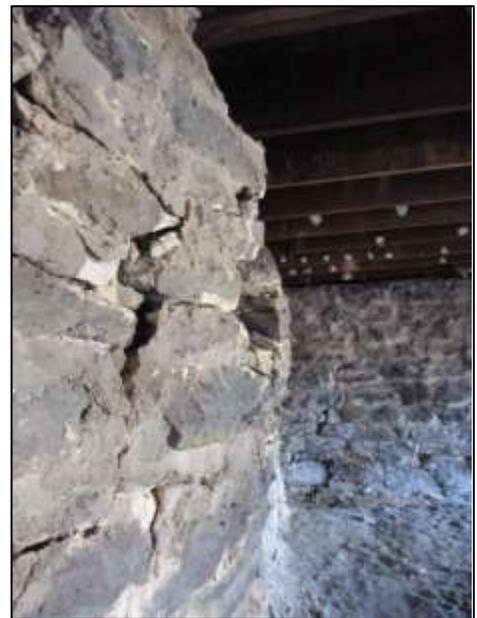
In order to assess the condition of the front basement wall hidden by the newer block wall, The Maintenance Company excavated a portion of the backfill against the front wall. What we discovered is that the wall hidden by the block wall was crumbling. The portion of the front wall not hidden by the block bowed inward during excavation and cracked considerably. The excavator noticed that the wall moved during his work.

Figure 3. The front foundation wall is crumbling into the basement

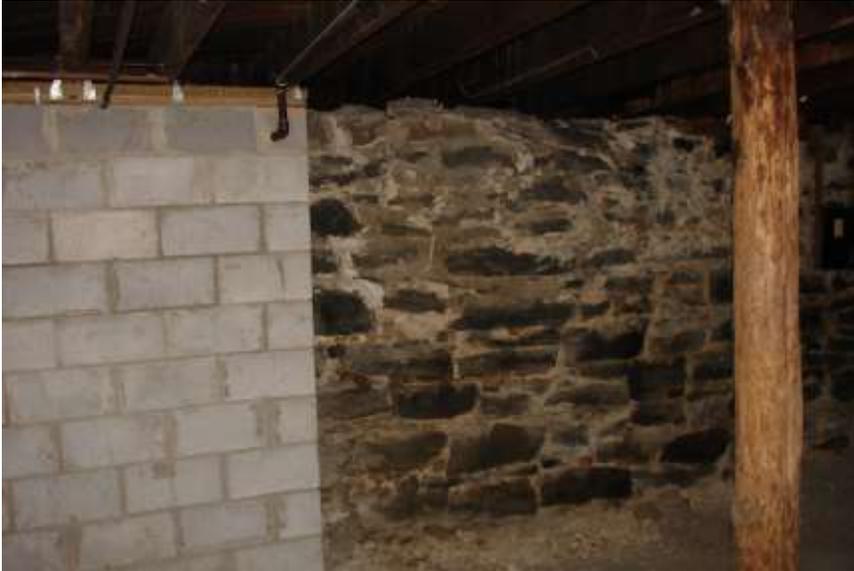
Figure 4. The concrete block wall built in front of the original stone wall. The deterioration of the stone is evident.

Consequently the stone wall requires rebuilding, while isolating the structure above. MHZC staff discussed with the applicants the possibility of phasing the repair work and rebuilding one section of the wall at a time. The engineer argues that is not feasible:

The sequencing of construction is where the problem lies. The front stone wall could collapse at any time, especially if any of the structure is disturbed. This is a dangerous situation for anyone working on the house. In order to gunite the interior side of the front wall, the newer block wall will have to be removed. If this block wall is removed, I am concerned that the crumbling stone wall would collapse.

Essentially, the wall has collapsed to the point that it is unsafe and cannot be repaired or rebuilt without the risk of fully collapsing. There is danger inherent both to the building itself and to members of the construction crew.

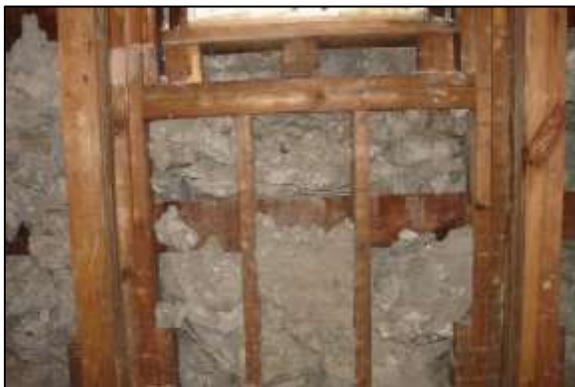
Complicating a potential repair effort is the unusual construction method for the exterior walls. These were built with wood studs supported by the stone wall beneath, and the stone cladding was laid in between the studs, rather than as a veneer as typically seen. The stones were mortared in place. It will be at least difficult and possibly infeasible to stabilize the stud/stone walls without losing some percentage of the stone veneer or to remove the stone and lift the house, replacing the stone after it is placed back onto a new

foundation. This adds another hazard to repairing or rebuilding the foundation walls.

Figure 5. The atypical construction method of laying the stone veneer inside the stud walls

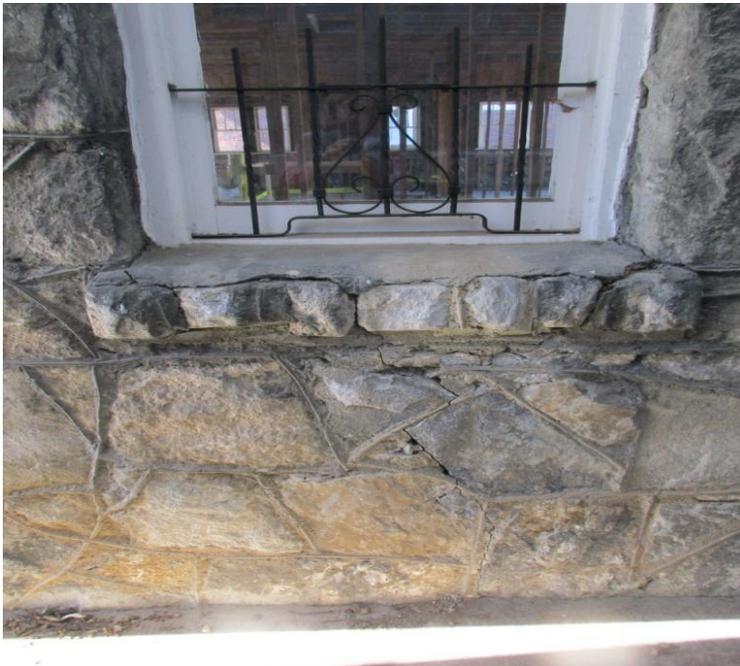
There was evidence of attempts to repair the stone cladding at several areas.

Repair work to window sill

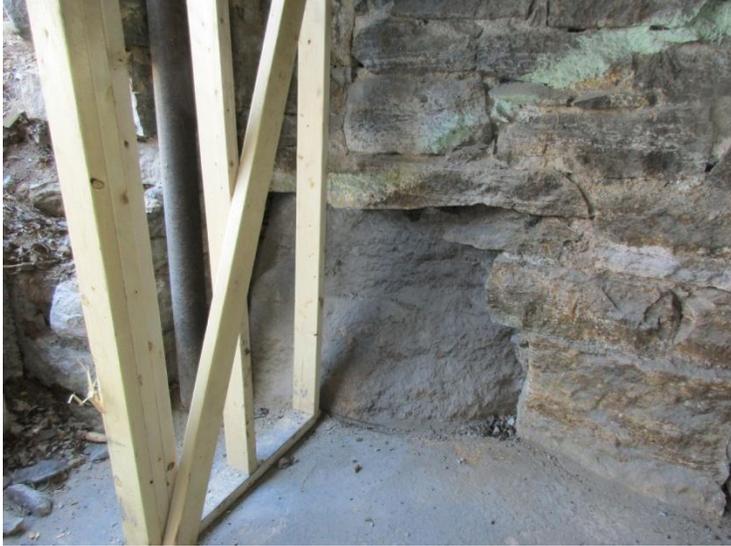
The east wall of the house is very close to the adjacent house. A large boulder was located along the back of the east basement wall. It appears that the boulder was too big to remove, so the stone wall was built on top of it.

Large boulder in East basement wall 1

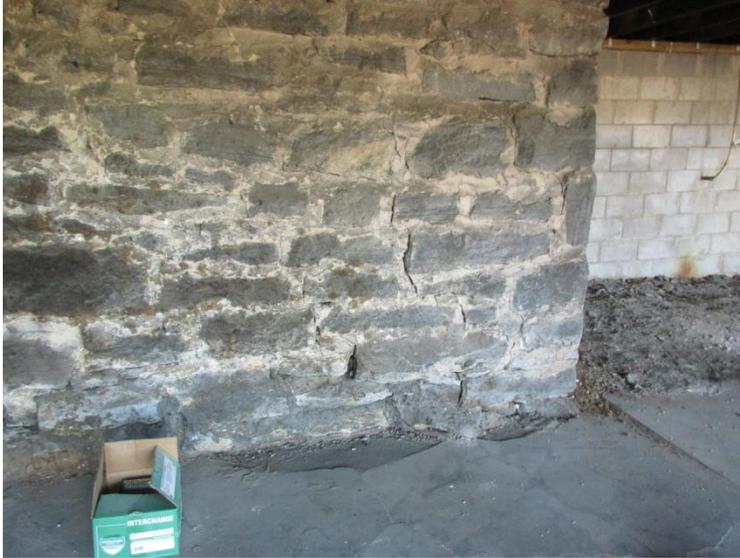
The slab at the covered entry to the front door was uneven and appears to have settled towards the inside corner. The concrete slab appears newer than original, but the settlement continued after the repair.

Cracks in basement wall at front porch. Note the crushed slab

The slab at the front porch would have to be removed and replaced.

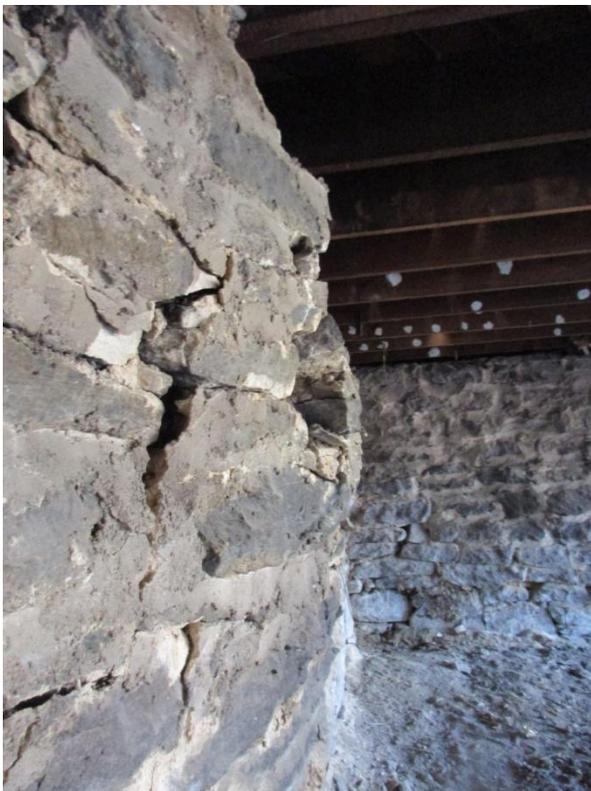
The portion of the front wall not hidden by the block bowed inward during excavation and cracked considerably. The excavator noticed that the wall moved during his work.

The bulge in the wall was more pronounced at a later site visit, indicating that it is moving and is unstable.

Bulge in front basement wall 1

I recommend the house be demolished along the front and west side and that any loose portions of the east wall be removed.

A new basement wall will be constructed along the front and west side. The east side basement wall will be left in place so as not to disturb the adjacent house. The stone left in place will be reinforced and gunited so that it will stay in place. A new basement wall will be constructed inside this area in order to support the floor and roof framing.

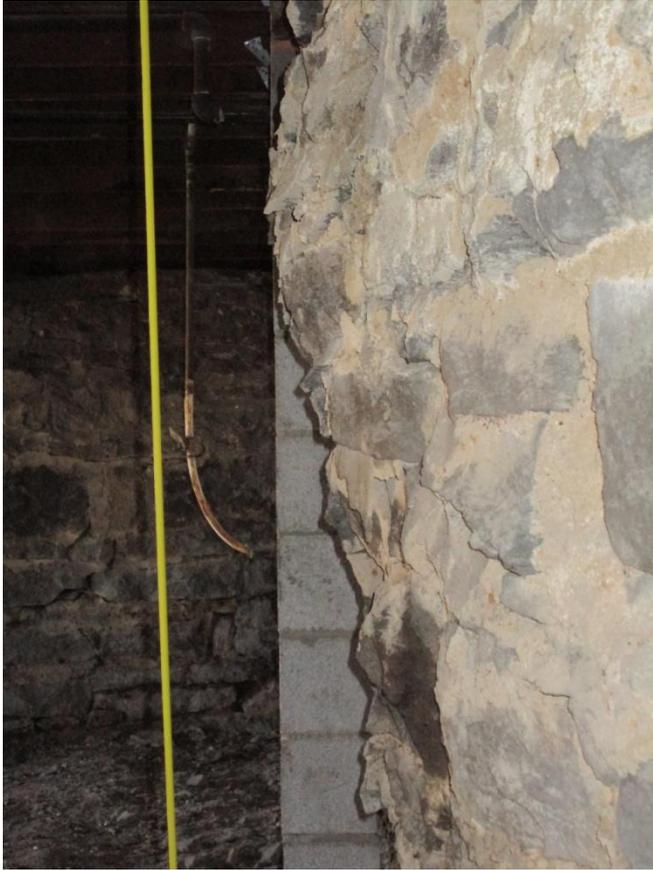
Bulge in front basement wall 2. Tape hung from framing as a plumb line

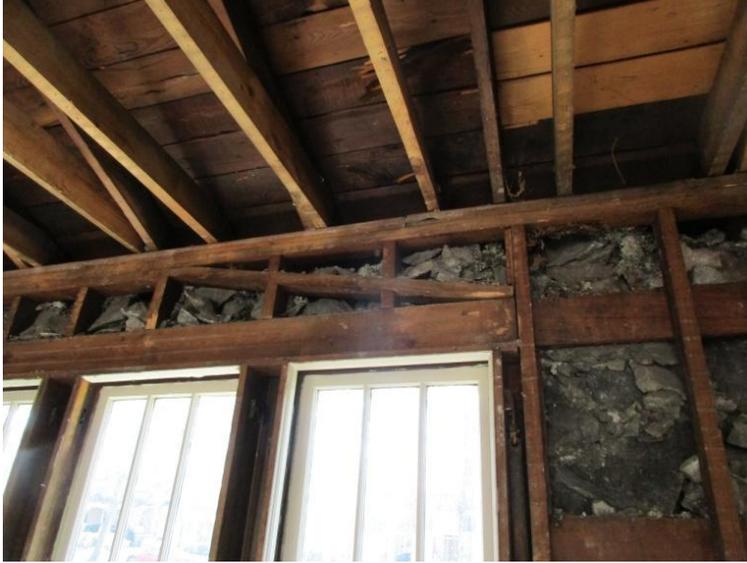
view of wall construction 1

When the framing was exposed we discovered that the exterior walls were constructed of wood studs supported by the stone wall and that the stone cladding was actually laid in between the studs, creating a stone/stud bearing wall.

There was no insulation or moisture barrier between the cladding and the plaster.

There were no ties, or other mechanical fasteners attaching the stone to the studs. The stone cladding was loose in several areas.

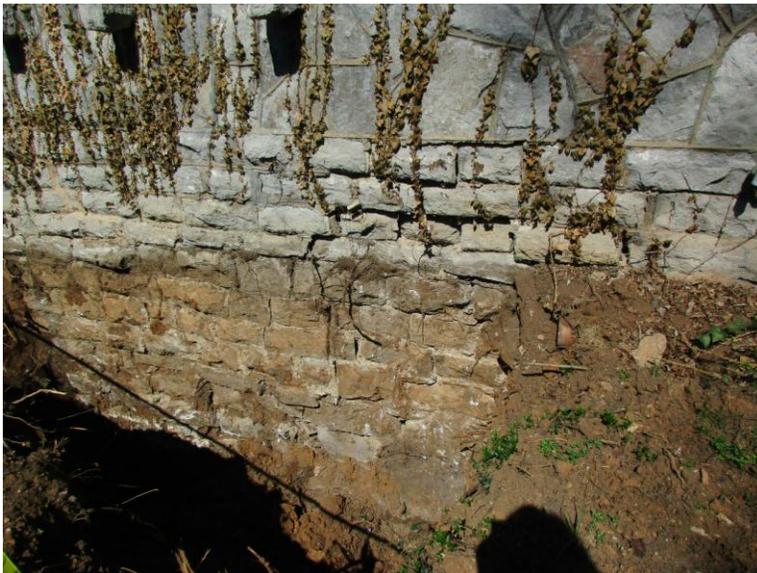
What we discovered is that the wall hidden by the block wall was crumbling.

crumbled front basemen wall behind block

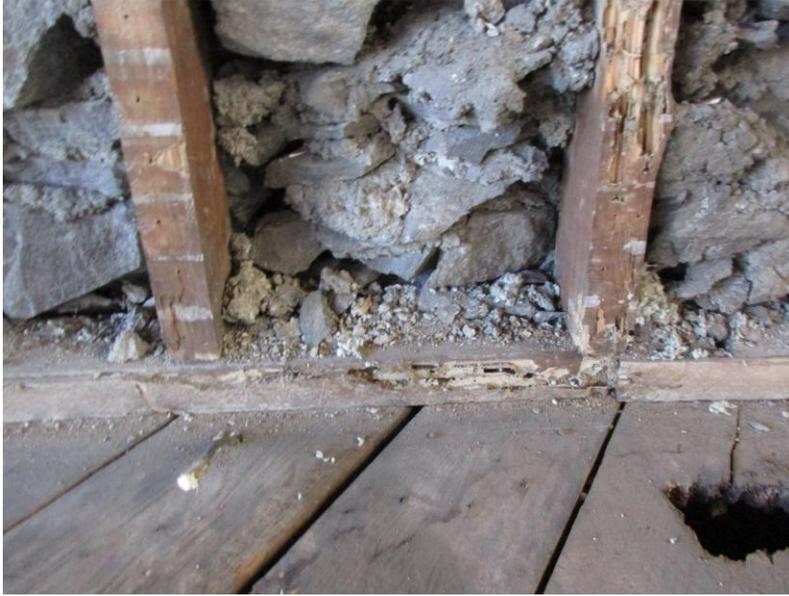
There was extensive termite damage in the studs along the east wall.

Termite damage to wood

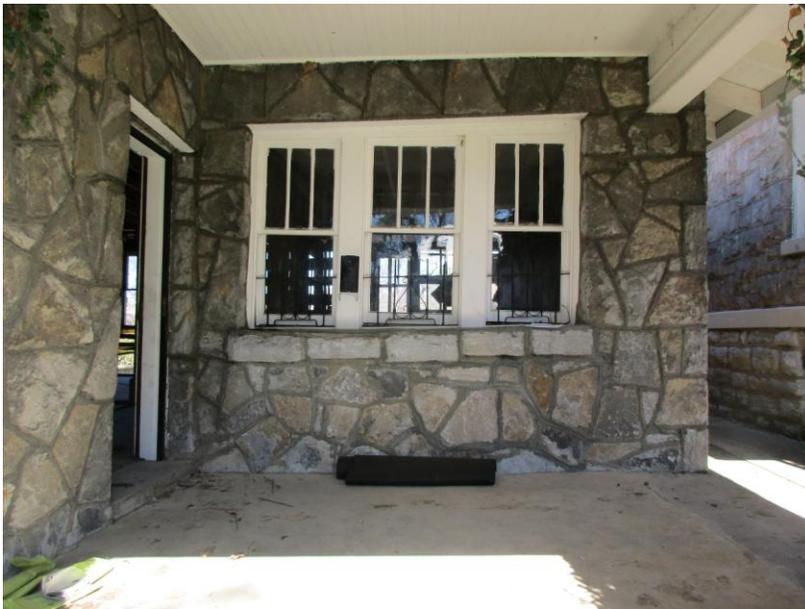
The stone cladding above the windows along the front had shifted over time and had been tuck-pointed, but the tops of the windows were not level.

repaired stone around window and uneven lintel
