1.10 Photographs

Nashville Electric Services Photos

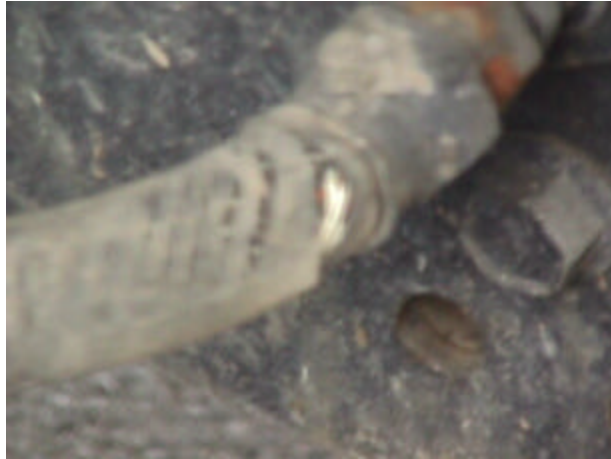
This dry-rotted front air brake hose was leaking brake application air. This defect should have been identified during the last PM inspection and during recent driver pre & post trip inspections.

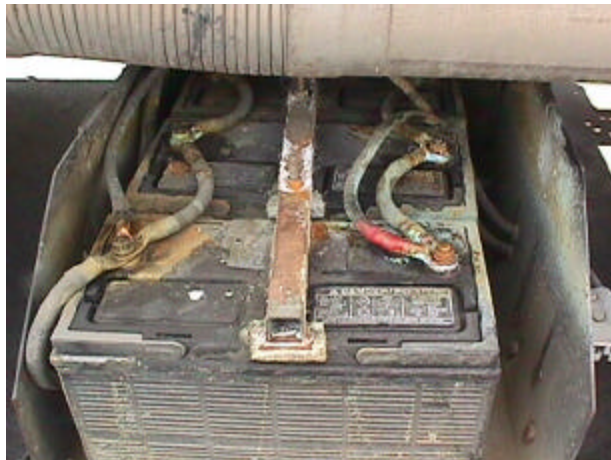
A basic tenant of preventive maintenance is battery, cable, terminal, and bracket cleanliness. The corrosion pictured here decreases component life and leads to costly no start service calls.

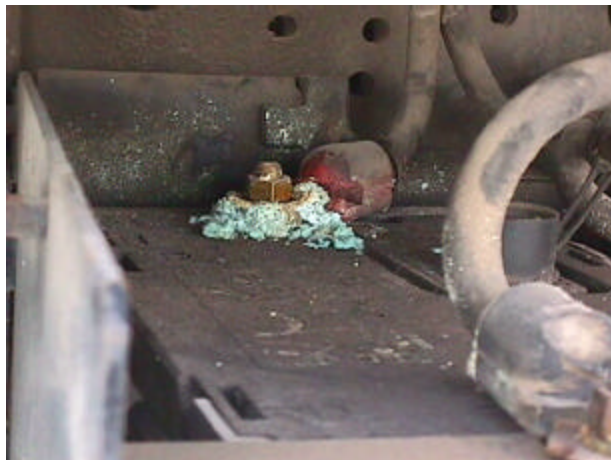
Yet another example of poor battery and starting system care.

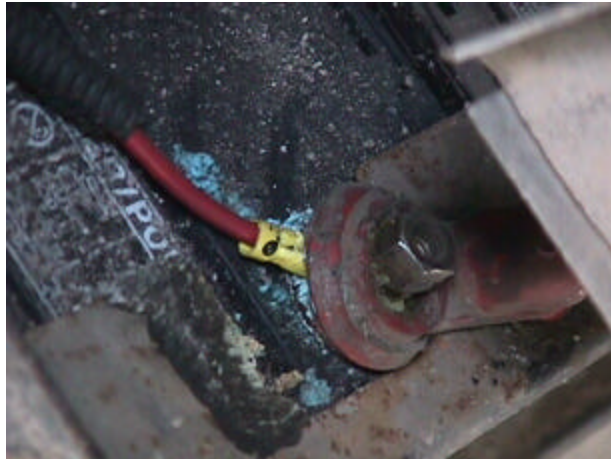
Another example of less than acceptable battery system maintenance.

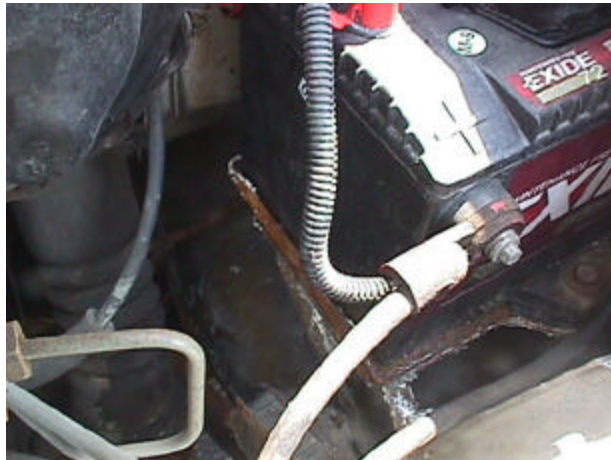
Van and auto battery trays require more thorough service to avoid costly replacement.

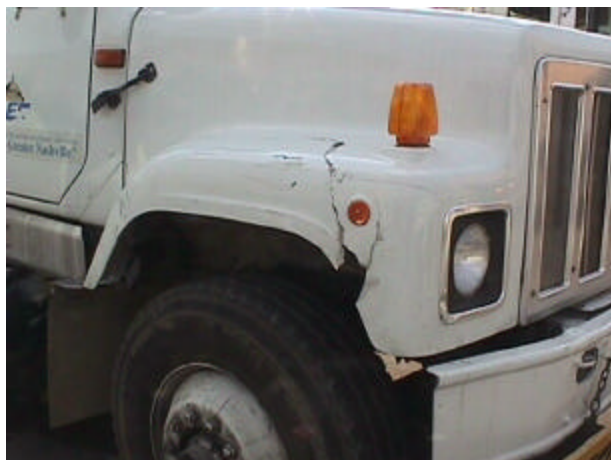
Several vehicles have unsightly, un-repaired accident damage. Many vehicles need their wheels painted.

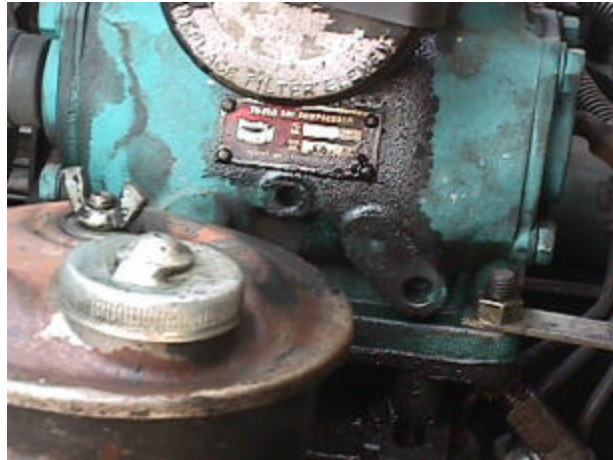
This air compressor is pumping oil. It should be replaced.

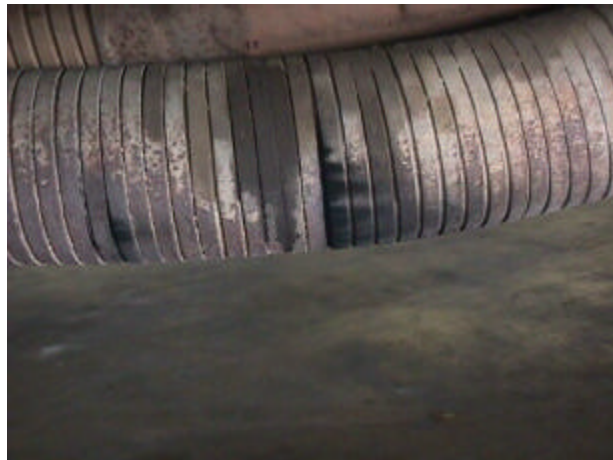
This vehicle has an exhaust leak in the after market flex pipe connection.

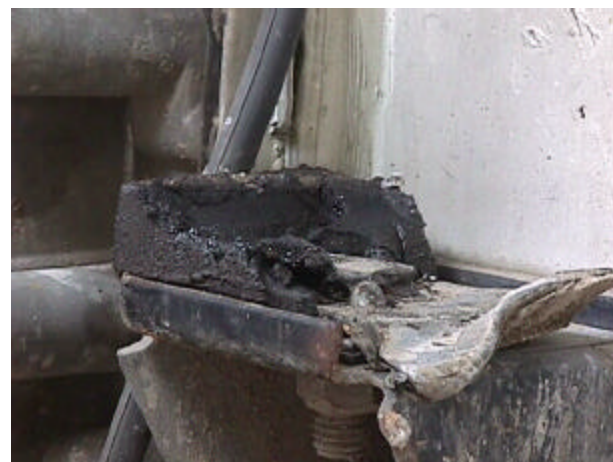
This Ford truck will incur hood damage if the defective hood pad is not replaced.

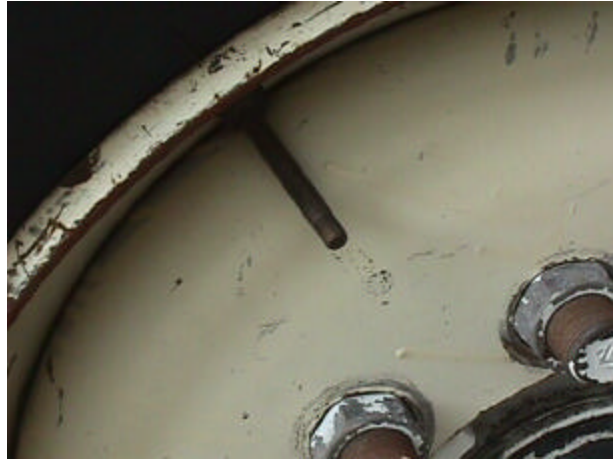
Several vehicles are missing tire valve stem caps.

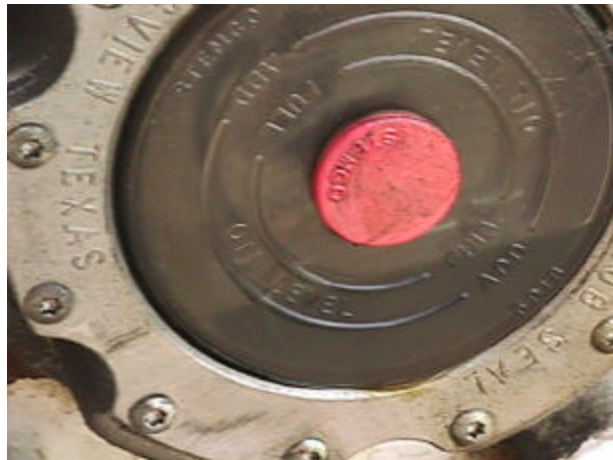
This over filled hub will eventually leak or cause the wheel seal to fail.

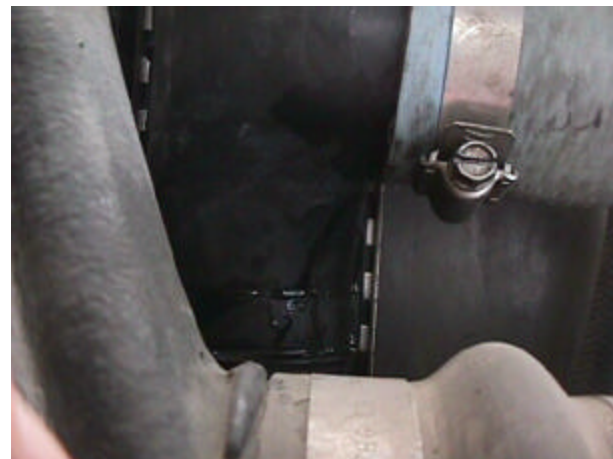
This vehicle has an obvious radiator leak. This should have been caught in previous inspections.

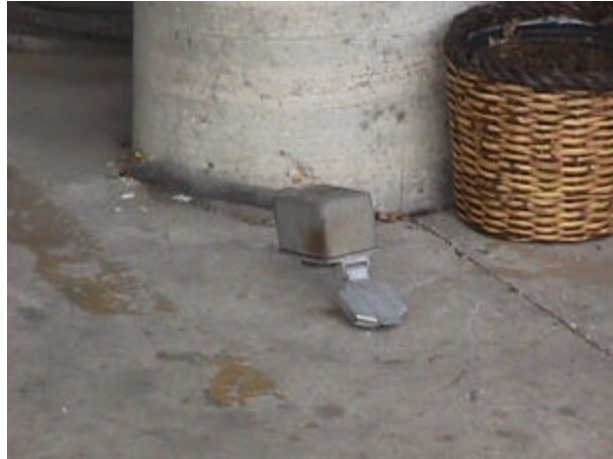
This 277 volt electrical outlet was “hot” and presented a serious safety issue. Facility inspection routines should be developed and implemented to promptly identify and repair safety violations.
