## 1.10 Photographs

### Housing Authority

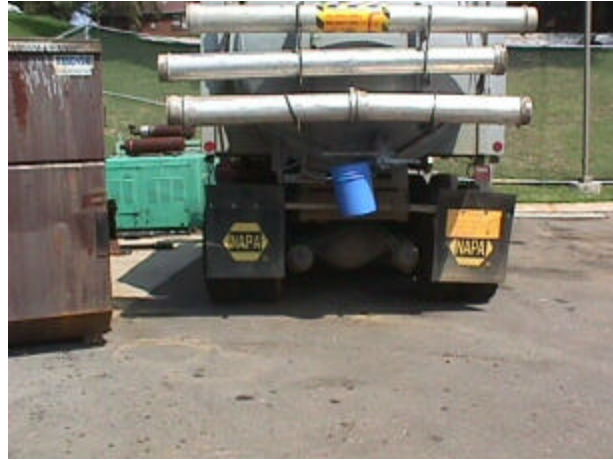
**We suggest that non-logo mud flaps should be used rather than advertise for local suppliers.**

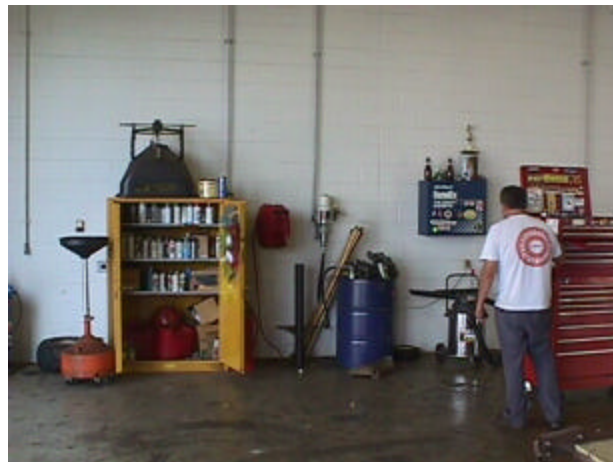
**This is the area that could house the needed industrial pressure washer.**

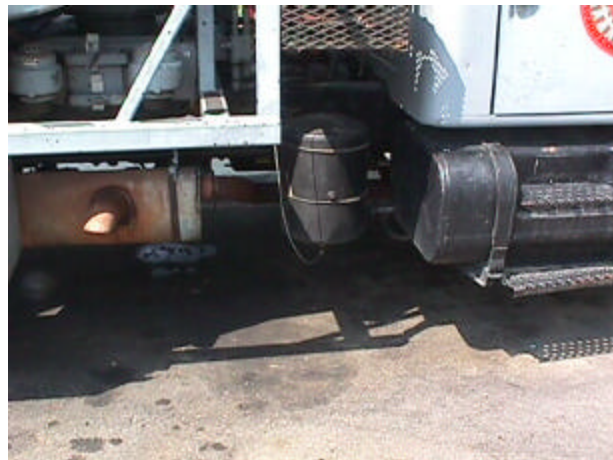
**We found a clean air system. This represents an acceptable level of driver pre-trip and PM process.**

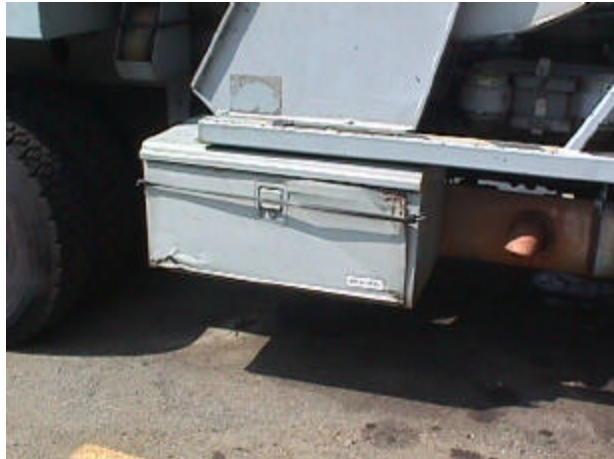
**This damaged cargo door was ordered for replacement.**

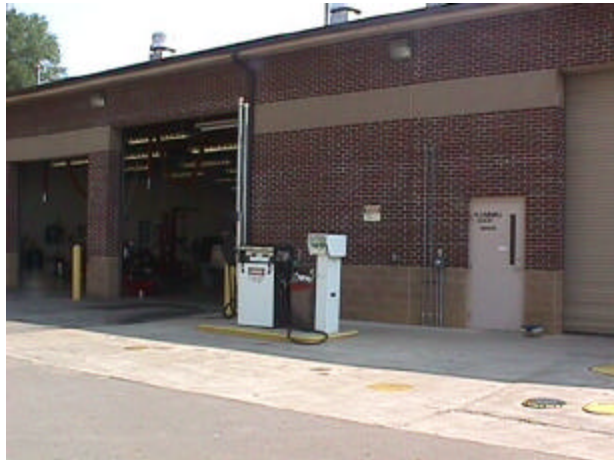
**The fuel tank vents are close to the garage bay door. We are concerned that possible conditions could allow vapors to waft into the garage ceilings where gas fired heaters operate.**

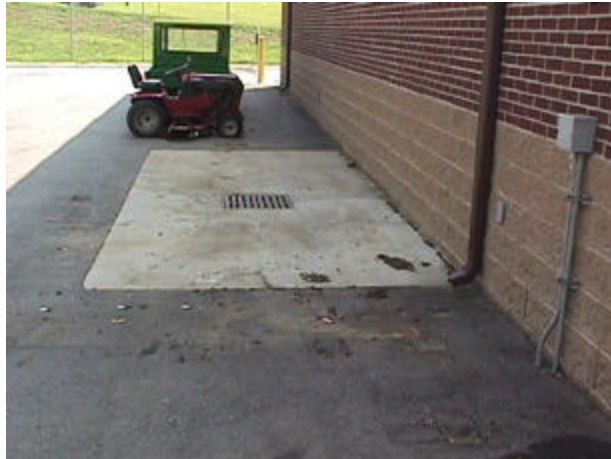
**An oil water separator was constructed into the buildings plan. This area could make an excellent work bay.**

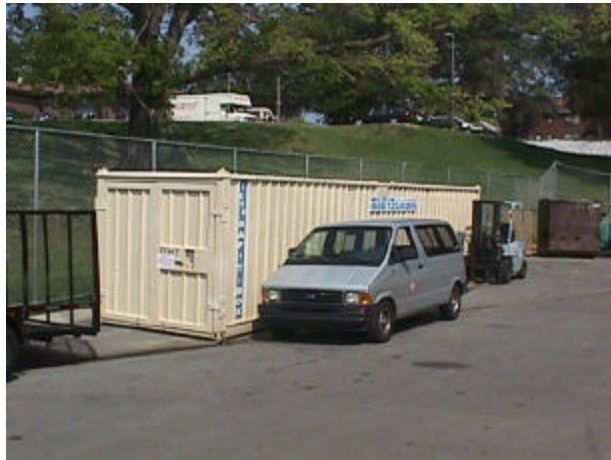
**The large storage container hampers vehicle access into and out of the garage.**

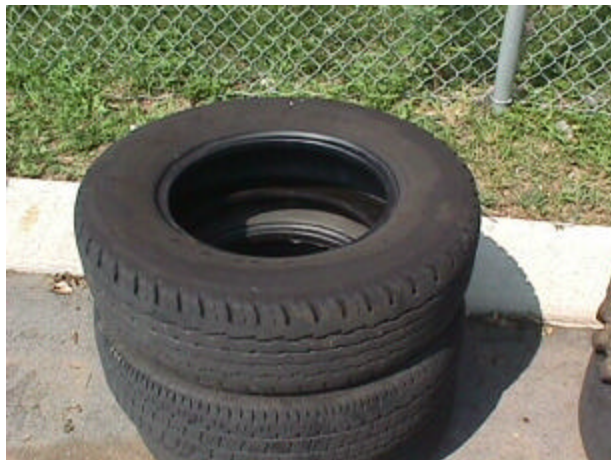
**Tires left outside collect rain water that provides mosquito breeding areas. They also detract from an otherwise orderly garage area.**

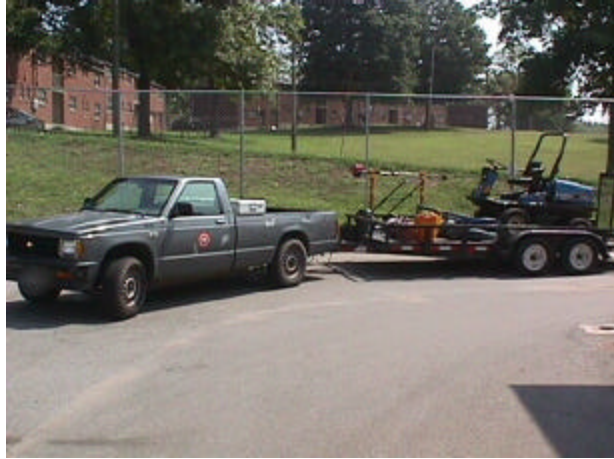
**This vehicle appears too small for the attached load. It may not handle safely in an emergency stop.**

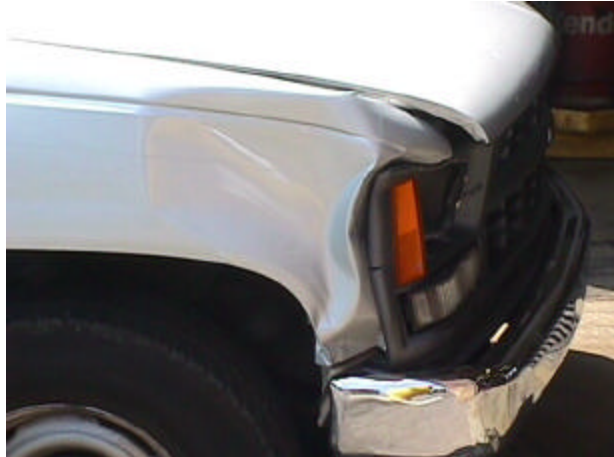
**Fleet appearance is well maintained. This accident which occurred on a Thursday was estimated for repair on Monday and scheduled for immediate repair.**
