NASHVILLE, TENNESSEE
HISTORIC PRESERVATION CONSULTANTS
THOMASON AND ASSOCIATES
REPORT PREPARED BY

April 25, 1988

NASHVILLE, TENNESSEE
METROPOLITAN NASHVILLE HISTORIC ZONING COMMISSION
PREPARED FOR

NASHVILLE, TENNESSEE
LOCKELAND SPRINGS AND EAST END NEIGHBORHOODS
HISTORIC OUTBUILDING STUDY

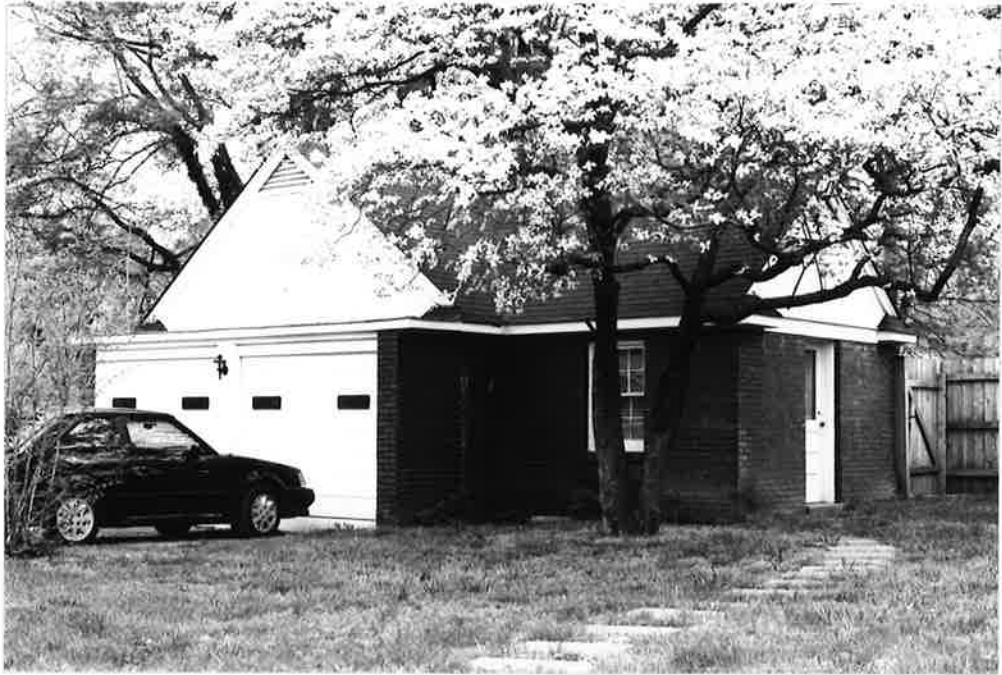
1415 Eastland: Brick garage with a gable roof and added modern overhead garage doors.

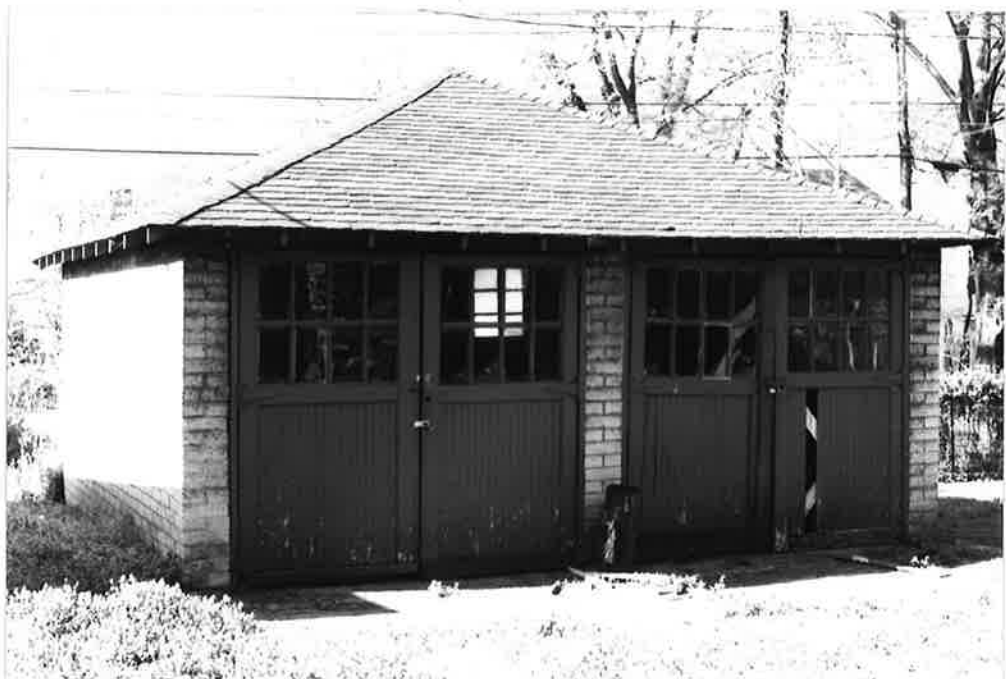
1204 Stratton: Brick garage with pyramidal roof and original glass and frame double doors.

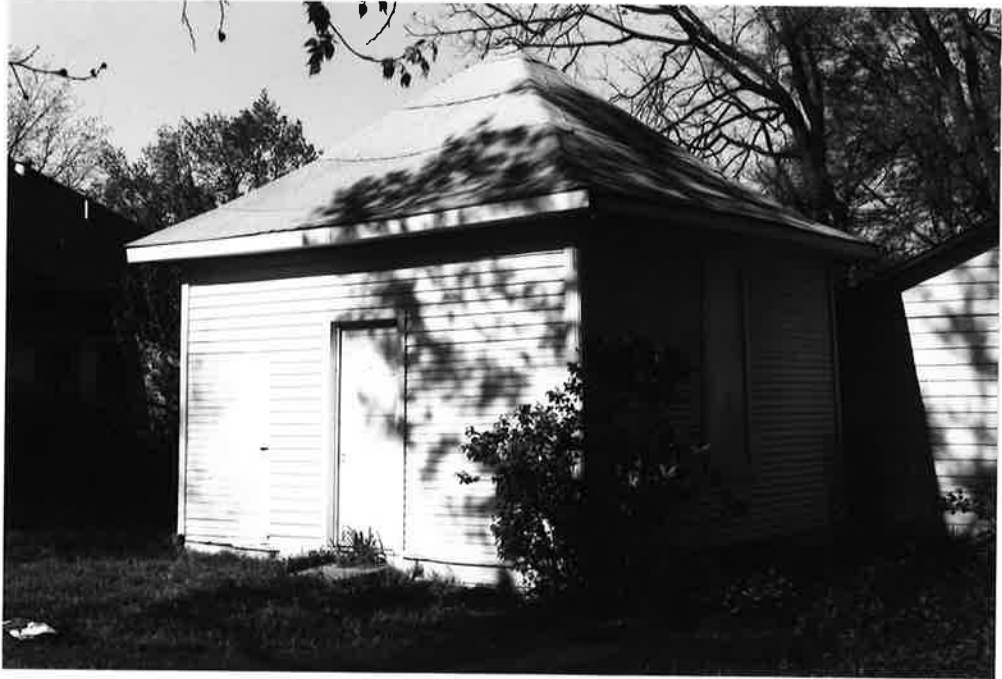
1309 Stratton: Servant's quarters building with a pyramidal roof.

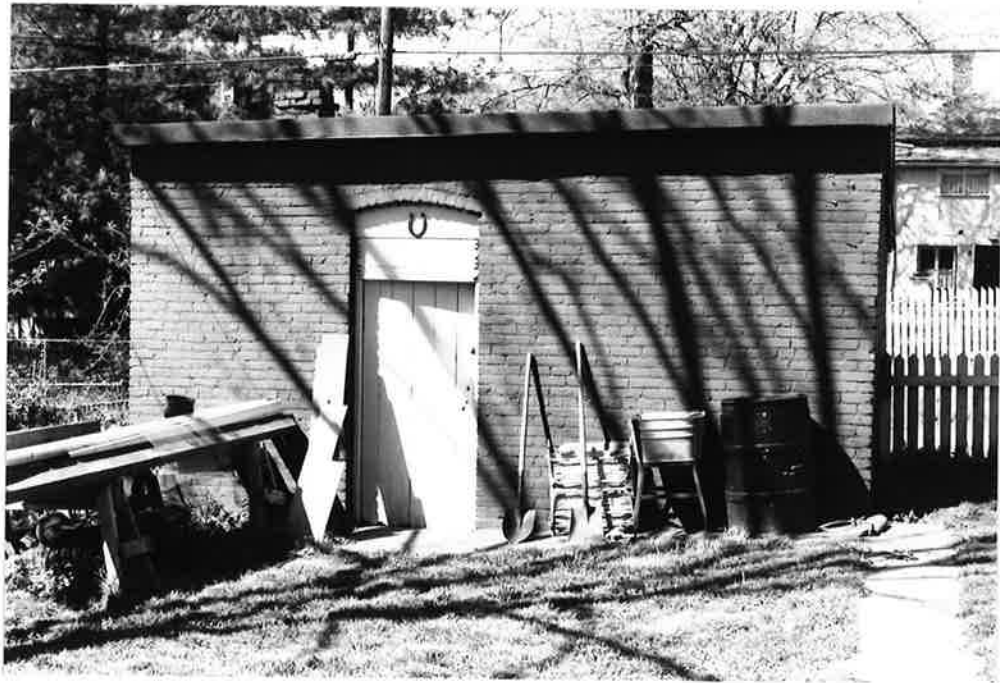
All 19th and early 20th century frame stables have been razed with the exception of the brick stable at 1409 Forrest Street. This simple shed roof structure appears to have been built ca. 1900 when the main residence at this residence was constructed. Although the stable doors on the alley facade have been altered, the original entrance facing the rear of the residence retains its brick relief arching and vertical board door. This stable was built with a stove flue and later became an automobile garage.

Brick outbuildings for stables and servant's quarters were rarely built in the survey area. The only remaining example is the ca. 1900 brick stable at the rear of 1409 Forrest Street. This shed roof building has had the stable doors altered but its basic plan and form remain. No other brick outbuilding from this period was identified.

1409 Forrest: Brick stable with a shed roof at rear of main residence.

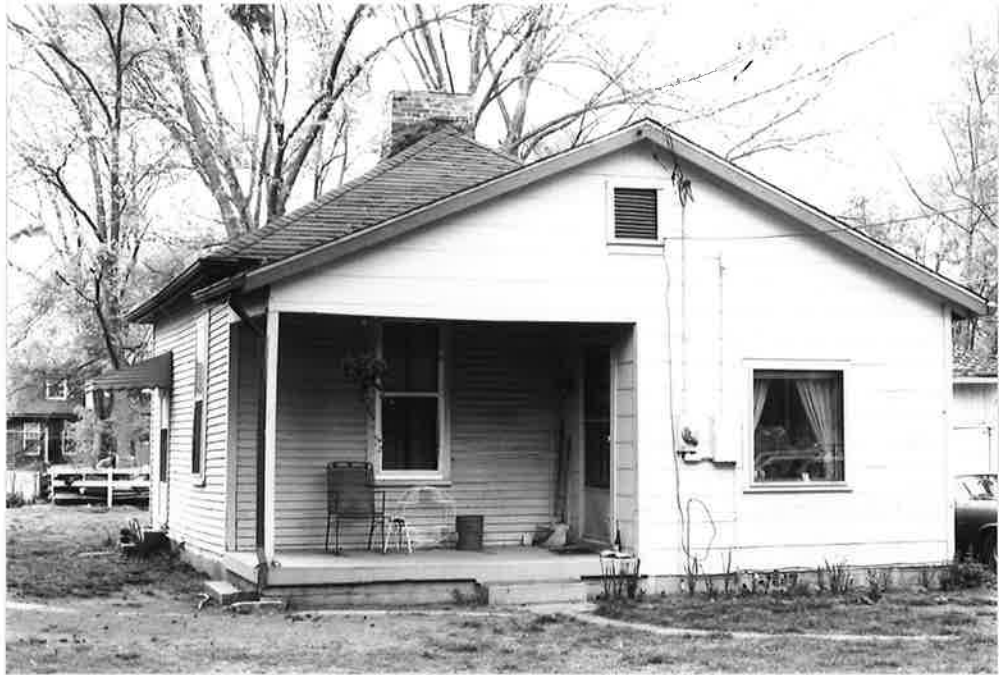
1501 Eastland: Remodeled servant's quarters at rear of main residence.

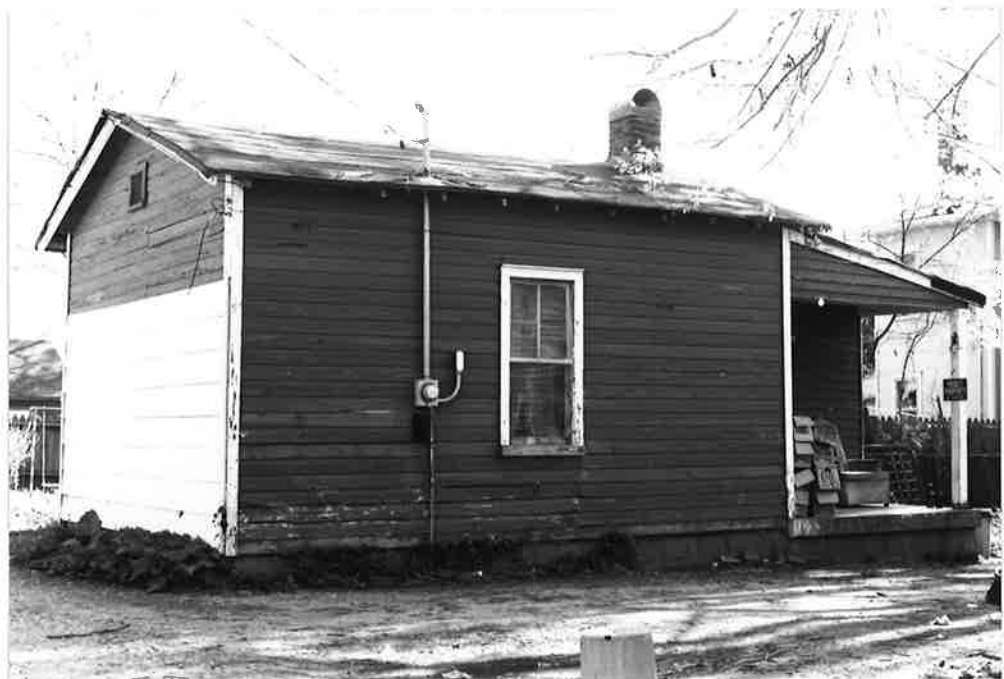
125 S. 11th St.: Original servant's quarters at rear of main residence.

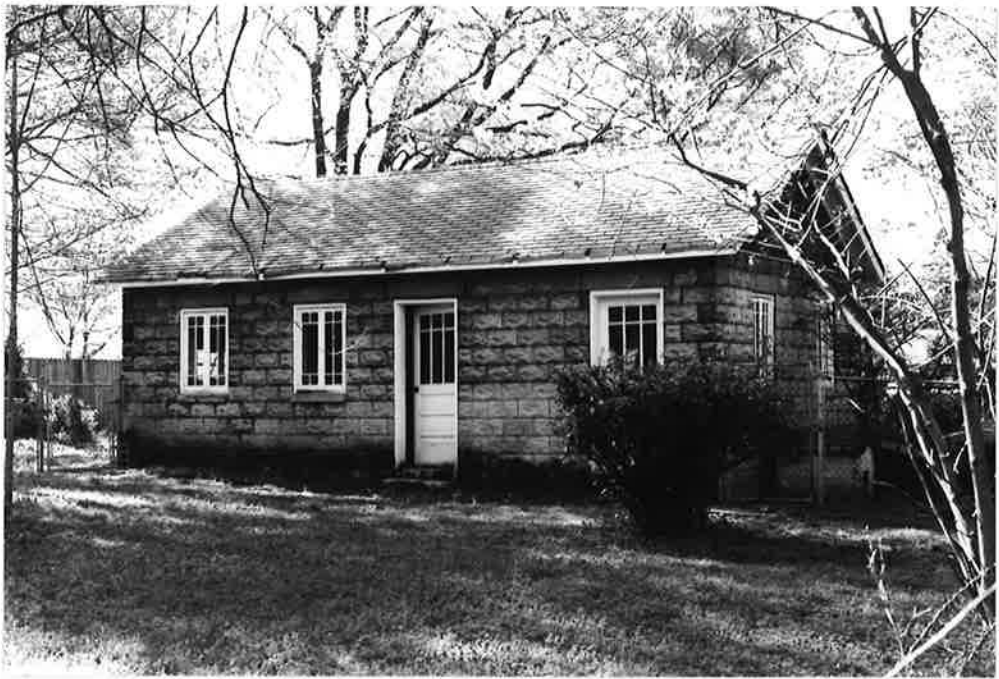
1500 Eastland: Hollow core concrete block garage with original doors and windows.

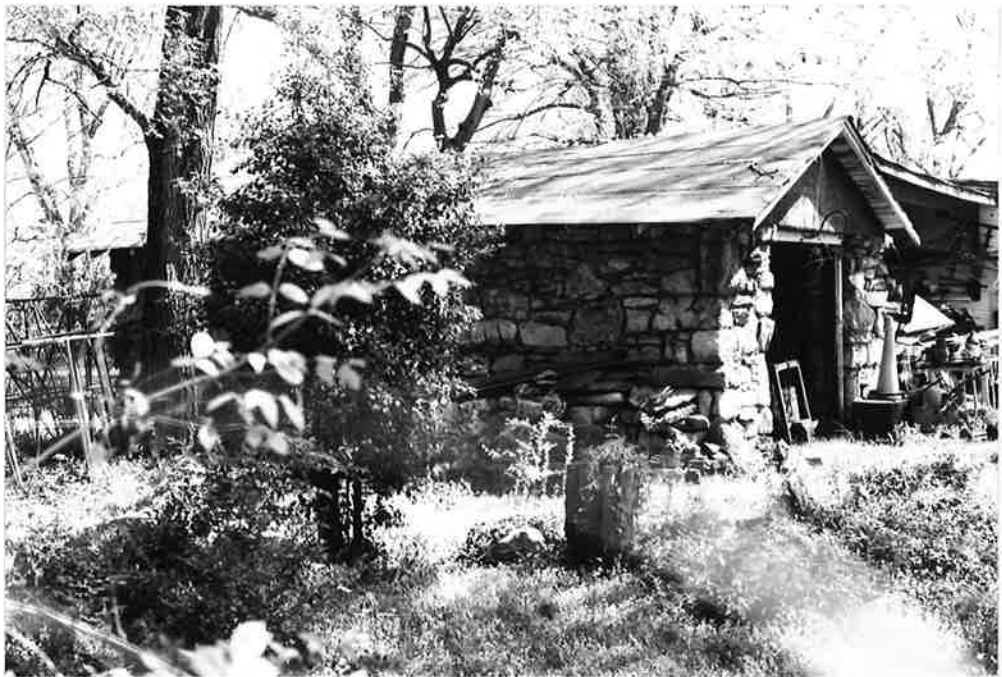
1403 Eastland: Stone veneer garage with a gable roof - is missing original doors.

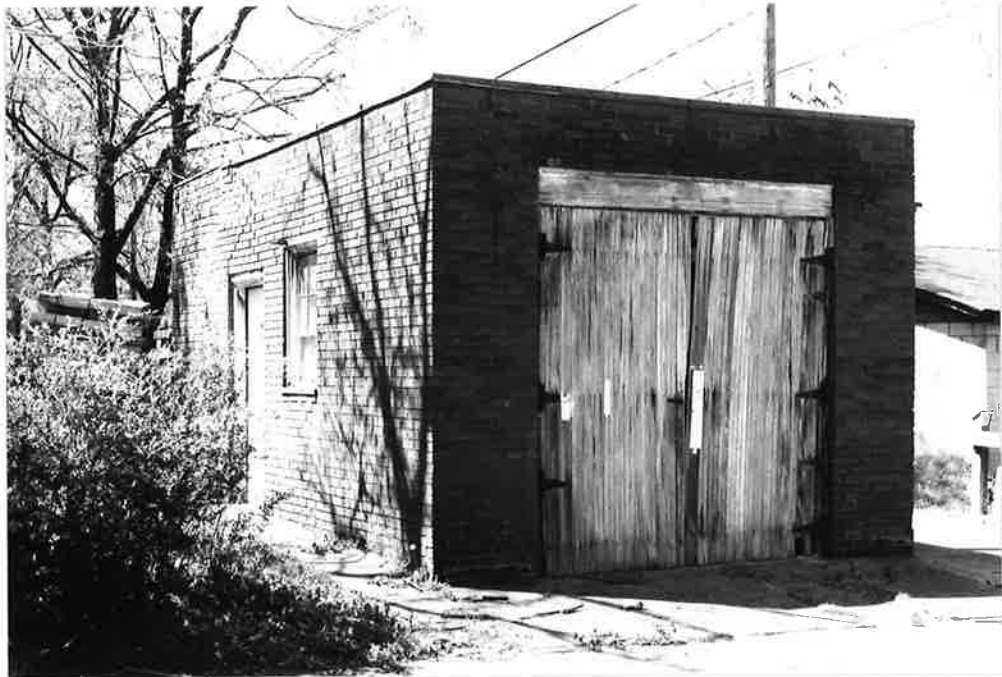
1115-17 Forrest: Single bay brick garage with a flat roof and vertical board double doors.

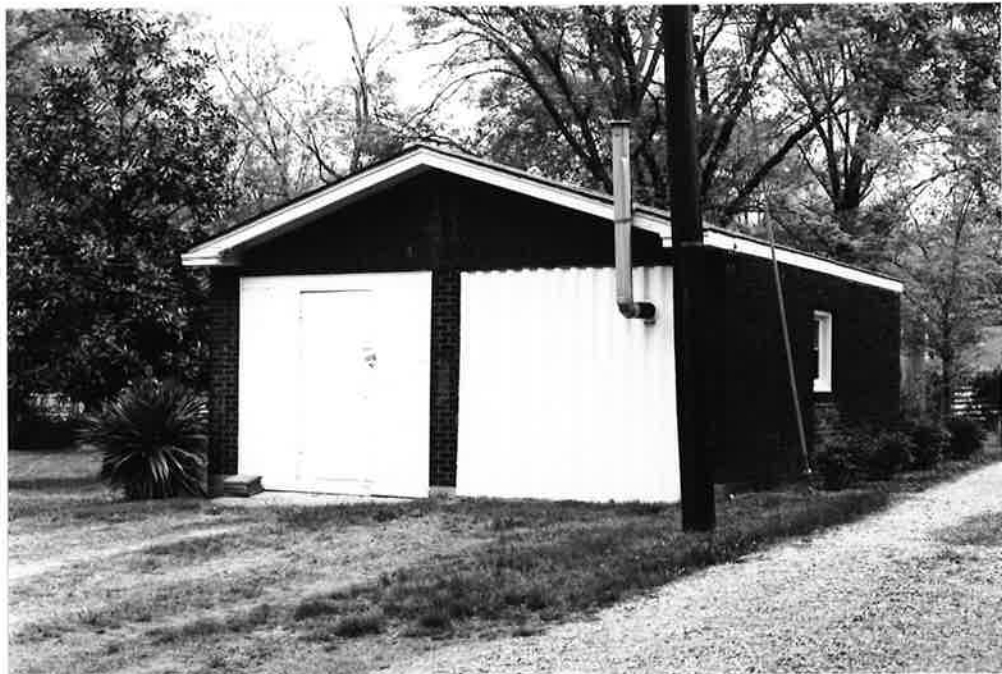
1411 Eastland: Brick garage with a gable roof and added modern doors and enclosures.

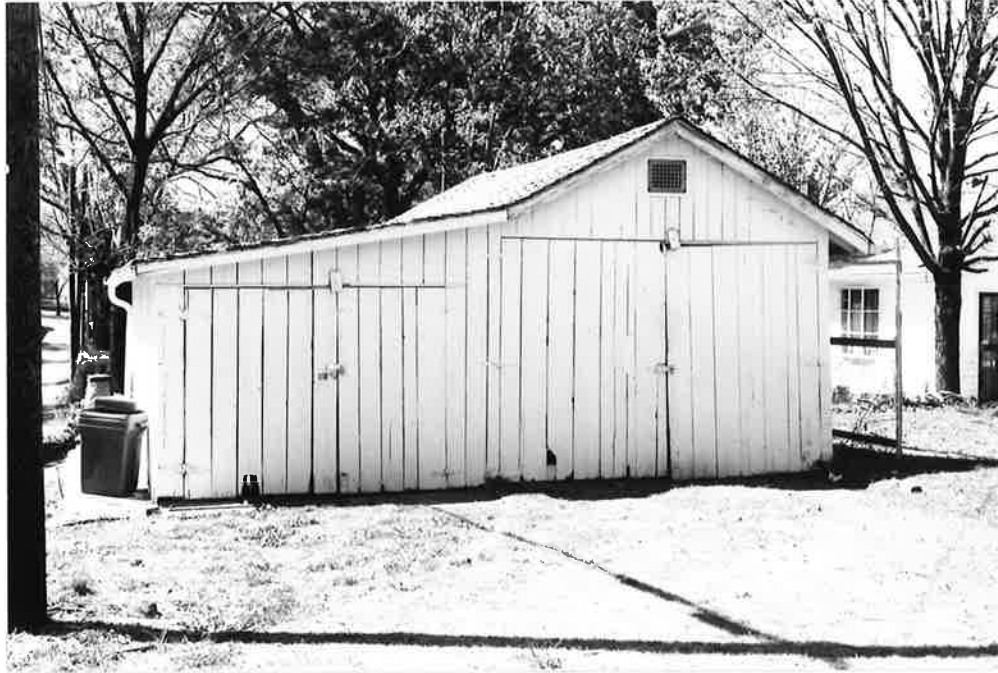
expanded to accommodate two cars and shed or flat roof additions were added laterally to the original structure. An example of this style of addition is seen at 1116 Ordway.

1116 Ordway: Gable roof frame garage with original shed roof wing.

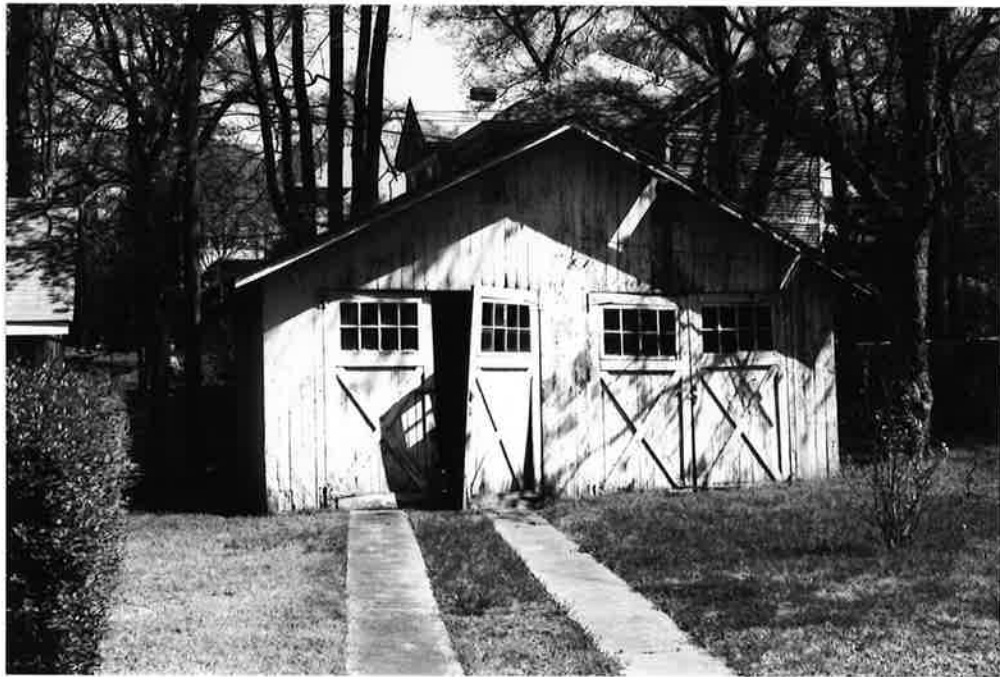
1403 Calvin: Gable roof frame two-bay garage with original glass and frame double doors.

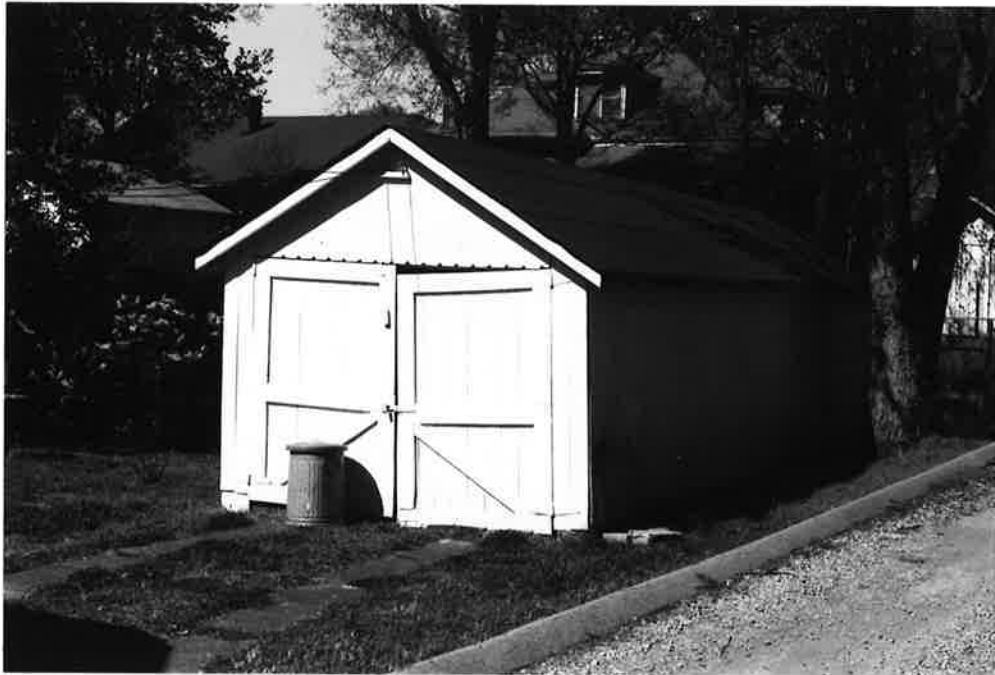
612 S. 17th St.: Gable roof frame garage with original frame, diagonal braced double doors.

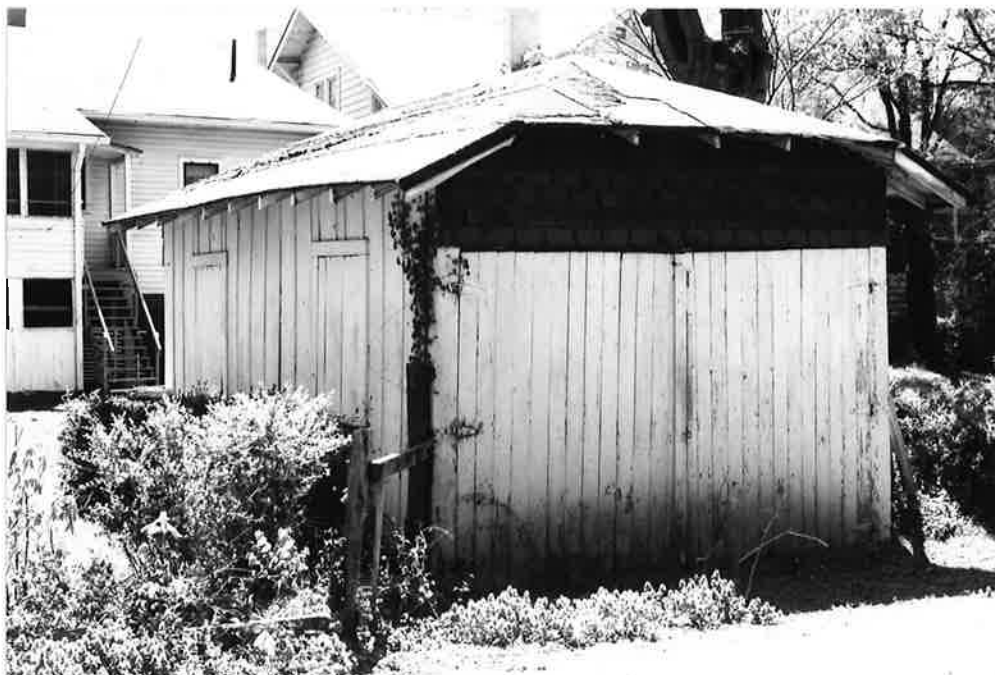
1109 Gartland: Frame garage with jerkinhead roof form variation and original vertical board double doors.
