2926 Melvin Road Culvert Replacement

Existing Conditions

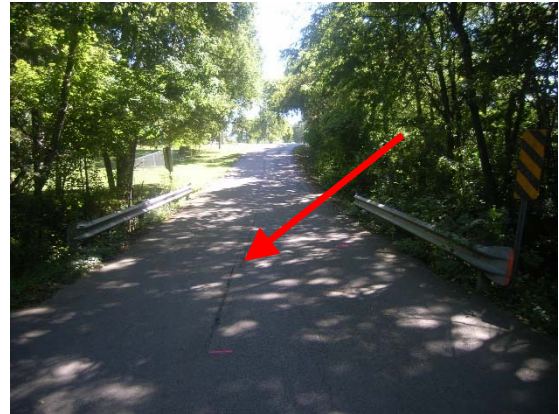
Pavement Cracking & Settlement

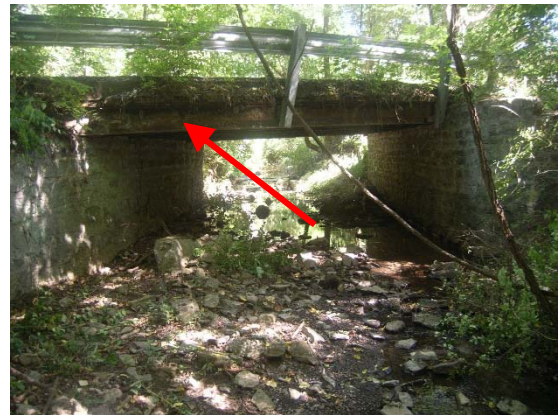
Section Loss along Steel Girders

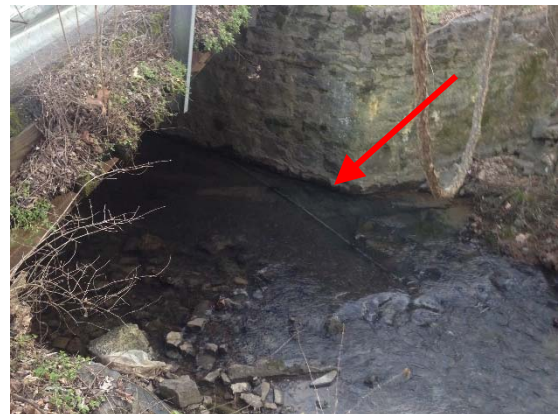
Scour Under Abutment Wall
