**ANNOTATED  
PHOTOGRAPHIC  
ELEVATIONS -  
EXISTING CONDITIONS (2013)**

Historic Structure Report

## Fort Negley

1100 Fort Negley Blvd.  
 Nashville, TN

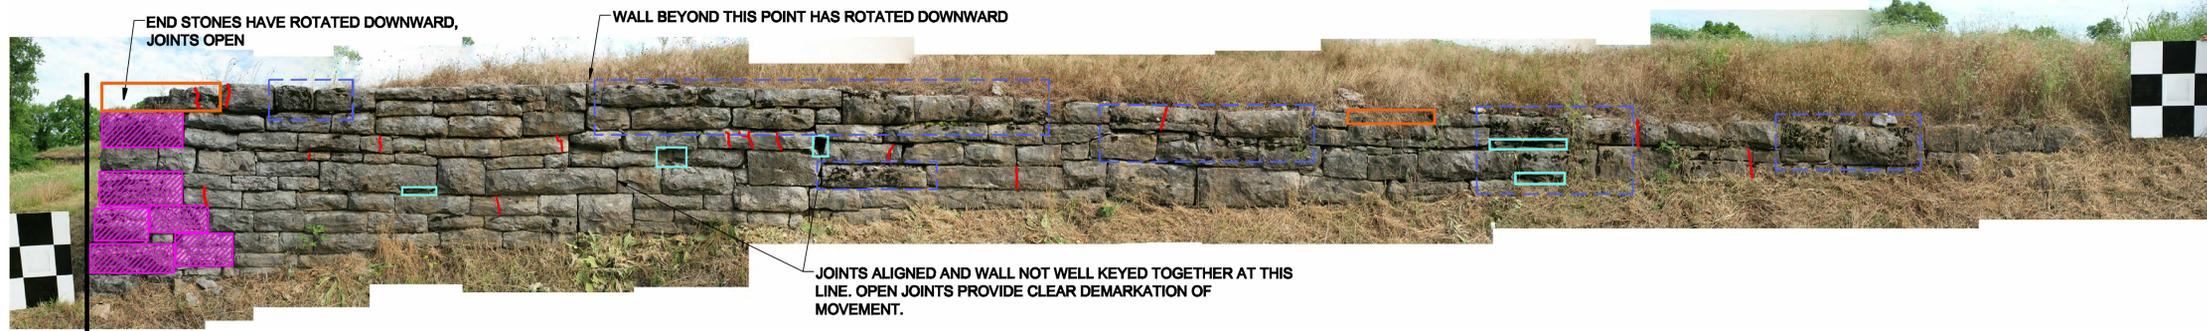
27  
**1 REDAN #1 - EXTERIOR - SOUTH SIDE**  
 SCALE: 3/8" = 1'-0"

CAMBER: SLIGHTLY BATTERED  
 STONE SIZE: RANDOM, BUT NOT A HUGE VARIATION IN OVERALL SIZES  
 COURSING: FAIRLY WELL COURSED  
 CHINKING: NOT MUCH, A LITTLE AT RIGHT SIDE  
 VEGETATION: SMALL WEEDS IN FACE, NO TREES  
 CRACKS: FALLS AWAY ROUGHLY PERPENDICULAR TO WALL

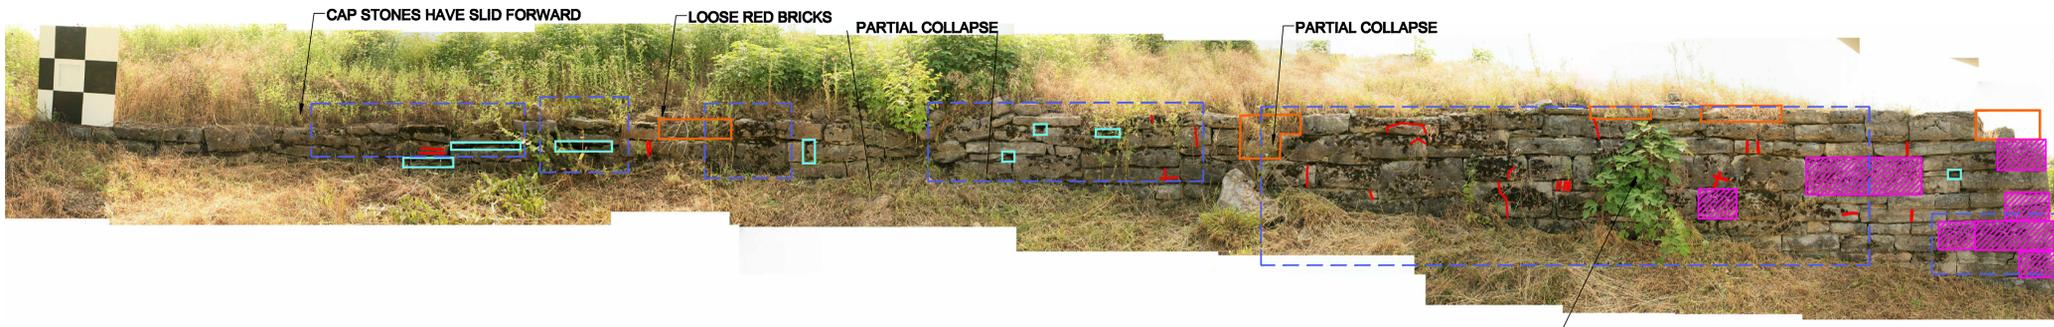
28  
**2 REDAN #1 - EXTERIOR - NORTH SIDE**  
 SCALE: 3/8" = 1'-0"

CAMBER: BATTERED AT RIGHT, LEANING OUT AT LEFT SIDE  
 STONE SIZE: RANDOM, SOME LARGE STONES. STONE AT RIGHT SIDE IS OF LESSER QUALITY  
 COURSING: NOT WELL DEFINED, IRREGULAR  
 CHINKING: NOT MUCH  
 VEGETATION: MOSTLY VINES AND WEEDS IN WALL, NO TREES  
 SLOPE: FALLS AWAY ROUGHLY PERPENDICULAR TO WALL

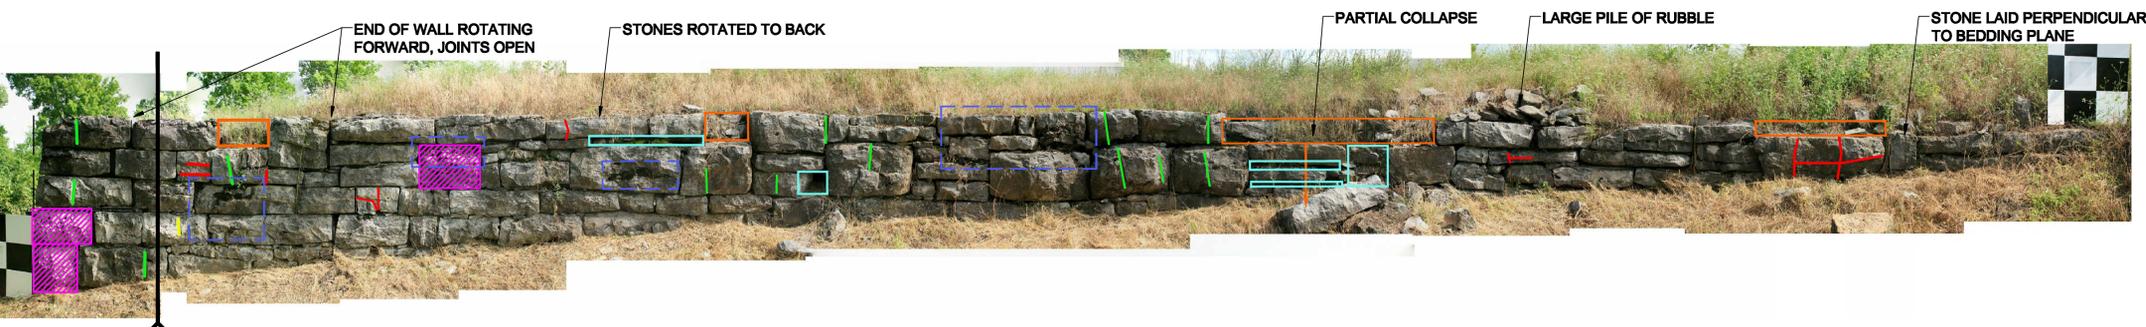
29  
**3 REDAN #2 - EXTERIOR - SOUTH SIDE**  
 SCALE: 3/8" = 1'-0"

CAMBER: SLIGHTLY BATTERED, MORE VERTICAL AT RIGHT  
 STONE SIZE: RANDOM, NOT MANY LARGE STONES  
 COURSING: SOMEWHAT COURSED, BUT NOT WELL DEFINED, IRREGULAR  
 CHINKING: NONE  
 VEGETATION: VINES AND WEEDS IN WALL, NO TREES  
 SLOPE: FALLS AWAY ROUGHLY PERPENDICULAR TO WALL, FAIRLY LEVEL

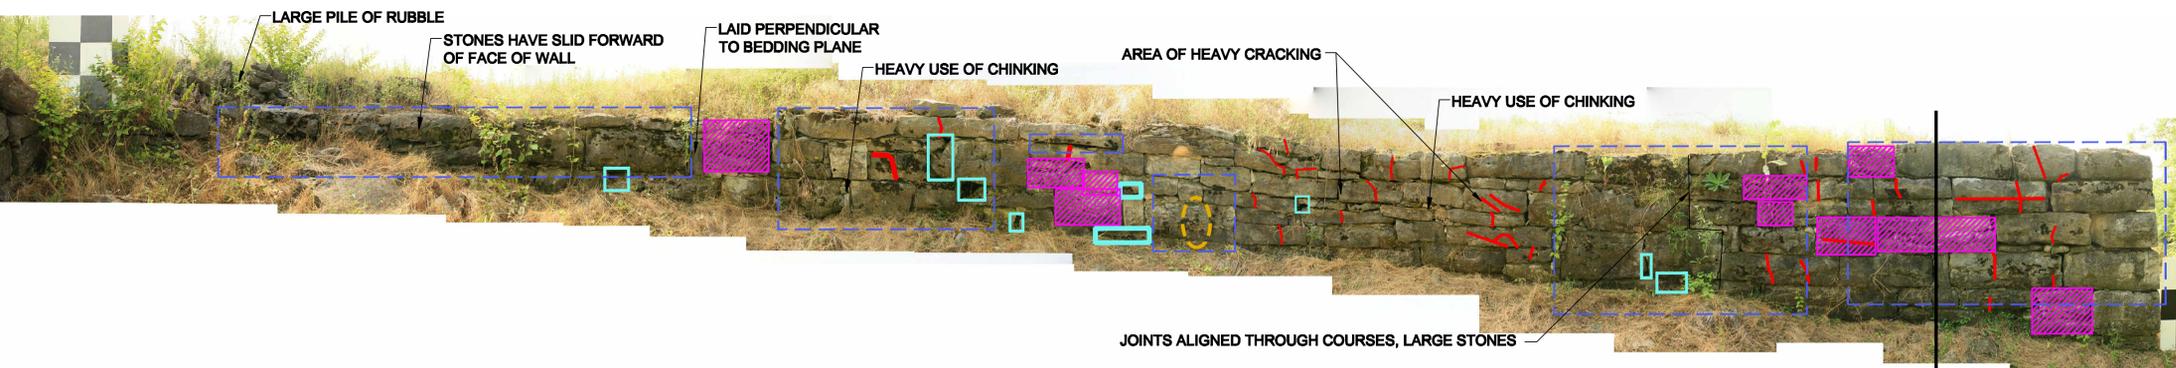
**4 REDAN #2 - EXTERIOR - NORTH SIDE**  
 SCALE: 3/8" = 1'-0"

CAMBER: MOSTLY BATTERED,  
 STONE SIZE: RANDOM. MANY STONES ARE FRACTURED AND CRUMBLING  
 COURSING: MOSTLY IRREGULAR, BUT SOME AREAS ARE MORE COURSED  
 CHINKING: FALLING OUT  
 VEGETATION: VINES AND WEEDS IN WALL, NO TREES  
 SLOPE:

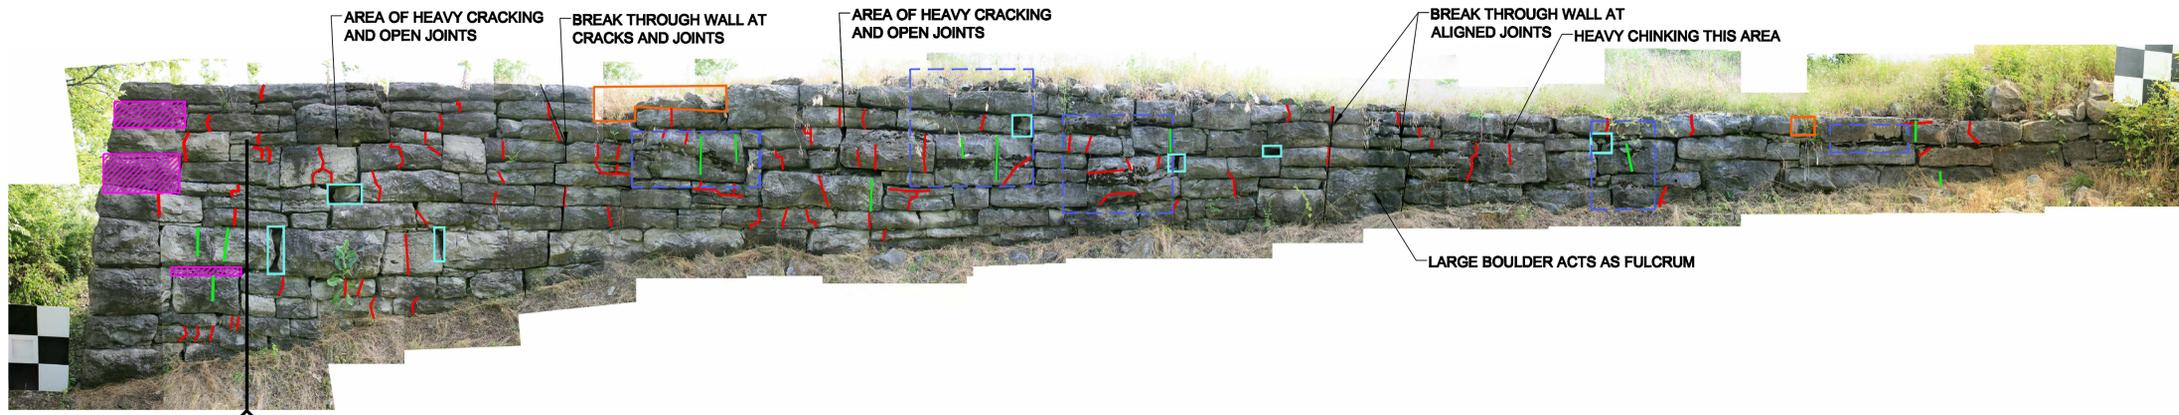
5 REDAN #3 - EXTERIOR - WEST SIDE  
SCALE: 3/8" = 1'-0"

CAMBER: OVERALL, BATTERED, BUT IRREGULAR  
STONE SIZE: RANDOM, SOME VERY LARGE STONES  
COURSING: MOSTLY NOT COURSED, MORE COURSED AT LEFT END  
CHINKING: AREAS OF HEAVY CHINKING AT THREE POINTS, CRACKS ALIGN WITH JOINTS FOR CLEAR BREAK THROUGH WALL HEIGHT  
CRACKS: SMALL WEEDS IN FACE, NO TREES  
VEGETATION: FALLS AWAY ROUGHLY PERPENDICULAR TO WALL, SLOPE PARALLEL TO WALL AT LEFT END  
SLOPE:

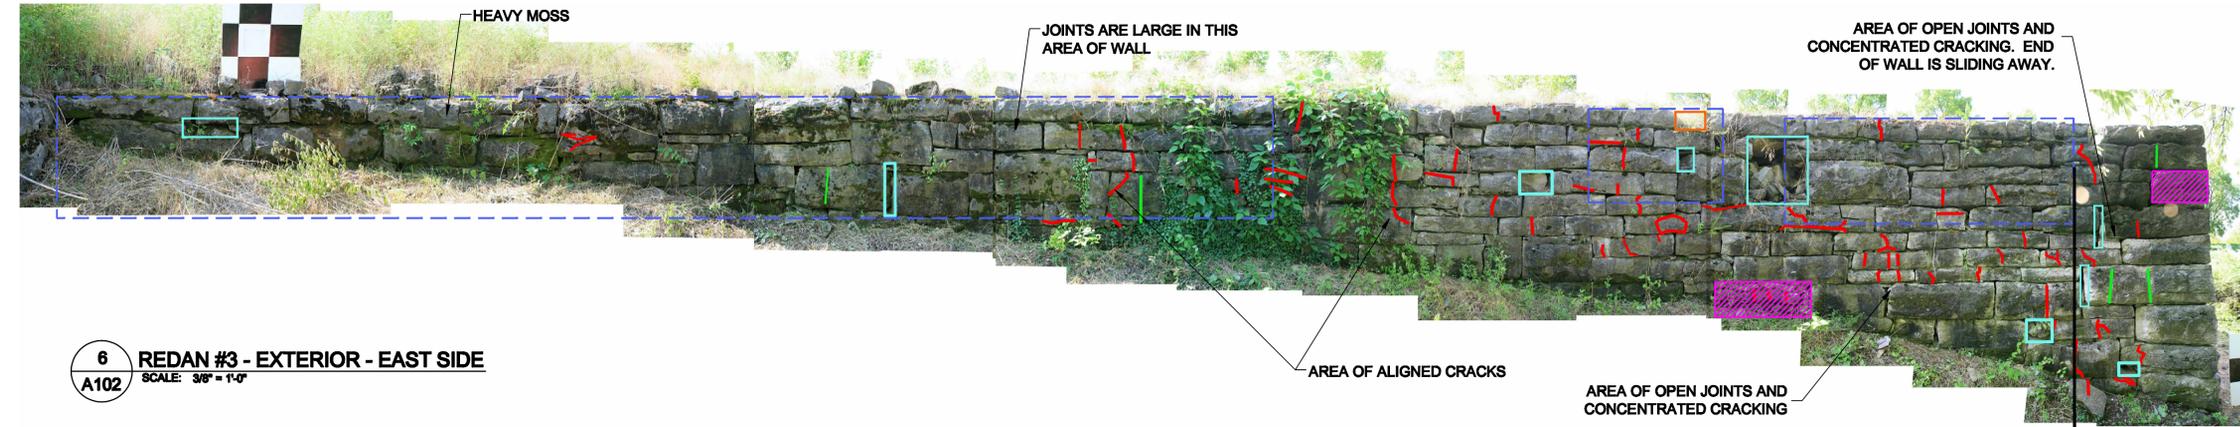
6 REDAN #3 - EXTERIOR - EAST SIDE  
SCALE: 3/8" = 1'-0"

CAMBER: BATTERED, BUT BULGING IN AREAS  
STONE SIZE: RANDOM, THERE ARE SOME LARGE STONES.  
COURSING: MIXED, SOME AREAS CLEARLY COURSED, OTHERS MORE RANDOM. MAY INDICATE REPAIR CAMPAIGNS  
CHINKING: NOT MUCH  
VEGETATION: VINES AND WEEDS IN WALL, NO TREES  
SLOPE: FALLS AWAY ROUGHLY PERPENDICULAR TO WALL. AT RIGHT END, GROUND SLOPES ALONG WALL AT A STEEP GRADE.

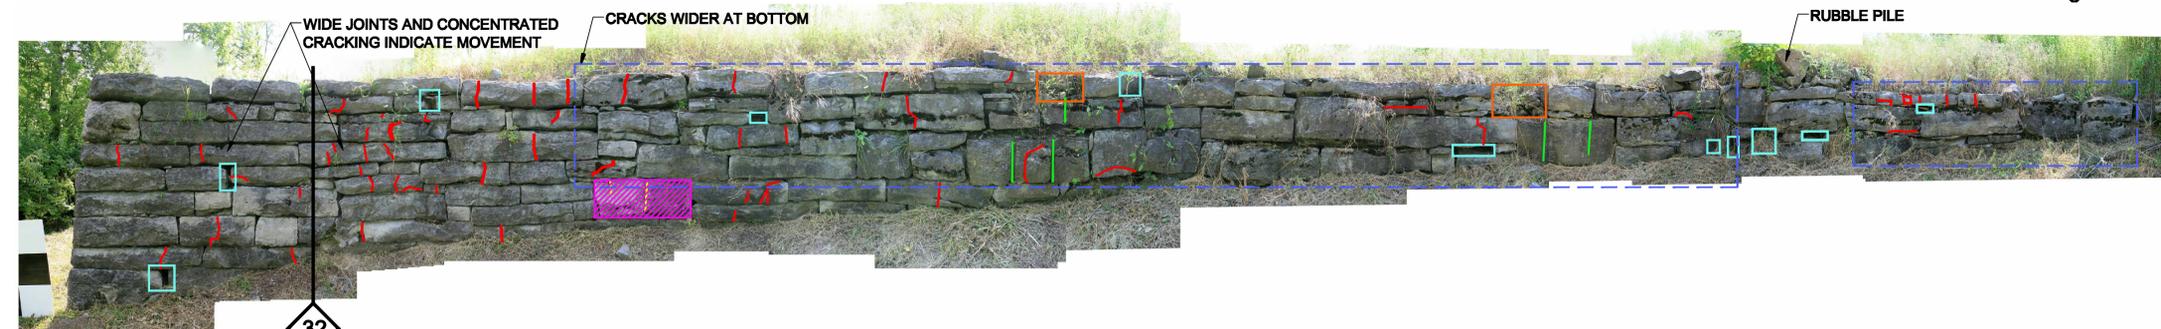
7 REDAN #4 - EXTERIOR - WEST SIDE  
SCALE: 3/8" = 1'-0"

CAMBER: SLIGHTLY BATTERED, BUT IRREGULAR  
STONE SIZE: RANDOM, SOME LARGE STONES AT RIGHT END  
COURSING: SOMEWHAT COURSED  
CHINKING: NONE  
VEGETATION: VINES AND WEEDS IN WALL, NO TREES  
SLOPE: FALLS AWAY ROUGHLY PERPENDICULAR TO WALL BUT MORE PARALLEL TO WALL AT LEFT END

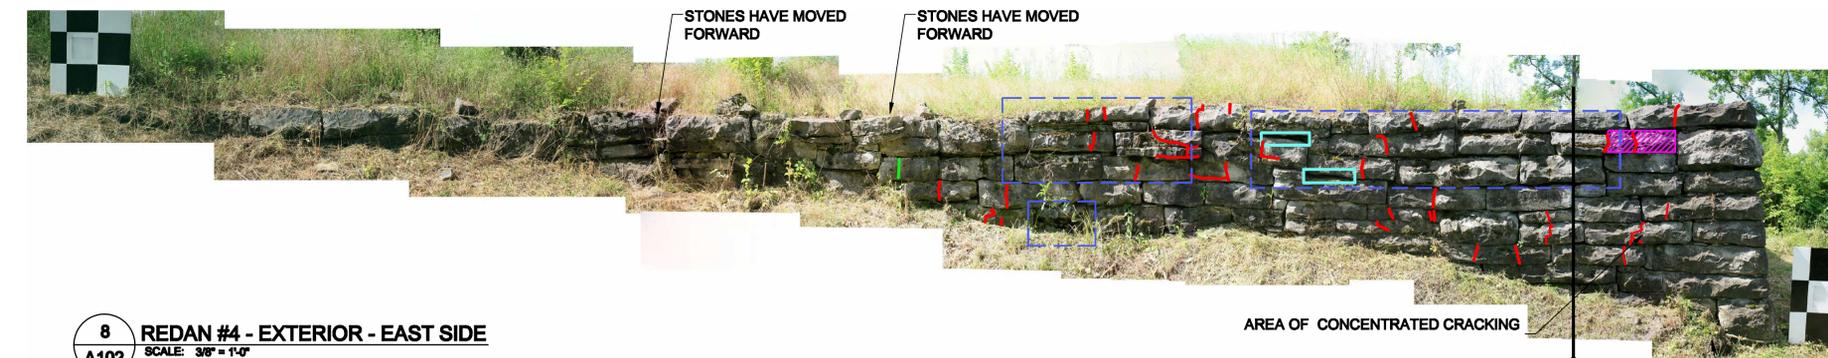
8 REDAN #4 - EXTERIOR - EAST SIDE  
SCALE: 3/8" = 1'-0"

CAMBER: BATTERED AT RIGHT, LEANING FORWARD AT LEFT  
STONE SIZE: FAIRLY UNIFORM, MEDIUM TO LARGE  
COURSING: MOSTLY IRREGULAR  
CHINKING: SOME AT RIGHT SIDE  
VEGETATION: VINES AND WEEDS IN WALL, NO TREES, BUT ONE STUMP  
SLOPE: PERPENDICULAR TO WALL, BUT SLOPES MORE PARALLEL AT RIGHT END

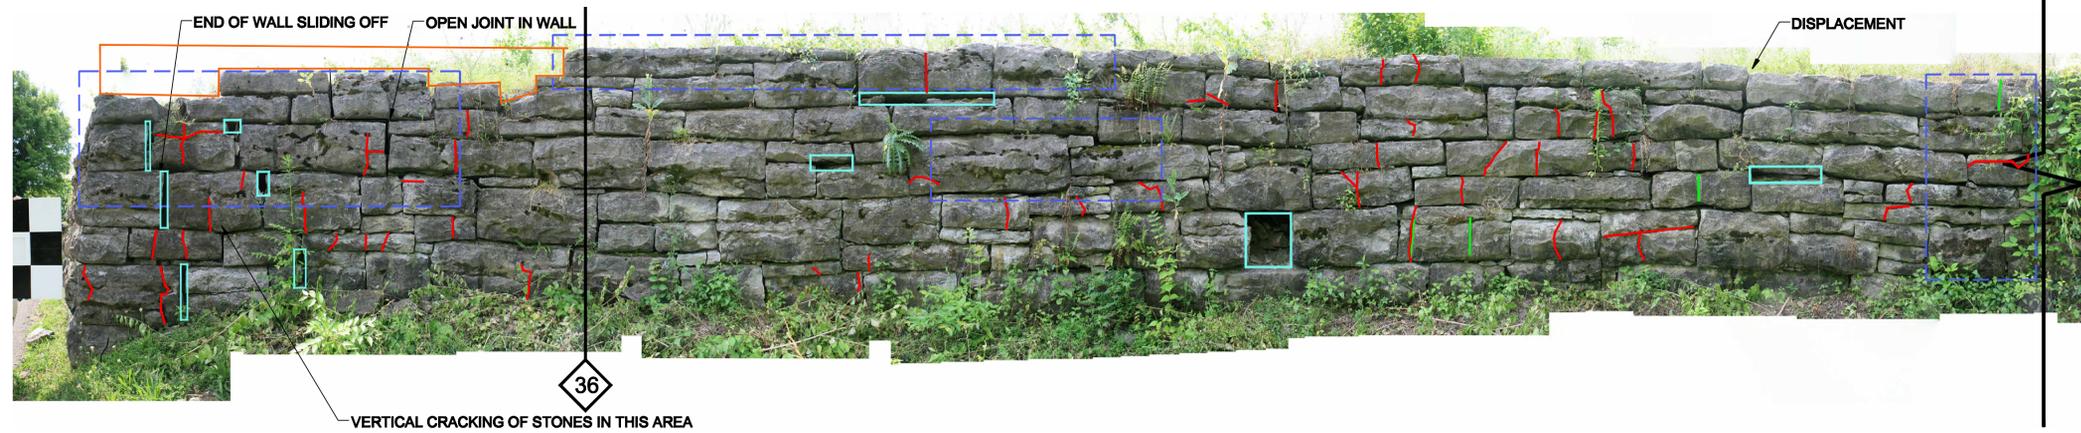
**9A** NORTH MAIN WORKS - EXTERIOR - LEFT END  
A103 SCALE: 3/8" = 1'-0"

CAMBER: SLIGHTLY BATTERED, MORE VERTICAL AT LEFT SIDE  
STONE SIZE: RANDOM, MANY LARGE STONES  
COURSING: NOT WELL DEFINED, IRREGULAR  
CHINKING: NOT MUCH AT RIGHT, BUT MORE PREVALENT MOVING TO LEFT  
CRACKS: EXTEND THROUGH WALL VERTICALLY  
VEGETATION: SMALL WEEDS IN FACE, NO TREES  
SLOPE: FALLS AWAY ROUGHLY PERPENDICULAR TO WALL

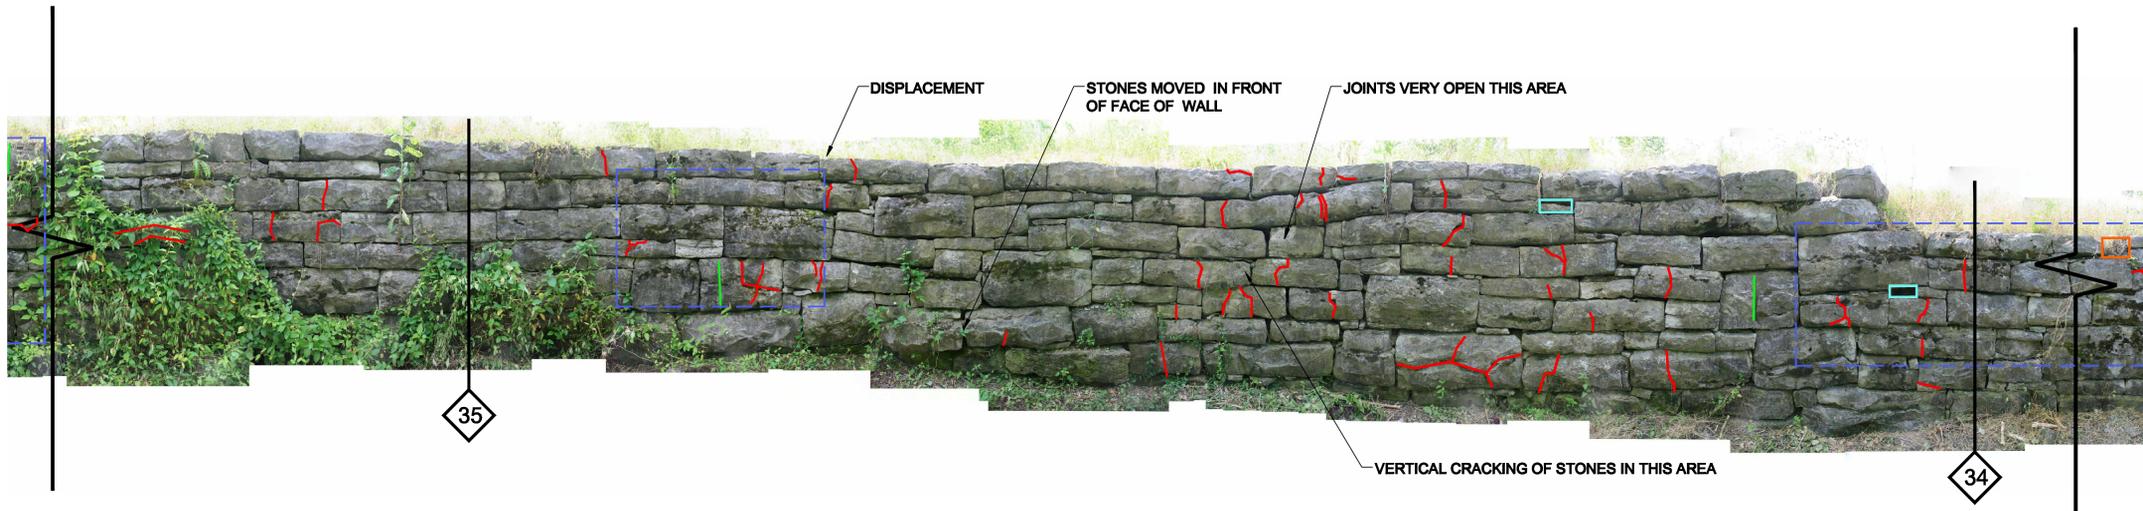
**9B** NORTH MAIN WORKS - EXTERIOR - CENTER  
A103 SCALE: 3/8" = 1'-0"

CAMBER: SLIGHTLY BATTERED, MORE VERTICAL AT RIGHT SIDE  
STONE SIZE: RANDOM, MANY LARGE STONES  
COURSING: NOT WELL DEFINED, IRREGULAR  
CHINKING: LARGE AND FLAT CHINKING STONES  
VEGETATION: MOSTLY VINES AND WEEDS IN WALL, NO TREES  
SLOPE: FALLS AWAY ROUGHLY PERPENDICULAR TO WALL BUT BECOMES PARALLEL AT RIGHT END

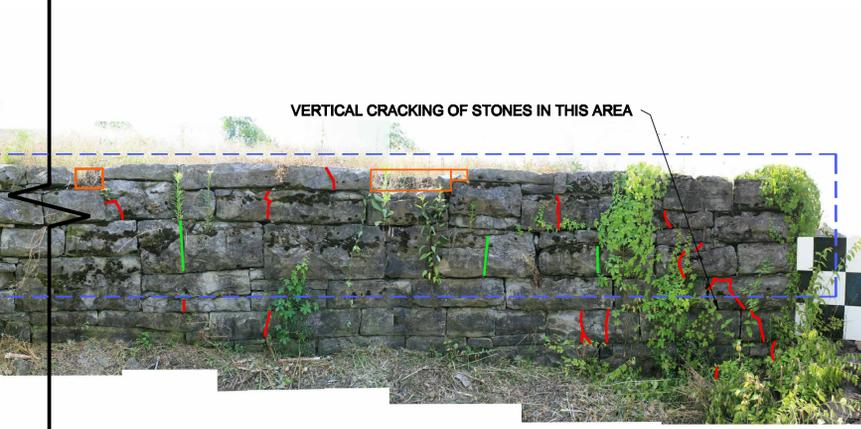
**9C** NORTH MAIN WORKS - EXTERIOR - RIGHT END  
A103 SCALE: 3/8" = 1'-0"

CAMBER: SLIGHTLY BATTERED, MORE VERTICAL AT RIGHT, BULGE MID-WAY TOWARD LEFT  
STONE SIZE: RANDOM, NOT MANY LARGE STONES  
COURSING: NOT WELL DEFINED, IRREGULAR  
CHINKING: VERY FEW CHINKING STONES  
VEGETATION: VINES AND WEEDS IN WALL, NO TREES  
SLOPE: FALLS AWAY ROUGHLY PERPENDICULAR TO WALL, FAIRLY LEVEL

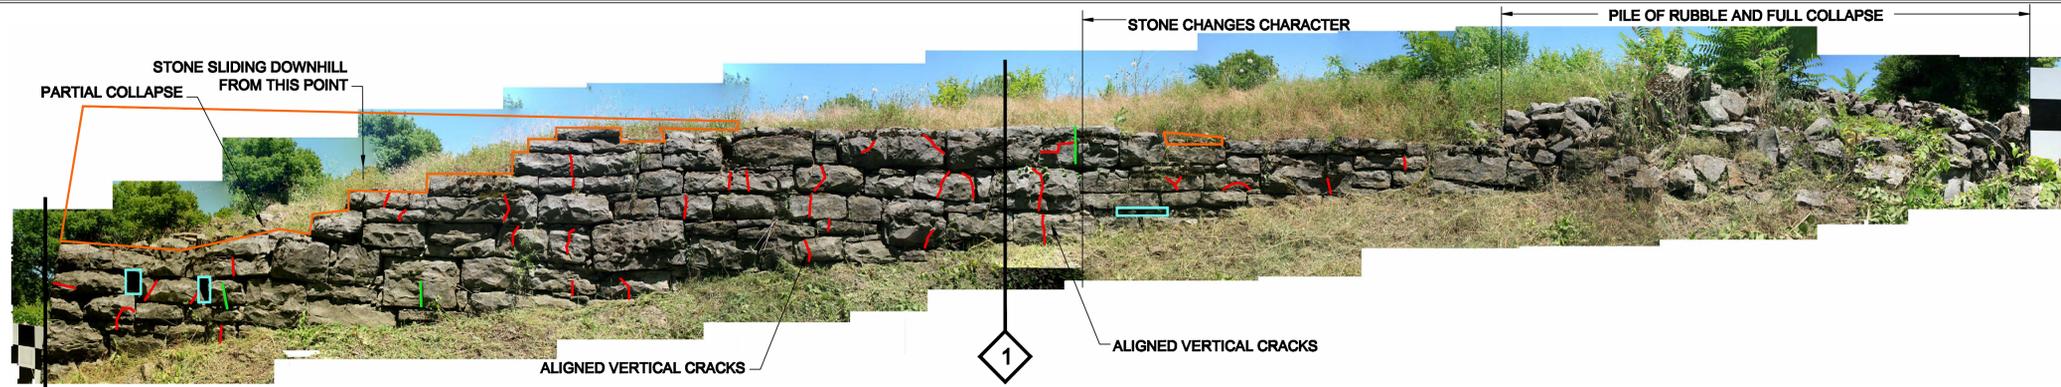
11 REDAN #5 - EXTERIOR - WEST SIDE  
SCALE: 3/8" = 1'-0"

CAMBER: SLIGHTLY BATTERED,  
STONE SIZE: RANDOM, NOT MANY LARGE STONES AT RIGHT, CHANGES WITH LARGER STONES TO LEFT END  
COURSING: MOSTLY IRREGULAR, CHANGES MIDWAY  
CHINKING: FALLING OUT  
VEGETATION: VINES AND WEEDS IN WALL, NO TREES  
SLOPE: SLOPE RUNS PARALLEL TO WALL
