METROPOLITAN GOVERNMENT OF NASHVILLE AND DAVIDSON COUNTY

STAFF RECOMMENDATION
1515 5th Avenue North
August 15, 2012

Application: Demolition
District: Germantown Historic Preservation Zoning Overlay
Council District: 19
Map and Parcel Number: 08112041500
Applicant: SWH Residential Partners, LLC, John Tirill
Project Lead: Robin Zeigler, robin.zeigler@nashville.gov

<p>Description of Project: The applicant proposes to demolish non-historic buildings on half of the original Werthan Mill site in Germantown for future development.</p> <p>Recommendation Summary: Staff recommends demolition of buildings 1-5 on the Werthan complex, finding that demolition meets 7.2 of the design guidelines for the Germantown Historic Preservation Zoning Overlay.</p>	<p>Attachments A: Photographs</p>
--	---

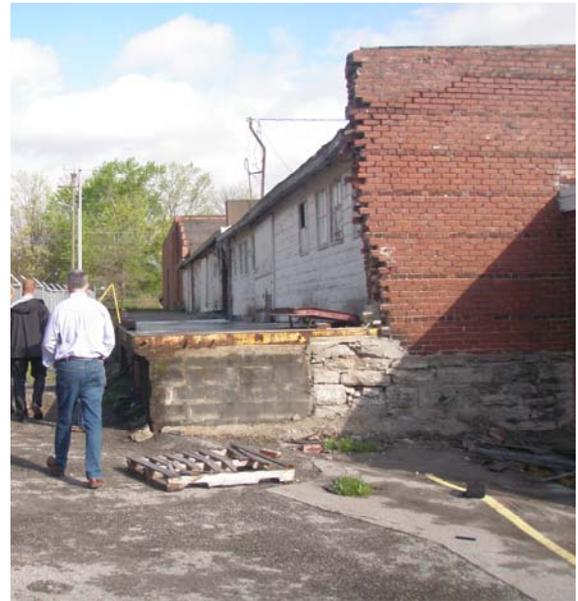
Picture #02
Exterior West

- Picture #02 above illustrates crumbling foundations and masonry walls.
- Picture #03 above illustrates one of many areas where water infiltrates the building regularly through damaged roof causing water damage to structure and roof decking
- Picture #04 above illustrates water damage and unstable structure with inadequate shoring (pallets)
- Pictures #05, 06 & 07 below illustrate typical decomposing brick and mortar, uneven settlement (deteriorating rock face stone foundation) and rotting wood trim.

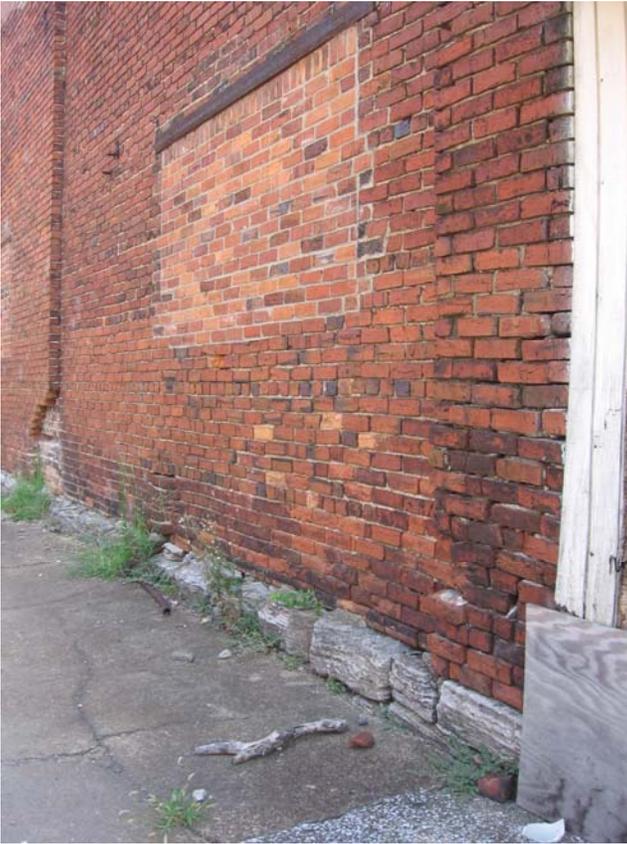
Picture #05
Decomposing Brick and Mortar

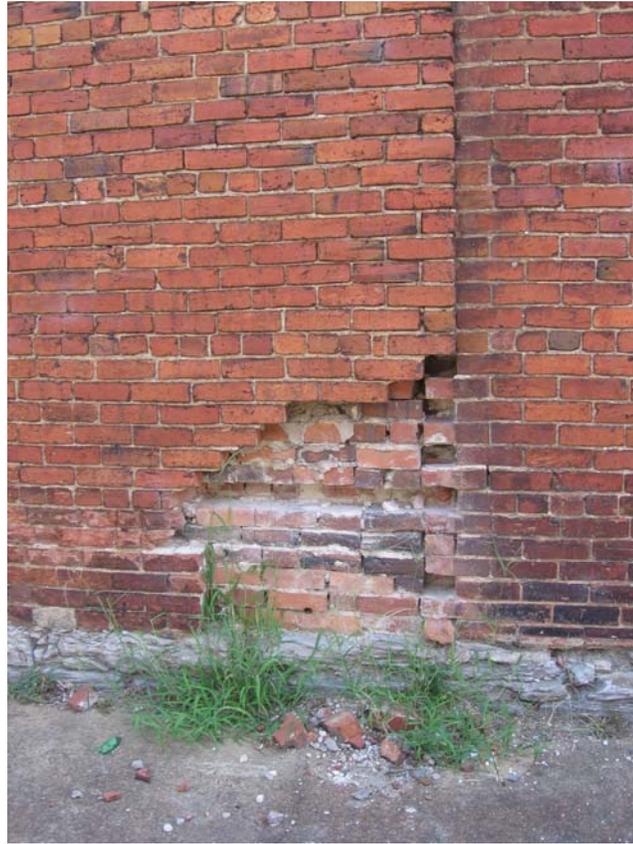
Picture #06
Decomposing Brick and Mortar

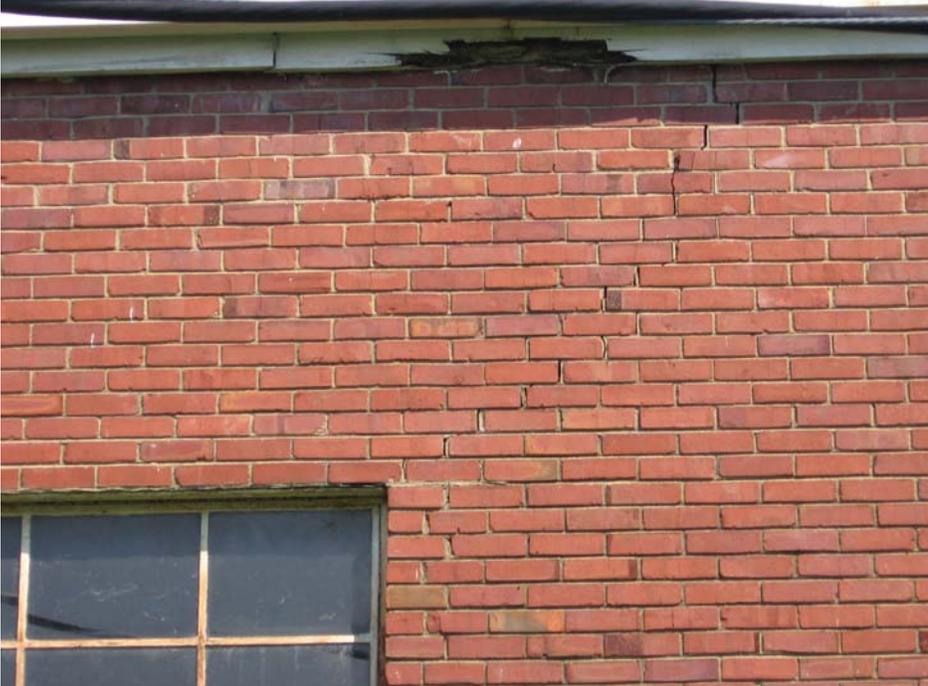
Picture #07
Uneven Settlement; Rotting wood trim

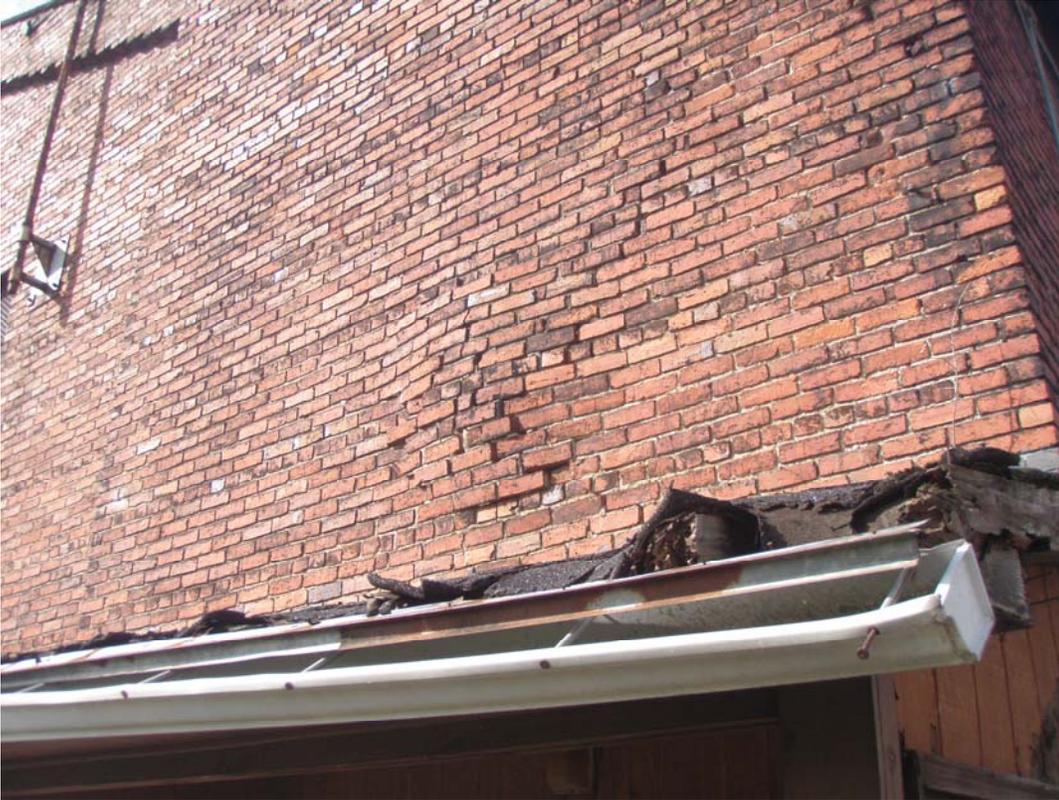
- Picture #08 below illustrates damaged/structurally unsound masonry walls and wood structure deterioration
- Picture #09 below illustrates typical water damage to structure and wood roof decking

Picture #08
Structurally unsound walls; wood roof deterioration

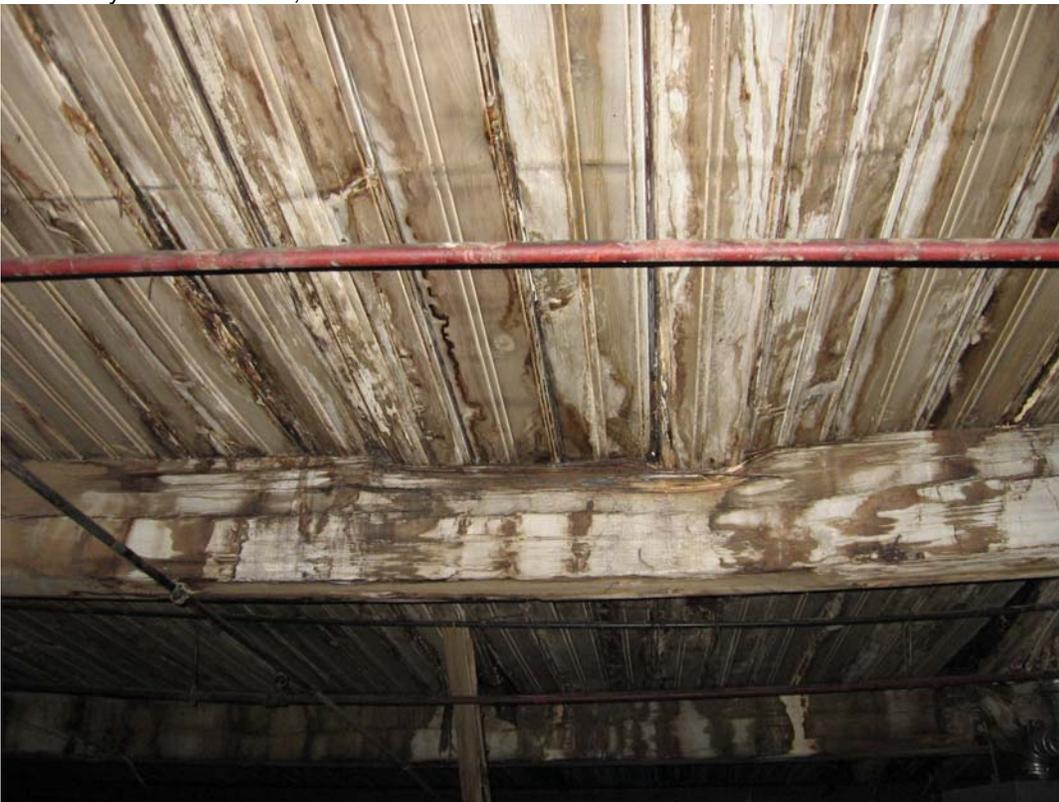
Picture #07
Water damage to structural beams and roof decking, typical

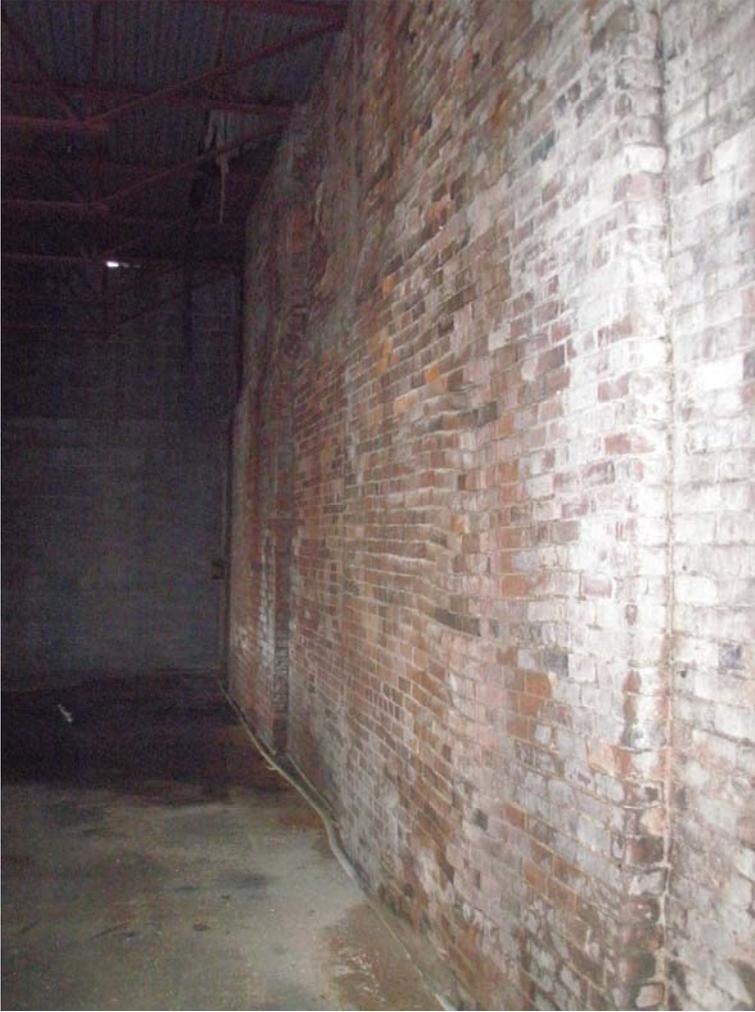
- Pictures #10 & 11 below illustrate North wall water infiltration, uneven settlement and storm damage. Following Tornado in 1972 North wall was deemed unstable by insurance company and building was declared unoccupiable

Picture #10
North wall – unstable, uneven settlement, storm damage

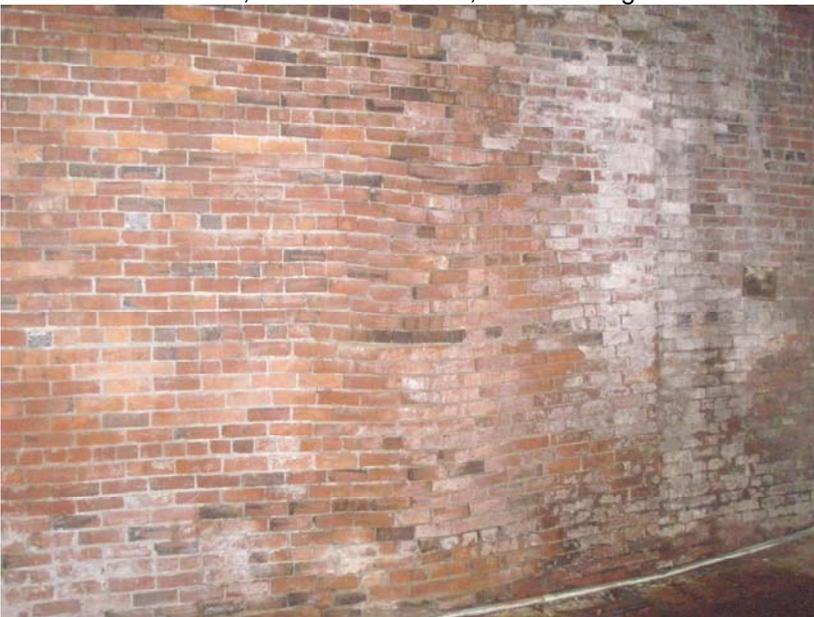
Picture #11
North wall – unstable, uneven settlement, storm damage

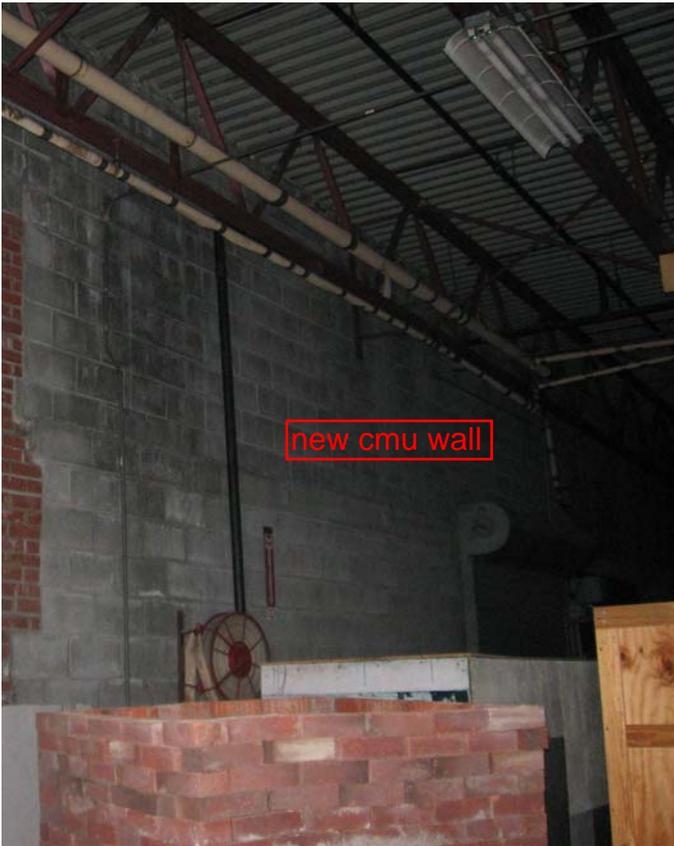
- Picture #12 illustrates rebuilt west brick wall. The original brick section was largely rebuilt following damage caused by the tornado in 1972.
- Picture #13 illustrates rebuilt west brick wall with CMU, along with standing water due to water infiltration.
- Picture #14/15 illustrates rebuilt west brick wall with all new brick and deteriorating/patched rock face stone foundation.

Picture #12
Rebuilt wall

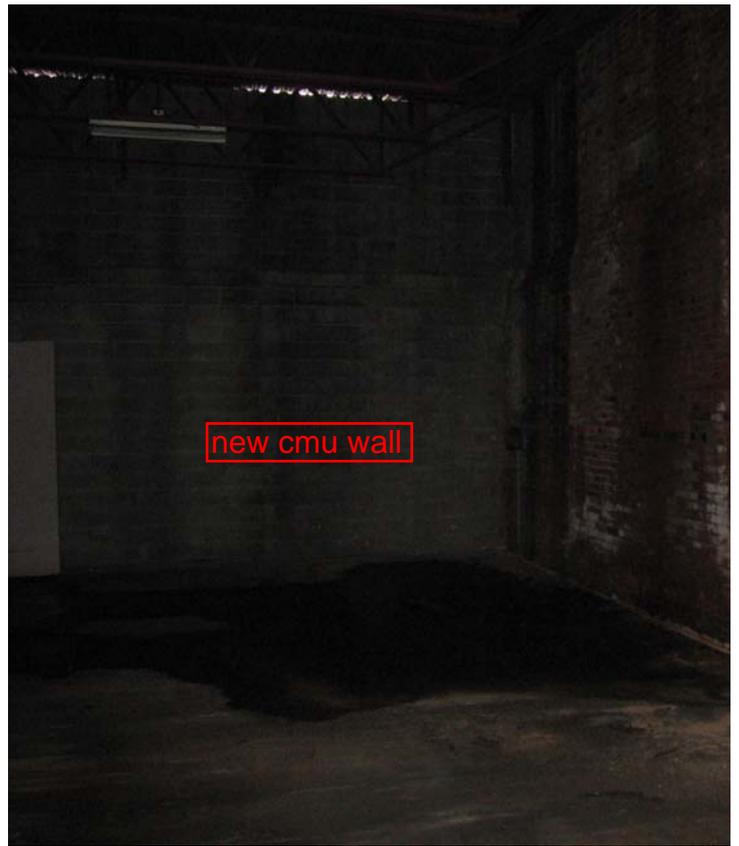
Picture #13
Rebuilt wall

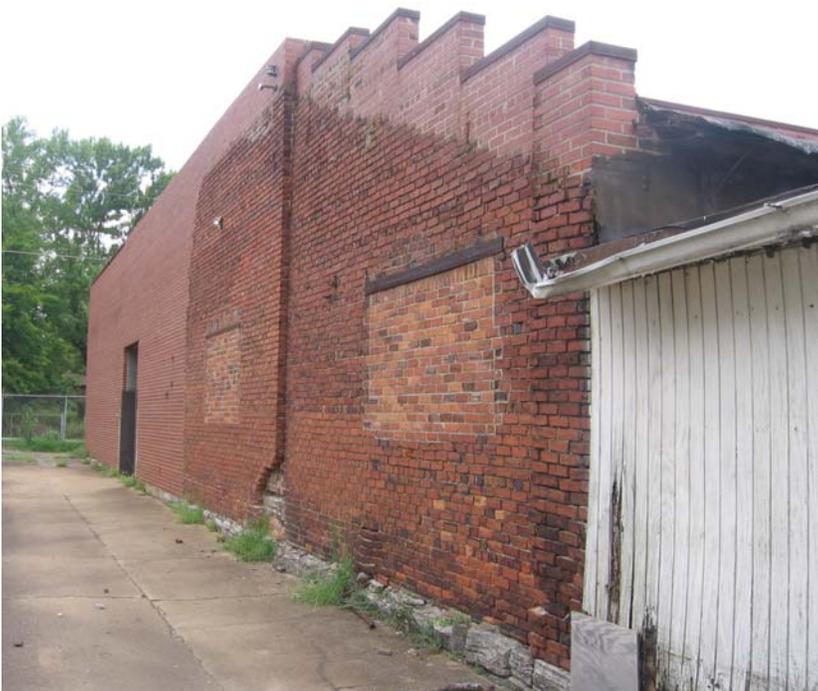
Picture #14

Rebuilt west wall with new brick and cmu block, decomposing brick and mortar, water infiltration and decomposition at roof line.

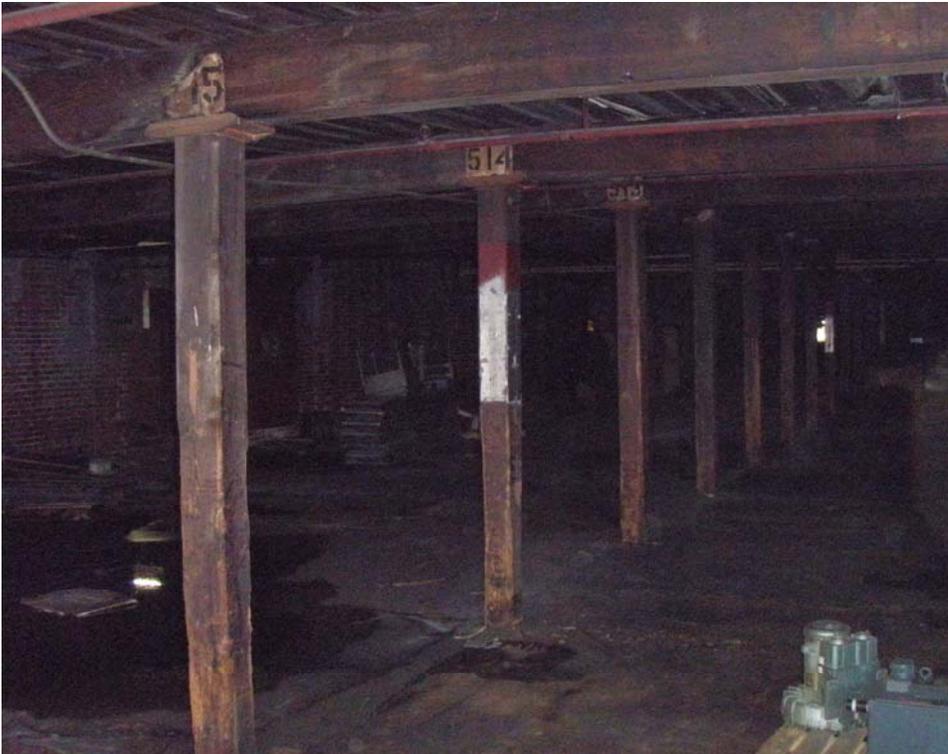
- Picture #15, 16, 17 below illustrates water infiltration into building causing damage to structure and roof decking.

Picture #15
Water infiltration

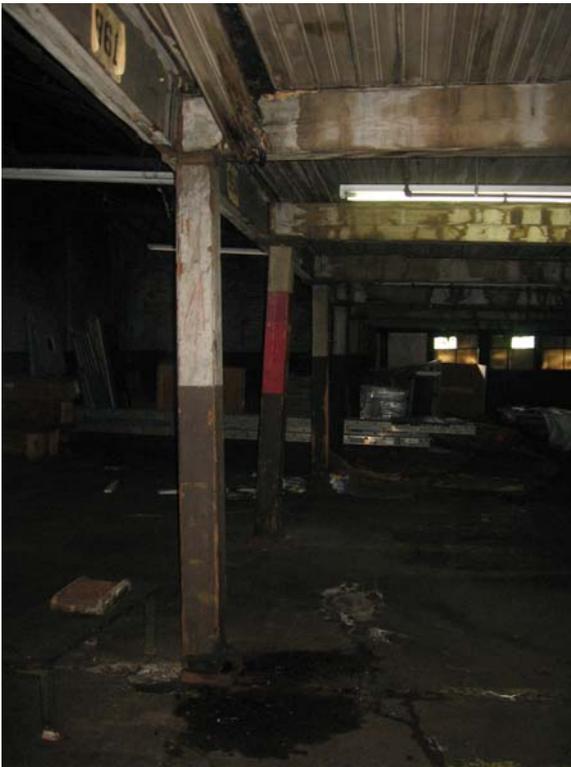
Picture #16
Water infiltration

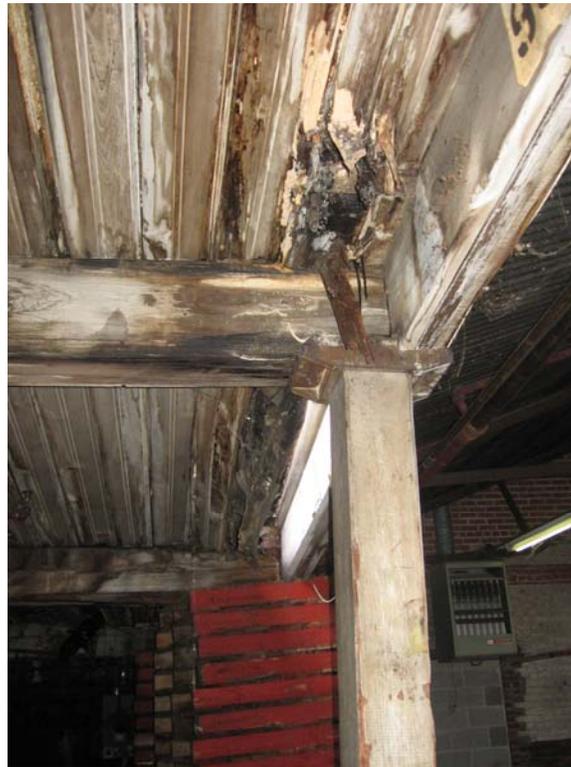
Picture #17
Water infiltration, separation from roof causing structural instability
