STAFF RECOMMENDATION
1203 Forrest Avenue
May 16, 2012

Application: Demolition
District: Lockeland Springs-East End Neighborhood Conservation Zoning Overlay
Council District: 06
Map and Parcel Number: 08309009400
Applicant: Neil McGlothlin/ Paragon Group LLC
Project Lead: Robin Zeigler, robin.zeigler@nashville.gov

**Re: Structural Review of Integrity of Residence
1203 Forrest Avenue
Nashville, TN 37206
AJDS Project No. 12-0421-000**

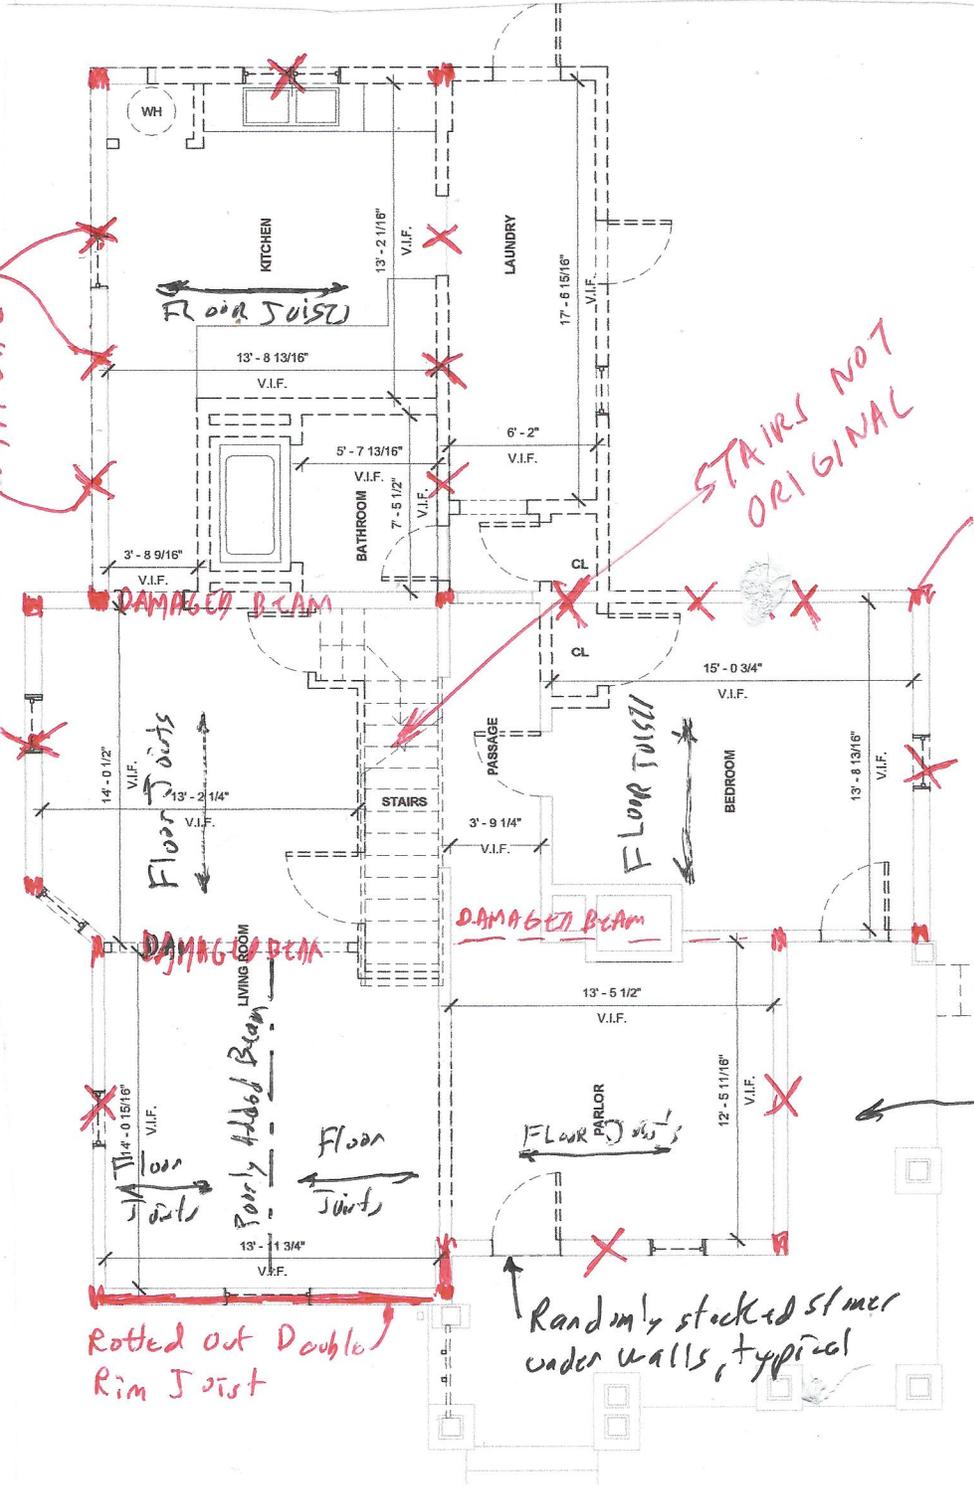
FIRST FLOOR PLAN

APPARENT ORIGINAL ROTTED
WOOD POSTS UNDER RIM
TYPICAL

STAIRS NOT
ORIGINAL

APPARENT BRICK
PILASTERS AT
CORNERS - DETERIORATED
TYPICAL

Apparent randomly
stacked studs under
slabs, typical

Randomly stacked studs
under walls, typical

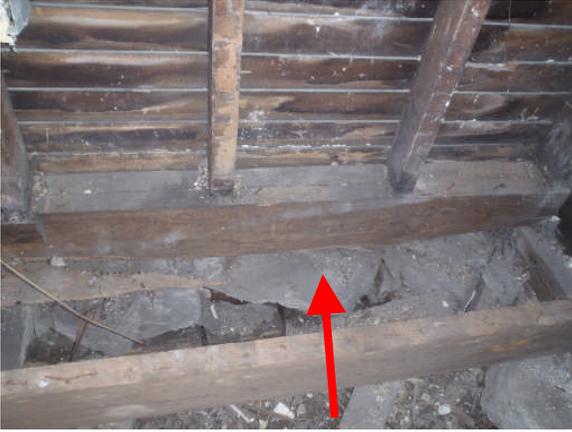
Loose stones as skirting under front wall

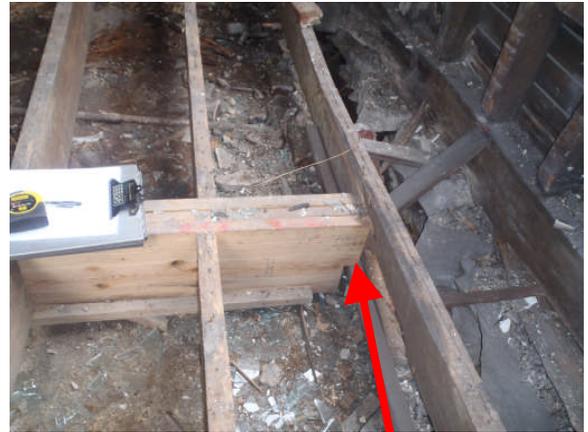
Added beam was poorly supported by ledger at single joist at front left

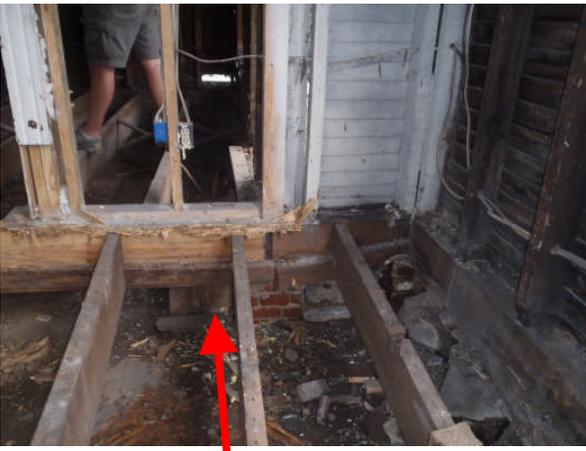
Left side floor joist frame into center beam w/poor supports

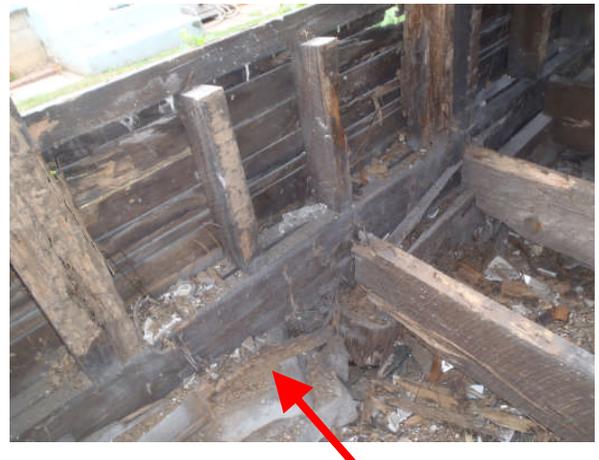
At other locations (especially at the left side), the rim joists appear to have moved outward and also the two plies have started to pull apart. A gap has been left between the double rim joists and the ends of the floor joists.

Loose stones as skirting under left wall
Double rim joist has moved outward away from ends of left floor joists

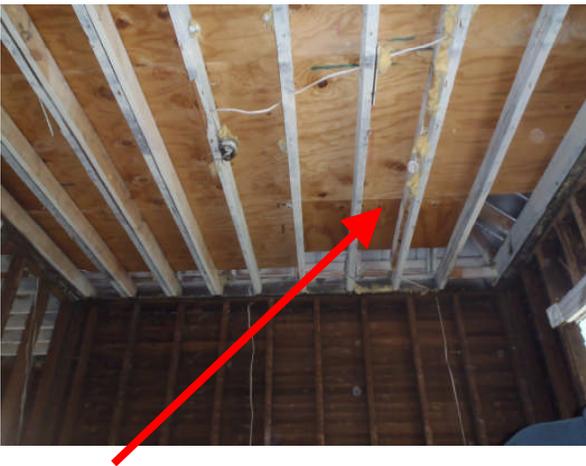
Second floor joists are actually only original 2x6 ceiling joists that also show signs of past charring from fire. Walls only have single top plates and no headers over windows. Rafters rest on ribbon board on top of ceiling joists.

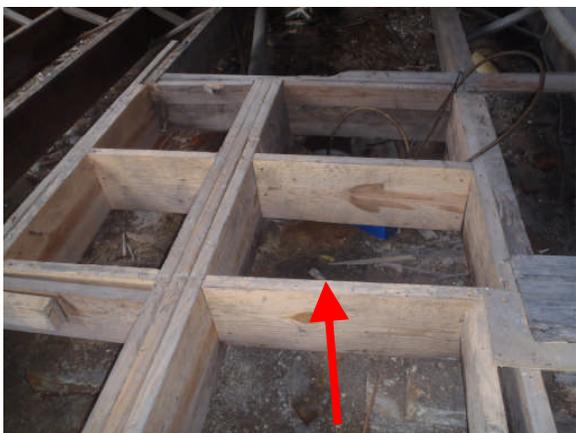
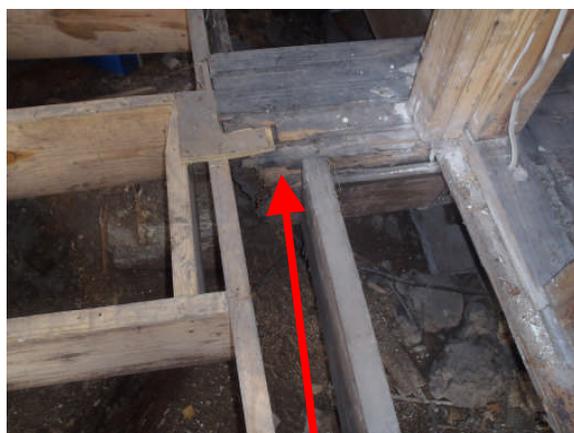
Poorly repaired floor system at location of original fireplace between study and dining room. There is termite damage in beam under wall also.

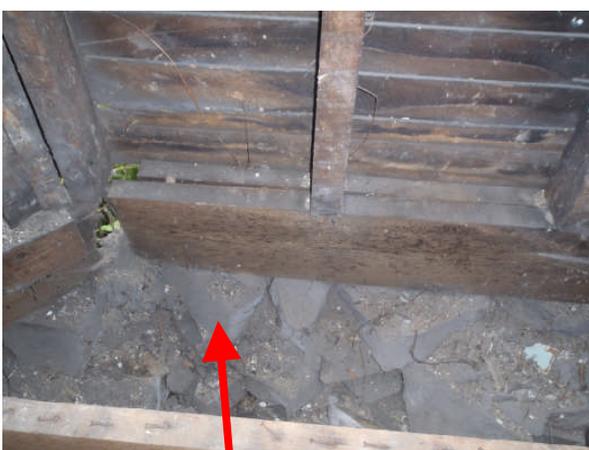
Additional areas of loose stones as skirting. No actual support under double rim joist was noted.

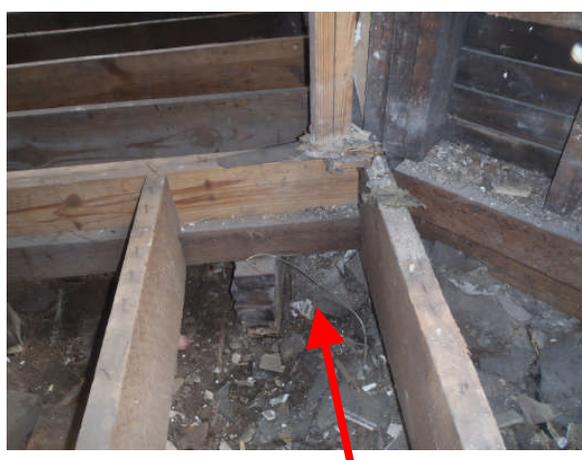
Apparent original brick pilaster at one corner of left bay window.

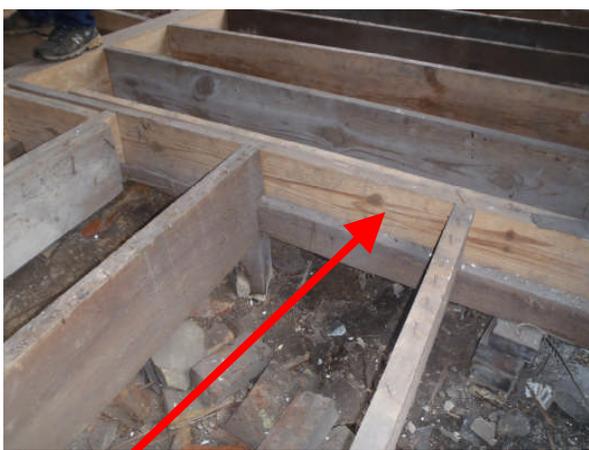
Poor support under main beam where floor joists change direction.

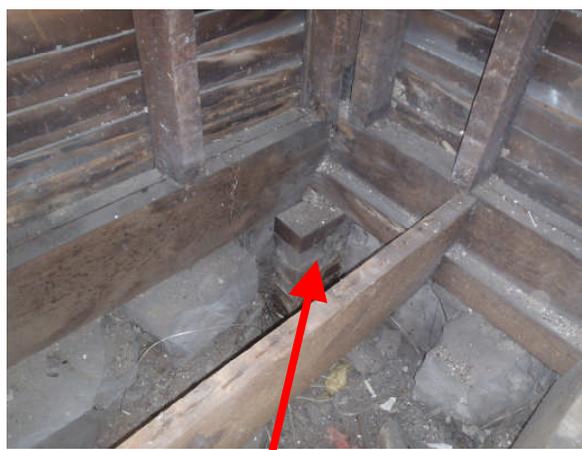
Another original brick pilaster at one of the corners

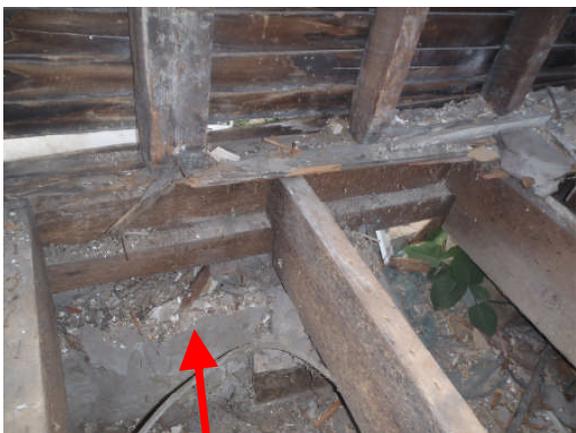
More areas of stacked stone skirting—no actual foundation.

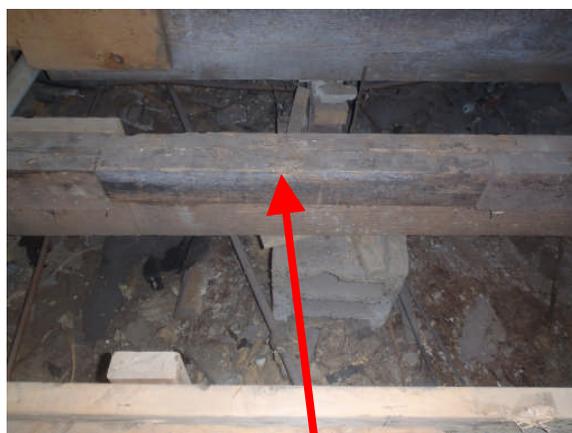
Poorly added supports under rear floor joists

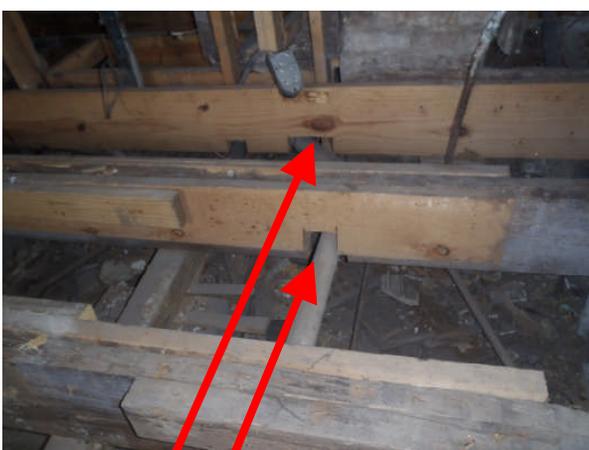
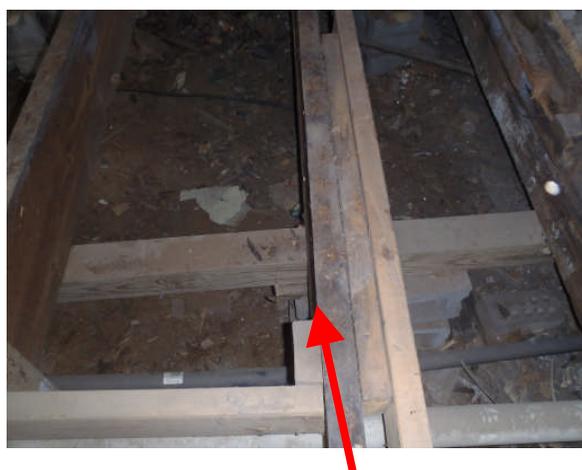
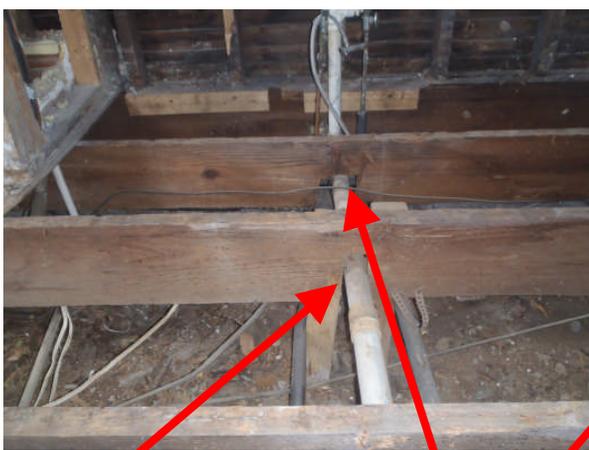
Rear floor joists notched for water line and poorly patched and supported.

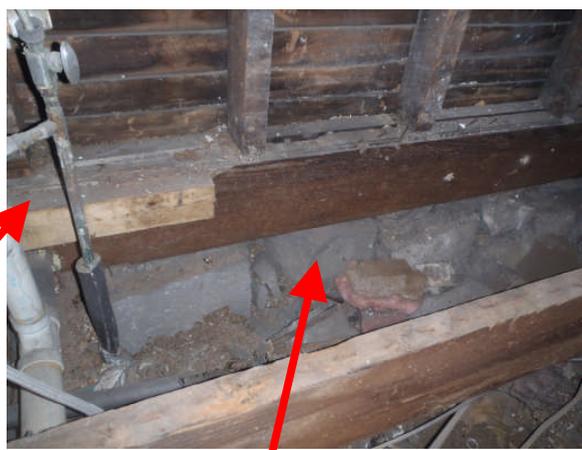
Poorly stacked stone skirting at rear—no actual structural foundation.

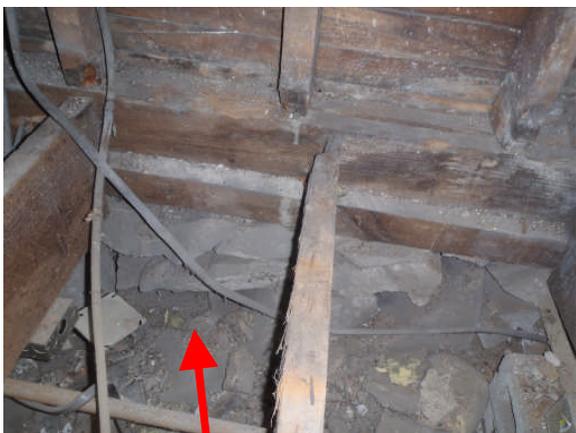
More areas of stacked stone skirting—no actual

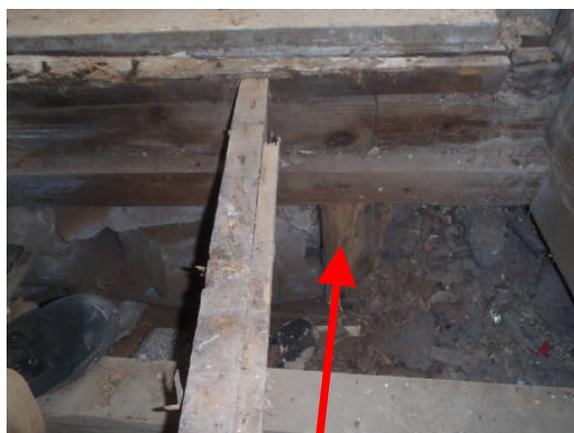
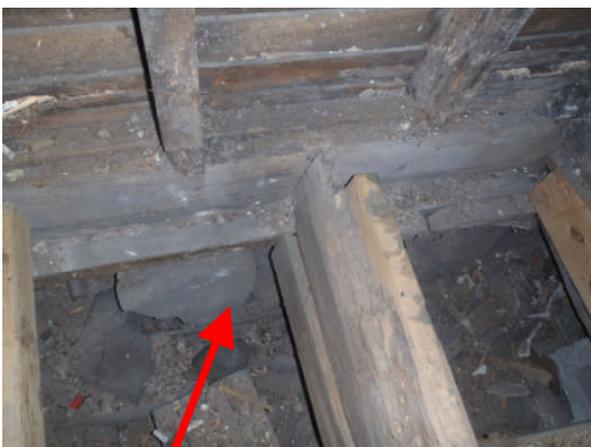
Original wood post at right side to support double rim joist

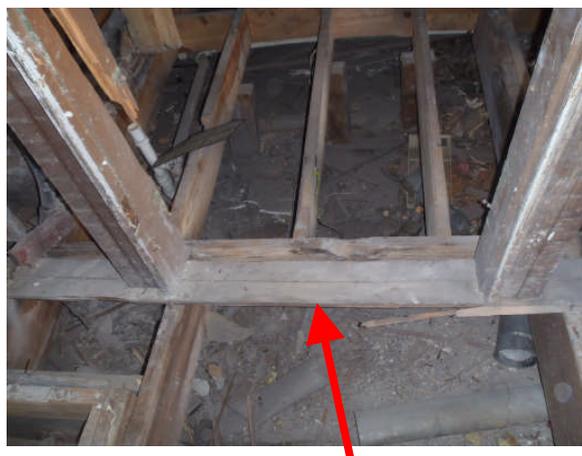
Poorly supported beam at right side under load bearing wall

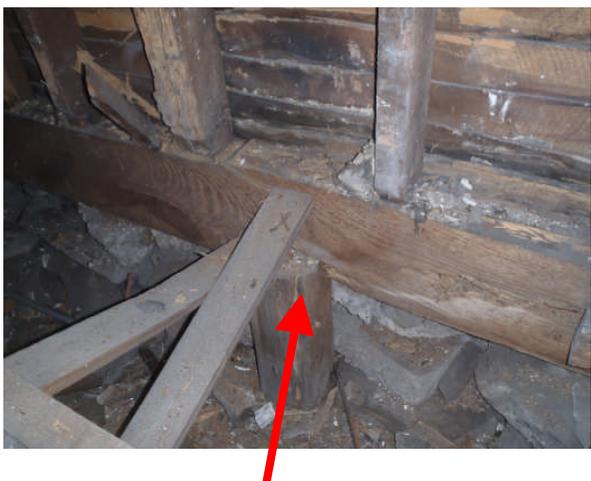
Original wood post at right side to support double

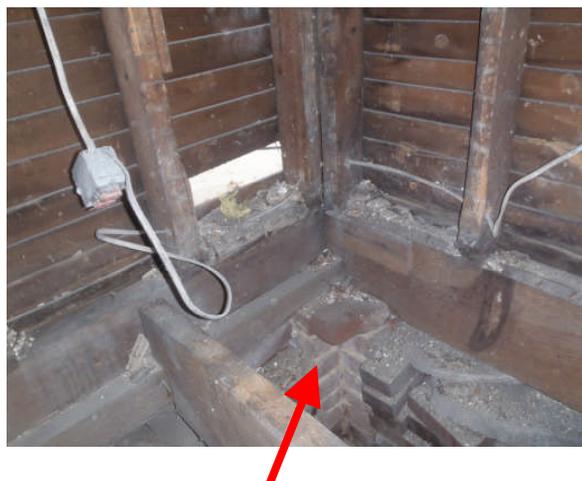
Deteriorated brick pilaster at corner at right side

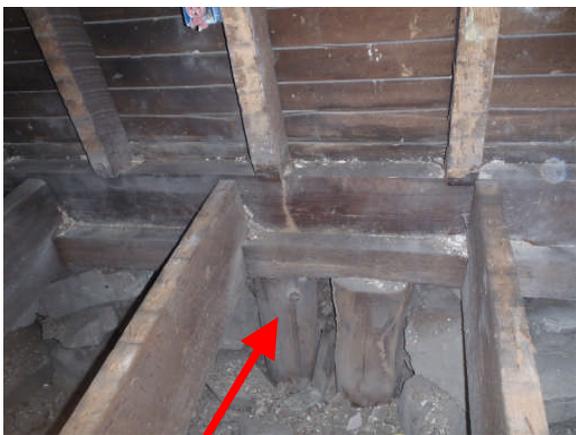
Original wood posts at right side to support double rim joist

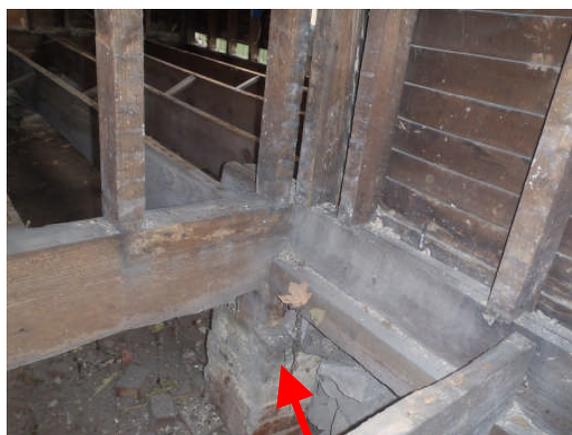
Deteriorated brick pilaster at corner at right side

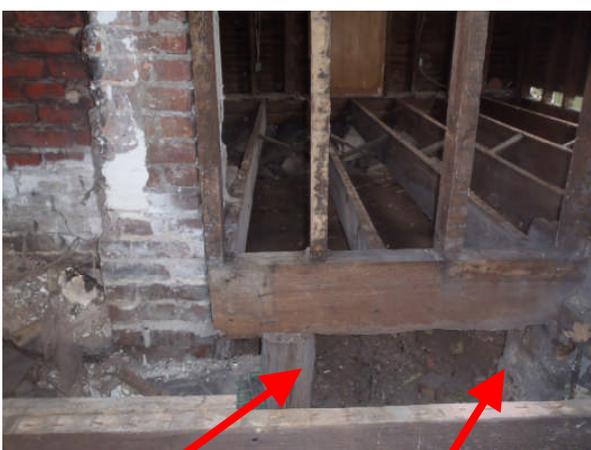
More wood posts at right side of fireplace

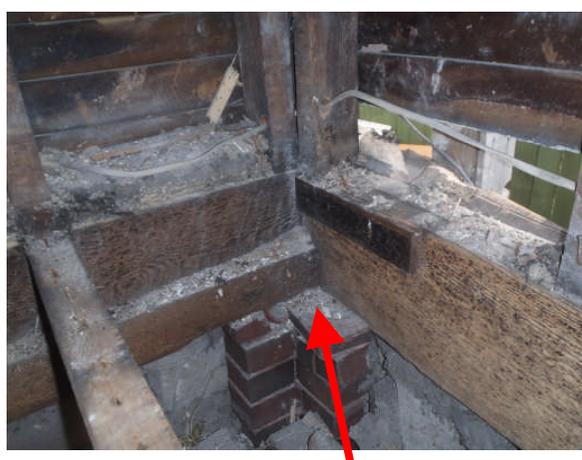
Another deteriorated brick pilaster at right side

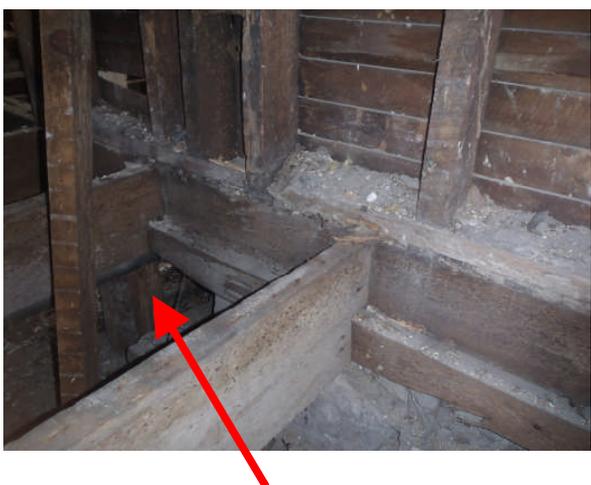
Original wood post at right side to support double

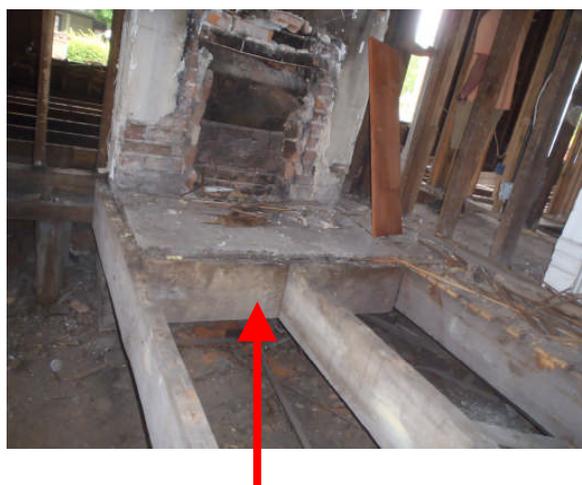
The remaining double fireplace at the right side has a poorly supported hearth area with headers that span between single floor joists. Beams apparently rely on the base of the fireplace for some amount of support.

Poorly supported header at hearth of fireplace

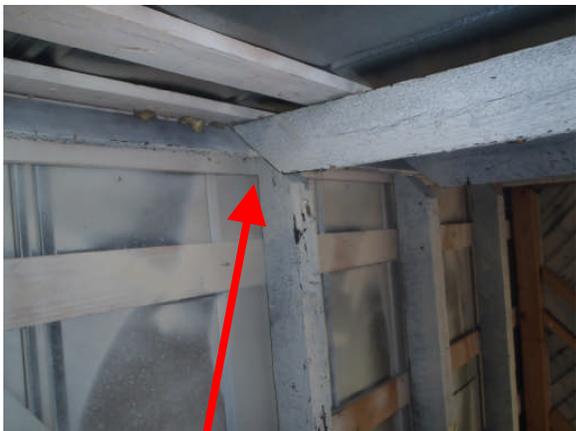
2x4 rafters with 1x ridge board, typical

With only original 2x4 rafters, the roof already has sags in it. The rafters would need to be sistered with 2x6s for proper support of the roof. With only the 1x4 ridge board, rafter ties should be installed at each pair of rafters to strengthen the roof system. Blocking would need to be installed under the ribbon board that presently supports the rafter so the loads from the rafters are properly transferred to the walls below. Installation of these required structural elements would lower the height at the second floor such that there would be very little usable space at the second floor. It would actually be better if the entire roof was taken off and then rebuilt with proper size rafters and a true ridge beam. This would be the only way to install the plywood decking and regular shingles on the roof as indicated on the proposed house plans.

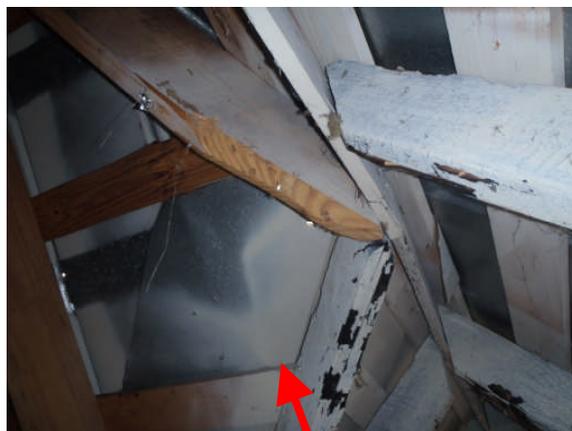
Intersection of valley rafter and hip rafter not supported, typical

At the intersection of hip and valley rafters, proper supports will need to be installed under these joints down to a load bearing wall or beam. These would probably require major reframing of the existing roof system to eliminate as many of these intersections as possible.

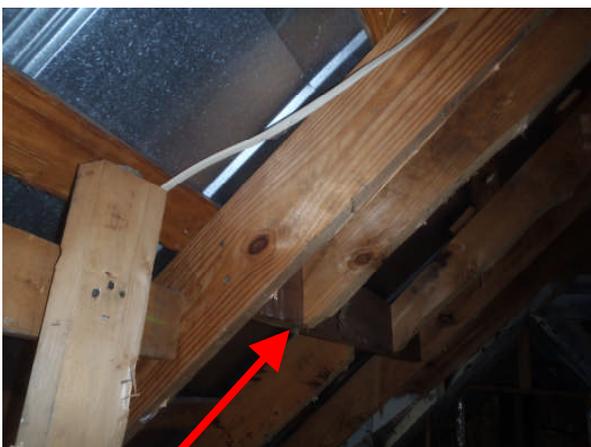
Where the original fireplace and chimney were removed near the front left of the residence, the roof framing was poorly patched as was done at the first floor framing.

Rafters not properly patched where chimney was removed in roof system at left

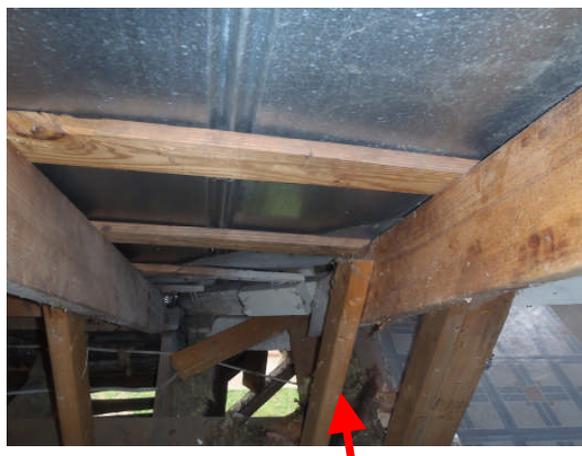
Knee walls rest on ceiling joists instead of true structural supports

Proper beams would need to be installed under all of the second floor knee walls as the roof that they are receiving from the roof is too much for just standard ceiling/floor joists.

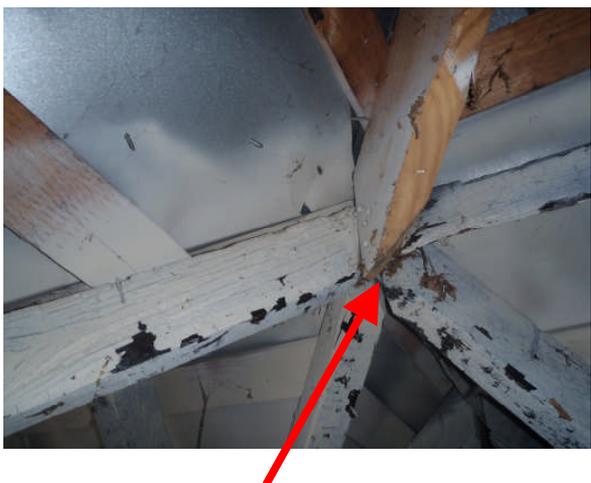
Another unsupported intersection of rafters

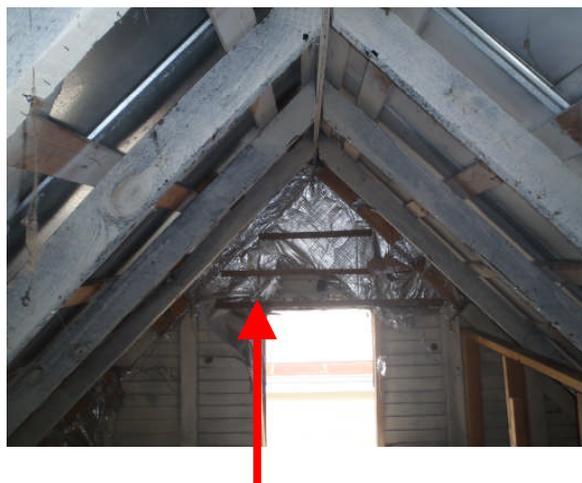
We noted that the left wall of the left dormer was poorly constructed with minimal number of studs and the studs were turned sideways with the 2-inch dimension parallel to the wall.

Left dormer wall is not framed properly
