STAFF RECOMMENDATION
1614 Benjamin Street
March 20, 2013

Application: Demolition of contributing building
District: Eastwood Neighborhood Conservation Zoning Overlay
Council District: 06
Map and Parcel Number: 08306003300
Applicant: Bill Franklin, Owner
Project Lead: Sean Alexander@nashville.gov

STRUCTURAL EVALUATION OF RESIDENCE

1614 Benjamin Street
Nashville, Tennessee
Project #213022

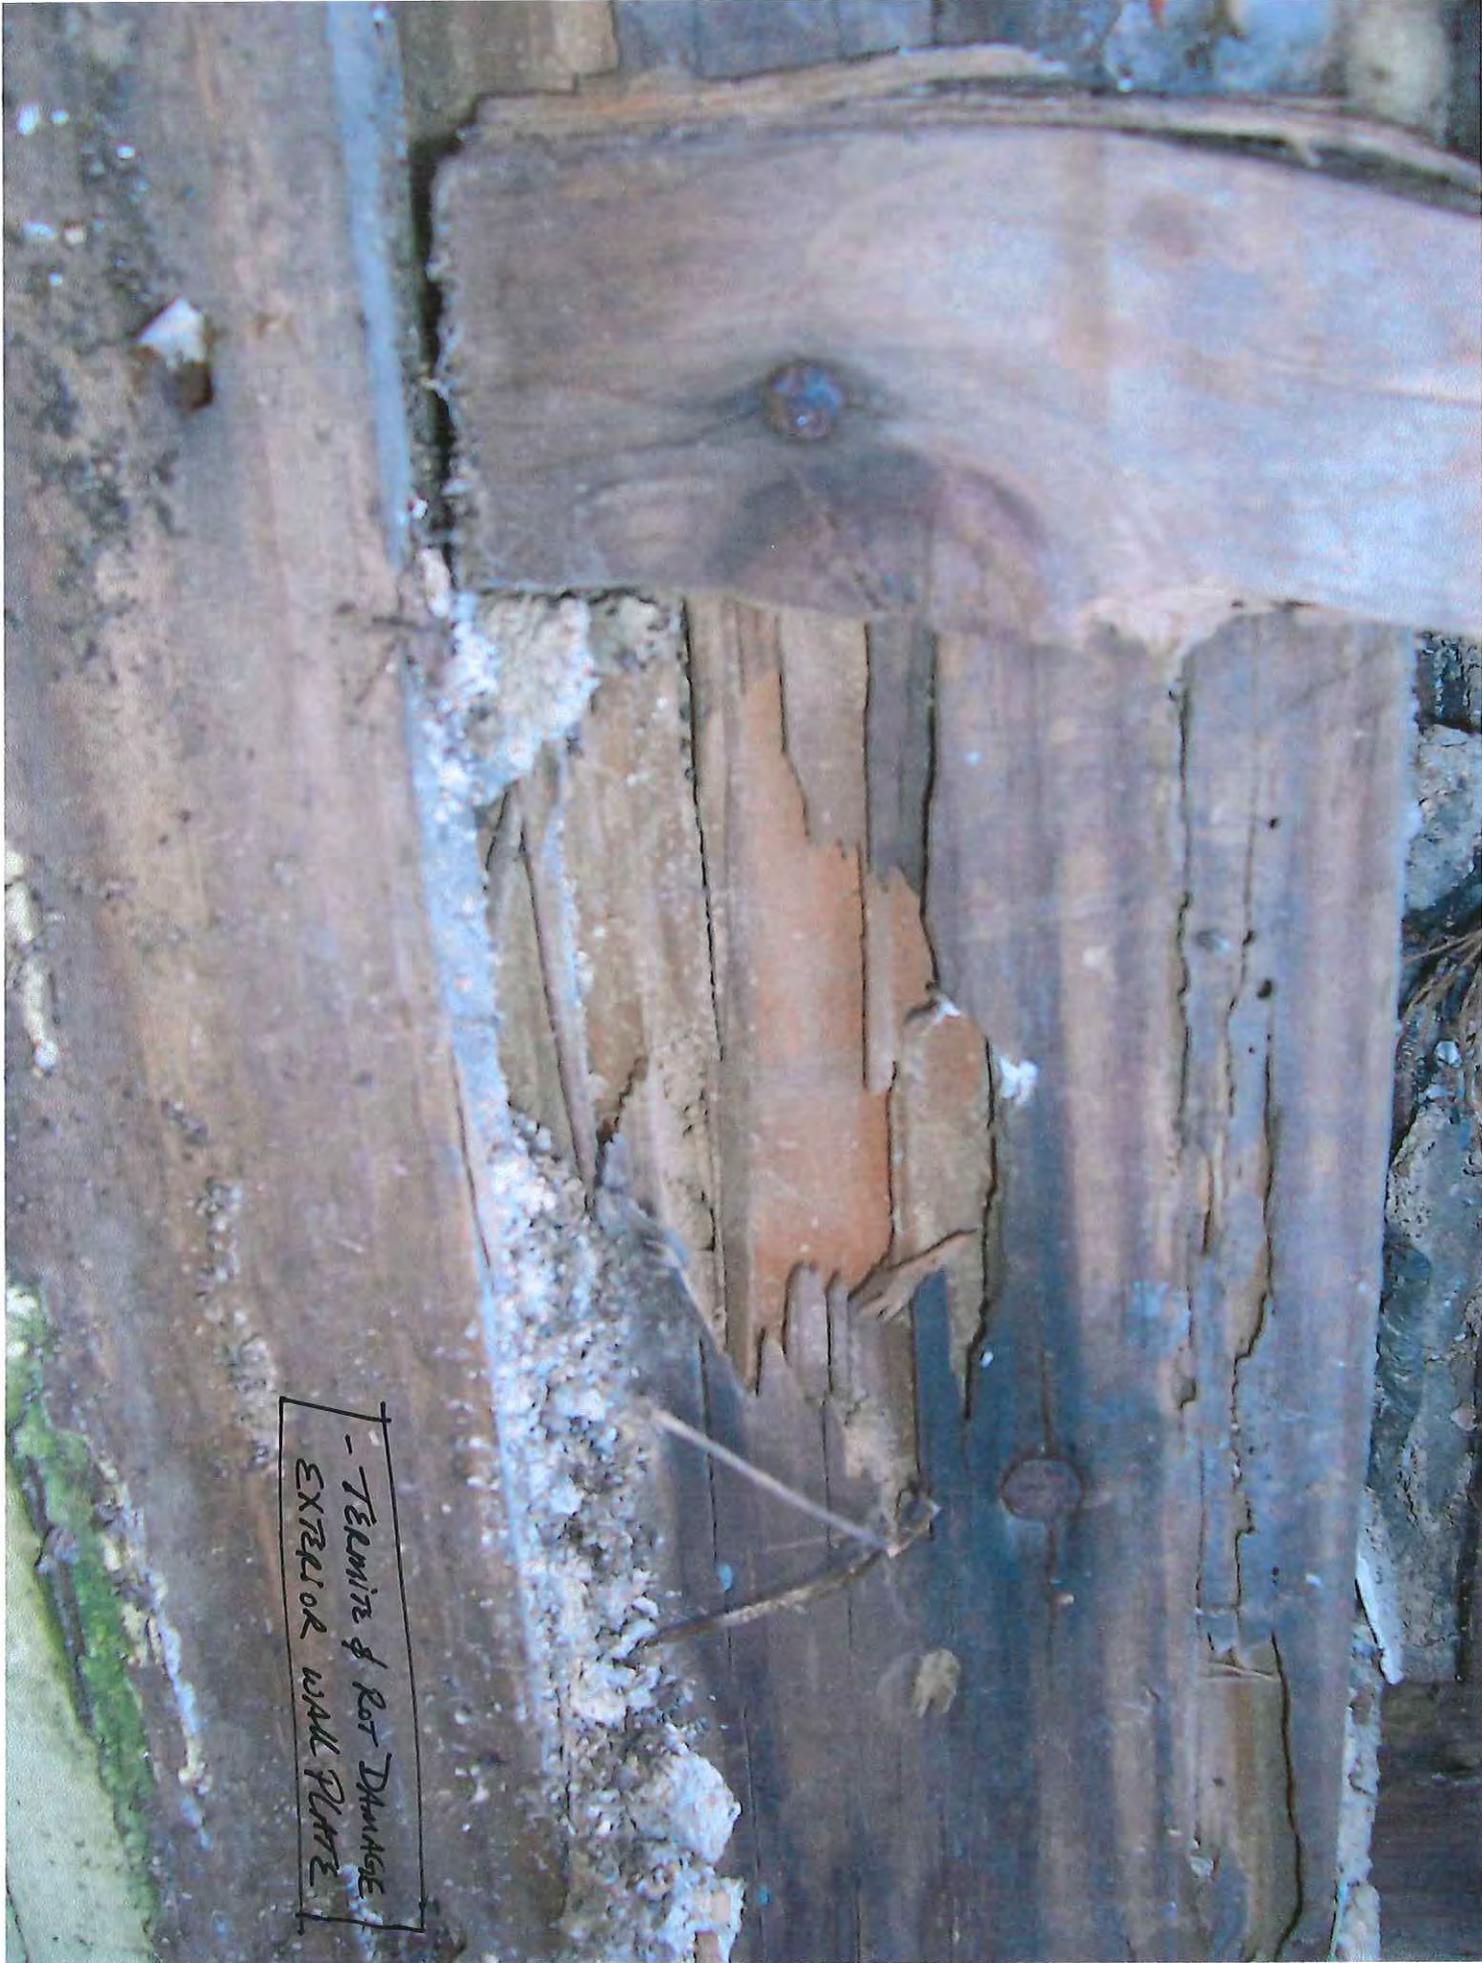
- TERMINATE & ROT DAMAGE
EXTERIOR WALL PLATE

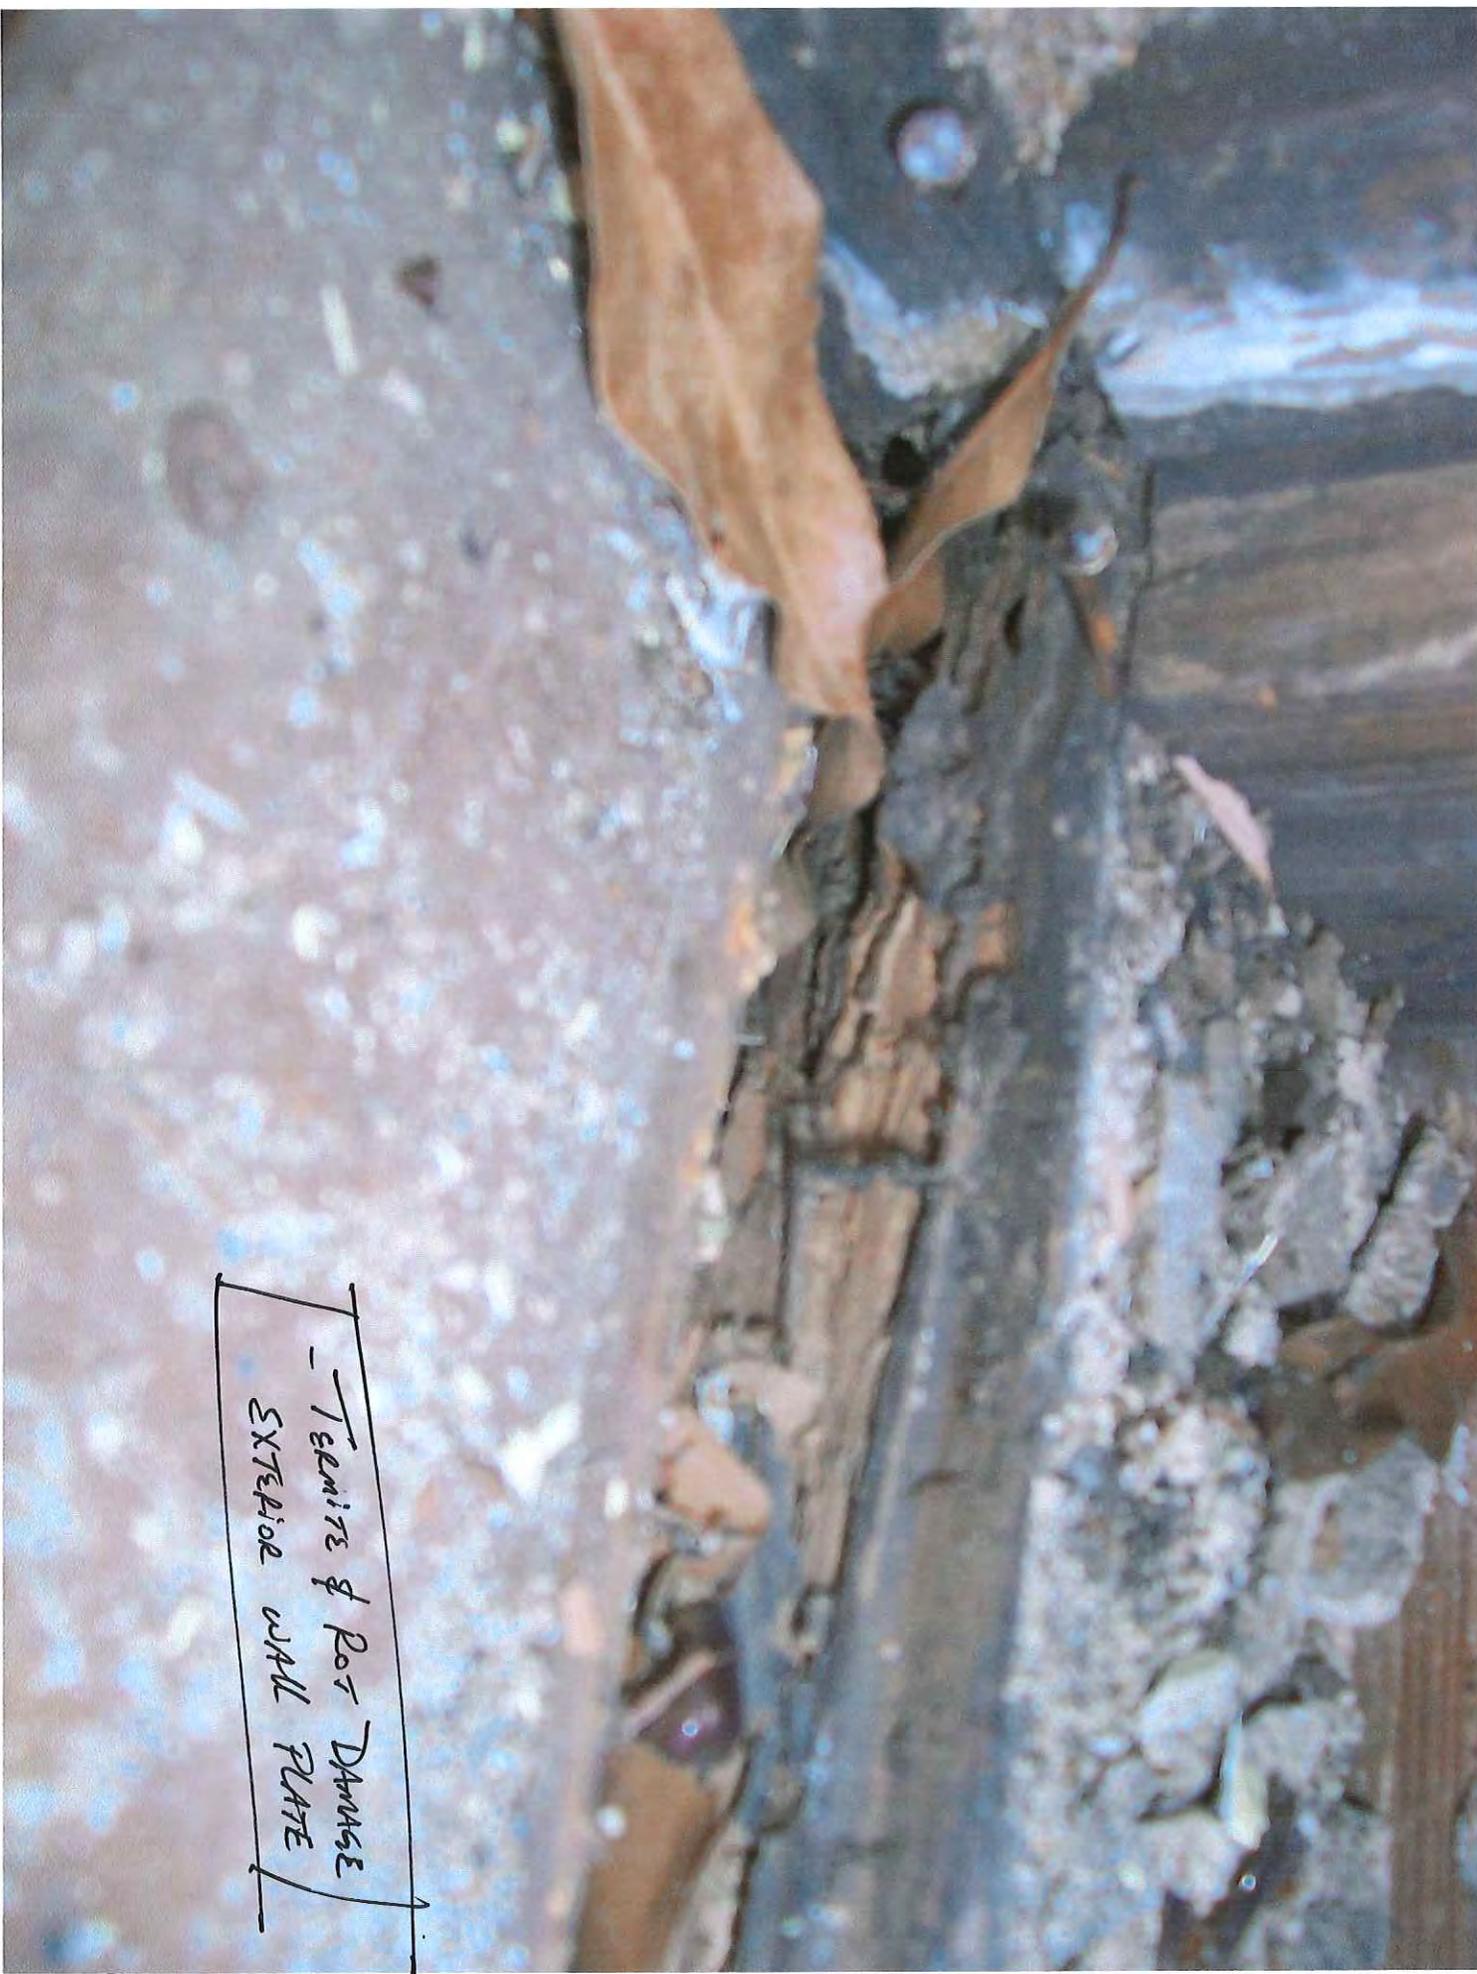
- Termites & Rot Damage
Exterior Wall Plate

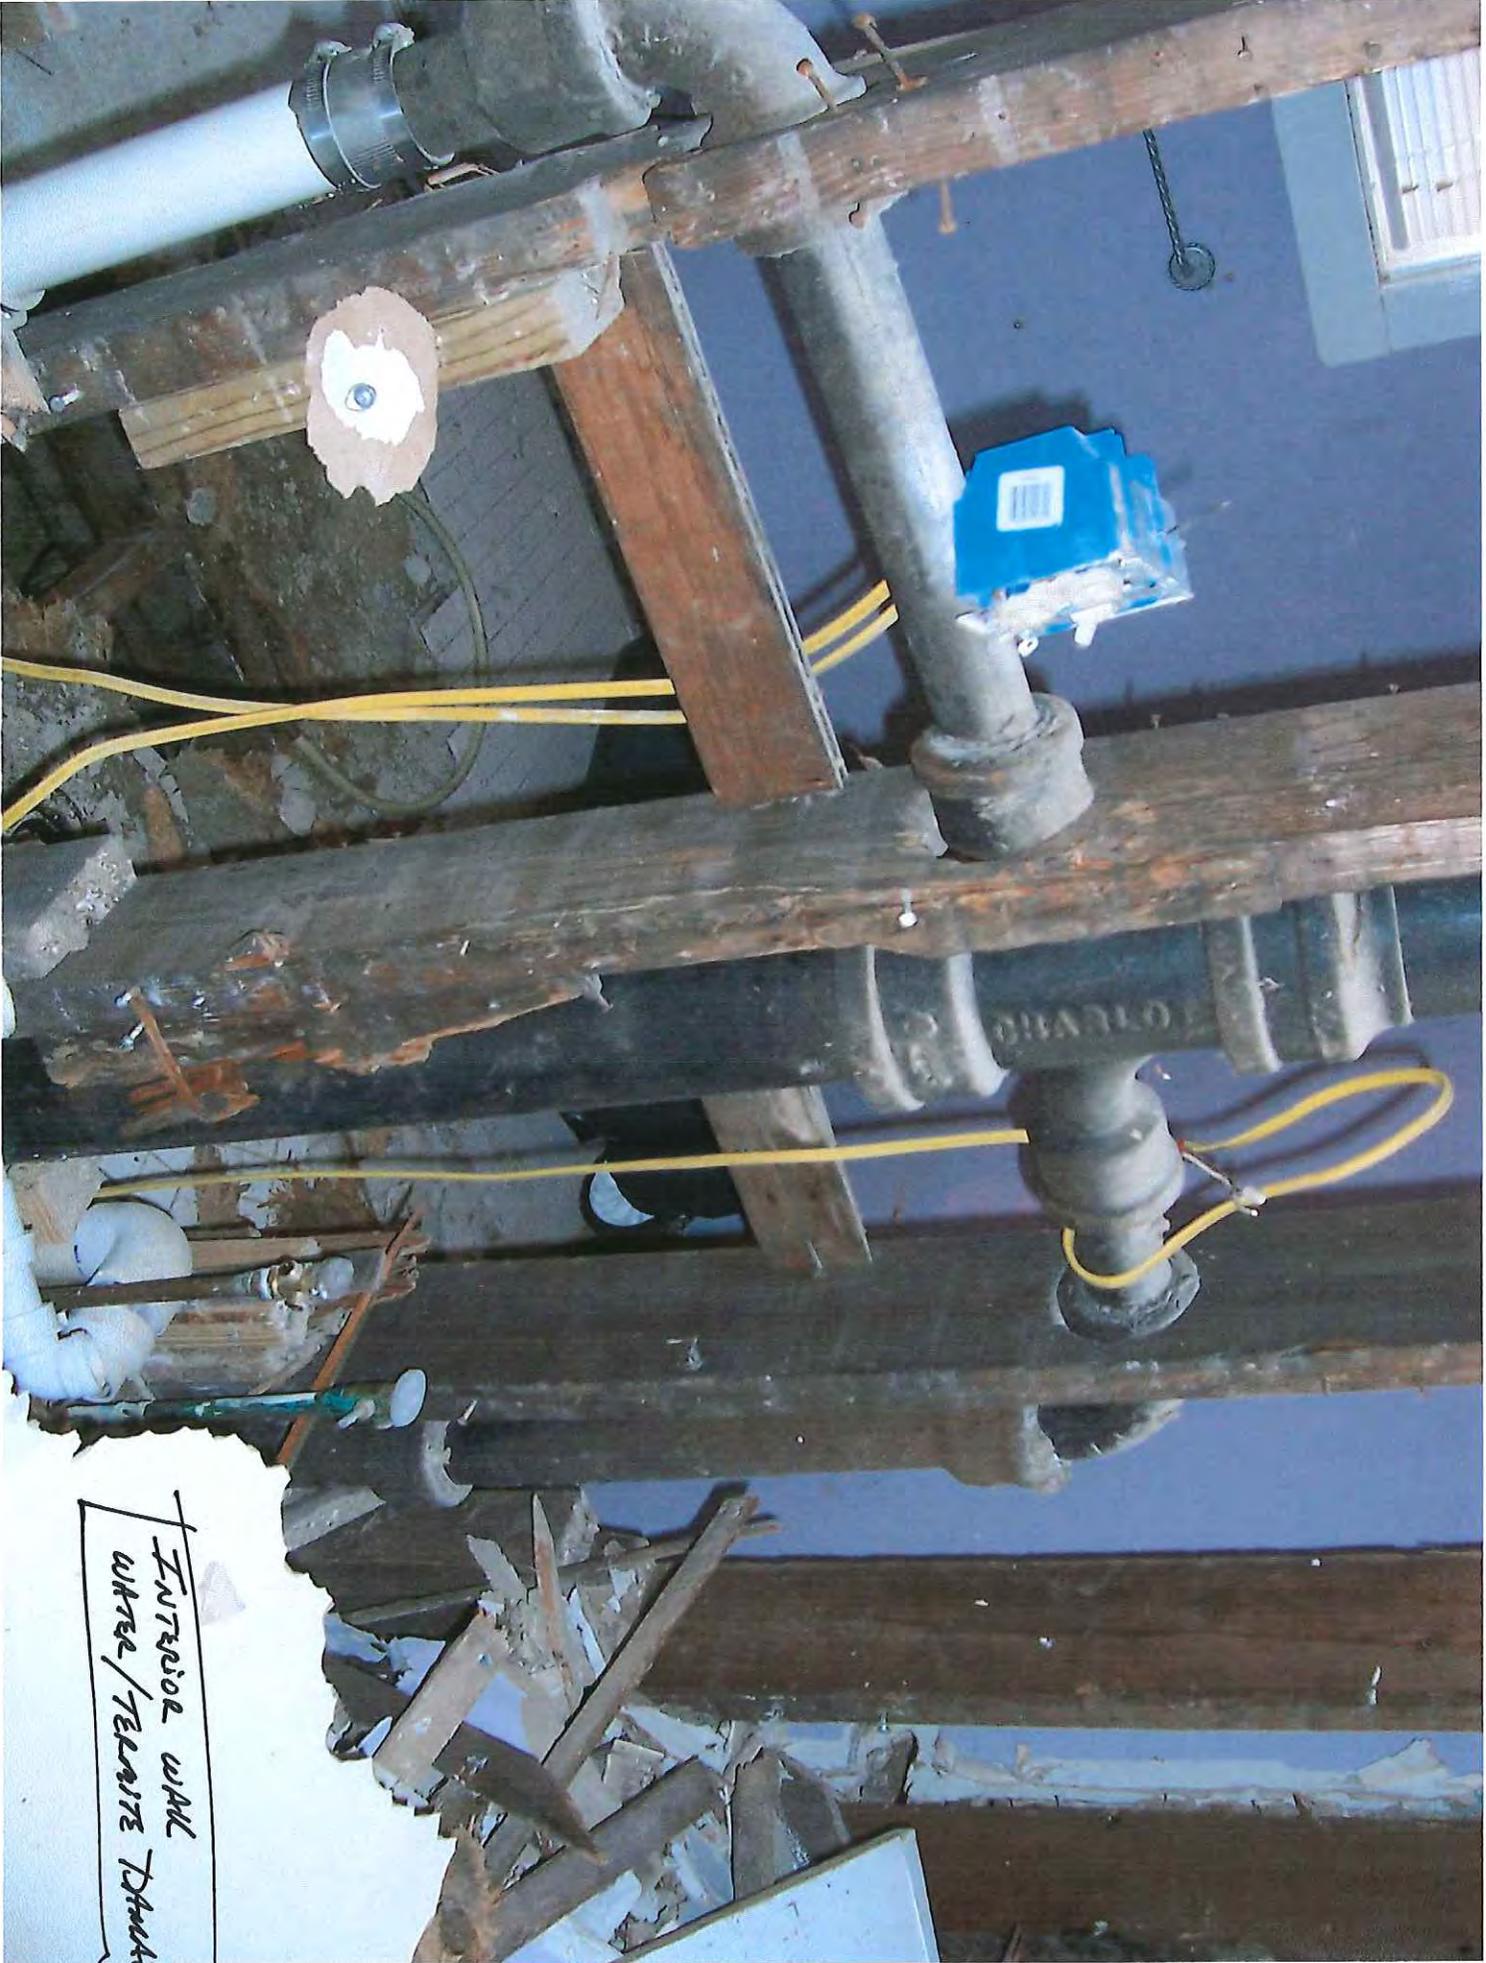
INTERIOR WALL
WIRE/REPAIRS THRUOUT

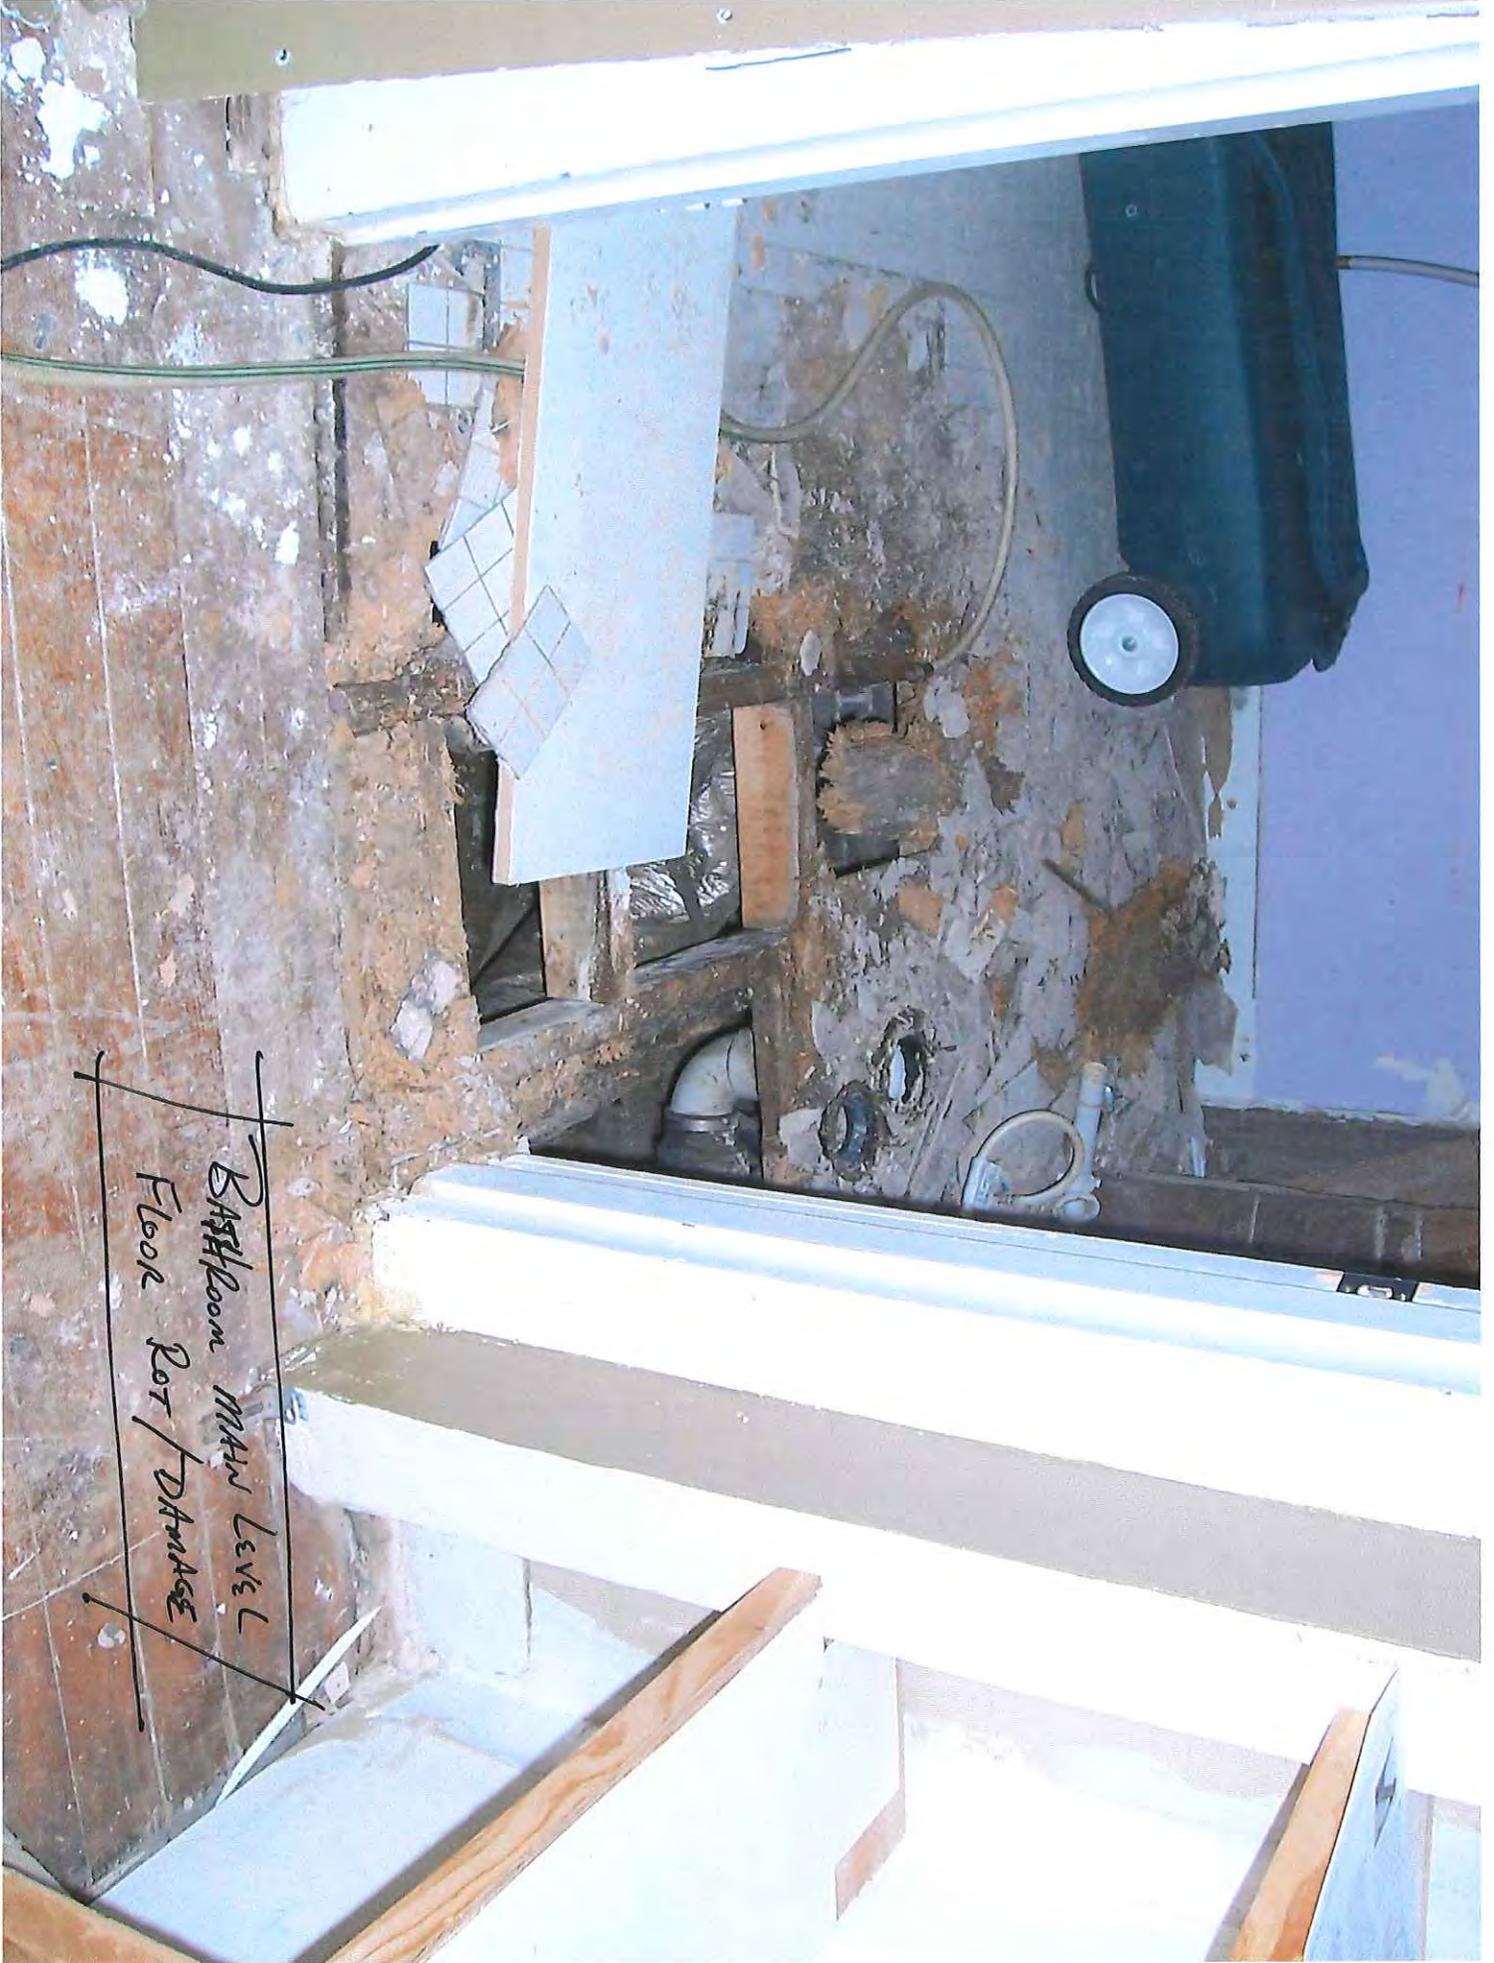
BATHROOM MAIN LEVEL
Floor Rot / Damage

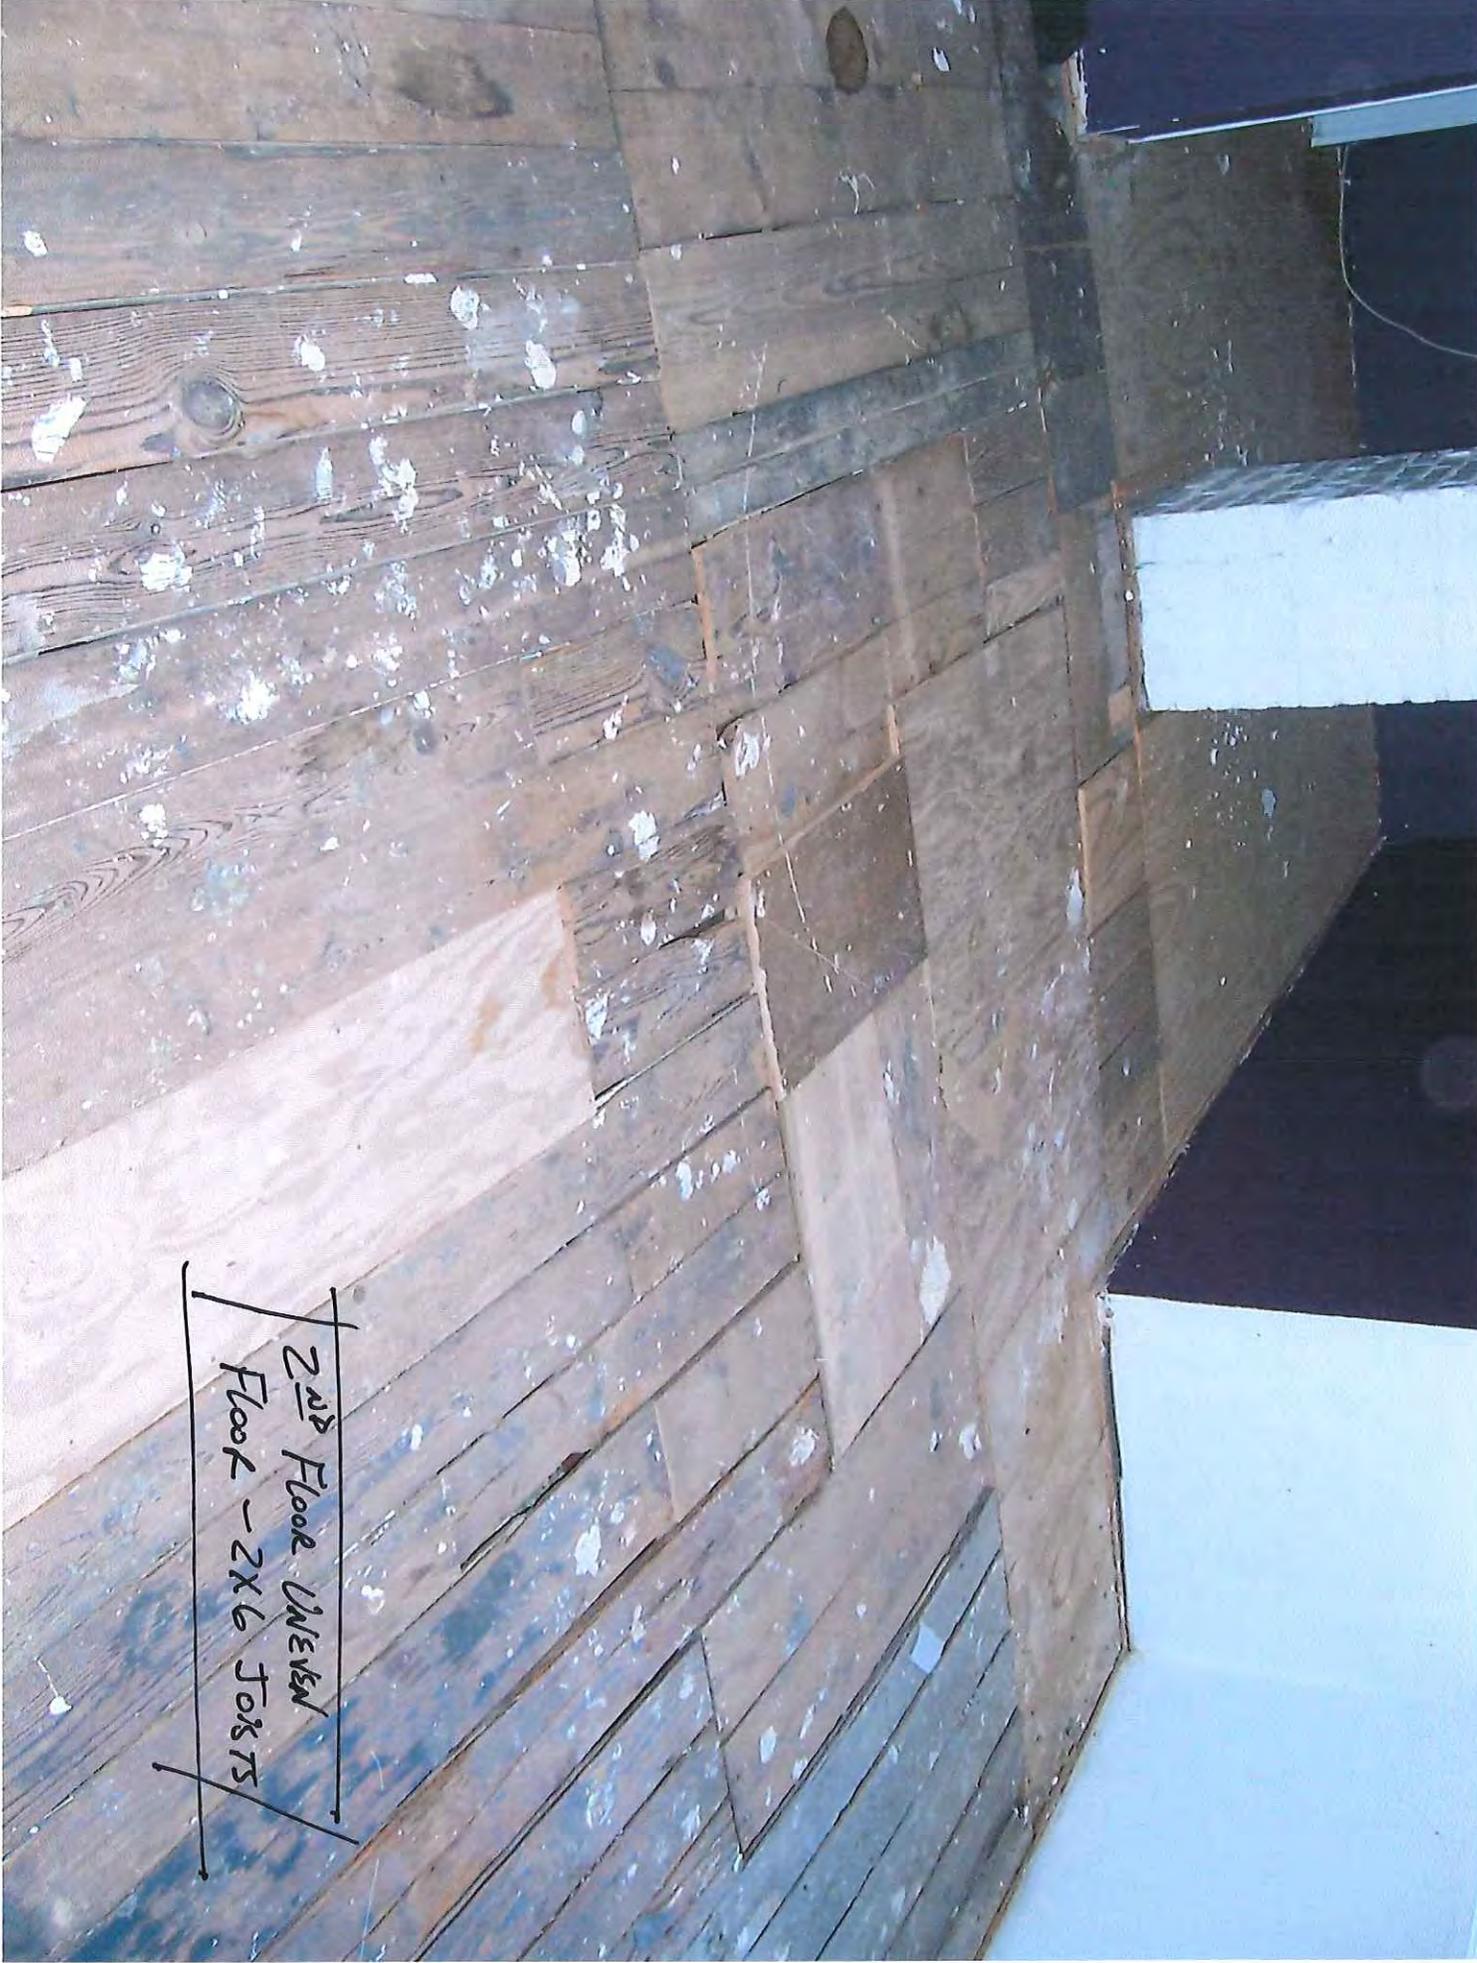
2ND Floor UNFINISH
Floor - 2X6 JOISTS

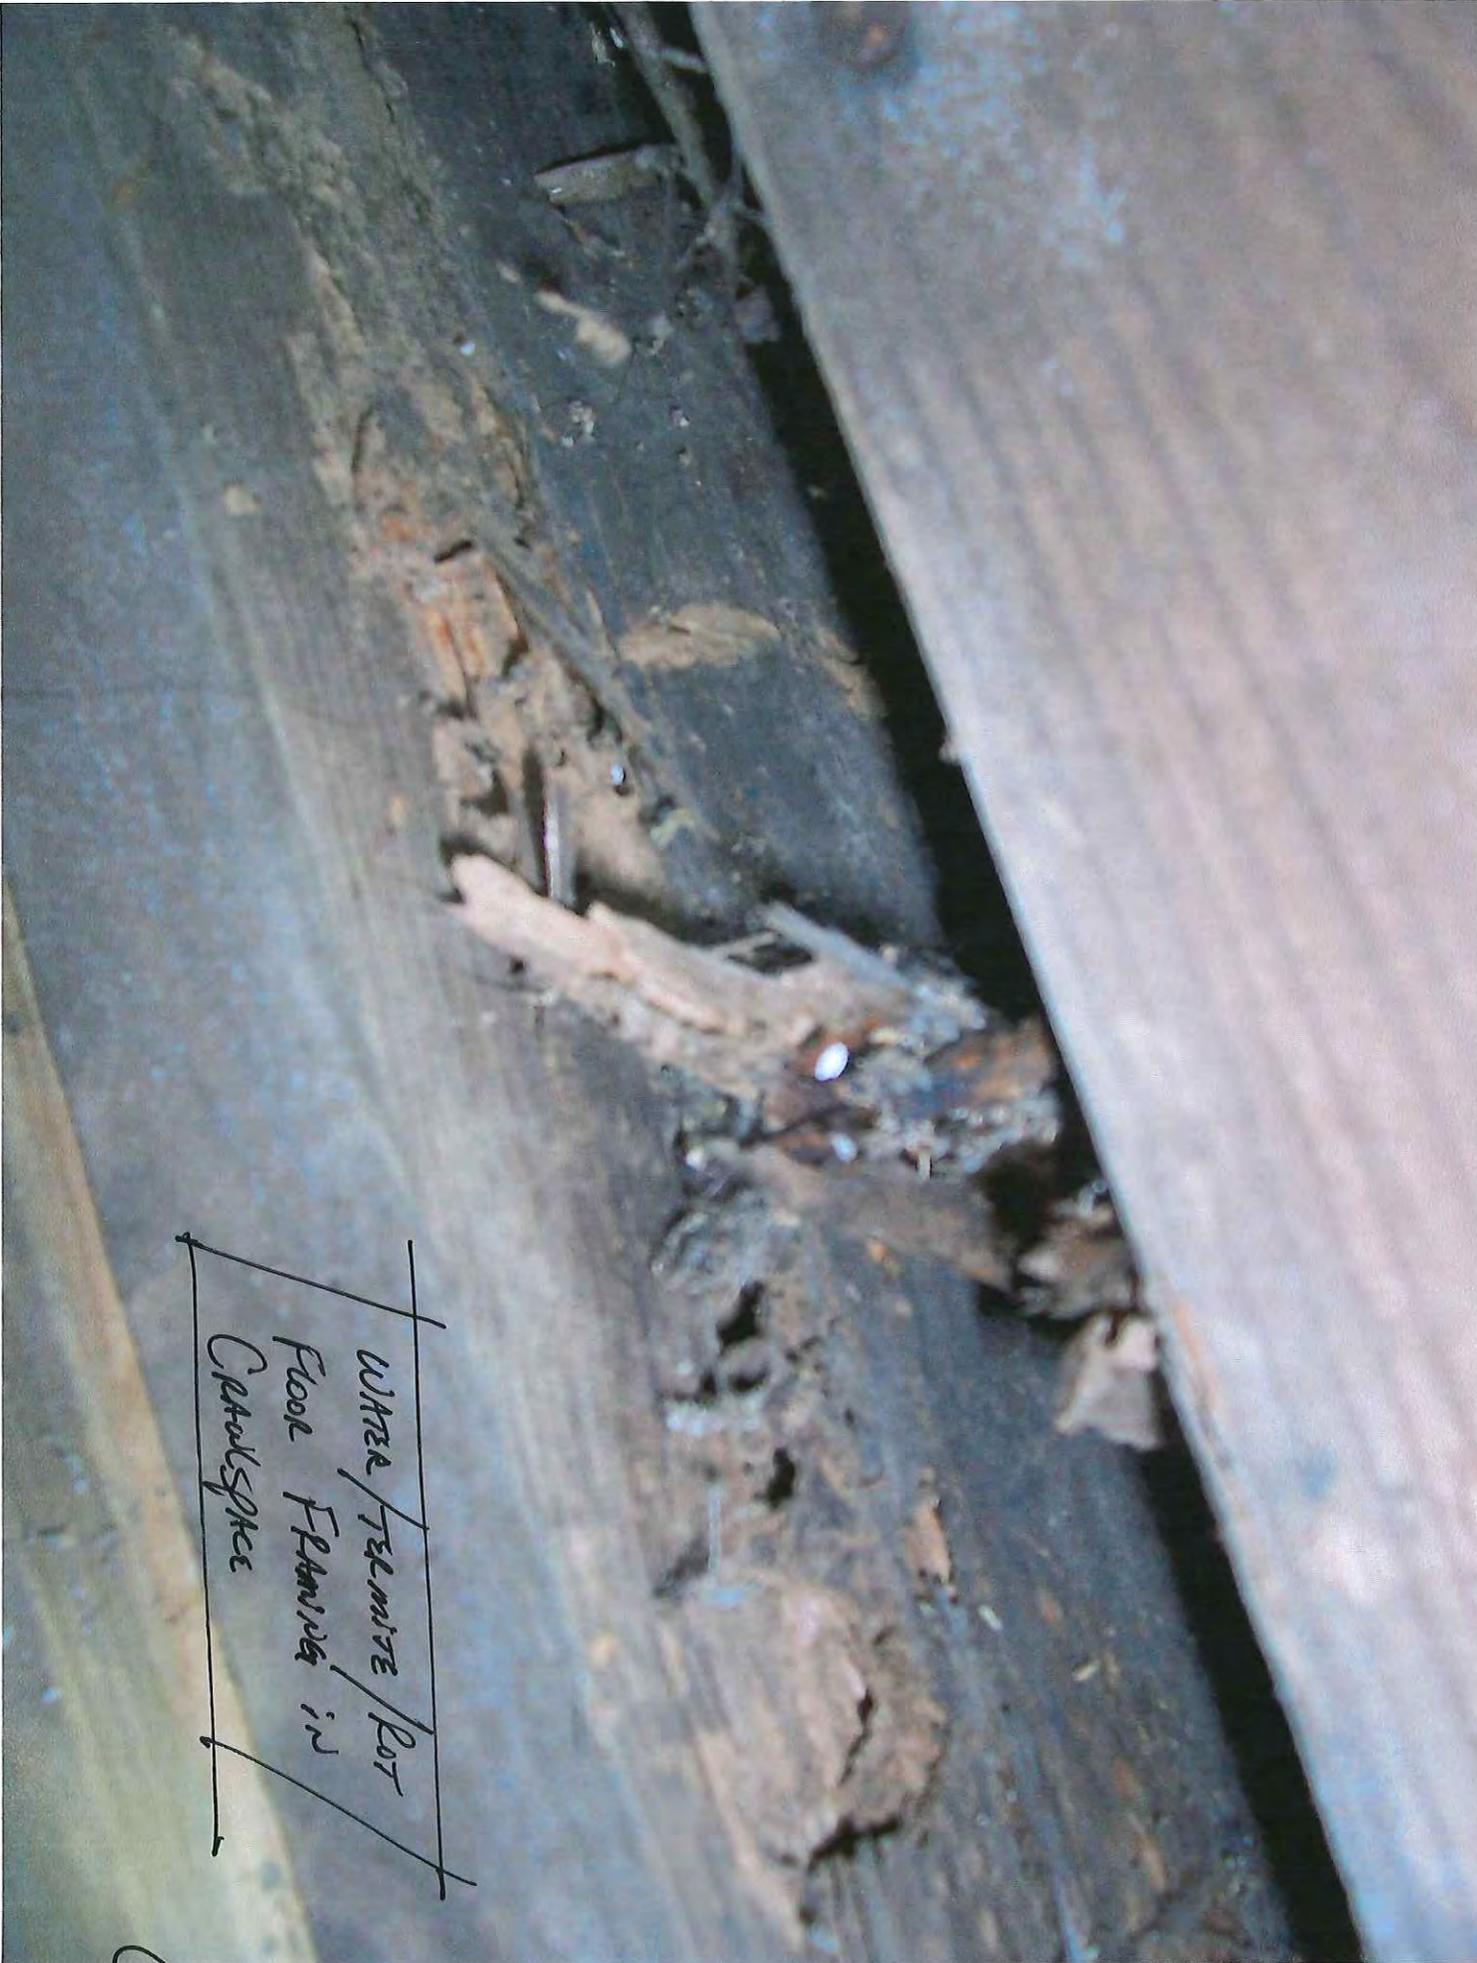
WATER / TERMITES / ROT
Floor Joists in
Crawlspace

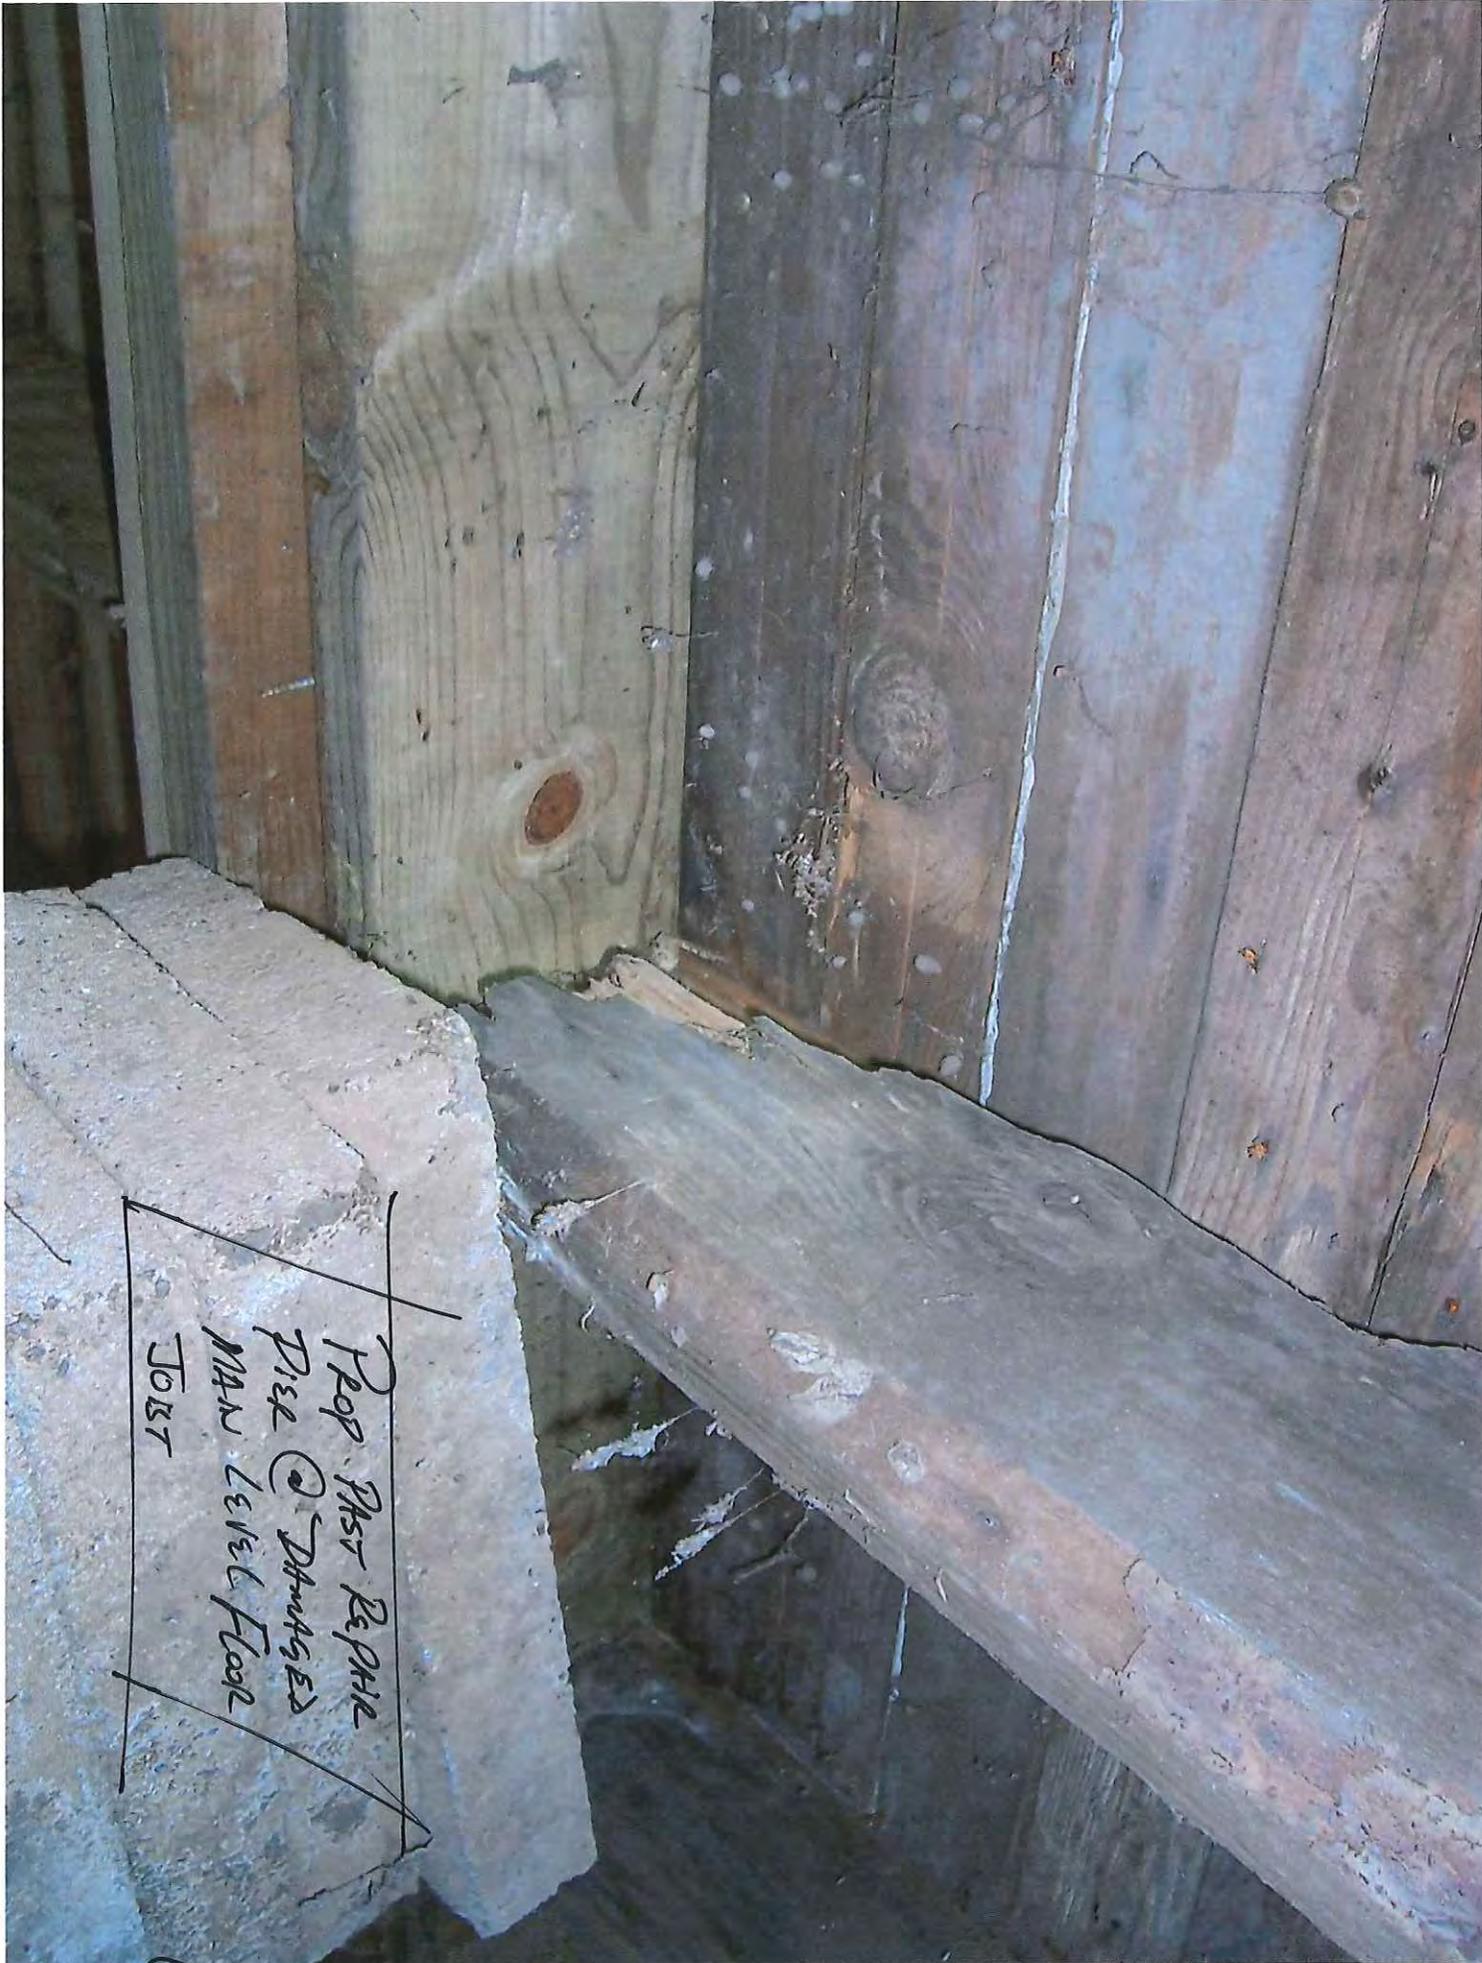
PROP RAST REPAIR
PICE @ DAMAGED
MAN LEVEL FLOOR
JOIST

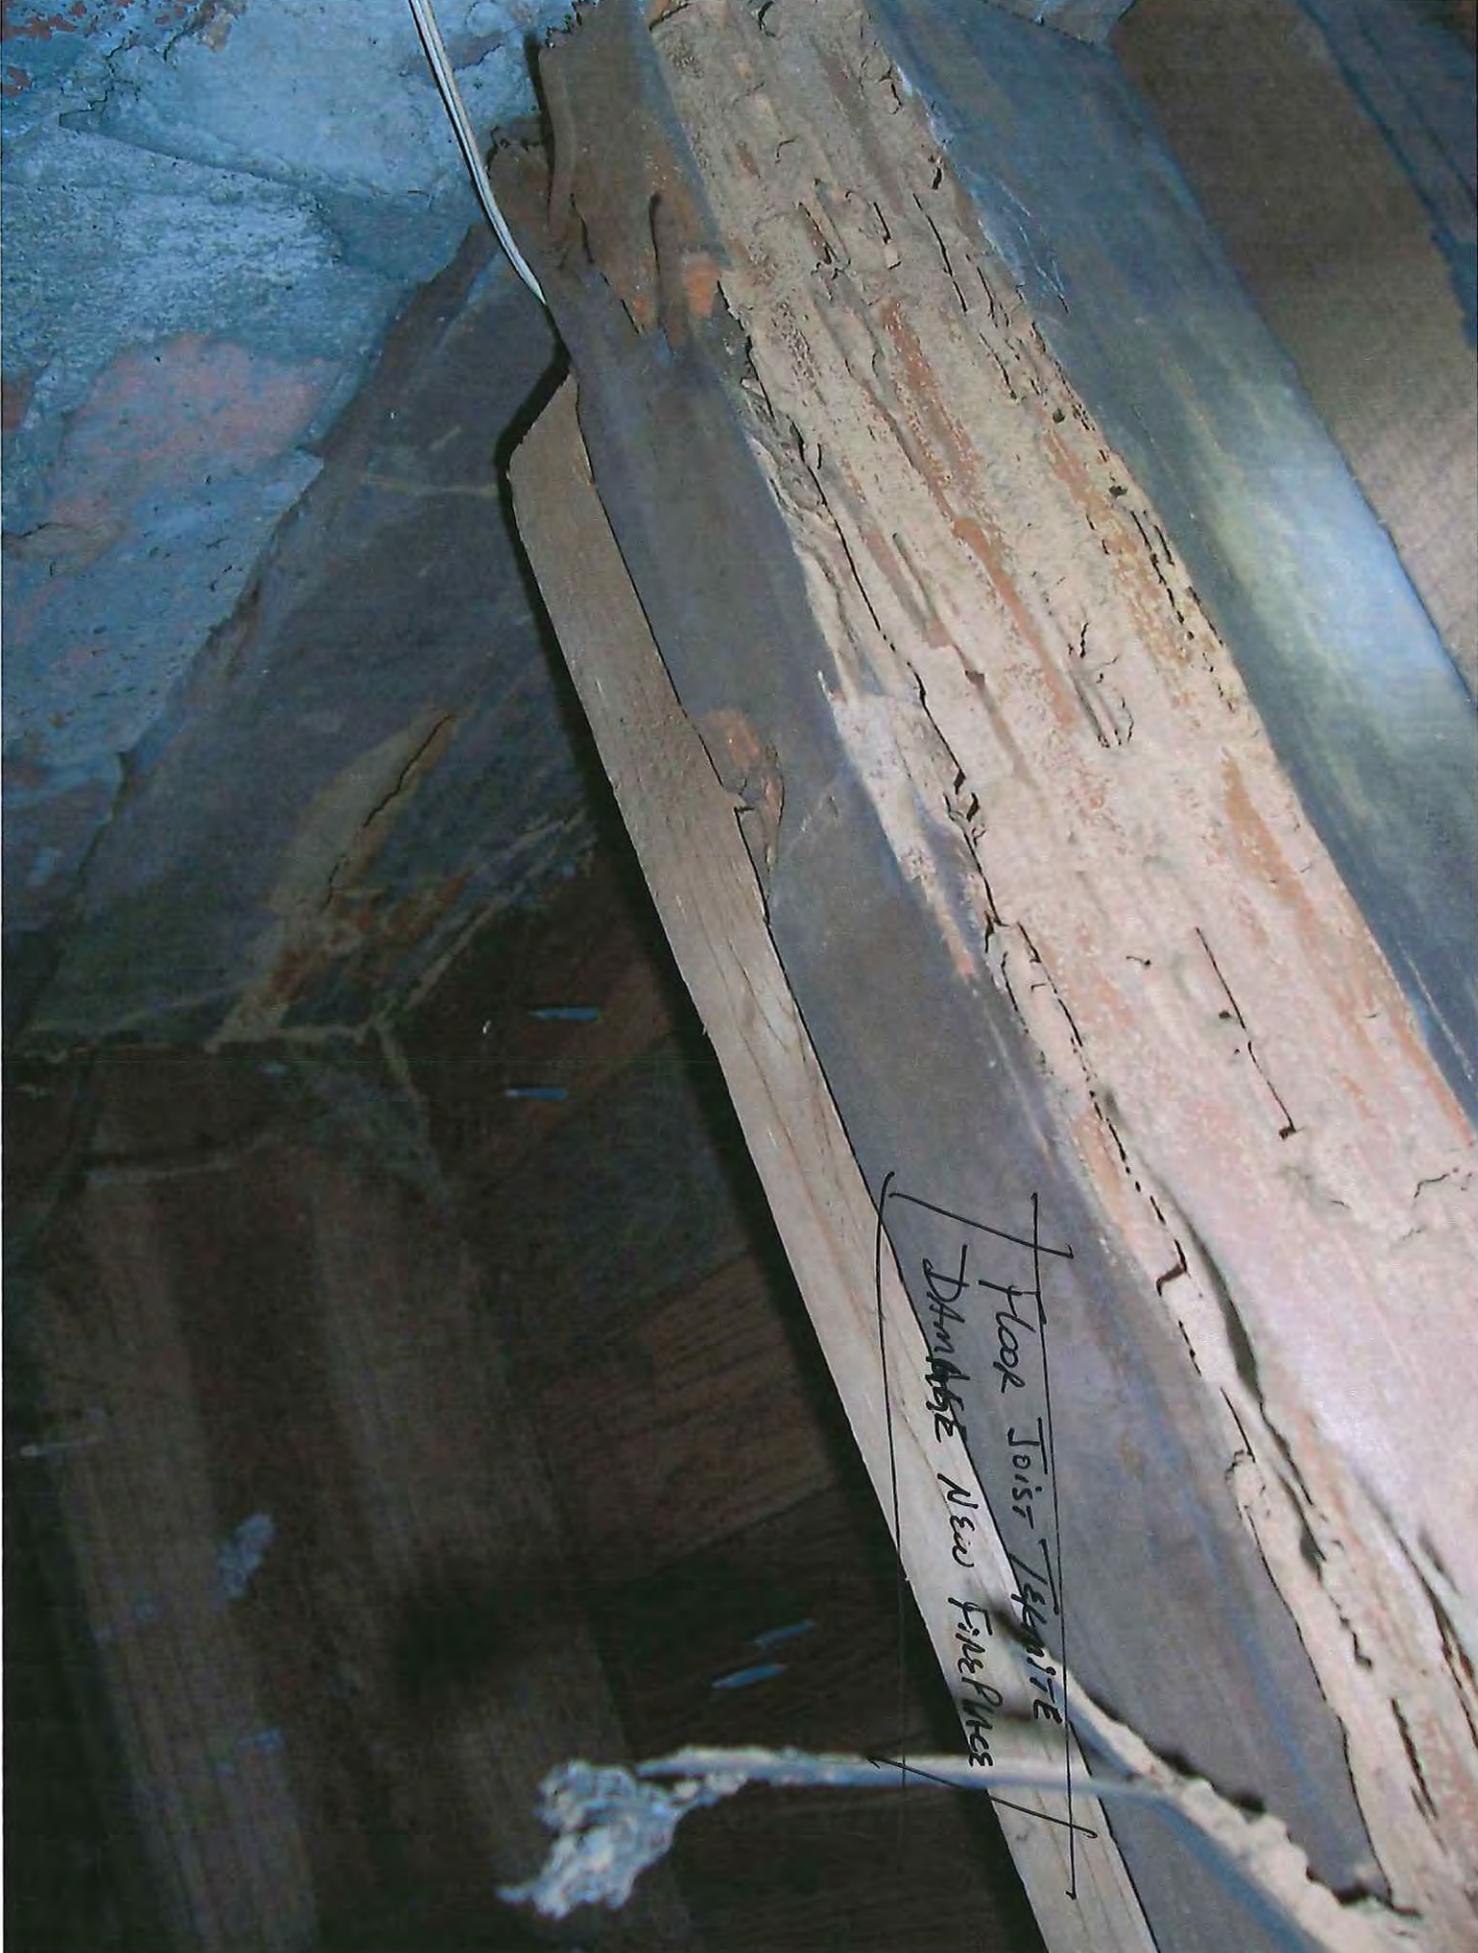
Floor Joist 154MITE
Damage New Pine Plies

←
KEMITE DORAGE
@ 2ply HEADER
FRAMING
SPACES
