STAFF RECOMMENDATION
1614 Benjamin Street
March 20, 2013

Application: Demolition of contributing building
District: Eastwood Neighborhood Conservation Zoning Overlay
Council District: 06
Map and Parcel Number: 08306003300
Applicant: Bill Franklin, Owner
Project Lead: Sean Alexander@nashville.gov

STRUCTURAL EVALUATION OF RESIDENCE

1614 Benjamin Street
Nashville, Tennessee
Project #213022

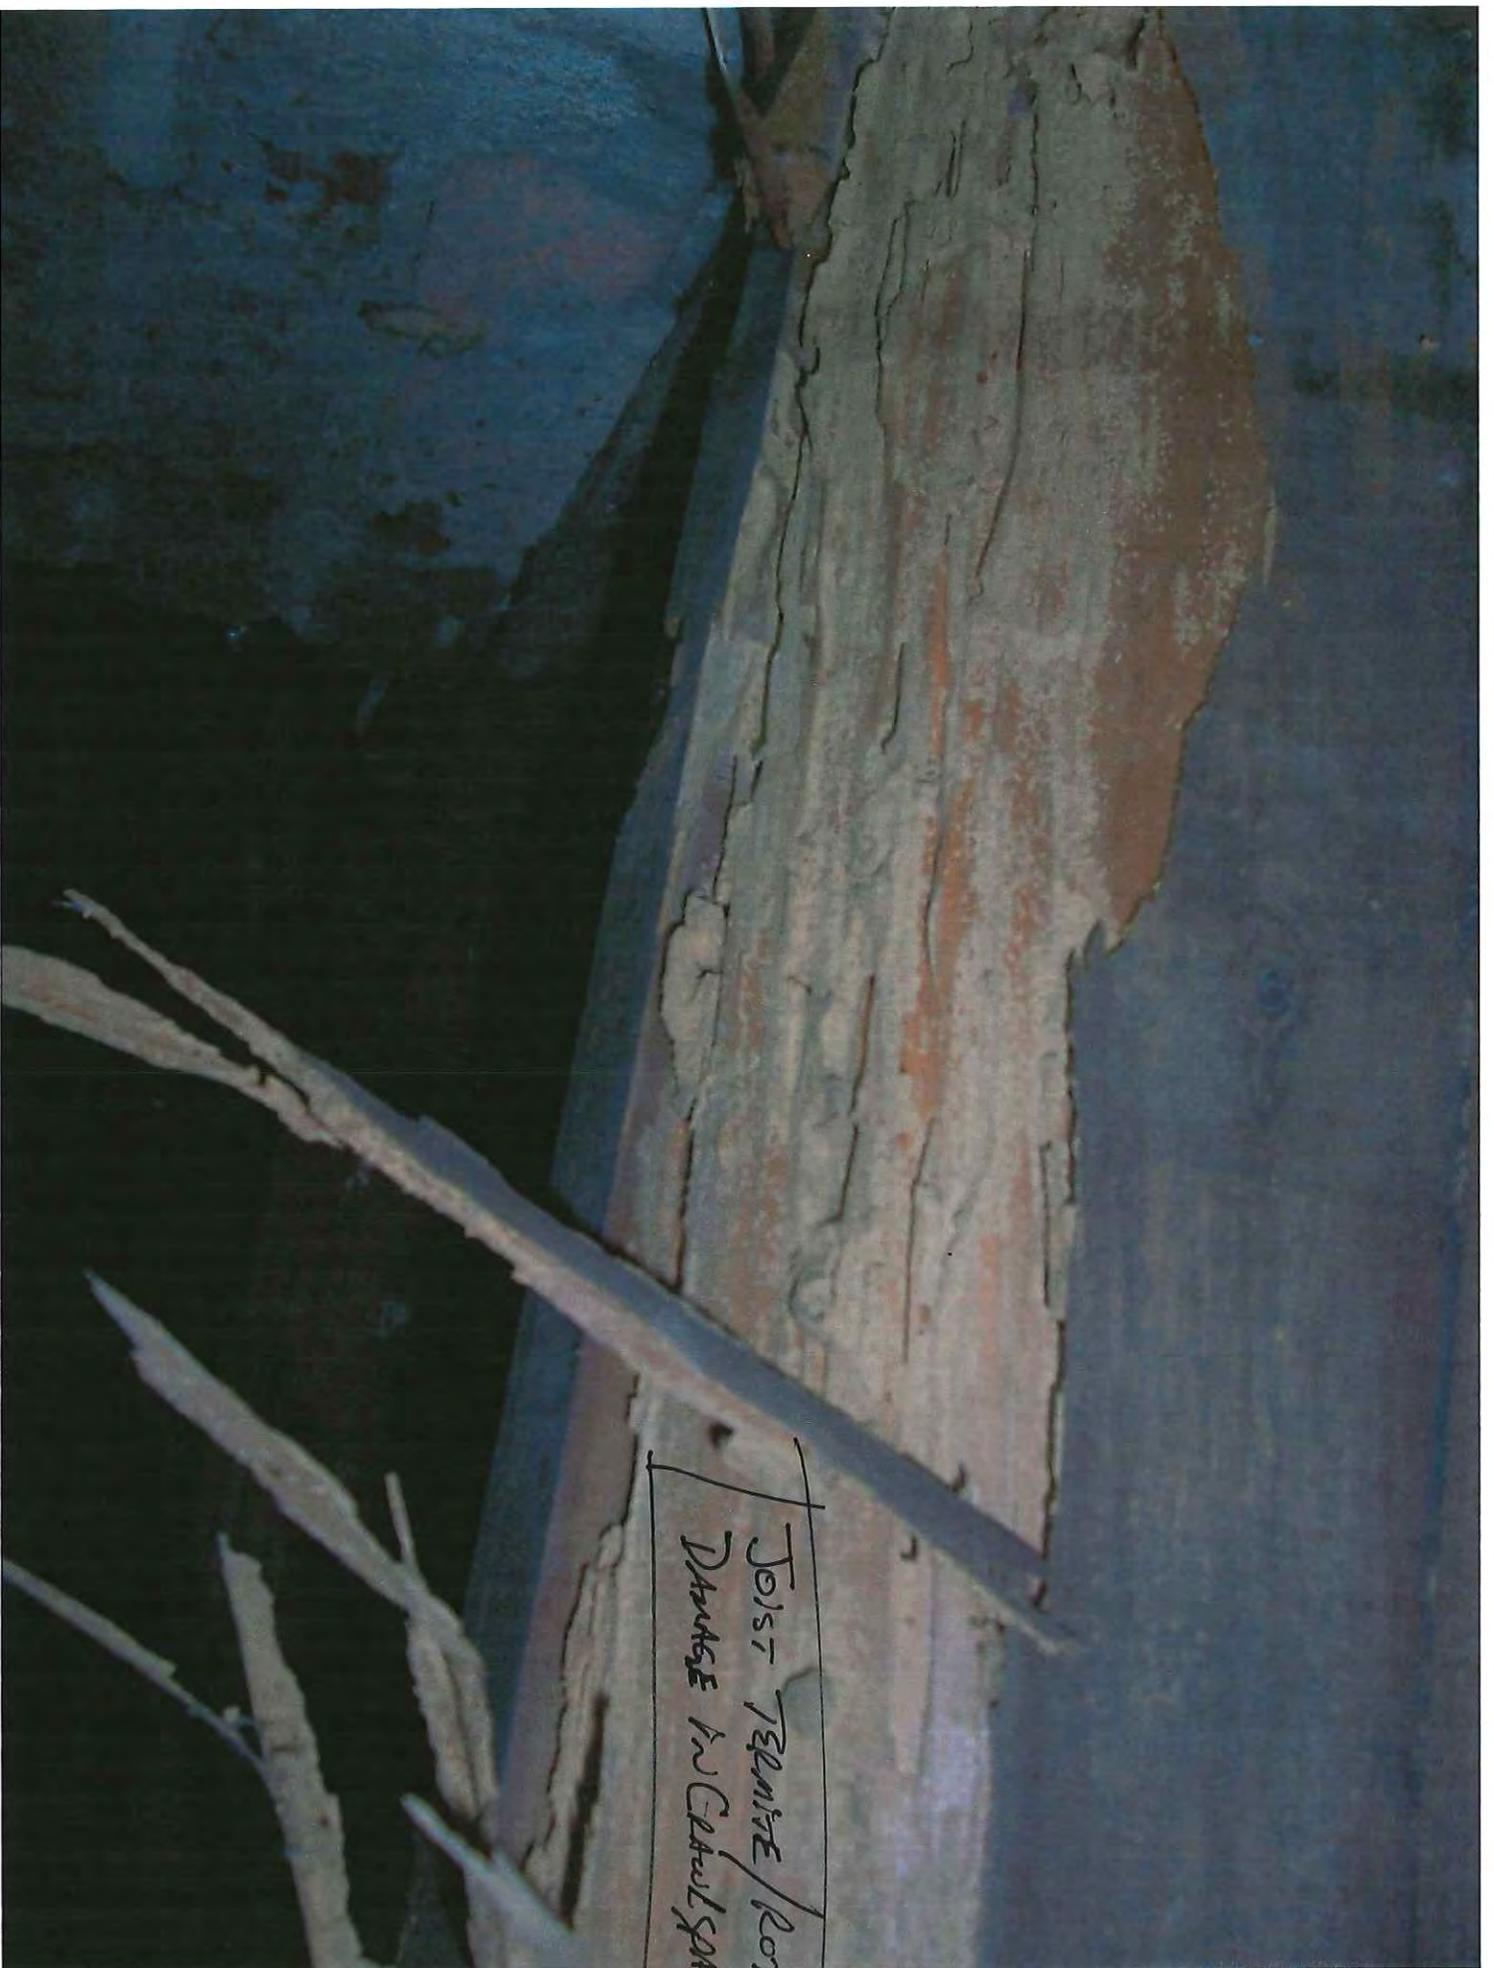
JOIST ROT
DAMAGE IN CEILING SPACE

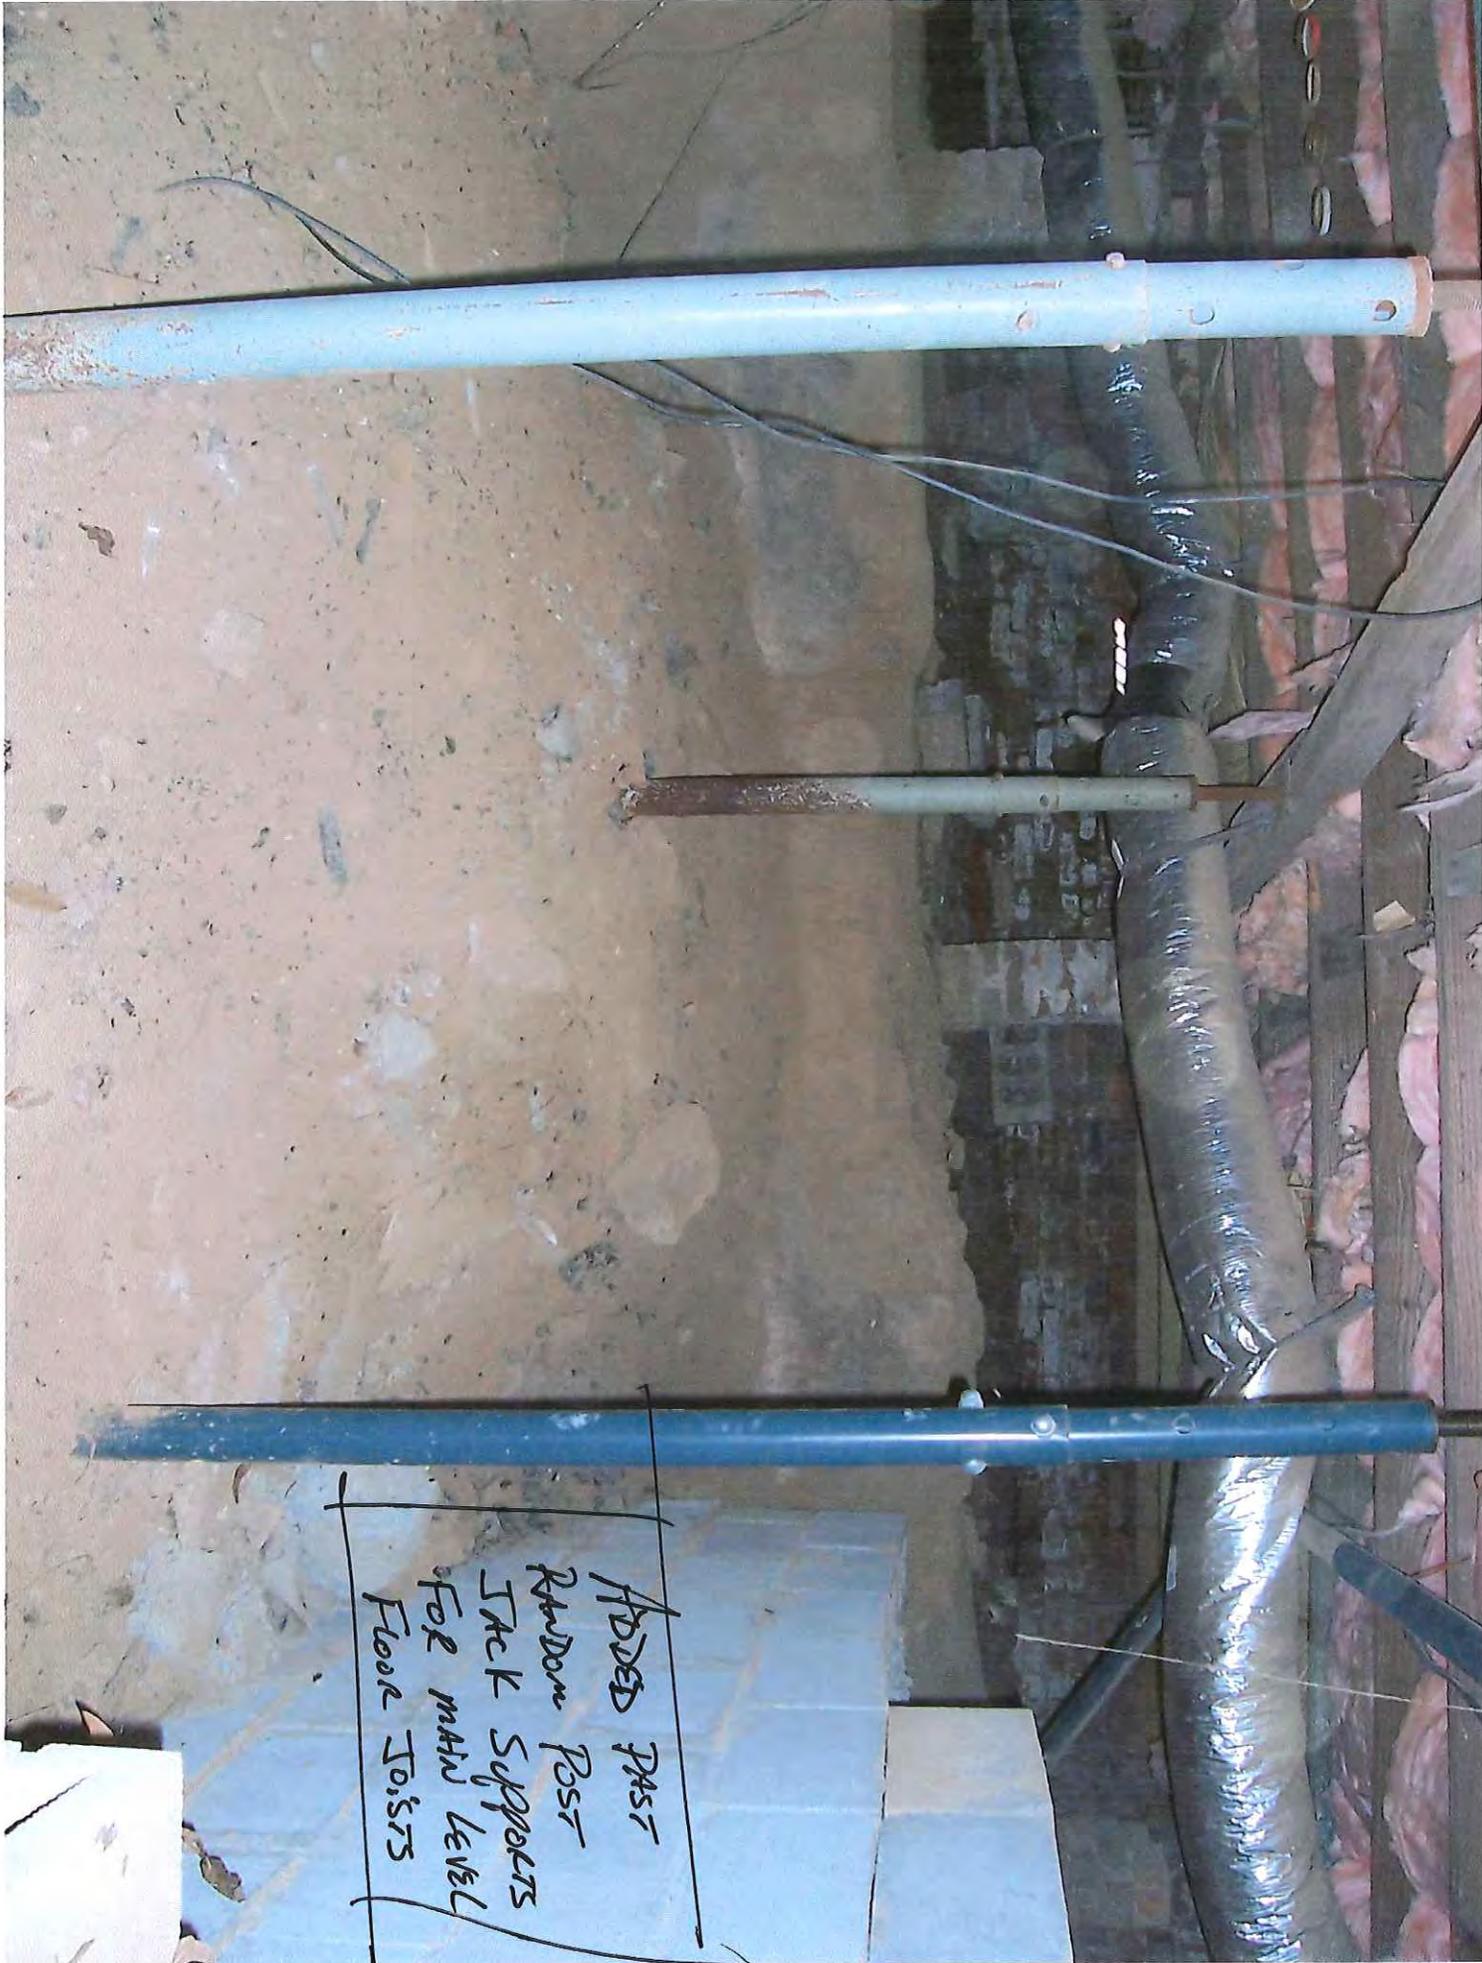
ADDED
POST
RANDOM
TACK SUPPORTS
FOR MAIN LEVEL
FLOOR JOISTS

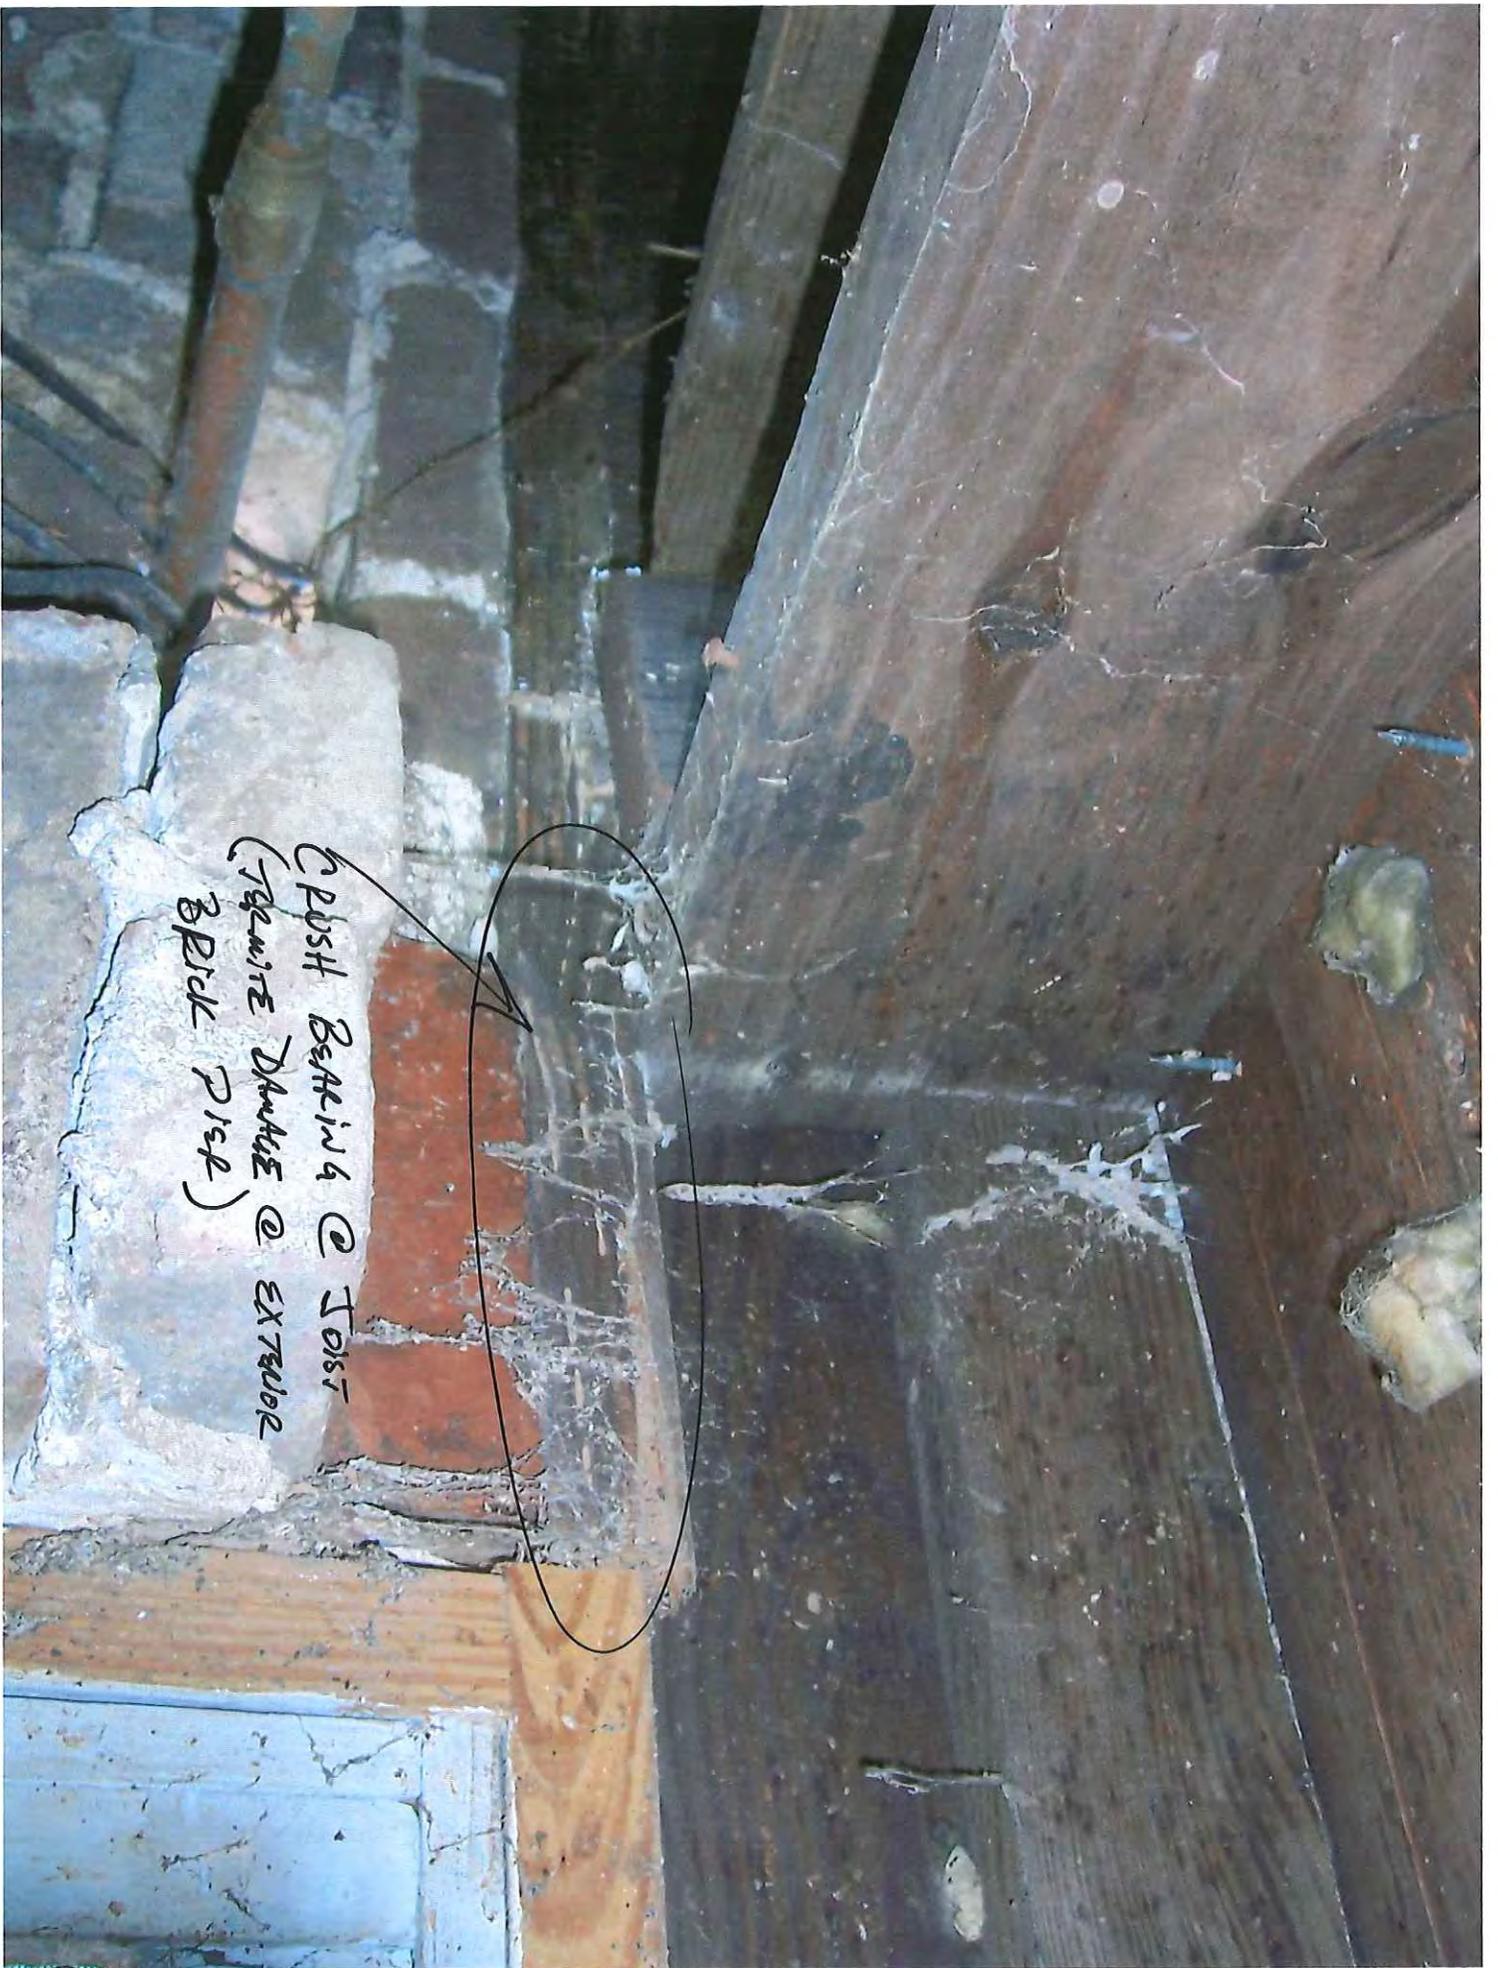
CPUSH BEARING @ JOIST
(REMOVE DAMAGED @ EXTERIOR
BRICK PIECE)

FOUNDATION SPUR
WALL @ BACK PART
@ PERIMETER
(NO FOOTING)
WALL CONTAINS AND
BACK DISLOADS

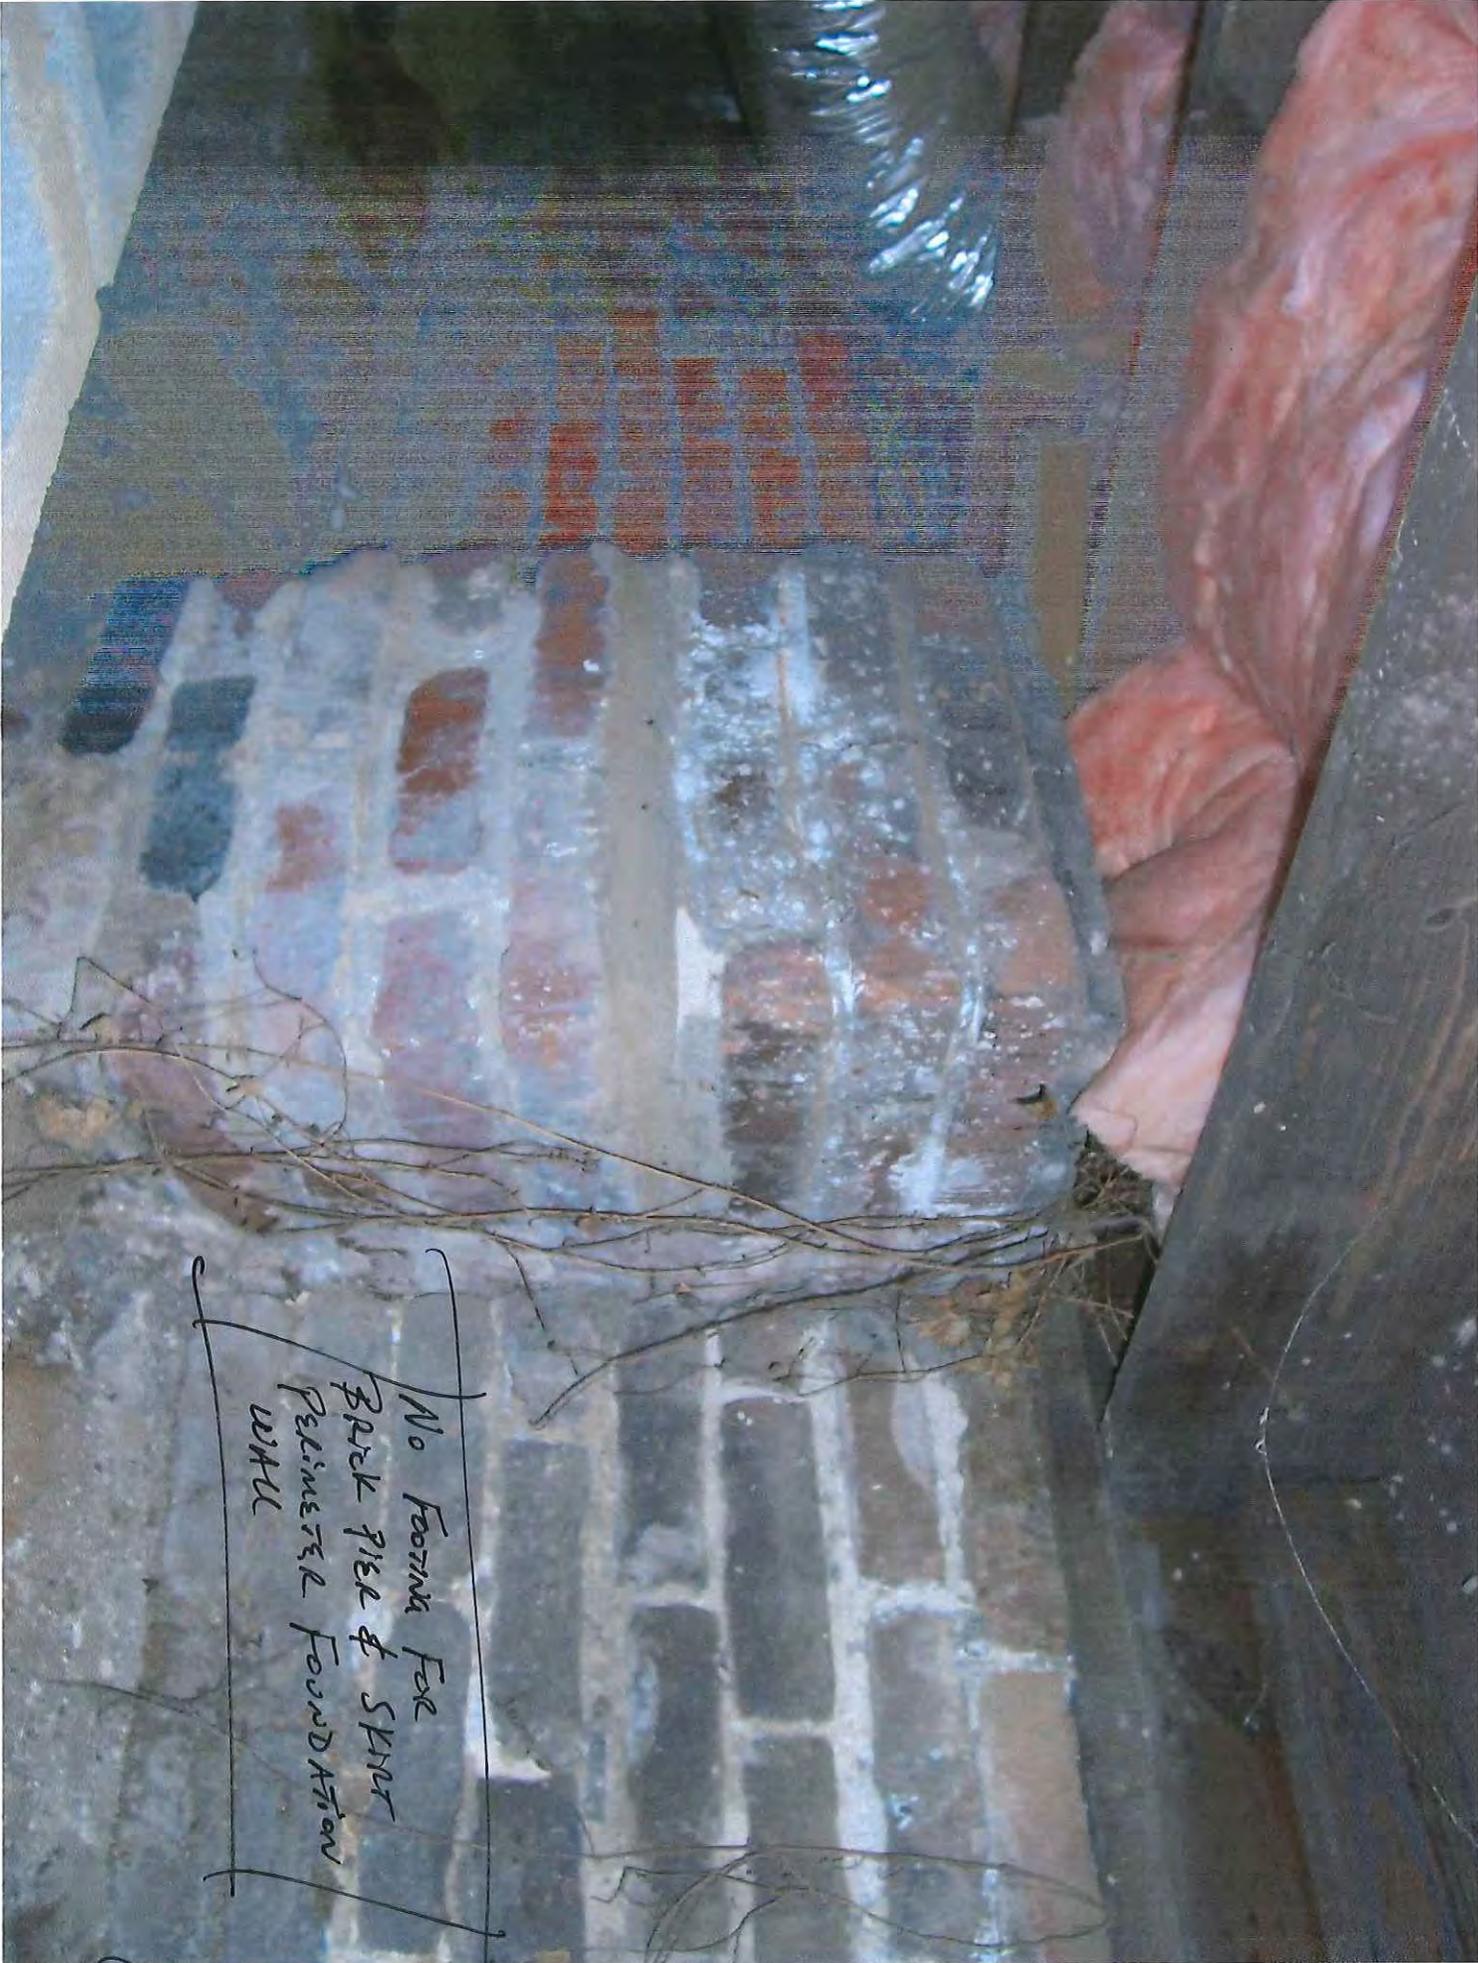
No FORMS FOR
BACK FILL & SKIN
PERIMETER FOUNDATION
WALL

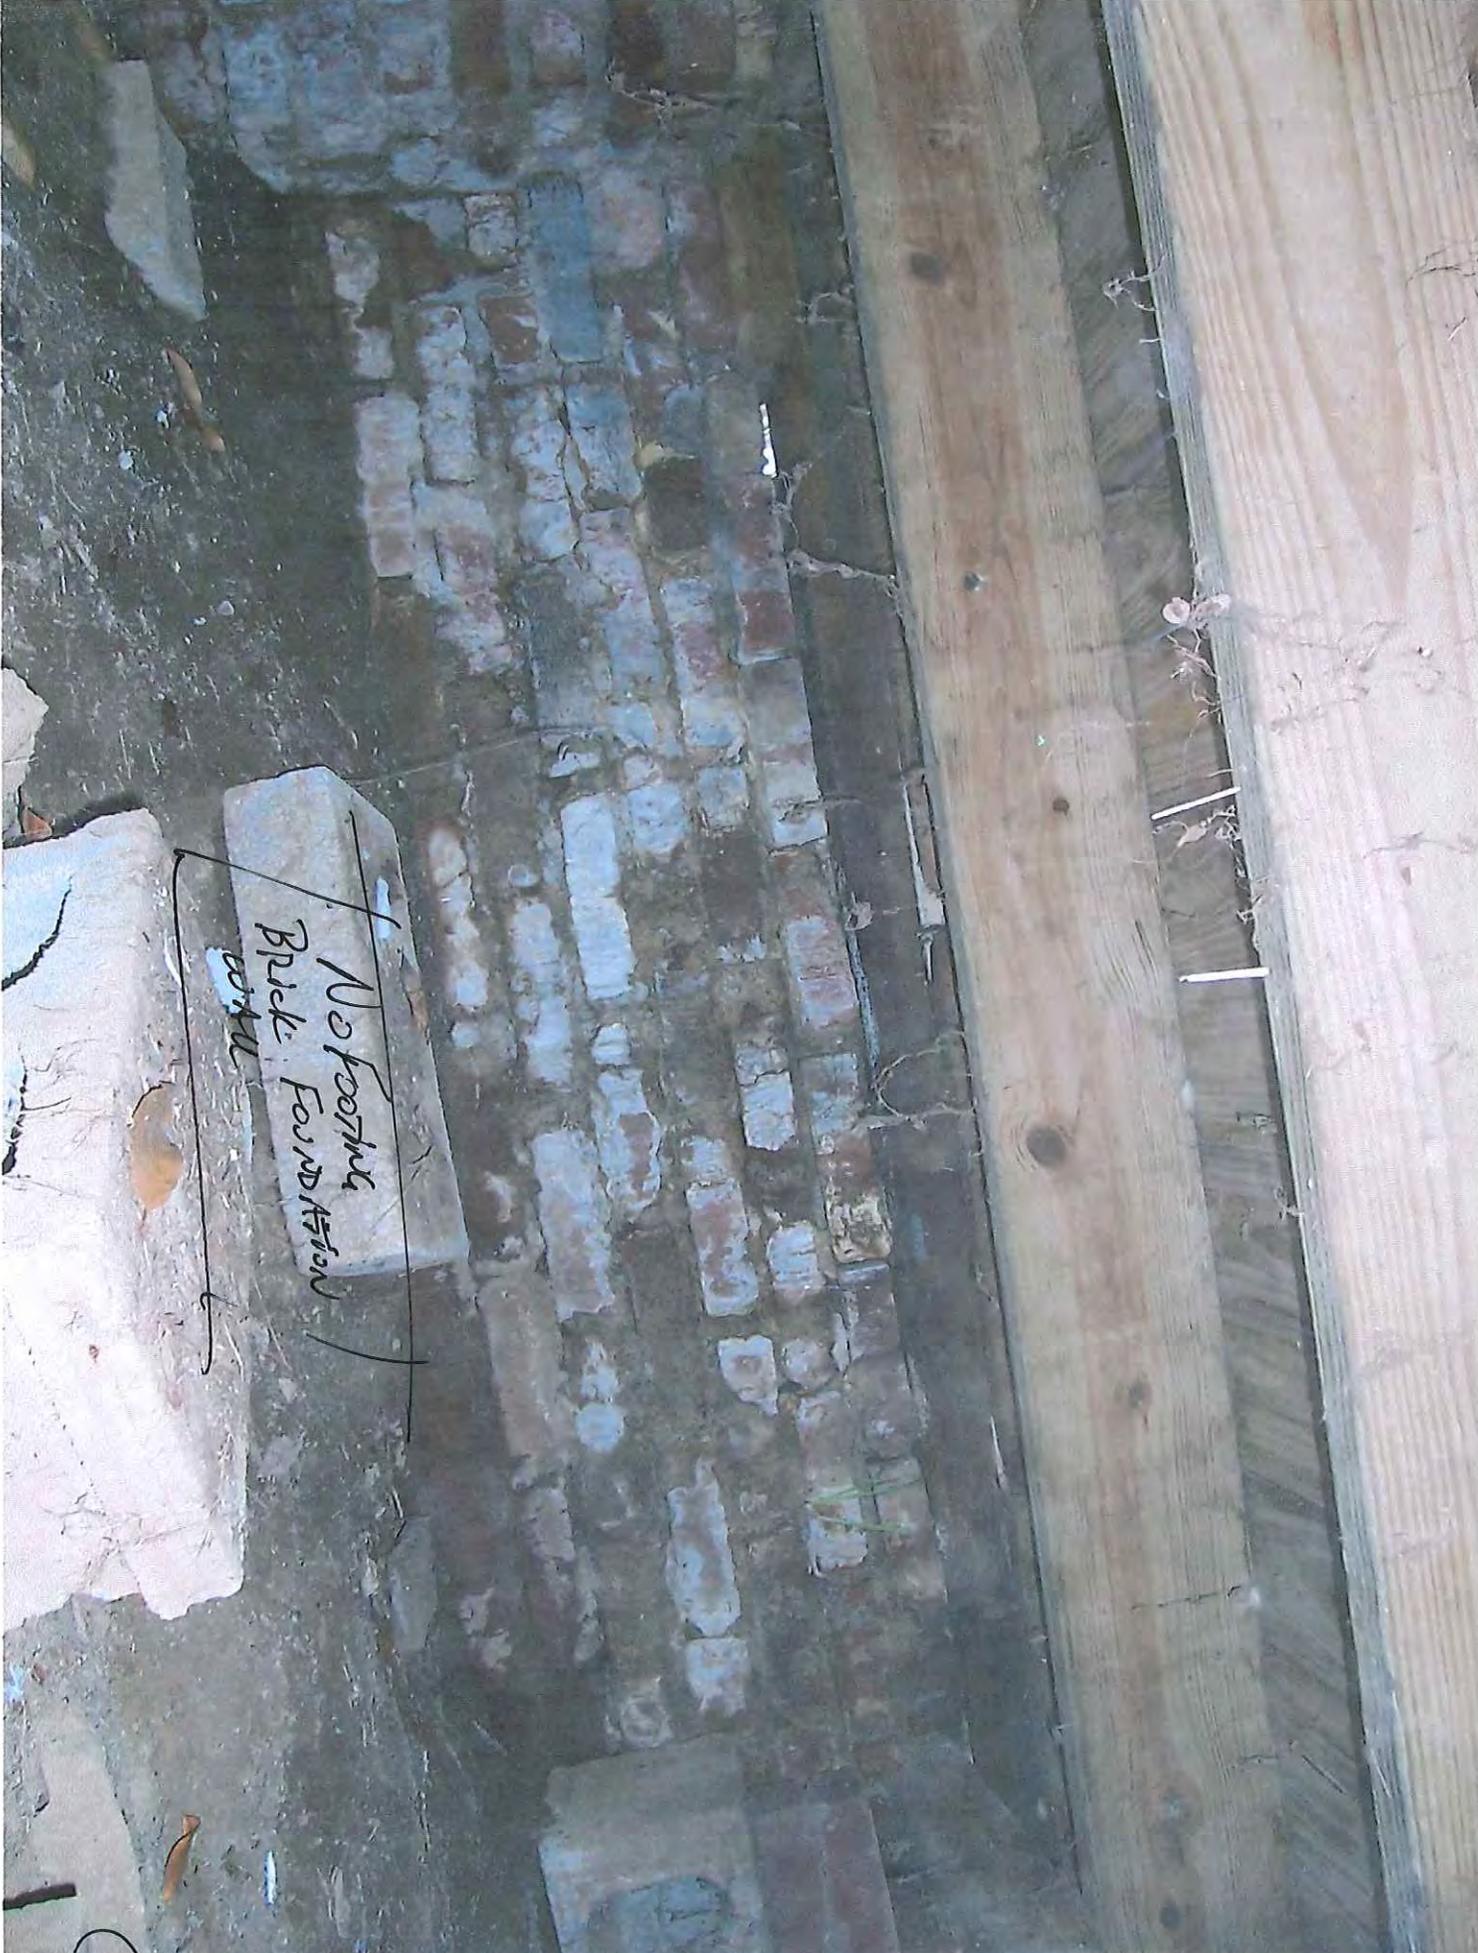
No Footing
Brick Foundation

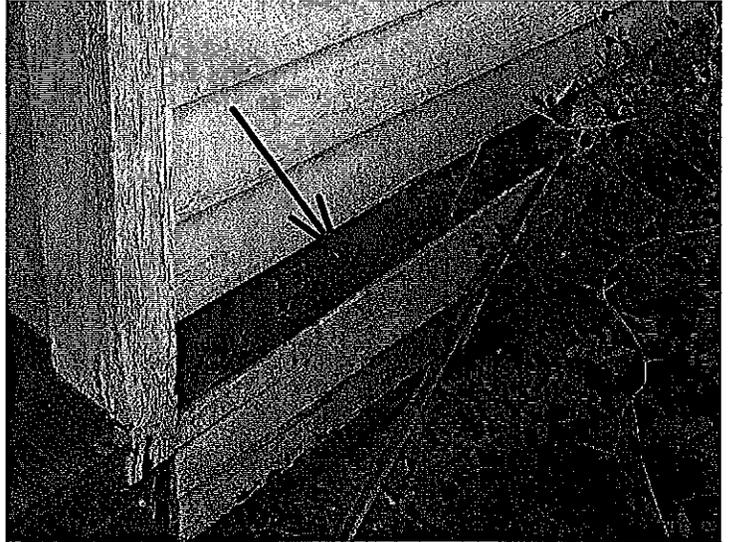
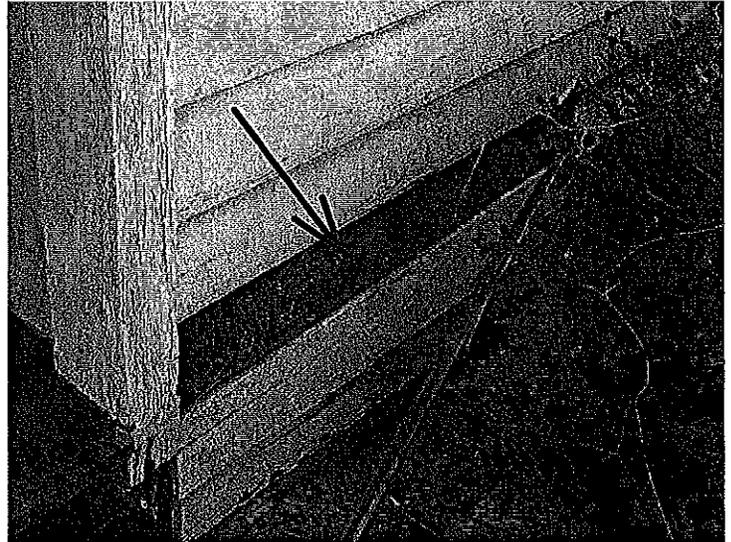
1. Type: Wood There are sections of wood siding missing from the front of the house. Recommend a qualified contractor to make necessary repairs.

1. **All Exterior Surface Type: Wood** There are sections of wood siding missing from the front of the house. Recommend a qualified contractor to make necessary repairs.

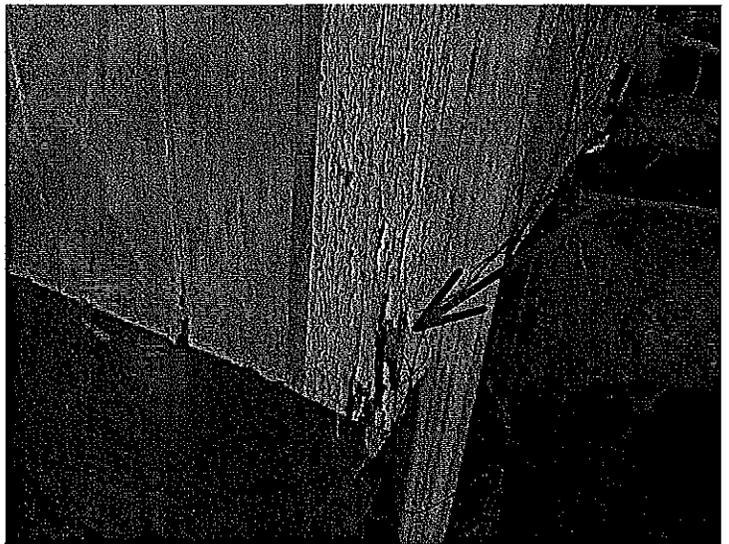
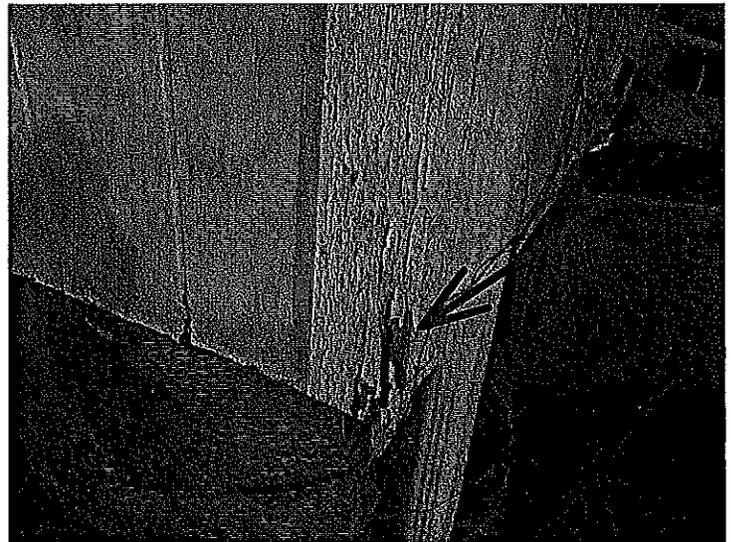
2. Trim: Wood There are several sections of trim that have rot present. Most of the sections are on the corners of the house. Recommend a qualified contractor to make necessary repairs.

2. **Trim: Wood** There are several sections of trim that have rot present. Most of the sections are on the corners of the house. Recommend a qualified contractor to make necessary repairs.

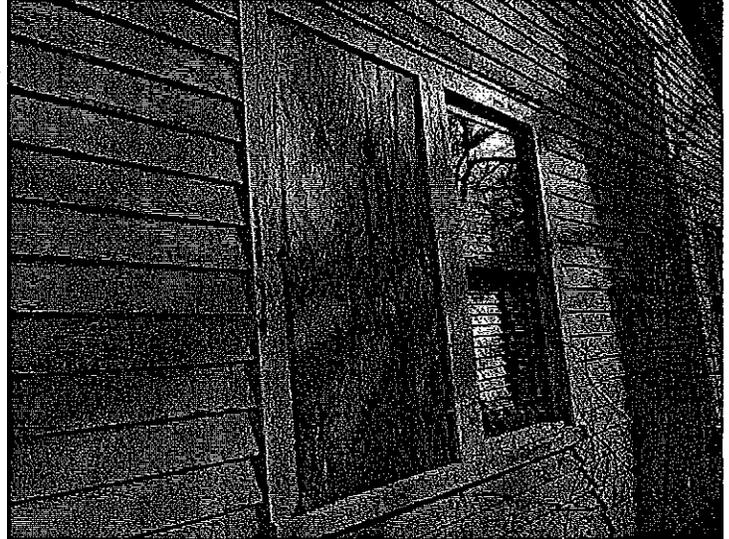
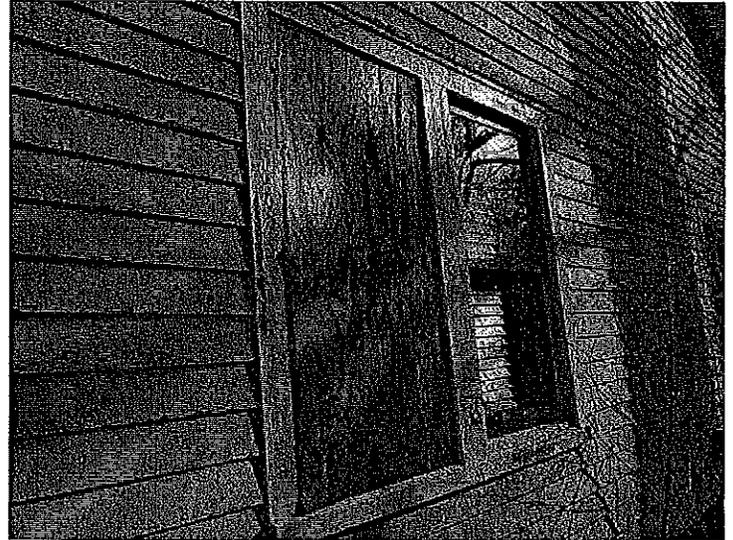
7. Windows: Wood The windows are all in need of replacing. Recommend a qualified window tech to replace the windows.

1. **Windows: Wood** The windows are all in need of replacing. Recommend a qualified window tech to replace the windows.

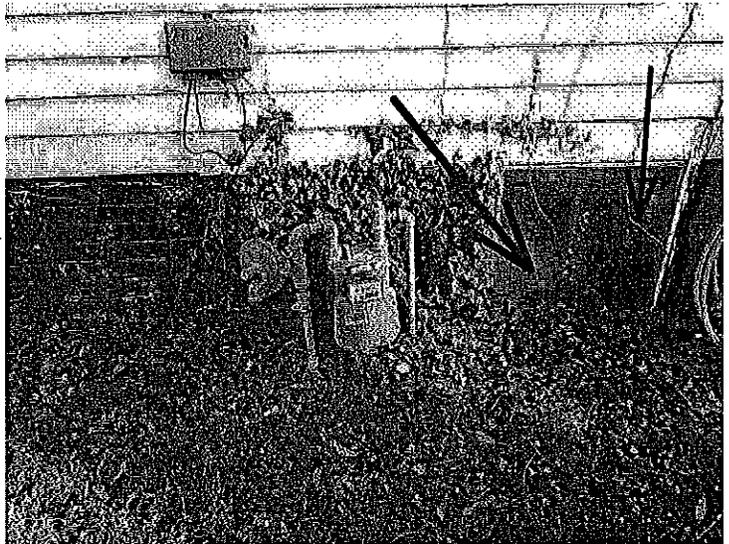
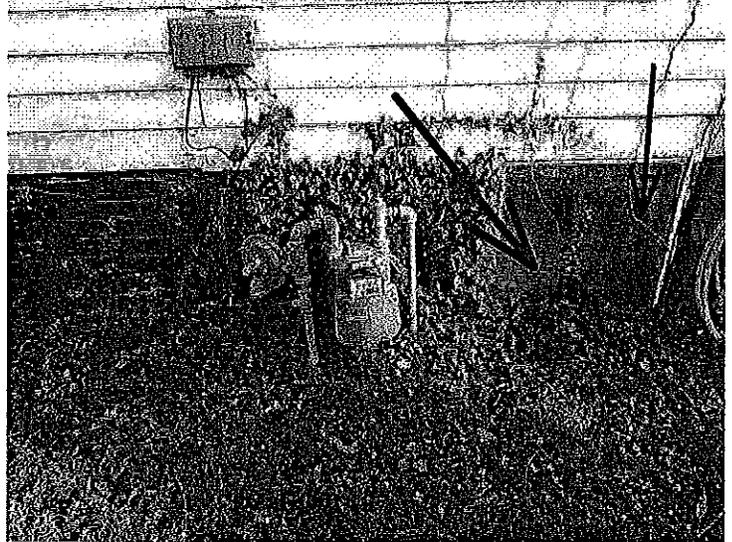
8. Basement Windows: Wood Single Hung The bottom of the crawlspace window on the right side of the house is below the soil. Recommend digging the soil back and installing a window well to keep moisture and water from entering the crawlspace.

3. **Basement Windows: Wood Single Hung** The bottom of the crawlspace window on the right side of the house is below the soil. Recommend digging the soil back and installing a window well to keep moisture and water from entering the crawlspace.

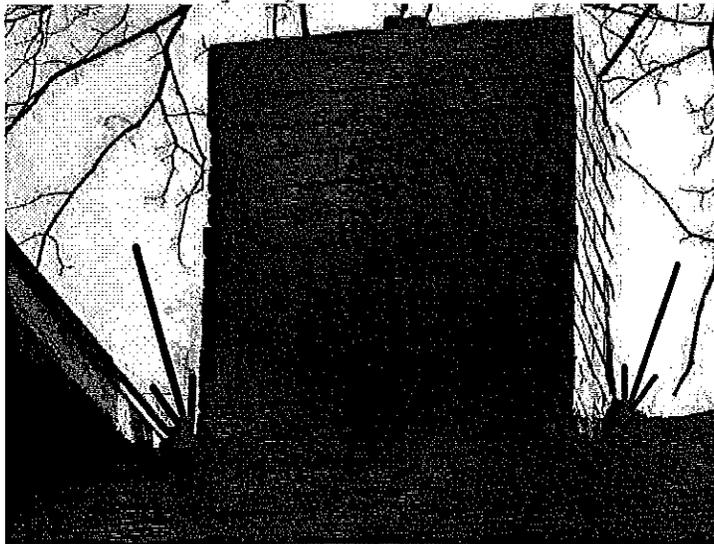
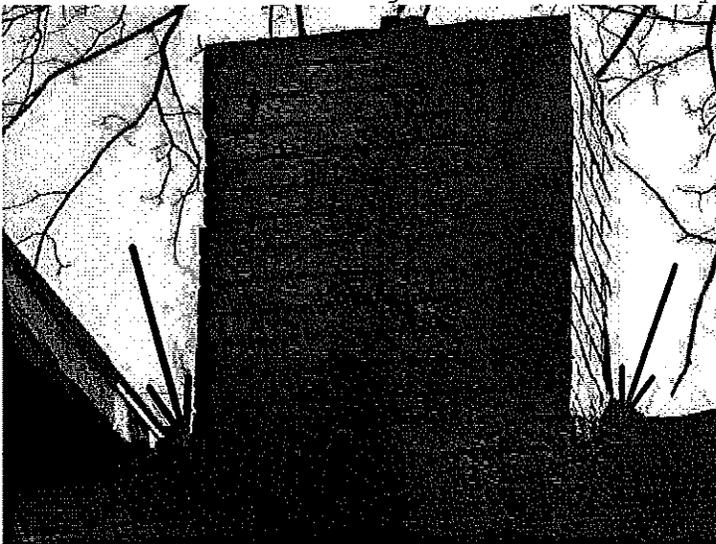
The chimney flashing is defective and the area around the flashing is leaking. There are water stains and drywall damage present around the chimney on the ceiling of the attic area. Recommend a qualified roofing contractor to evaluate the flashing and make necessary repairs.

2. **Chimney Flashing Aluminum** The chimney flashing is defective and the area around the flashing is leaking. There are water stains and drywall damage present around the chimney on the ceiling of the attic area. Recommend a qualified roofing contractor to evaluate the flashing and make necessary repairs.

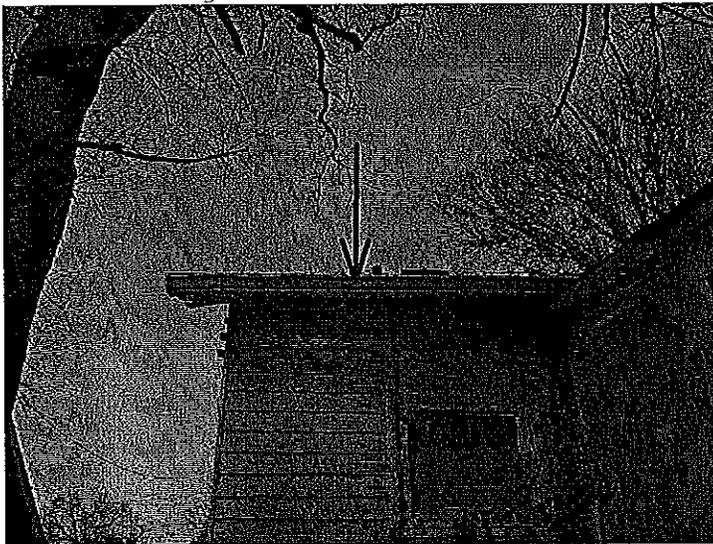
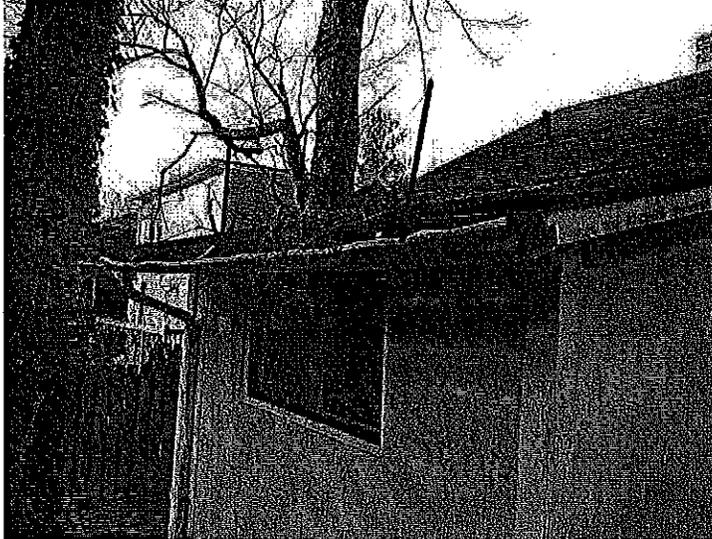
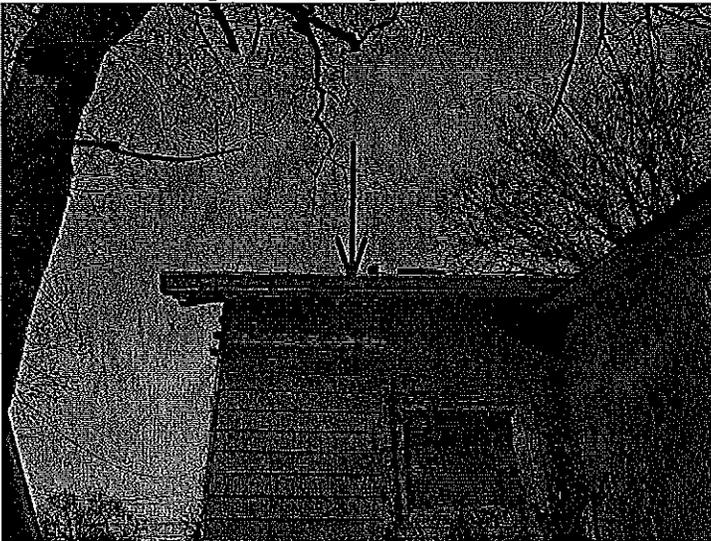
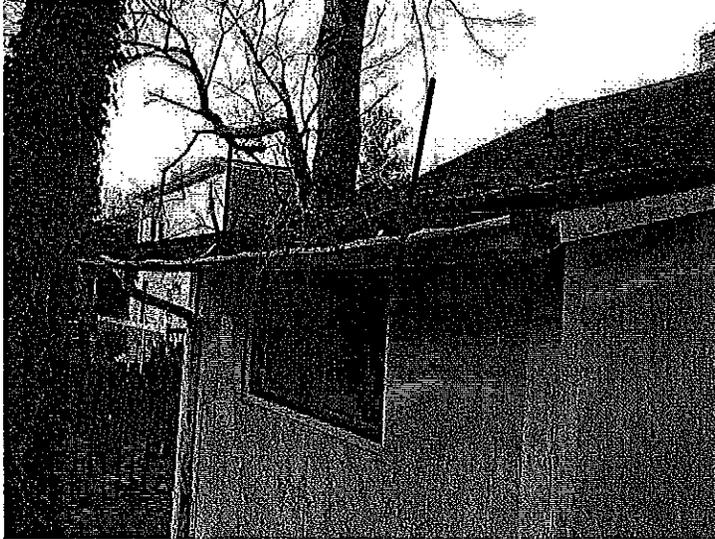
Gutters: Aluminum All the gutters around the house are sagging or not hanging properly. Recommend a qualified gutter tech to evaluate and install new gutters.

4. **Gutters: Aluminum** All the gutters around the house are sagging or not hanging properly. Recommend a qualified gutter tech to evaluate and install new gutters.

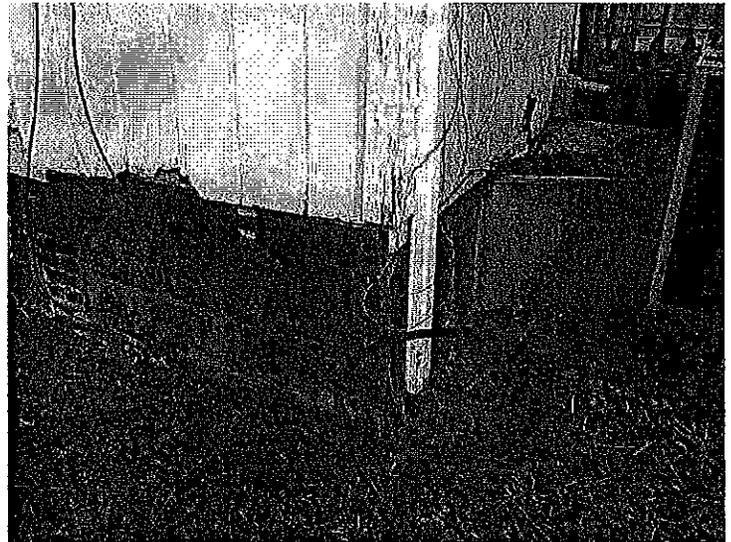
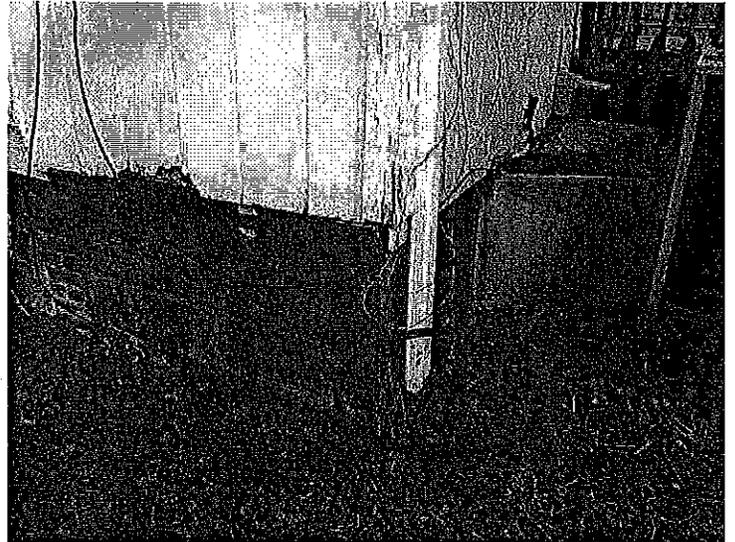
12. Downspouts Aluminum Recommend installing corrugated pipe to the downspouts to allow water to flow away from the foundation.

5. Downspouts Aluminum Recommend installing corrugated pipe to the downspouts to allow water to flow away from the foundation.

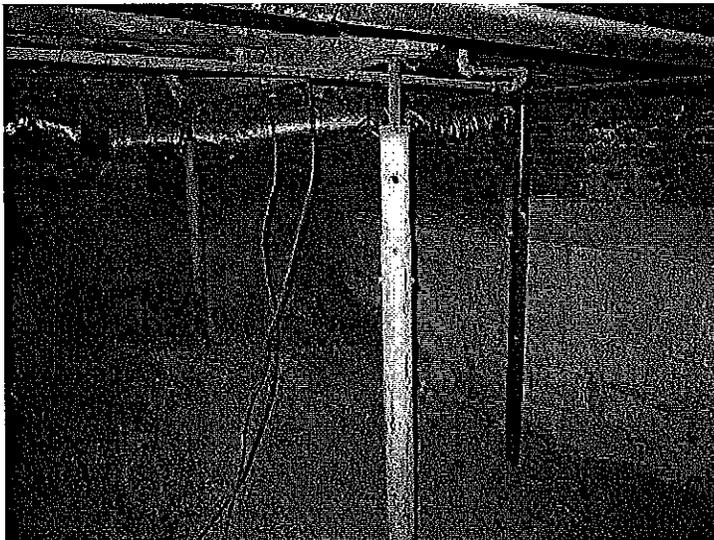
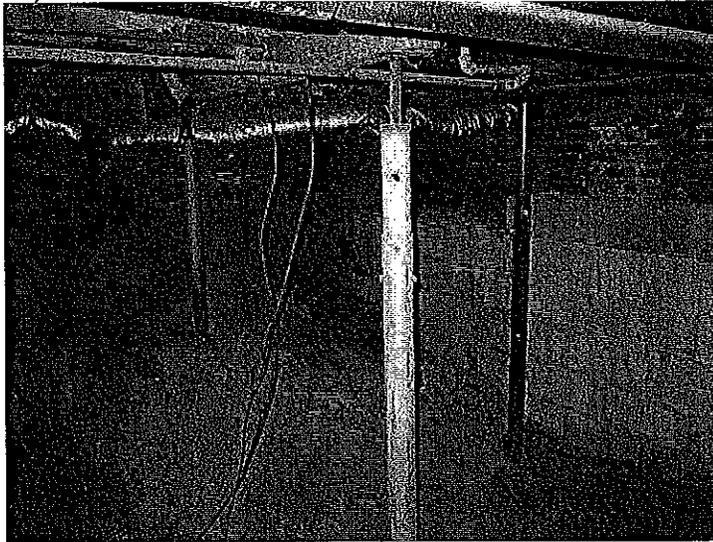
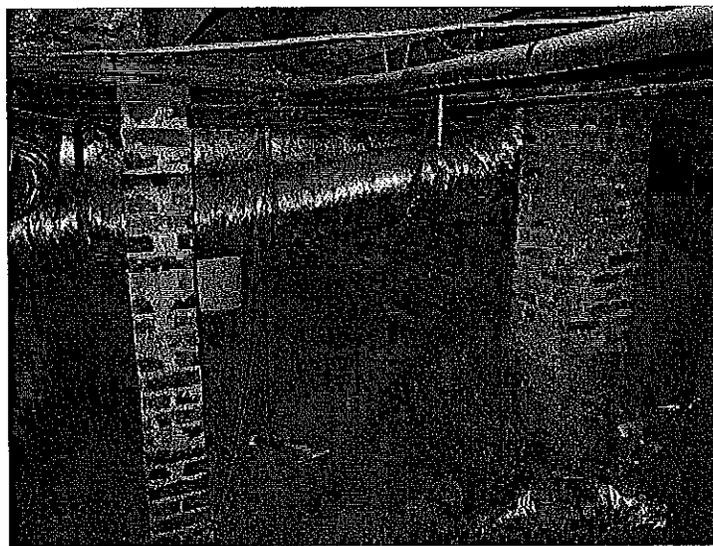
7. Piers/Posts: Steel posts, Brick, Wood Piers There are two wood piers present to the left of the crawlspace entrance. One pier is bowing and the other pier has earth to wood contact. Recommend replacing the piers with metal jack post for structural stability.

3. Piers/Posts: Steel posts, Brick, Wood Piers There are two wood piers present to the left of the crawlspace entrance. One pier is bowing and the other pier has earth to wood contact. Recommend replacing the piers with metal jack post for structural stability.
