STAFF RECOMMENDATION
1614 Benjamin Street
March 20, 2013

Application: Demolition of contributing building
District: Eastwood Neighborhood Conservation Zoning Overlay
Council District: 06
Map and Parcel Number: 08306003300
Applicant: Bill Franklin, Owner
Project Lead: Sean Alexander@nashville.gov

STRUCTURAL EVALUATION OF RESIDENCE

1614 Benjamin Street
Nashville, Tennessee
Project #213022

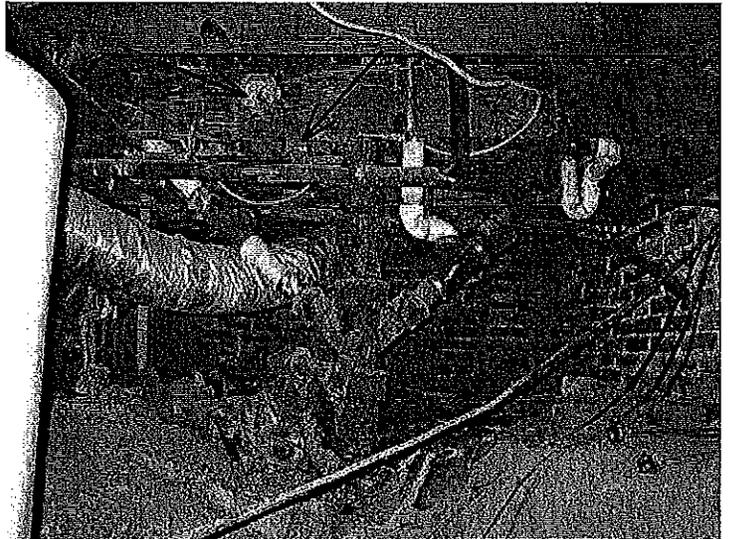
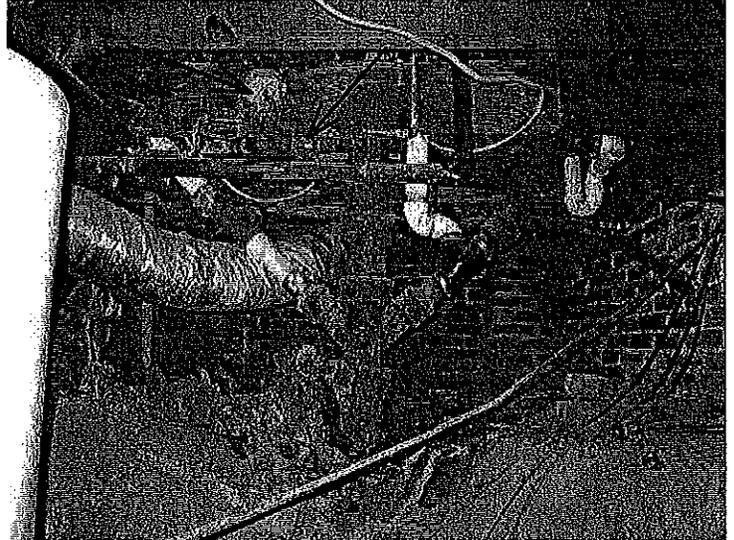
- 6. Ventilation: Vents
- 7. Insulation: Fiberglass Batts
- 8. Vapor Barrier: Under entire home
- 9. Electrical: 110 VAC/220 VAC
There are several junction boxes present with wires exposed. Recommend a qualified electrician to cap the boxes.

6. Main Crawl Space Electrical: 110 VAC/220 VAC
There are several junction boxes present with wires exposed. Recommend a qualified electrician to cap the boxes.

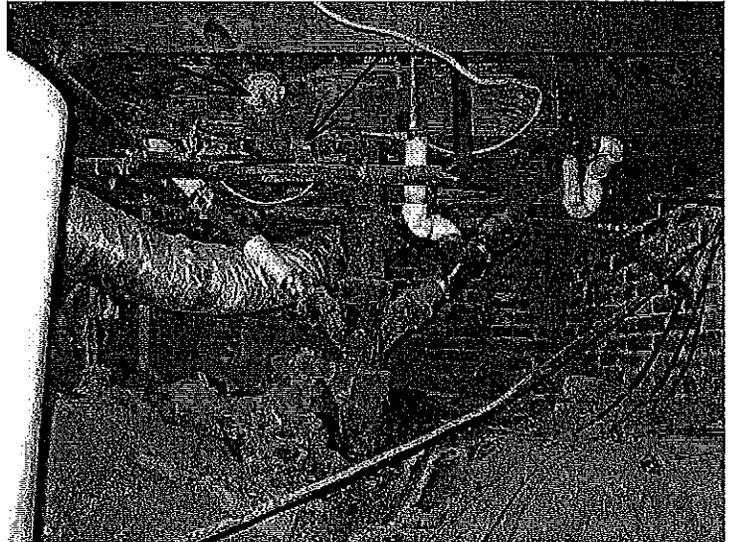
- A NP NI M D
- 1. Service Line: Copper
 - 2. Water Lines Copper
 - 3. Drain Lines Galvanized and PVC
The plumbing drains are galvanized and PVC. Most of the plumbing drains will have to be replaced in the future.
