**METROPOLITAN GOVERNMENT OF NASHVILLE AND DAVIDSON COUNTY**

**STAFF RECOMMENDATION**  
**1818 Wildwood Avenue**  
**July 17, 2013**

**Application:** Demolition  
**District:** Belmont-Hillsboro Neighborhood Conservation Zoning Overlay  
**Council District:** 18  
**Map and Parcel Number:** 11704013600  
**Applicant:** Manuel Zeitlin, architect  
**Project Lead:** Robin Zeigler, robin.zeigler@nashville.gov

RE: Structural Observation Report  
Residence, 1818 Wildwood, Nashville

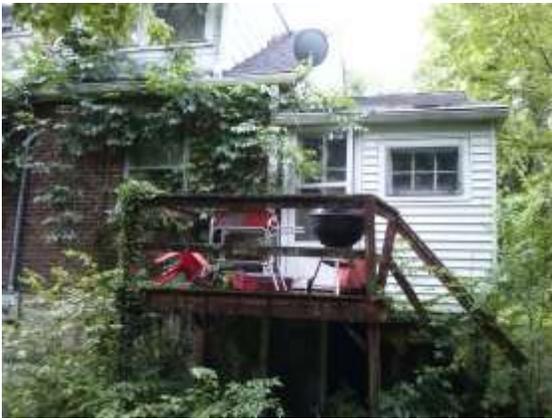
Figure 1: rear corner addition

The brick of the home is compromised by the allowing plant life to scale the foundation and walls. (See figure 1.) The negative slope of the front yard caused the porch to fail. It was never repaired creating water damage near the front door. (See figure 2.)

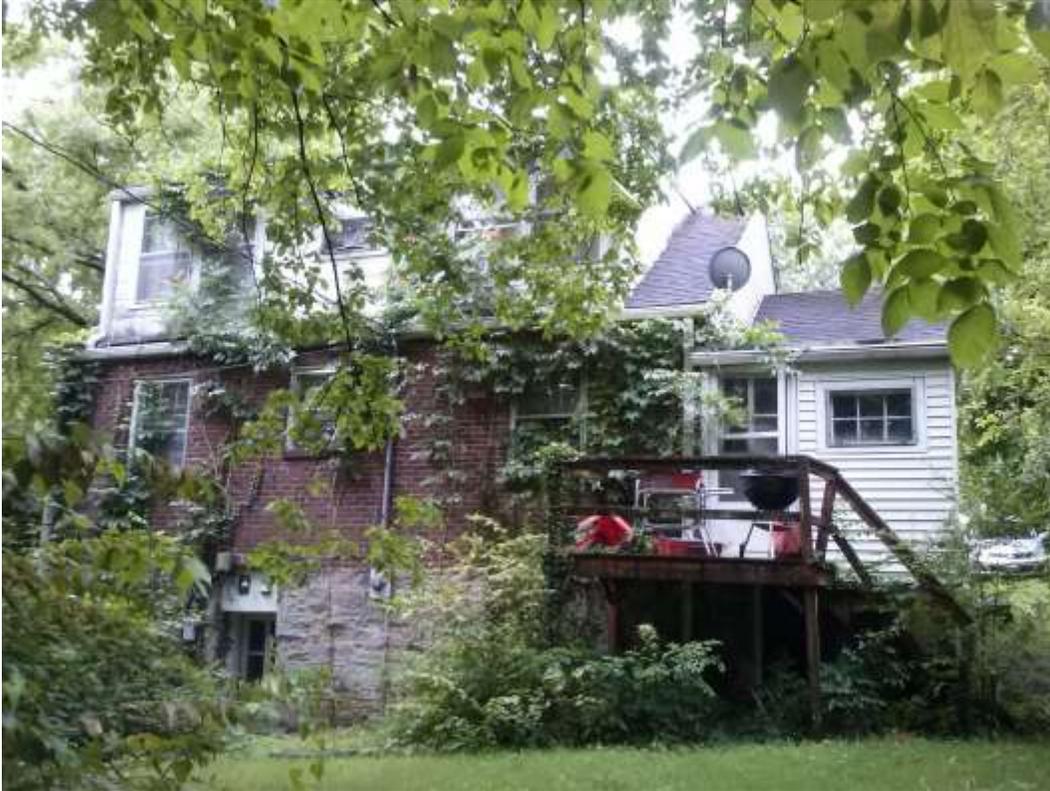
Figure 3: rear elevation

The poor construction of the rear dormer has caused significant ceiling damage in a rear room. The current owner believes that the rear corner and rear dormer additions were constructed in the 1960s or early 1970s without a permit and has indicated that they have caused problems since they first purchased the home.

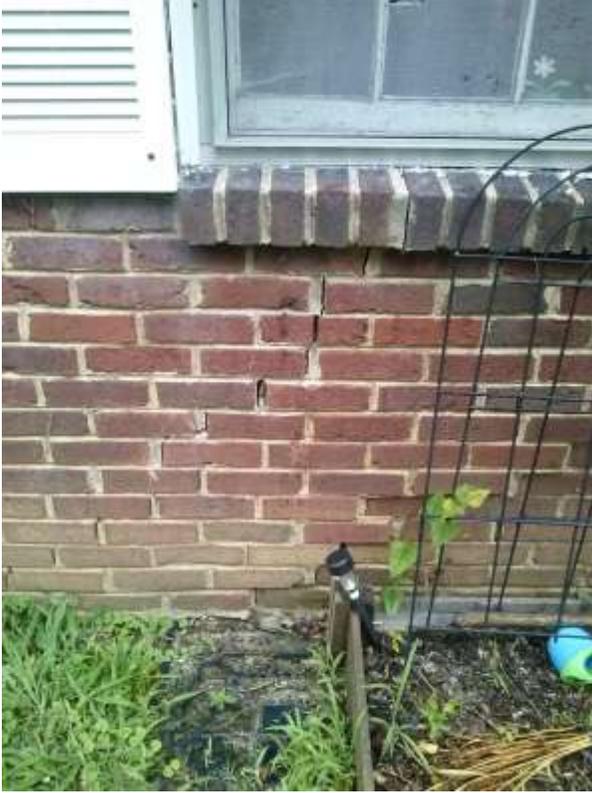
Figure 10: Crack below front window

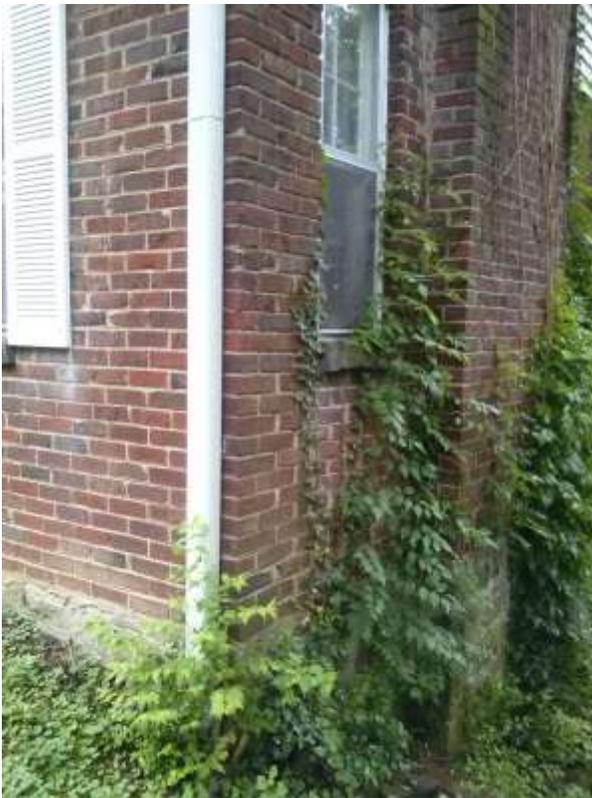
Figure 11: Front right corner

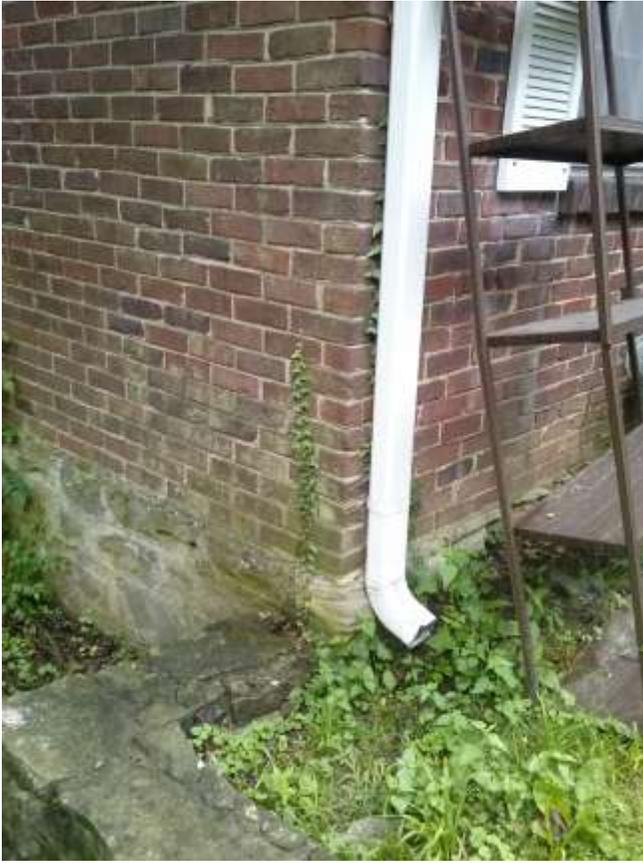
Figure 12: Front left corner

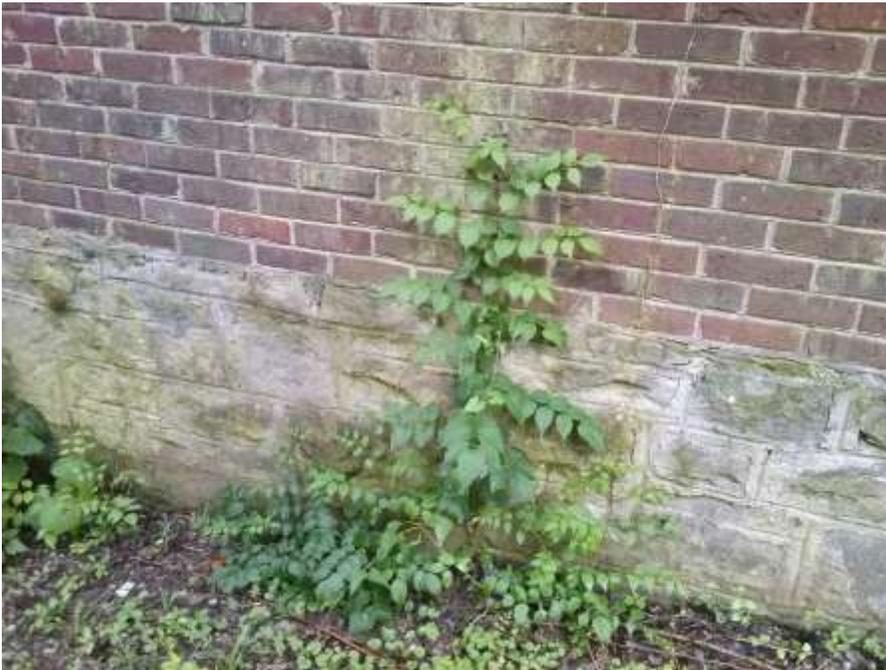
Figure 13: Left side foundation

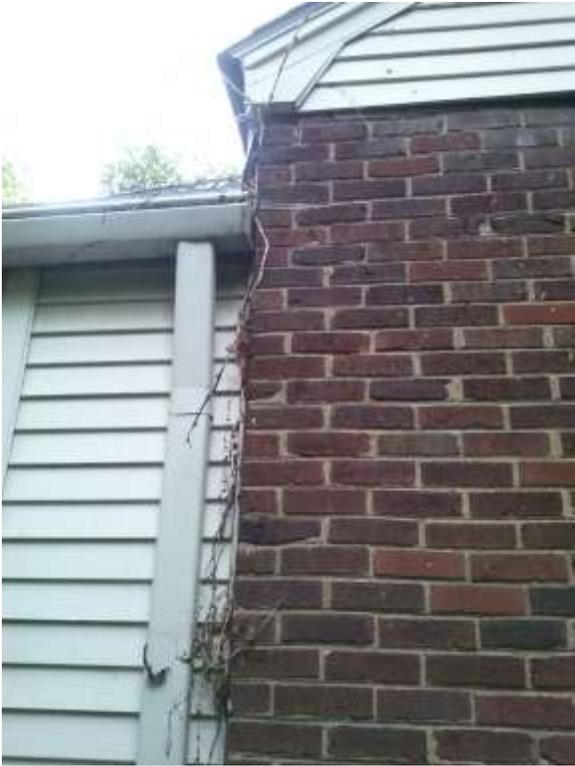
Figure 14: Connection between original house and later addition

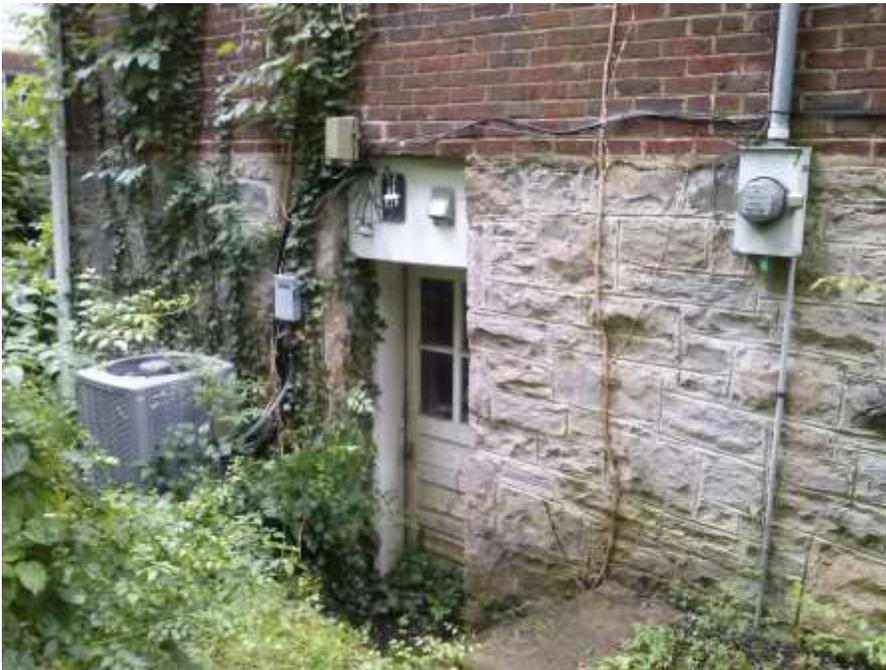
Figure 15: Rear basement entrance

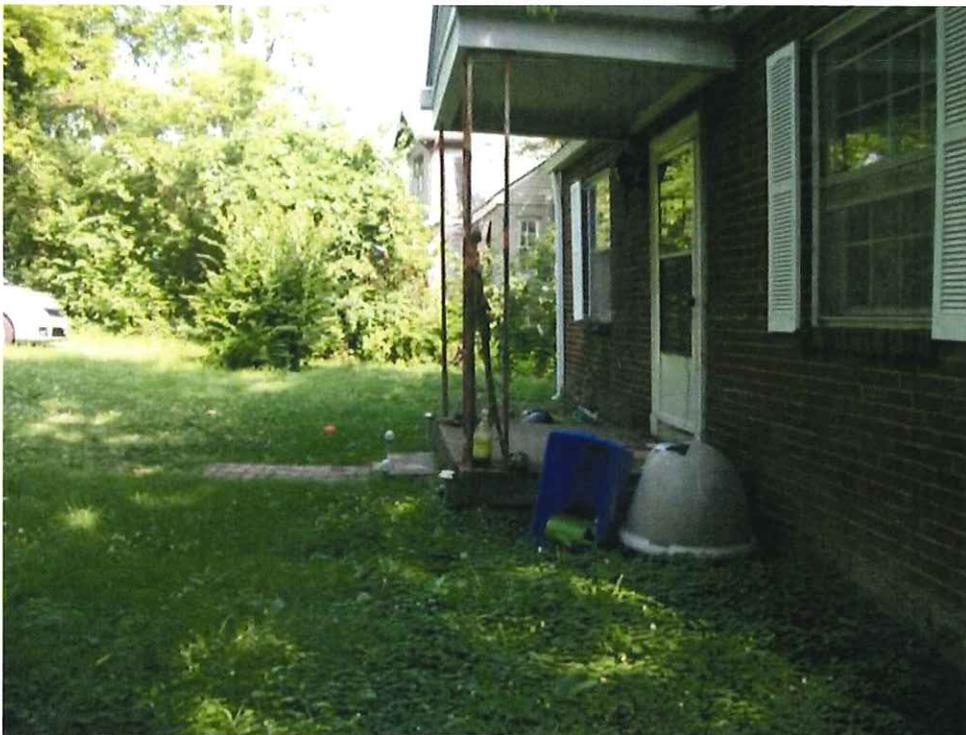
The ground surface slopes downward from the street to the residence (Photo 2). Building codes require the ground surface to have a positive slope away from the foundation with a minimum fall of 6-inches over 10-ft. Allowing runoff to pool and infiltrate next to the foundation can saturate clayey soils contributing to settlement and increase pore water pressure against the foundation. GEC recommends:

Photo 2: View of front of residence from right front corner showing the ground surface slope toward the front of the residence.

- The residence is set too low on the lot to correct this problem without constructing a structural retaining wall in front of the residence and/or by raising the height of the foundation walls.

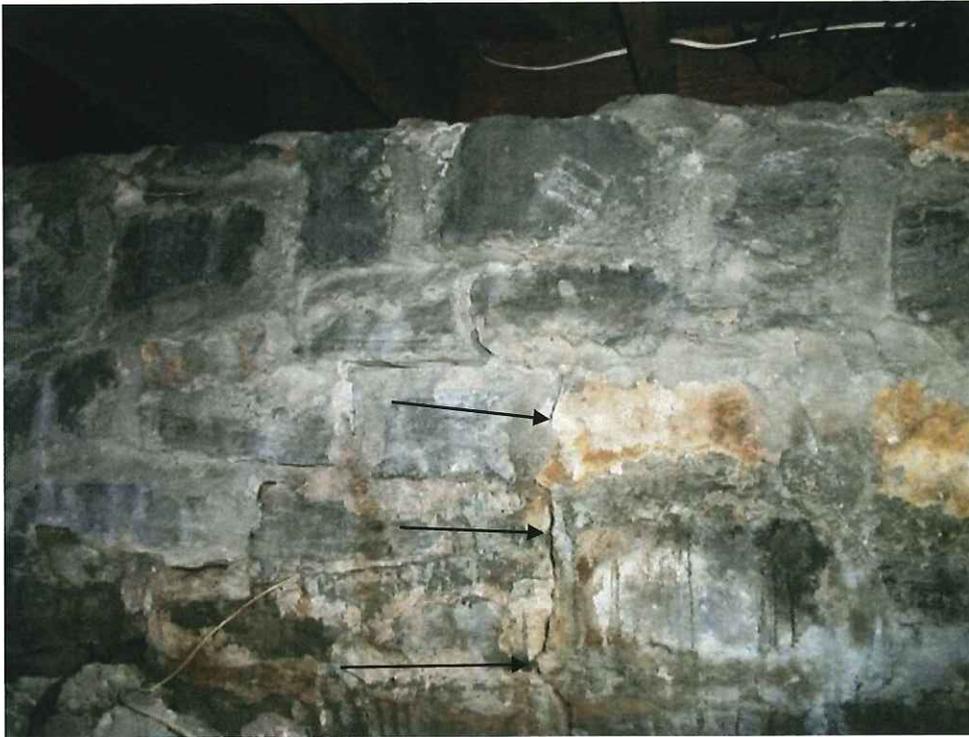
At the front stone foundation wall of the residence, the ground surface is close to the top of the foundation wall. The stone foundation wall has no steel reinforcement and has rotated from the lateral earth pressure pushing against it so it leans inward. The inward lean of the wall has created tension forces causing cracking of the stone front foundation wall (Photos 3 through 6) and brick veneer on the front wall (Photos 7 through 9). The inward lean of the front foundation wall has made the wall unstable. The danger for collapse is low but not negligible. A heavy rainfall event could cause collapse of the foundation walls if runoff penetrates into the basement. GEC recommends:

Photo 3: View of right end of front foundation wall showing 1/4- to 1/2-inch wide cracks

- The front foundation wall needs to be removed and replaced with a reinforced poured concrete or concrete masonry block foundation wall constructed on a reinforced

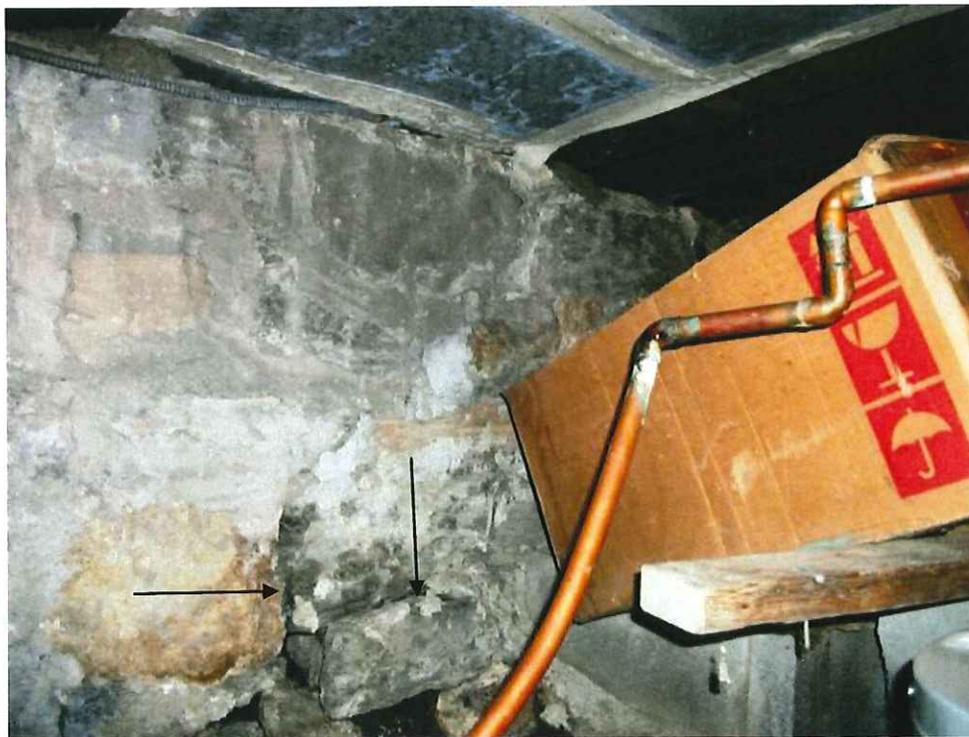
Photo 4: View of middle of front foundation wall showing 1/4- to 1/2-inch wide crack and offset stones.

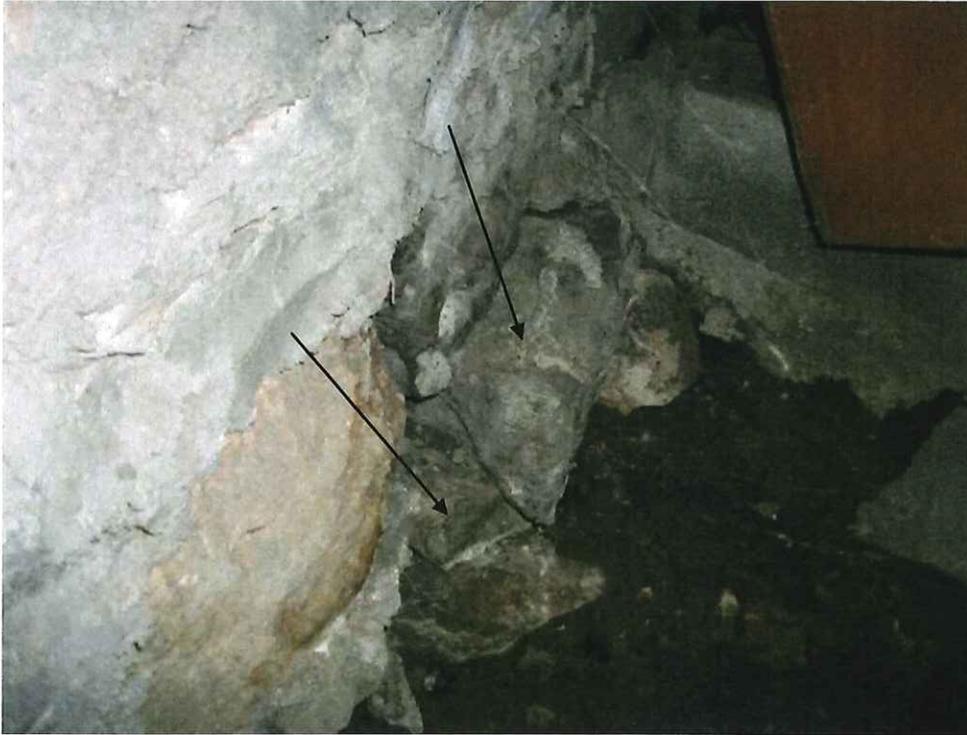
Photo 5: View of offset stones at base of middle of front foundation wall.

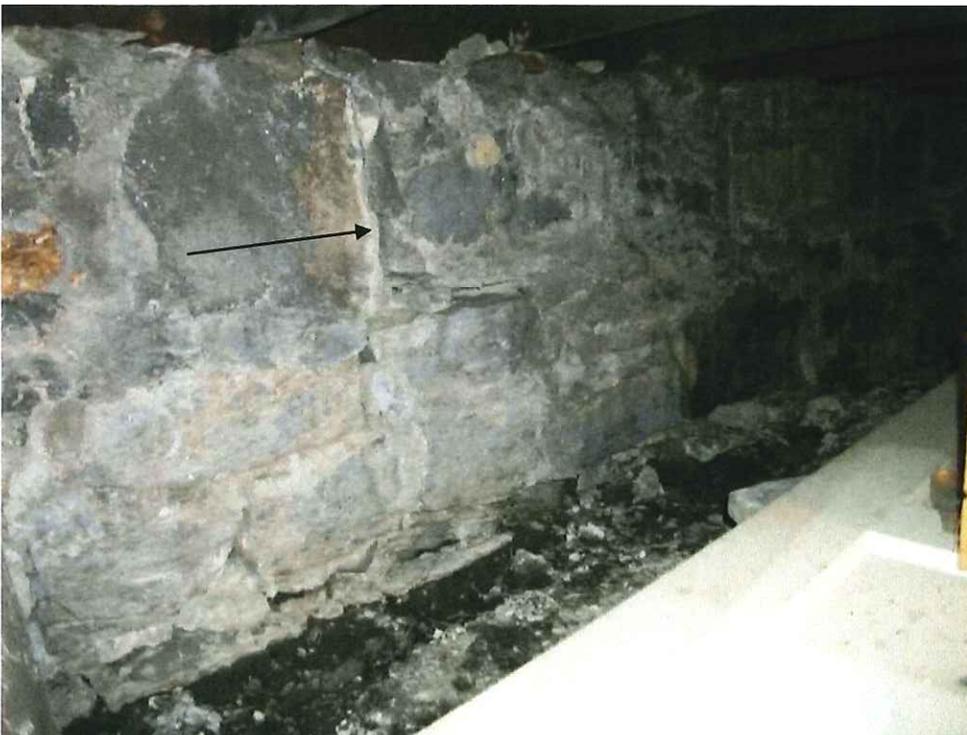
Photo 6: View of crack 1/4- to 1/2-inch wide at left end of front foundation wall.

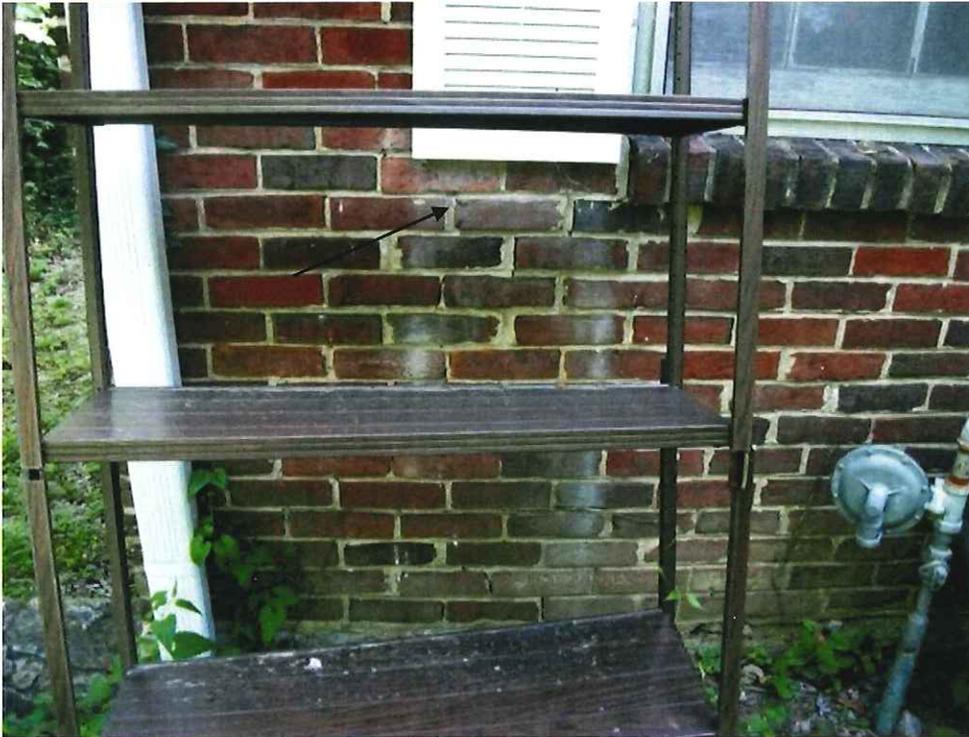
Photo 7: At left end of front wall there is a  $\frac{1}{8}$ -inch wide crack in the brick veneer.

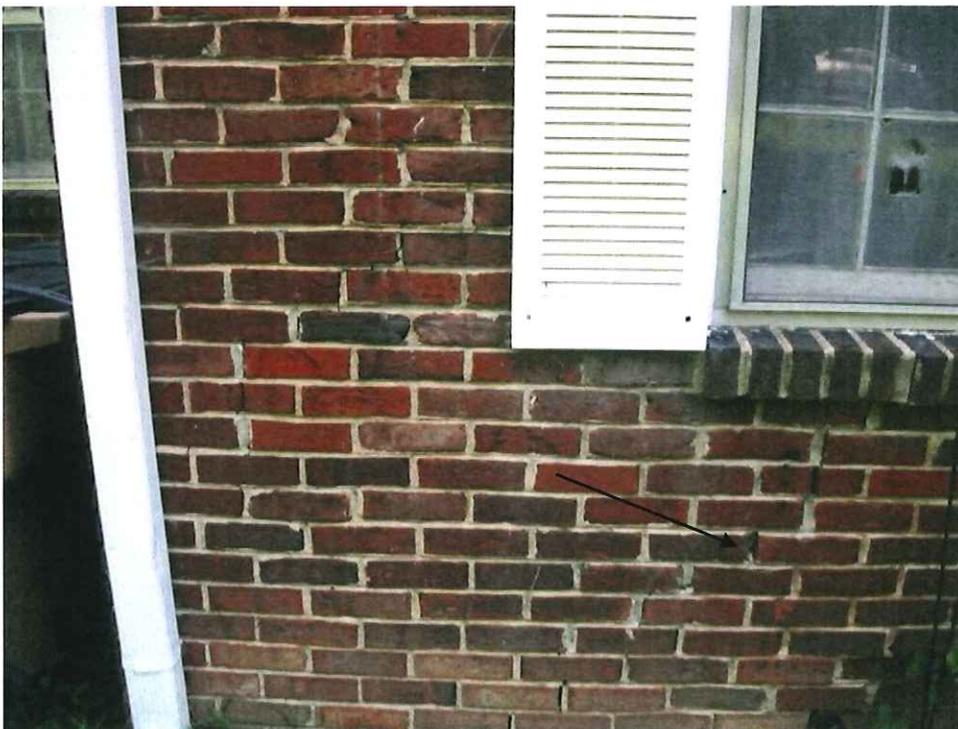
Photo 8: Cracking of brick veneer on front wall beneath window to the left of the front door.

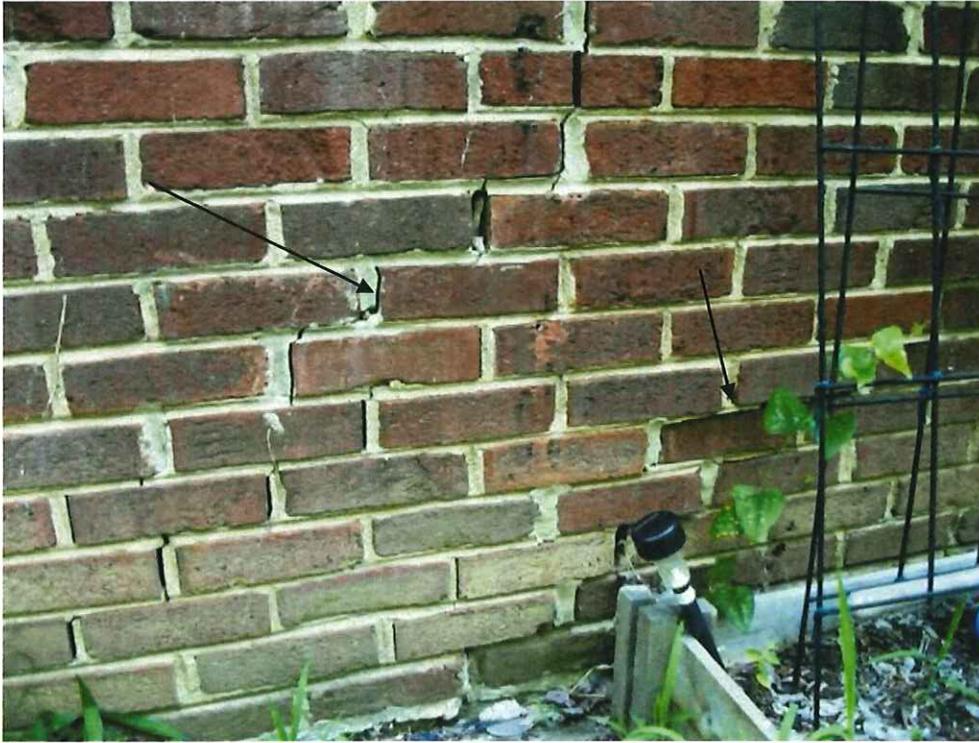
Photo 9: Close-up of brick cracks beneath window to left of front door and brick pushed inward at base of wall.

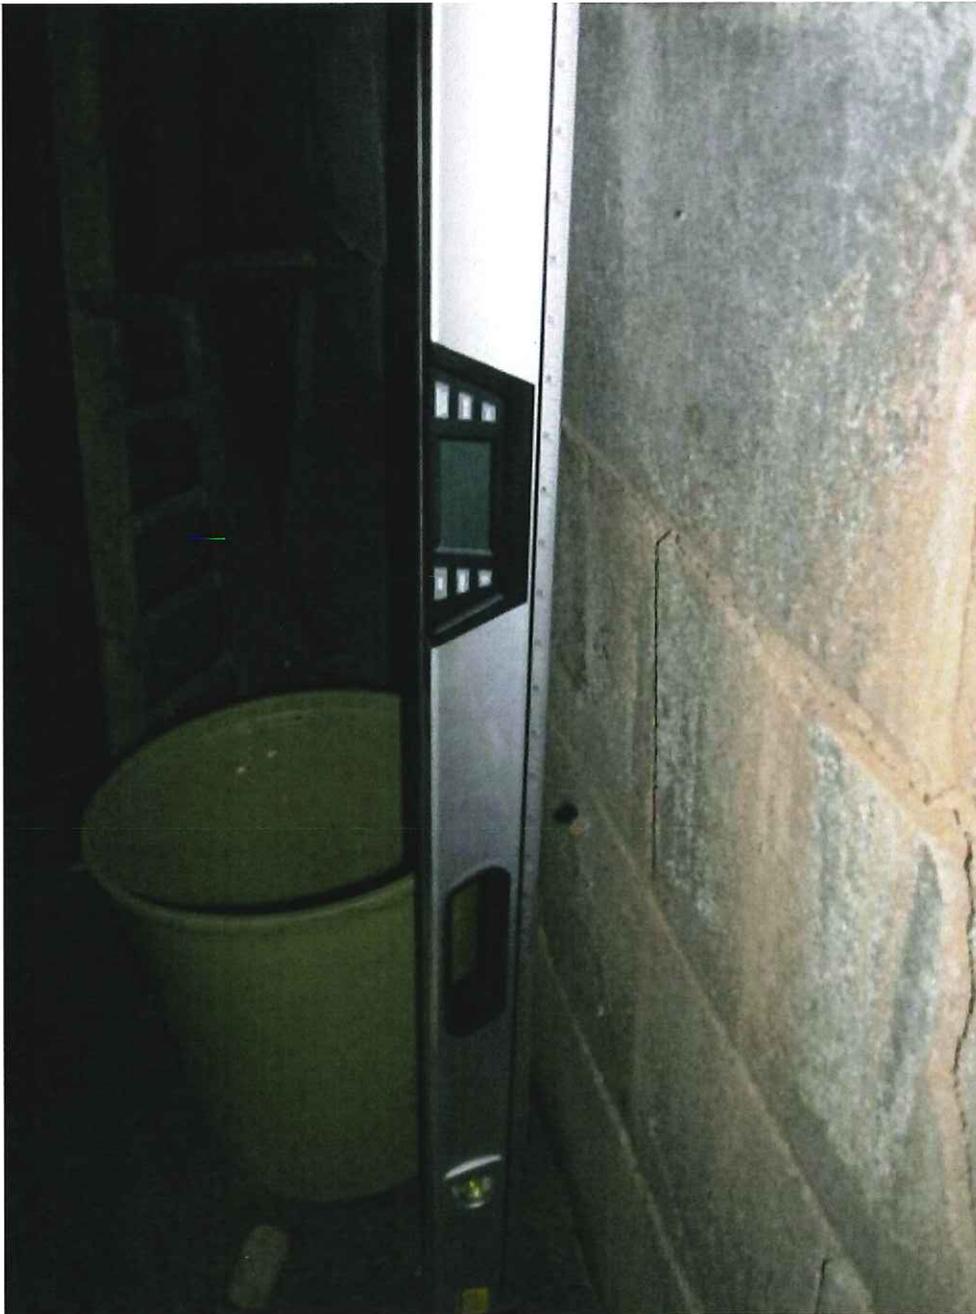
The interior retaining walls separating the dug-out portion of the basement from the crawlspace portion along the foundation walls are constructed of non-reinforced hollow core block. The walls appear to be constructed on the slab without a structural footing. These retaining walls are cracked and leaning inward (Photos 10 through 12). GEC recommends:

Photo 10: Retaining wall for dug-out basement has an inward lean of 2 to 3-inches. Photo is typical of retaining wall condition.

- The retaining walls need to be removed and replaced with reinforced poured concrete or concrete masonry block retaining walls constructed on a reinforced perimeter poured concrete strip footing. The wall construction should be compliant with the requirements of the 2006 IRC.

- The foundation walls need to be removed and replaced with taller reinforced poured concrete or concrete masonry block foundation walls constructed on a reinforced perimeter poured concrete strip footing set at a deeper elevation so there is a full basement and the retaining walls are no longer necessary.

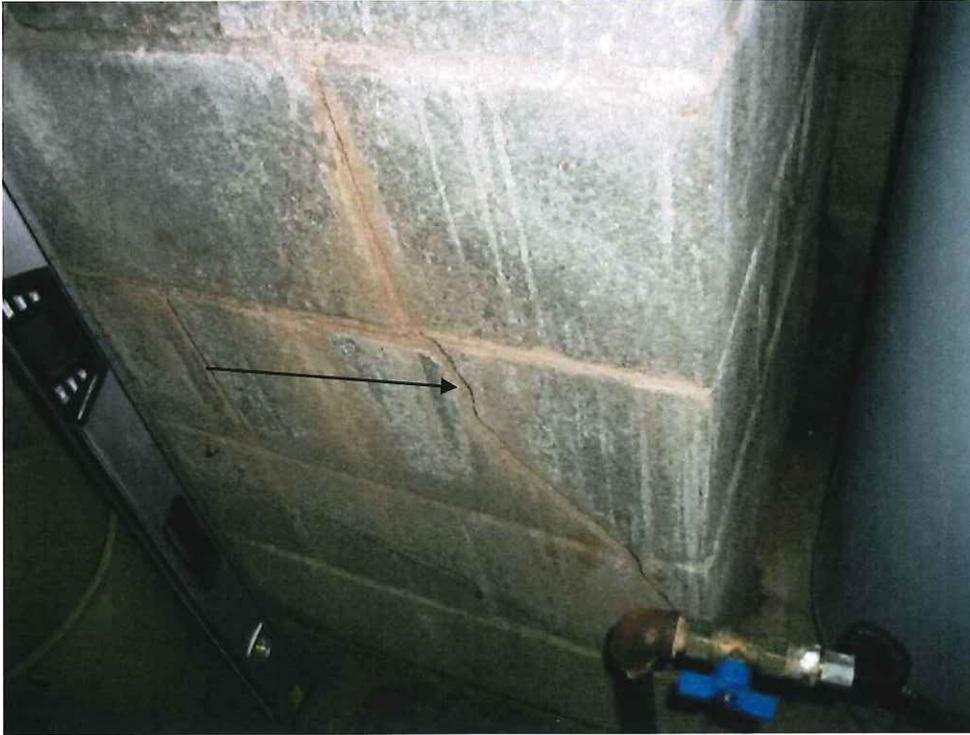
Photo 11: Example of crack in retaining walls.

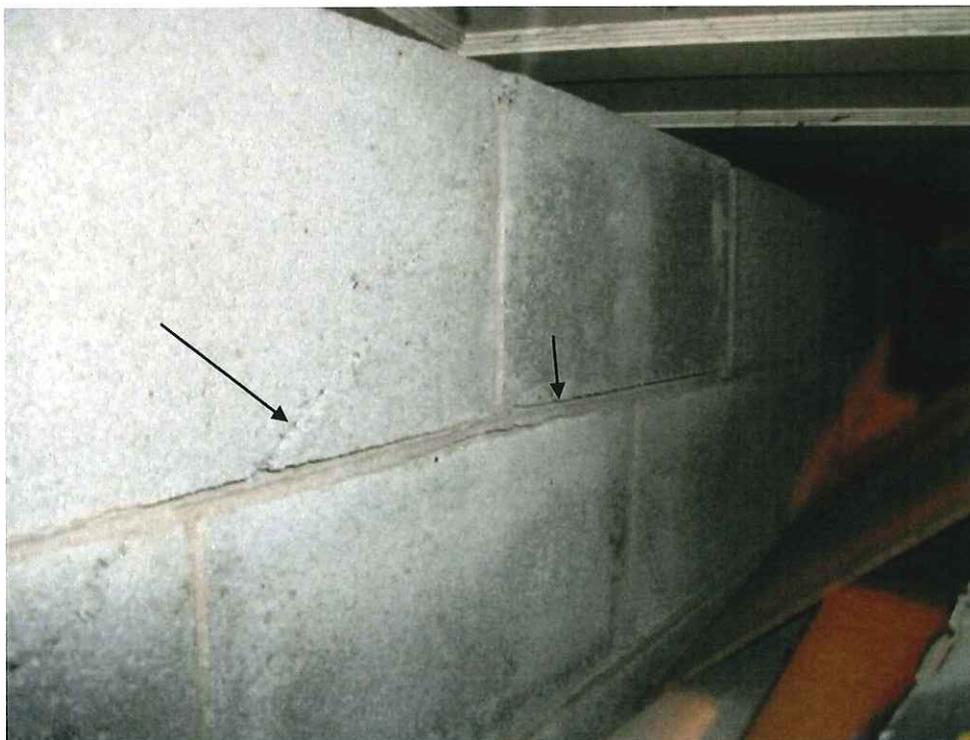
Photo 12: Example of cracks in retaining walls.

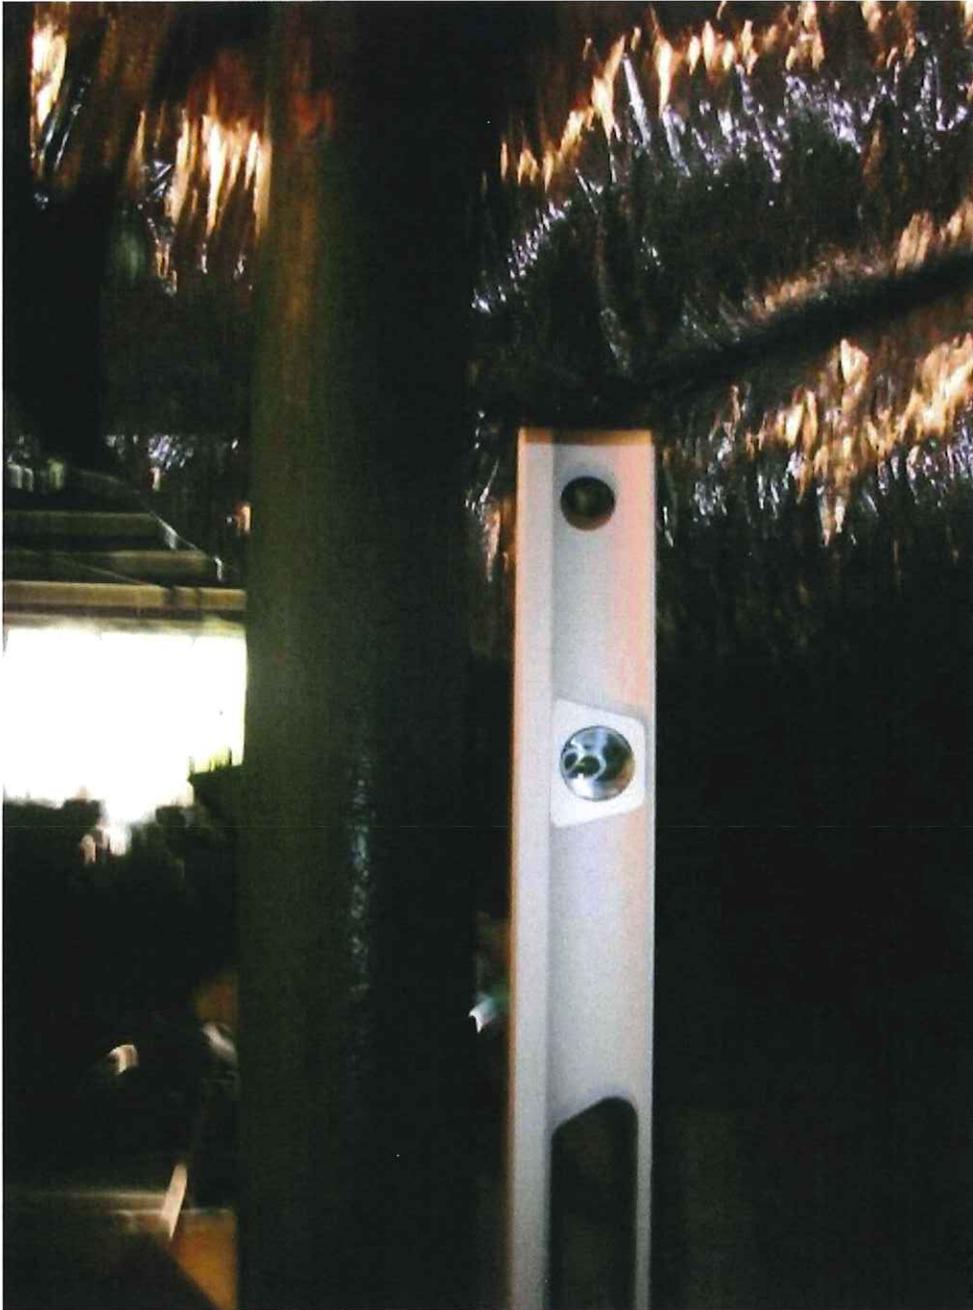
The lean of the front foundation wall has pushed on the floor framing causing the steel posts supporting the main left-to-right girder to lean toward the rear foundation wall 2 to 3-inches at the top (Photos 13 through 15). As the posts were originally installed as vertical supports, the movement has made them structurally unstable. GEC recommends:

Photo 13: Steel post supporting girder is leaning to the rear 2 to 3-inches at top.

- All support posts for the framing need to be re-set vertically with bearing on a thickened, reinforced grade beam in a basement slab or on individual poured concrete pier pads. Posts need to be anchored to the concrete at the base and securely connected to the framing at the top.

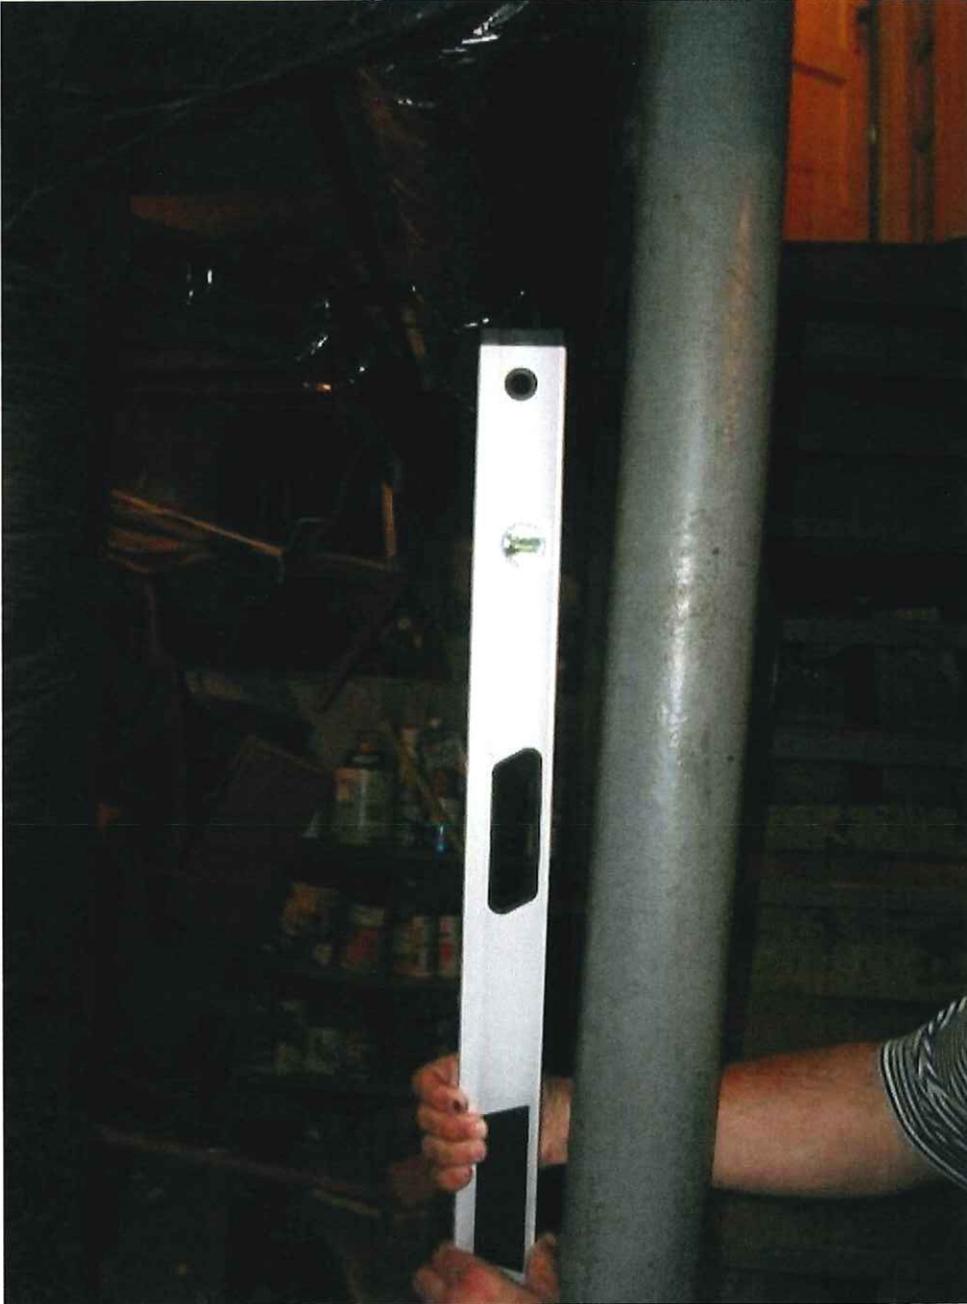
Photo 14: Steel post is leaning 2 to 3 inches to the rear at top.

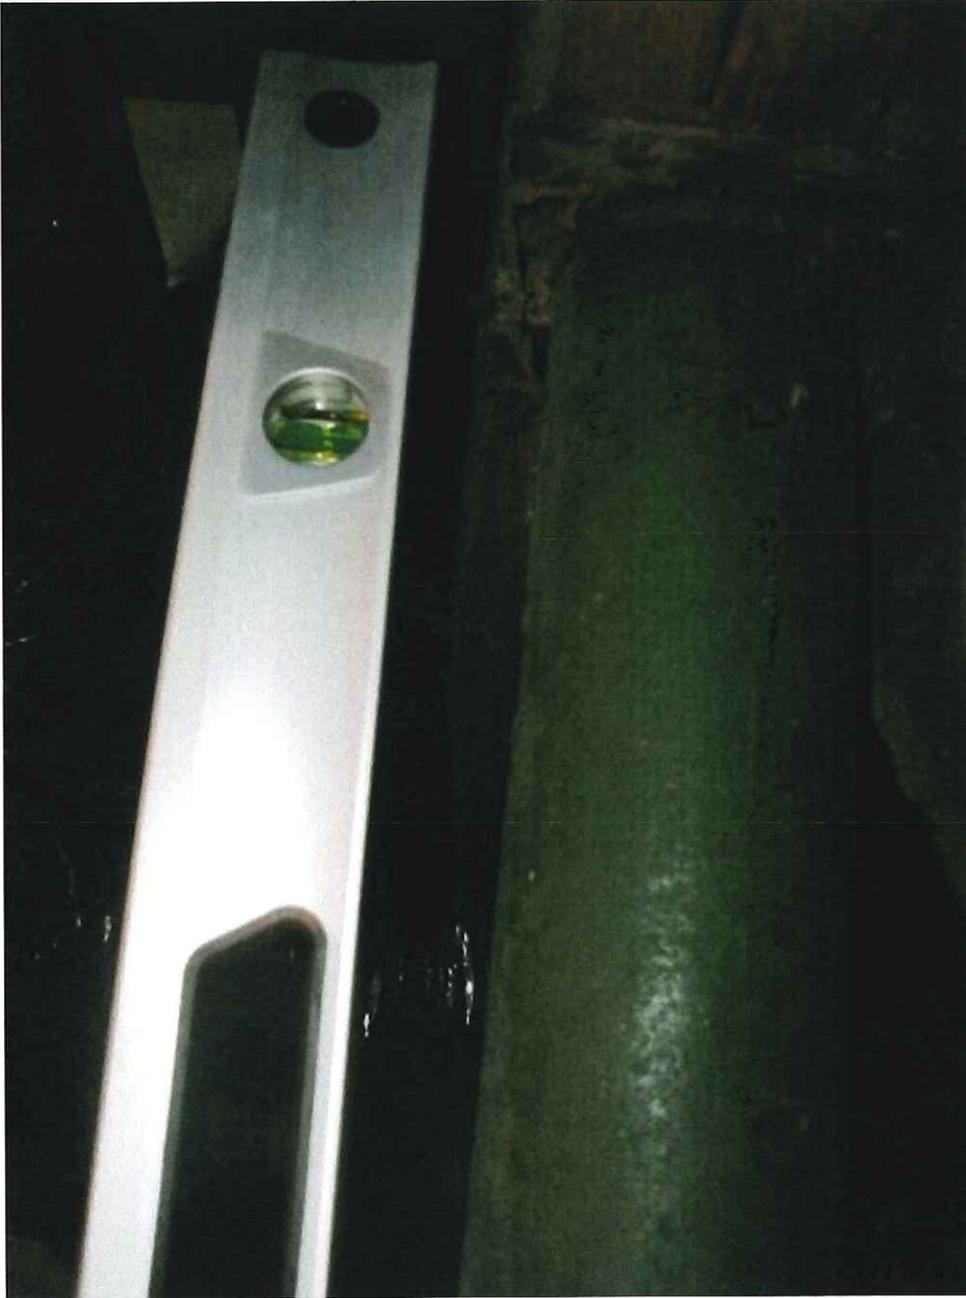
Photo 15: Steel post is leaning 2 to 3 inches to the rear at top.

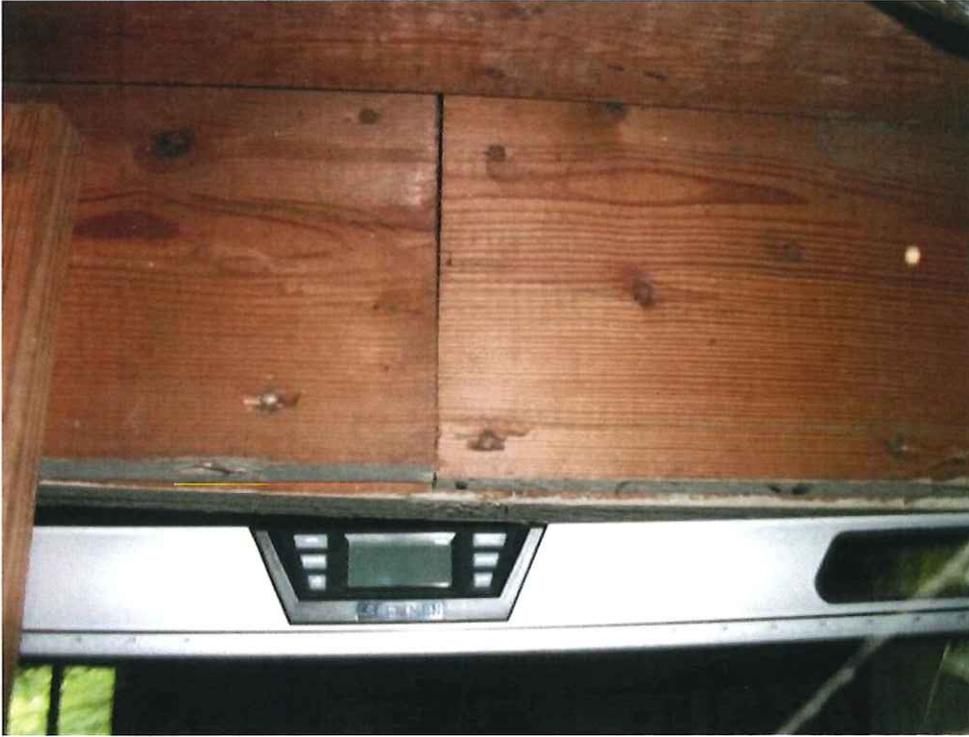
The main left-to-right girder is improperly constructed with unsupported splices in the girder plies (Photo 16). The girder also appears to be over-loaded for the loads of the two-story residence as there is visible deflection in the girder including several inches of deflection at the right end of the residence (Photo 17). GEC recommends:

Photo 16: Unsupported splice in girder ply and sag at right end of the girder.

- Additional structural steel posts are needed to support the girder.

- A new girder of steel or LVL beams designed for the existing spans can be installed. This method would not need additional support posts so that the basement area would be more open for storage compared to the alternative of adding more posts.

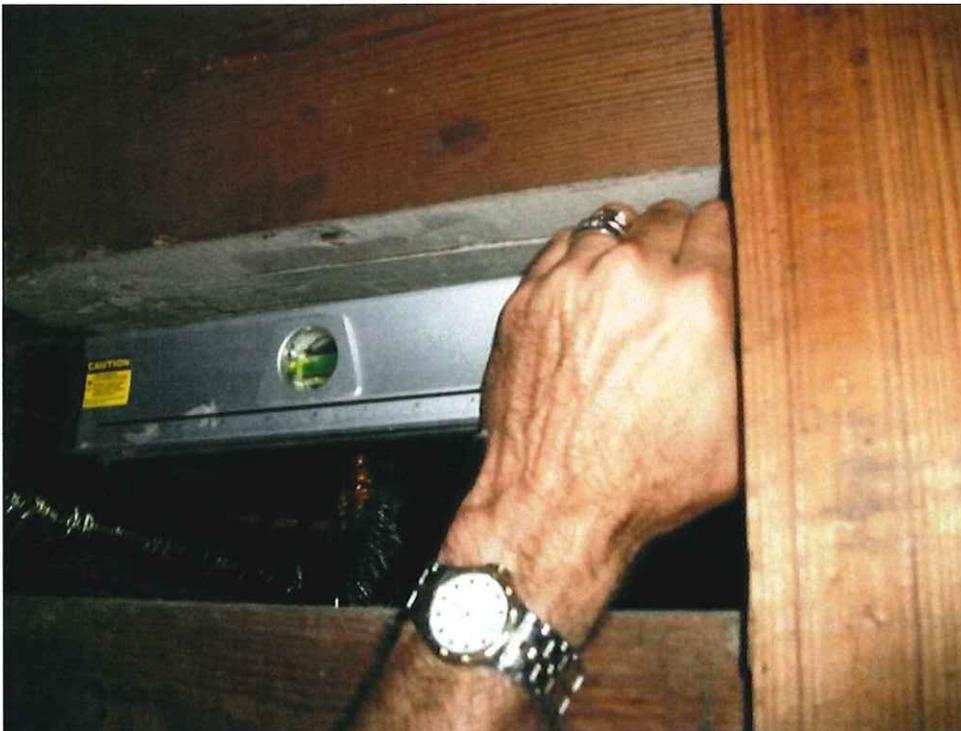
Photo 17: Girder sag at right end of residence.

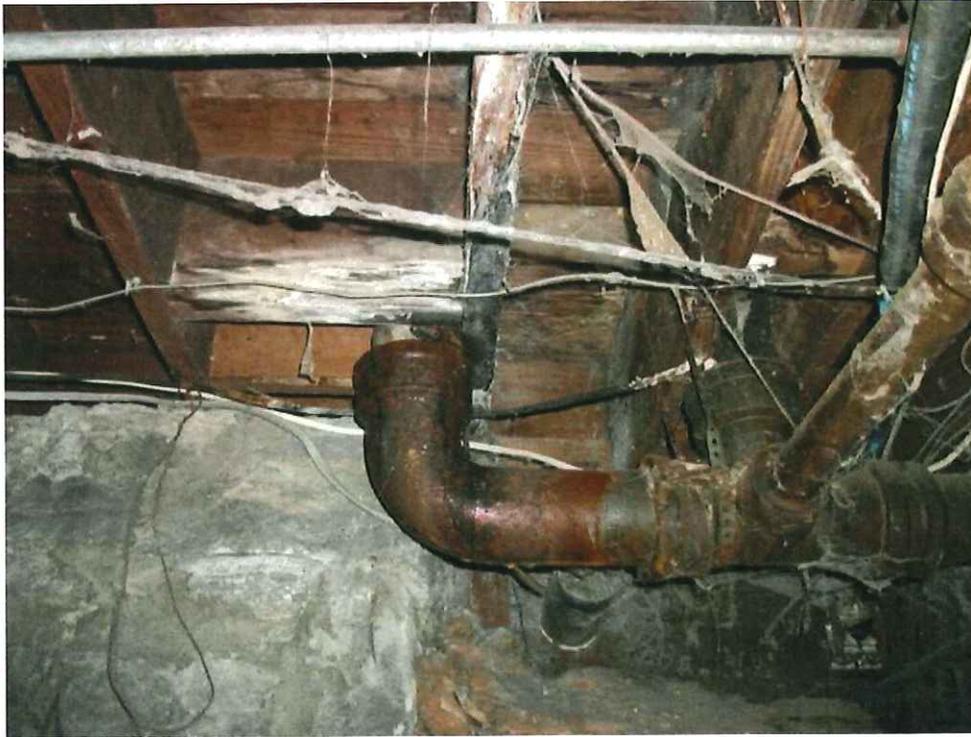
There are some water leaks in the cast iron drain lines (Photo 18). Near the rear wall of the basement, there are two areas of active fungal growth where the framing has been wet from the leaks (Photos 18 and 19). GEC recommends:

Photo 18: Active leak in cast iron drain line. White fungal growth is visible on the framing around the drain.

- Repair the plumbing leaks.
- Wood weakened by the fungal growth needs to be removed and replaced.
- Wood that has been wet but has not been structurally weakened needs to be dried and treated with a fungal killer/inhibitor.

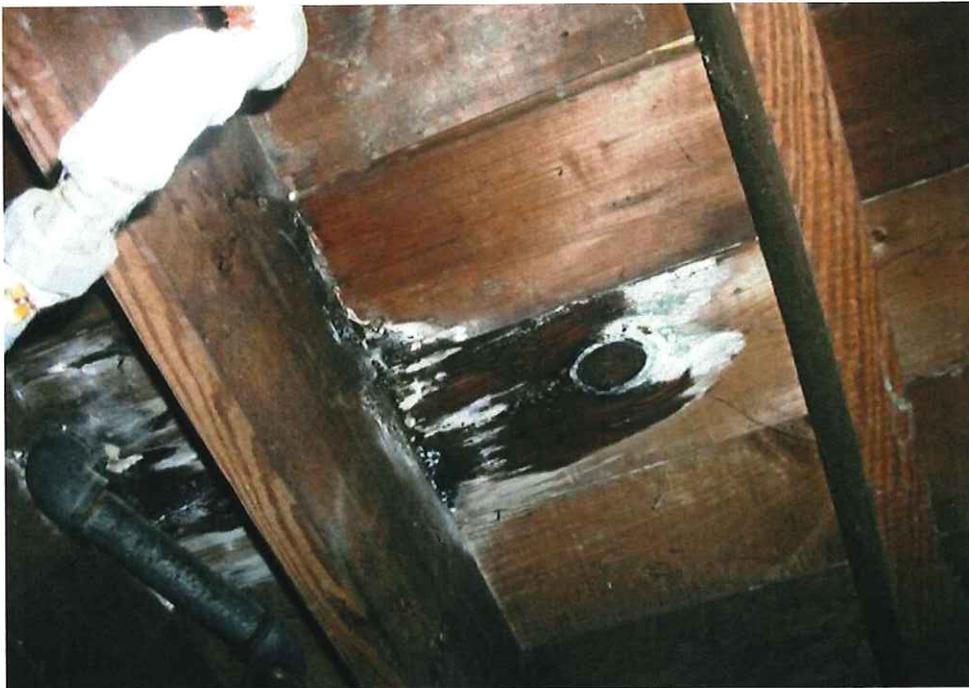
Photo 19: White fungal growth around leaking drain line.

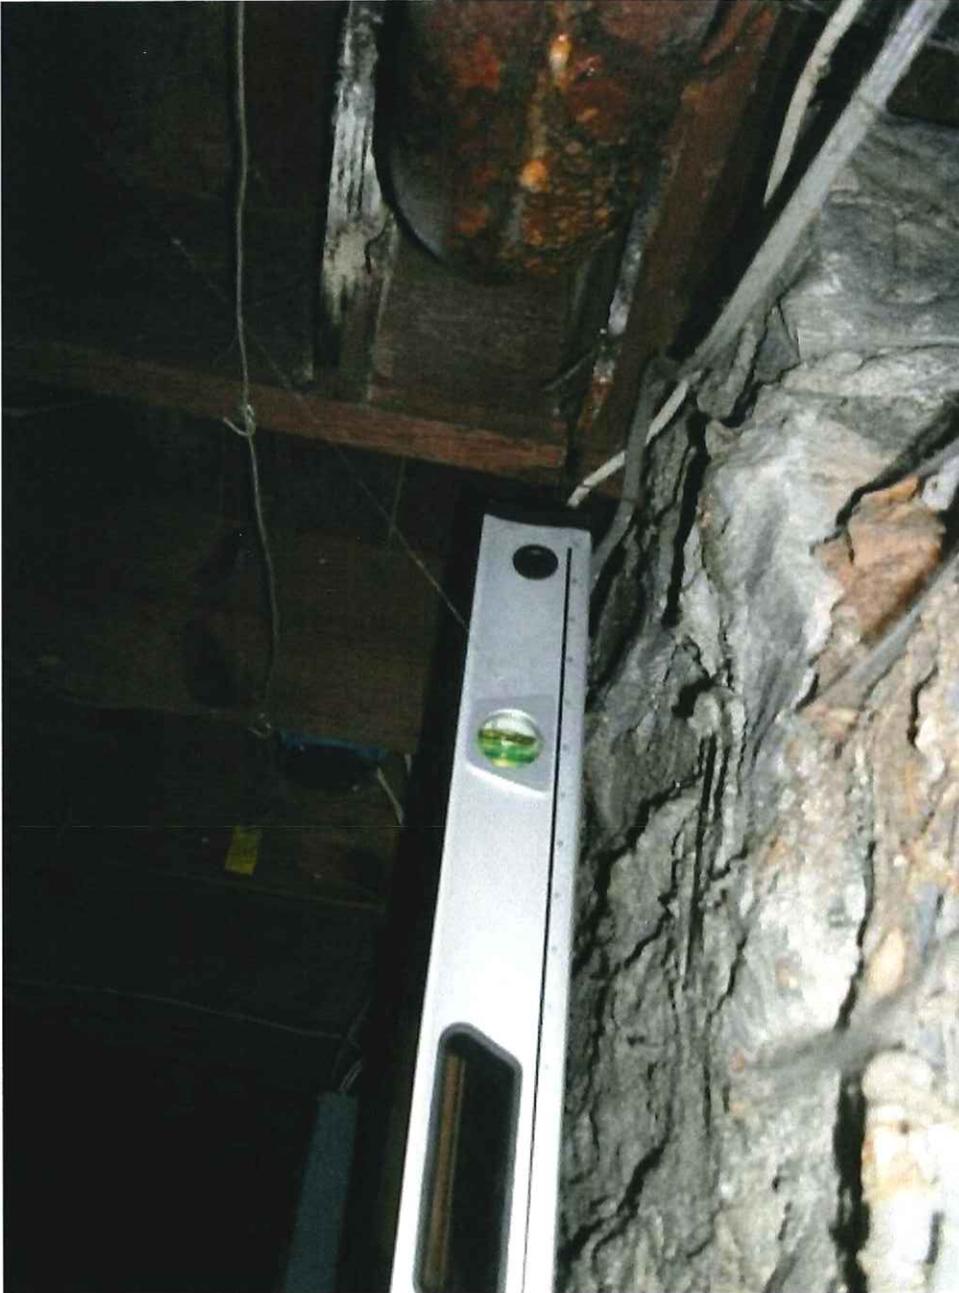
The forces pushing on the subfloor framing from the front foundation wall have pushed through the framing to the rear wall of the residence. The rear stone foundation wall is now leaning outward 1 to 2 inches at the top (Photo 20). The outward lean of the rear foundation wall has created tension forces causing cracking of the rear foundation wall and the rear ends of the side foundation walls (Photos 20 through 25) and cracking and bowing of the brick veneer on the rear foundation wall (Photos 26 through 28). GEC recommends:

Photo 20: Rear foundation wall is leaning outward 1 to 2 inches at the top.

- As previously discussed for the front foundation wall, the rear and side foundation walls need to be removed and replaced.
- The brick veneer on all sides of the residence has experienced cracking and bowing. The bowing cannot be corrected without removing the brick veneer and re-installing the brick with brick ties. Therefore, all the brick on the residence needs to be removed and replaced.
