**METROPOLITAN GOVERNMENT OF NASHVILLE AND DAVIDSON COUNTY**

**STAFF RECOMMENDATION**  
**1818 Wildwood Avenue**  
**July 17, 2013**

**Application:** Demolition  
**District:** Belmont-Hillsboro Neighborhood Conservation Zoning Overlay  
**Council District:** 18  
**Map and Parcel Number:** 11704013600  
**Applicant:** Manuel Zeitlin, architect  
**Project Lead:** Robin Zeigler, robin.zeigler@nashville.gov

RE: Structural Observation Report  
Residence, 1818 Wildwood, Nashville

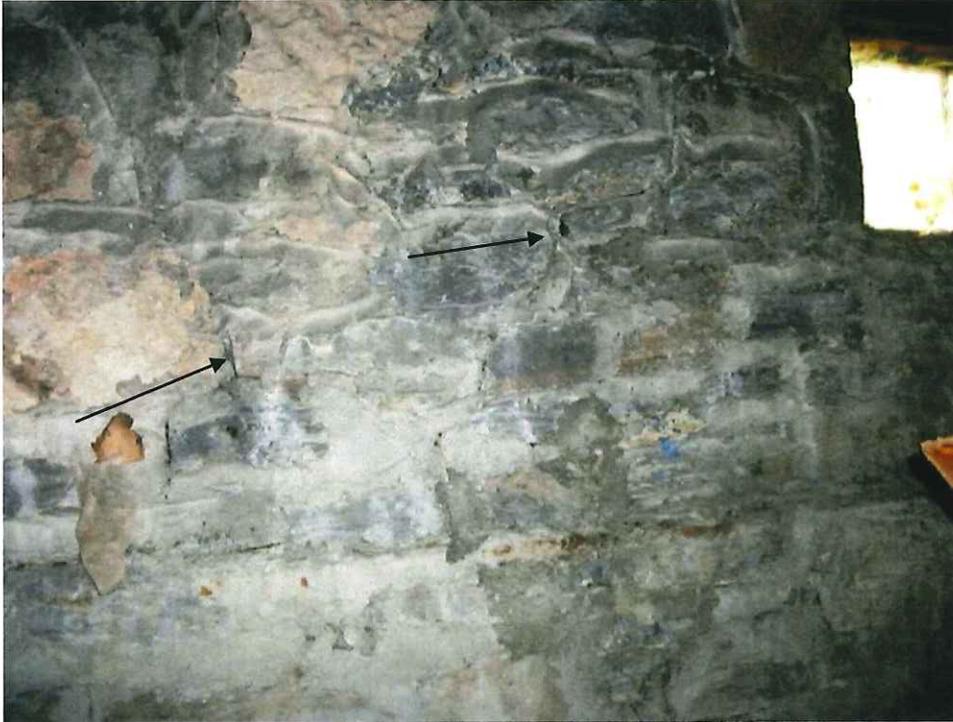
Photo 21: Cracking of right foundation wall.

- As previously discussed for the front foundation wall, the rear and side foundation walls need to be removed and replaced.
- The brick veneer on all sides of the residence has experienced cracking and bowing. The bowing cannot be corrected without removing the brick veneer and re-installing the brick with brick ties. Therefore, all the brick on the residence needs to be removed and replaced.

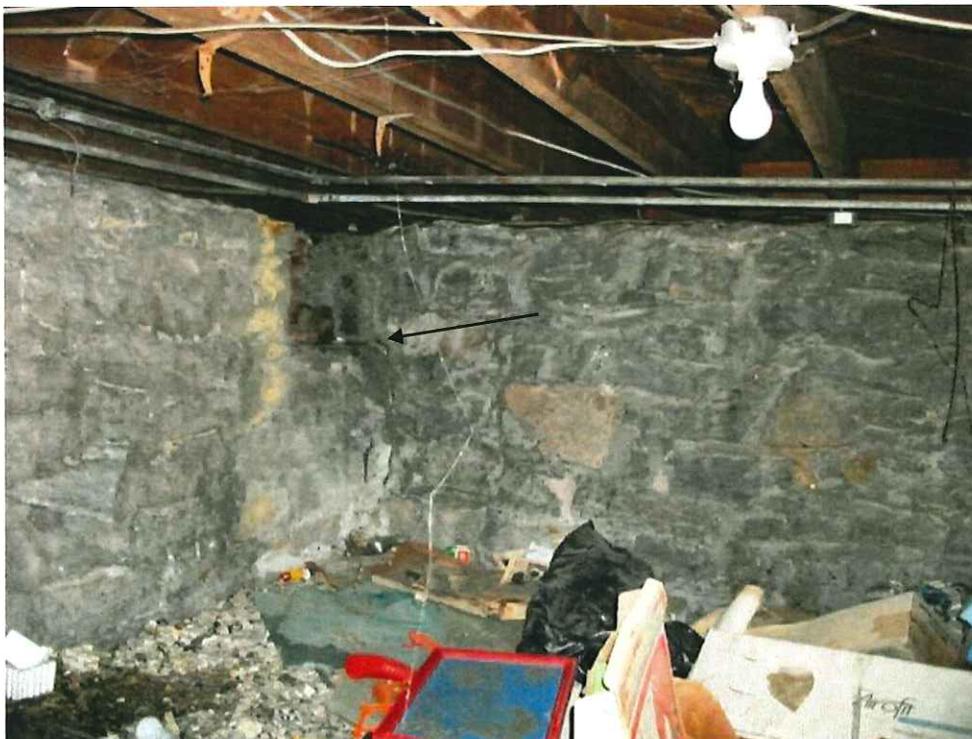
Photo 22: Cracking on rear foundation wall at left rear corner.

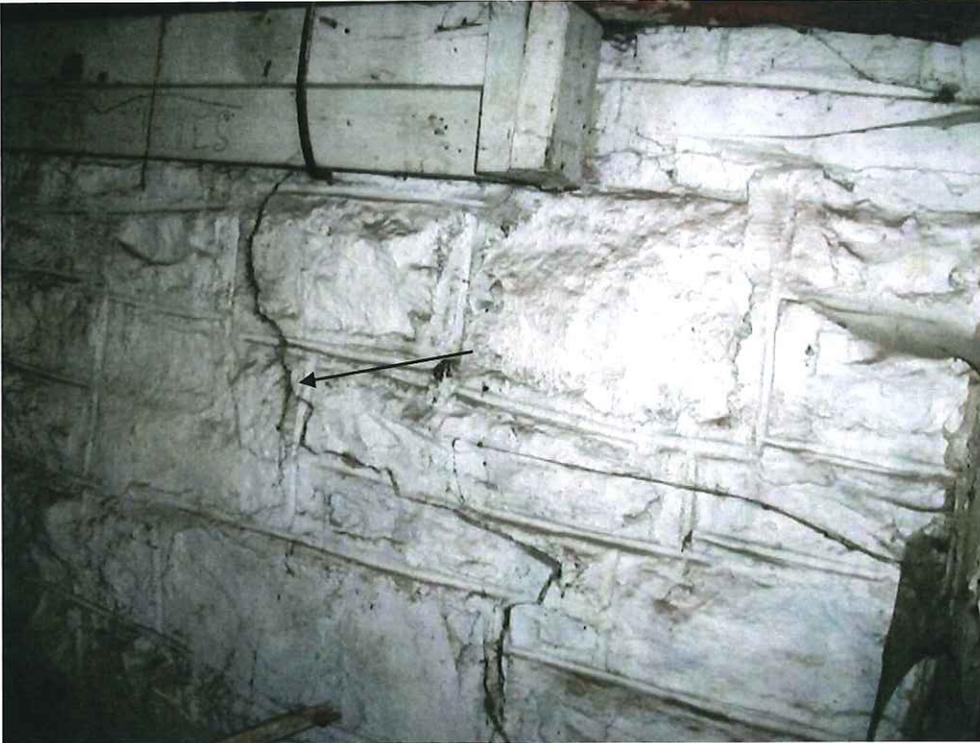
Photo 23: Cracking on rear foundation wall of crawlspace area at left rear corner.

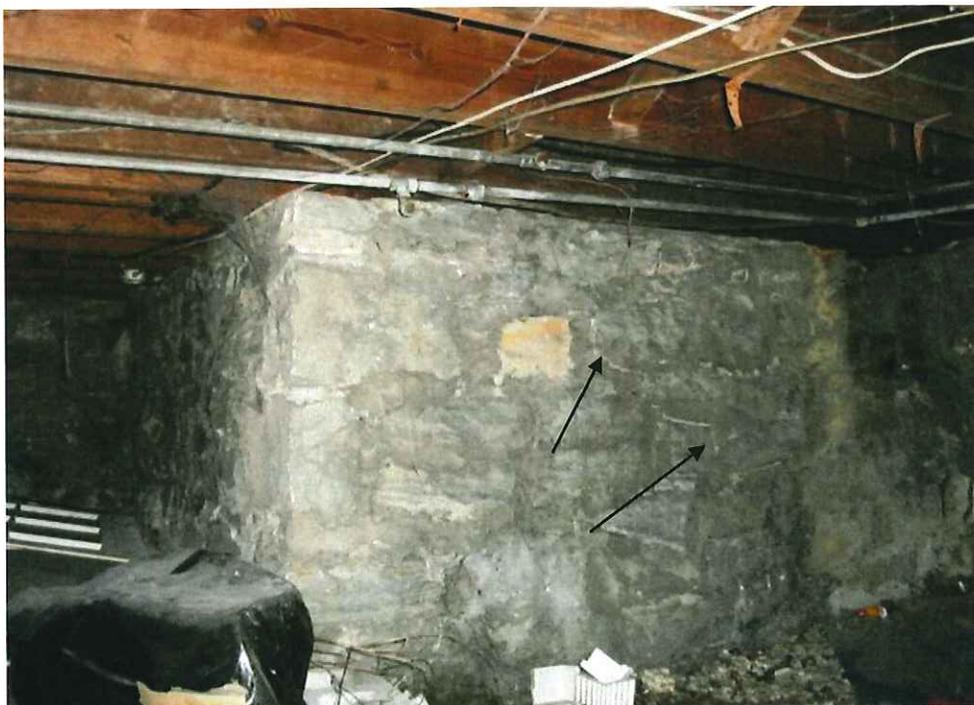
Photo 24: Cracking of rear end of left foundation wall.

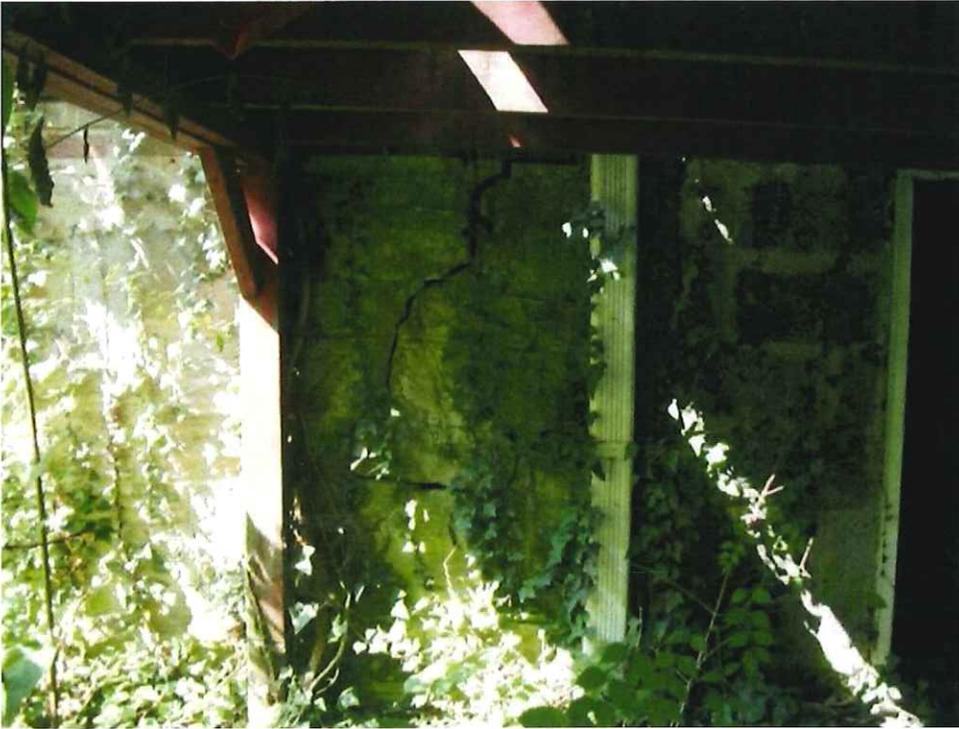
Photo 25: Same crack in Photo 24 viewed from outside residence.

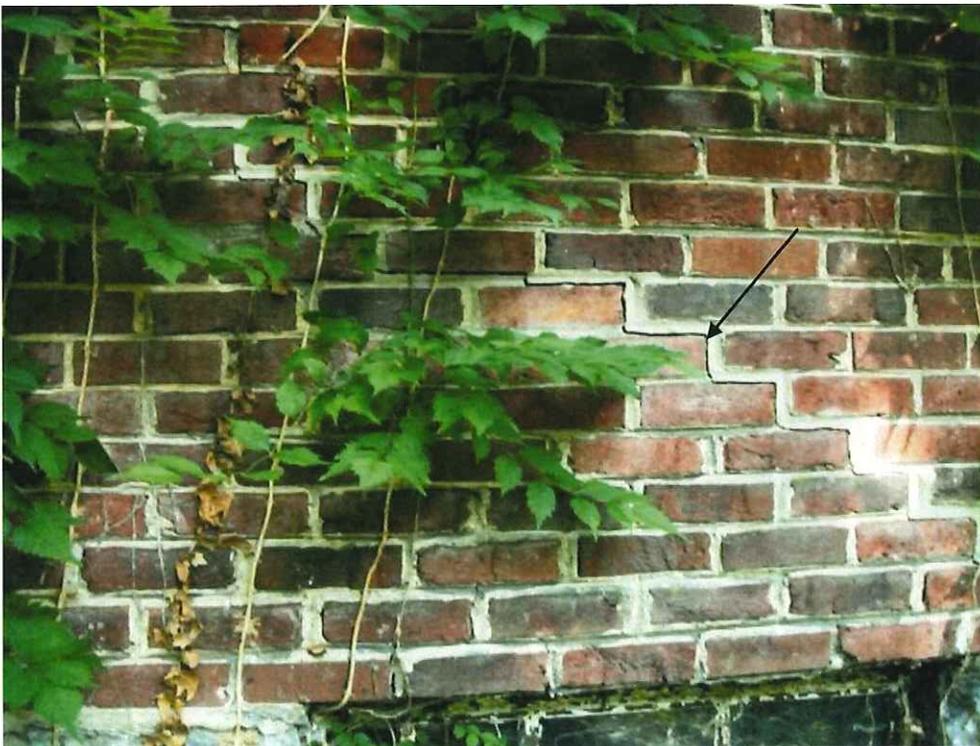
Photo 26: Bowing and cracking of the brick veneer on the right side of the residence.

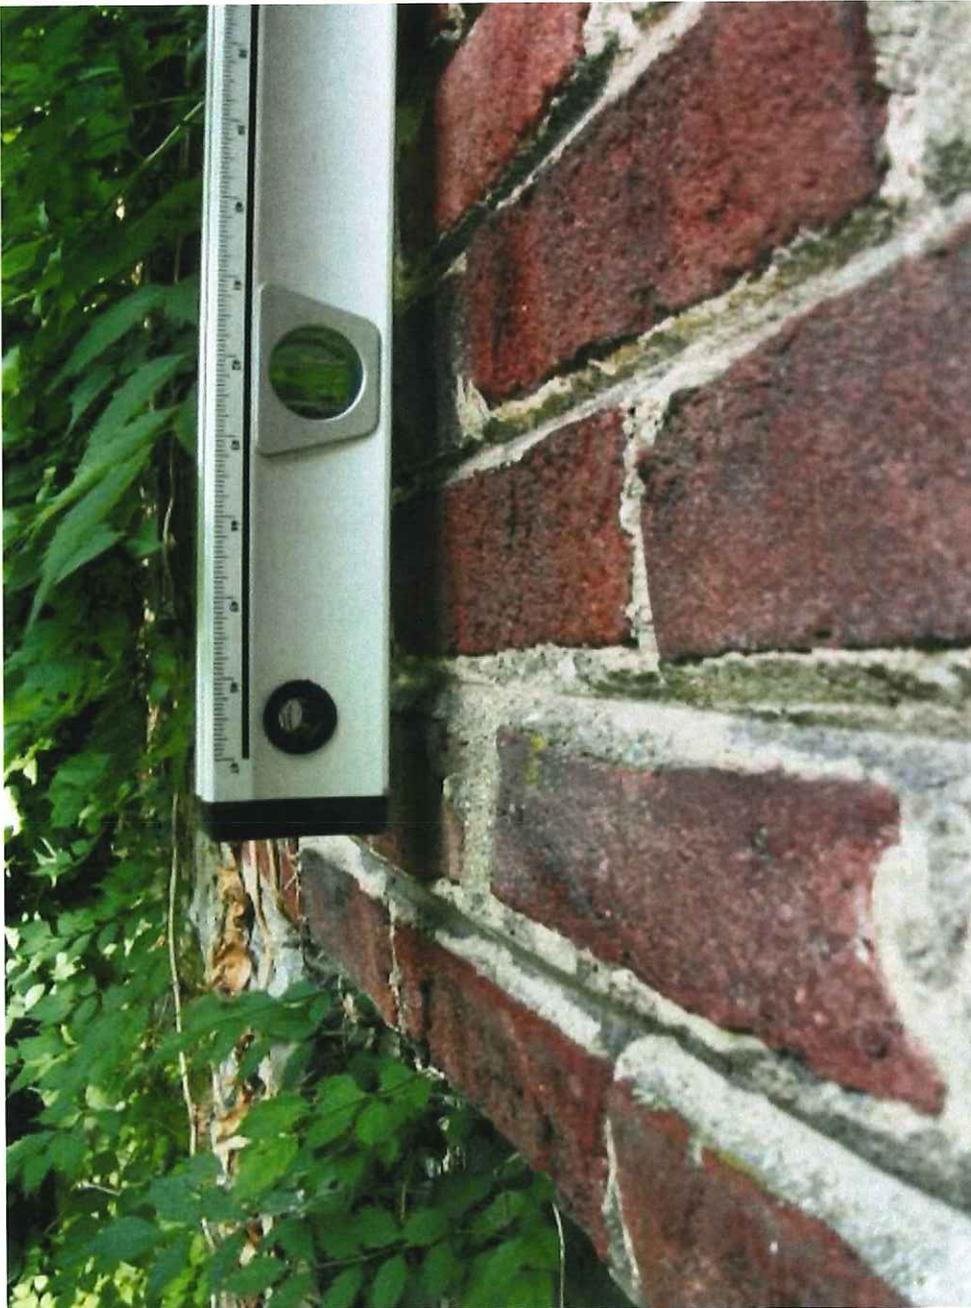
Photo 27: Bowing of the brick veneer on the rear wall of the residence.

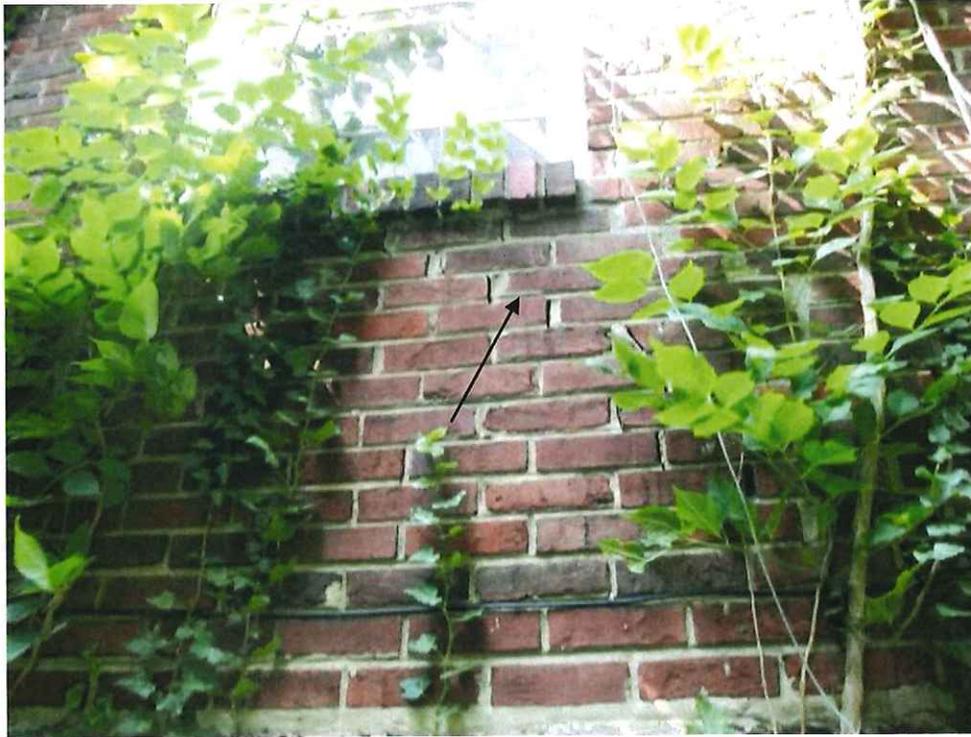
Photo 28: Cracking of brick veneer on the rear wall of the residence.

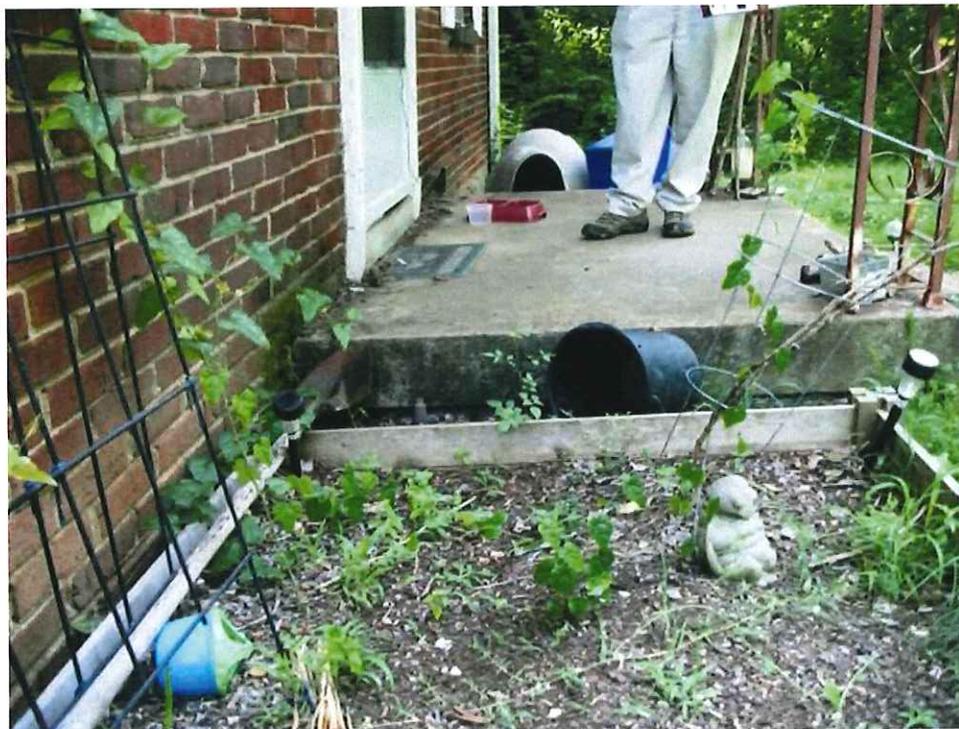
The front porch has settled next to the residence from surface water runoff erosion and consolidation of the backfill in front of the front foundation wall (Photo 29). The downward movement of the slab next to the residence has caused it to kick upward at the front edge. The upward movement has caused the support posts to push the roof upward and damage the framing connections at the front wall of the residence (Photo 30). GEC recommends:

Photo 29: Settlement of front porch slab.

- The front porch and front porch roof need to be removed and replaced. The subgrade beneath the porch should be compacted clean stone. Soft soils should be removed and replaced with compacted gravel before installing a new slab. The ground surface should

be graded to drain away from the front porch slab and front foundation wall when the new porch is installed.

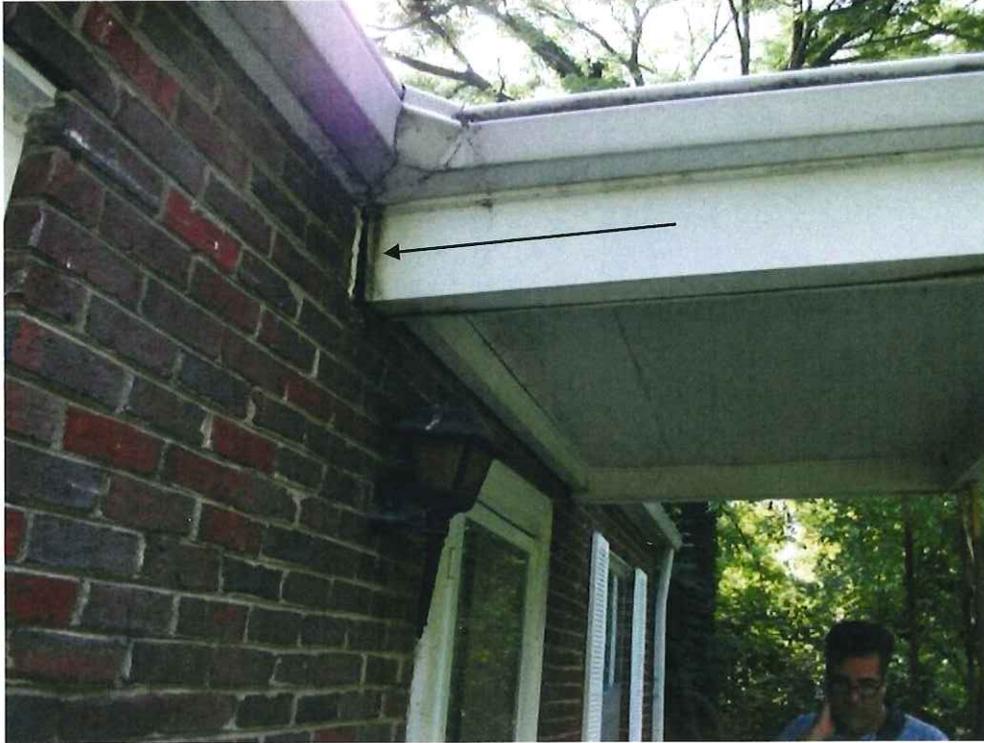
Photo 30: Damage to front porch roof framing connection to the residence.
