STAFF RECOMMENDATION 1810 Ashwood Avenue January 15, 2013

Application: Demolition
District: Belmont-Hillsboro Neighborhood Conservation Zoning Overlay
Council District: 18
Map and Parcel Number: 10416007800
Applicant: Andrew Oeltmann, owner
Project Lead: Robin Zeigler, robin.zeigler@nashville.gov

LIMITED STRUCTURAL INSPECTION

1810 Ashwood Avenue
Nashville, TN

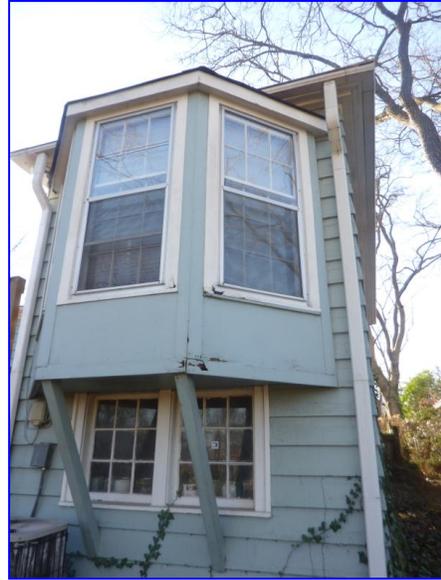
Image 4: Rear Addition

The only portion of the building in need of structural repair is the rear left addition and there are two supports needed for the historic portion of the home. The report provides recommendations for these two supports that would be relatively easy to accomplish without replacing the entire foundation and the use of temporary foundation supports, as described in the Adler estimate. In addition, if the applicant did not wish to make the repairs necessary to stabilize the rear addition, the design guidelines would allow for its removal.

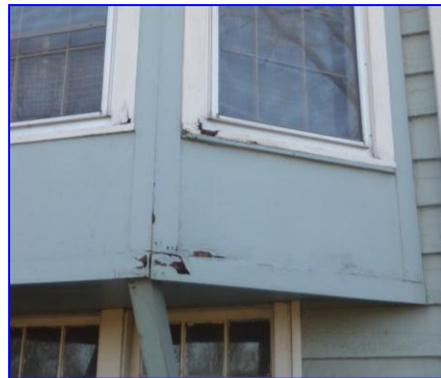
Mr. Smith notes that some siding and windows needs to be replaced. The example photographs submitted by Mr. Smith all show the rear addition and the enclosed side porch. In staff's inspection, these are also the only areas where staff found that siding and windows appeared to need replacement. These issues and the water damaged caused by the decayed siding and windows can easily be remedied with the removal of the rear addition and the enclosure portions of the side porch. They are not structural issues that render the home inhabitable.

Image 5: Window and siding decay

The estimate for window replacement seems to be for all windows; however, only the windows of the rear addition appear to require replacement. The damage to the side porch windows and siding could be corrected with removal of these items at a minimal cost and allowing the side porch to be a porch again. The windows and enclosure of the side porch, do not affect the structural integrity of the building.

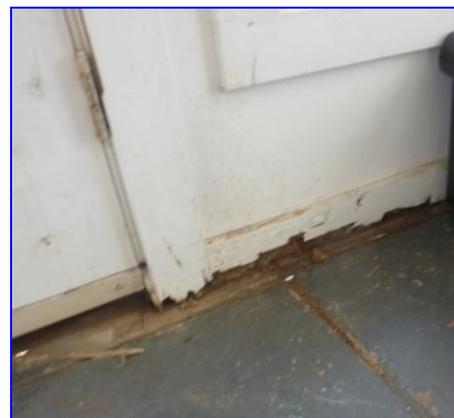
The enclosure of the side-porch is greatly decayed but the engineer's report states that the foundation of the porch appears to be "performing acceptably." The design guidelines would allow for the removal of the non-historic enclosure, removing the decay issues with the side porch.

Image 6: Example of decay in the enclosed porch.

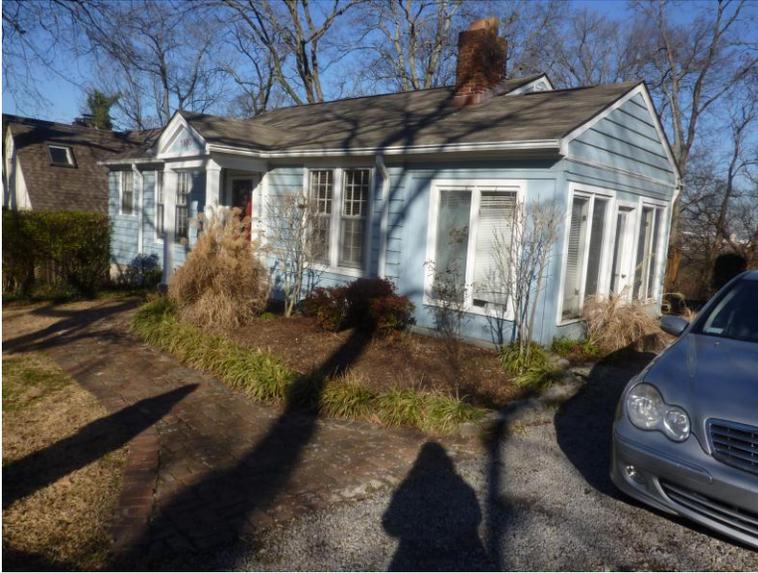
Side Porch

To the right is an original side porch that was enclosed with inferior materials that are now decayed. The guidelines would allow for the removal of the enclosure and the restoration of the original porch or a new enclosure.

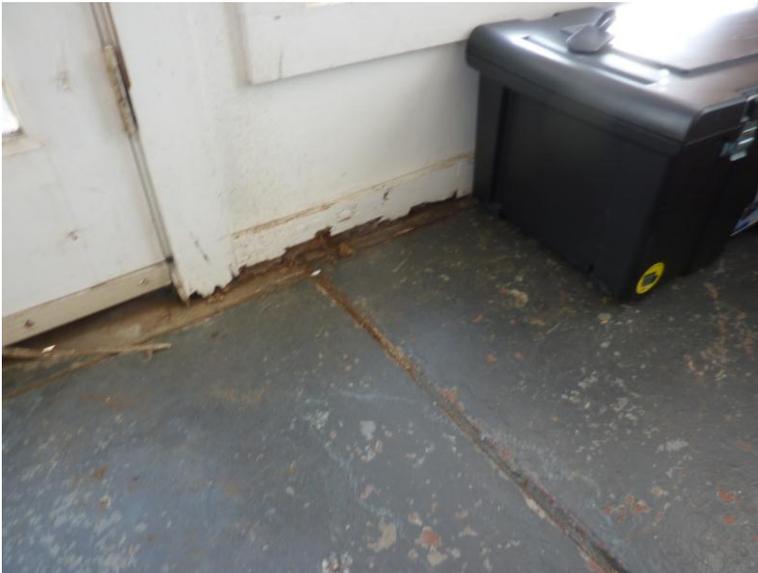
This photograph is the interior of the outside wall of the enclosure.

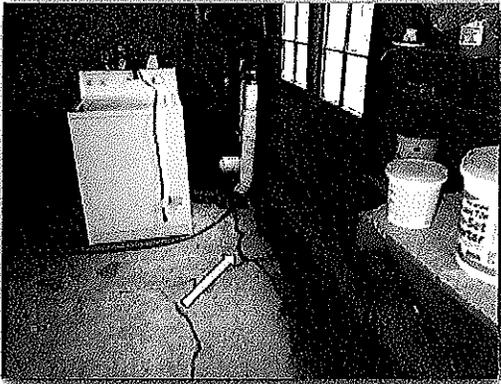
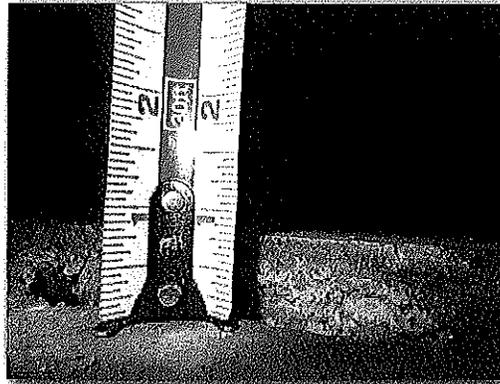
The back-left bedroom addition is built over a concrete slab which does not have a turned-down edge or perimeter footing. As a result, differential settlement has occurred. This settlement is most pronounced along the left side, lower left photo, where the slab has rotated downward under the left wall. This settlement has rotated the right edge of the slab, at a crack, upward approximately 7/8ths of an inch, lower right photo and arrow in lower left photo.

The foundation for this addition needs to be re-built. A suitable concrete perimeter footing at least 12 inches below grade, at least 18 inches wide and 12 inches thick with two #4 rebar, needs to be provided. The foundation wall needs to be built on top of the footing in a permanent manner such that the ground will be at least six (6) inches below any wooden wall framing.

This project will be quite expensive considering that if the current addition is kept intact, it will need to be temporarily supported during the re-construction project.

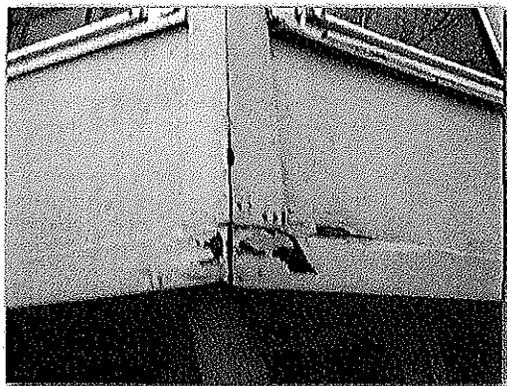
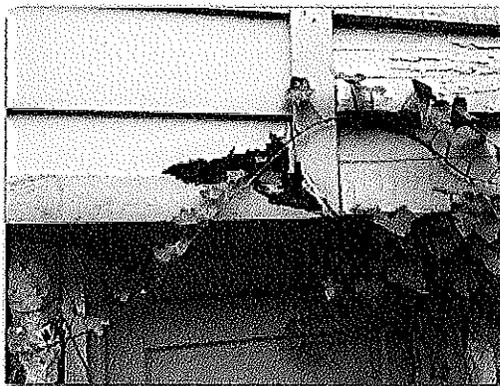
The exterior siding of this building consists of wood siding which has been painted. There are several areas around the house where deferred maintenance has caused significant rot in the siding. Examples are shown in the following photos. The rotted siding needs to be removed so that the extent of the damage can be determined and all rotted framing also replaced.

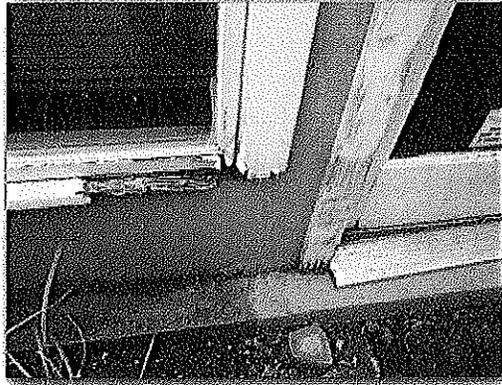
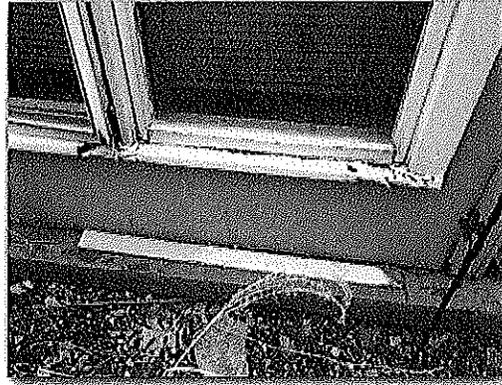
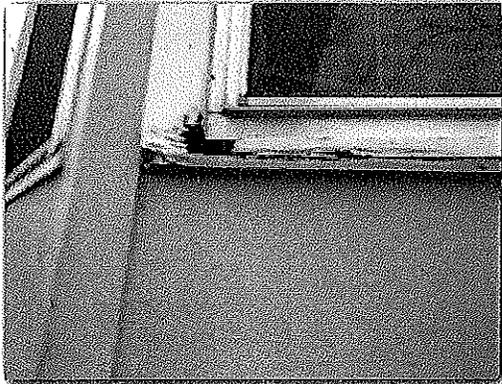
Many of the wooden windows also have significantly rotted trim. Examples are shown in the following photos. These windows are rotted to the point that water is entering the structure and most likely wood framing rot has occurred. Not only do the windows need to be replaced, but wall framing rot will need to be repaired.
