**STAFF RECOMMENDATION**  
**1209 Forrest Avenue**  
**December 16, 2015**

**Application:** Demolition

**Description of Project:** The applicant requests demolition of the structure due to fire damage suffered in March 2015.

RE: **Jamie Lawrence**  
1209 Forrest Avenue  
Nashville, Tennessee 37206  
**Claim Number: 031675552**  
Donan Project Number: 07-15050359-0

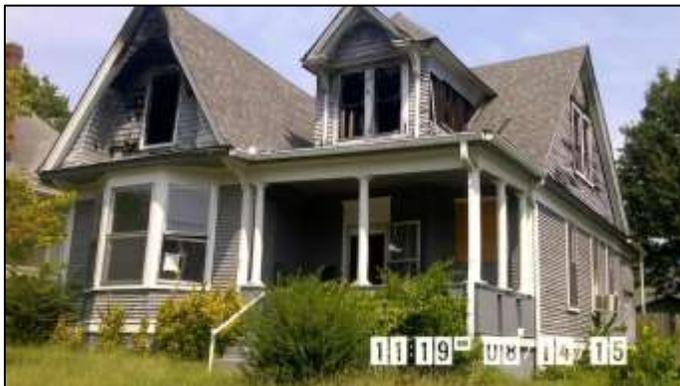
Figure 1. Fire damage at 1209 Forrest Avenue

**Analysis and Findings:** In March 2015 the house suffered a fire which destroyed the second floor and damaged the first floor.

The structural integrity of the house is significantly compromised by the fire and preexisting conditions. The fire destroyed the roof, second story and the top of one first-story non-load bearing wall, according to the engineer's report. The first floor was damaged by water and smoke. In addition, the engineer's reports and the restoration company note the following significant preexisting deficiencies in the building's integrity, beyond the fire damage:

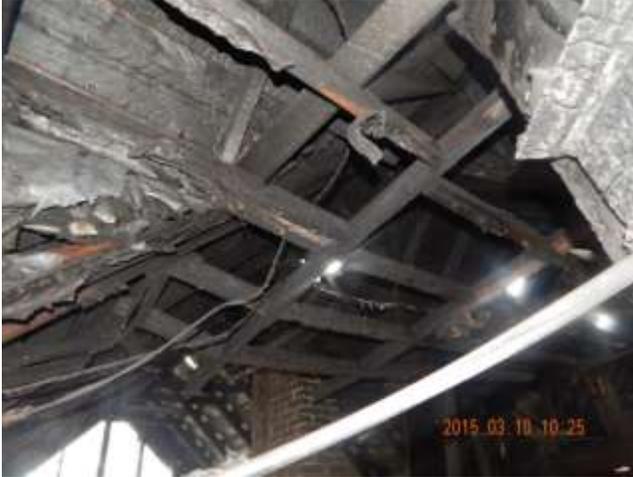
Figure 2. Fire-damaged ceiling joists

The entire roof structure is burnt and should be replaced. The only visible fire-related damage to other structural members is several charred ceiling joists over the two southernmost rooms along the west side of the house and the top of the partition wall dividing these two rooms. An estimated three to five charred joists should be replaced. The partition wall dividing the two rooms should also be reframed; this should not require temporary walls because the joists run parallel with the wall and the roof structure will be removed. Replacing the charred members described above and supplementing the timber posts that bear directly onto soil will make the house sound and in better condition than it was pre-fire.

- Replacing the roof structure, up to five ceiling joists over the two southernmost rooms along the west side of the house, and the partition wall dividing these two rooms will restore the structural integrity of the house to a sound and better-than-before condition. New roof framing should conform to current building code standards.
- It is recommended to supplement timber piles that are in direct contact with the soil. At which time, one should consider jacking portions of the girder to help straighten the floor structure.

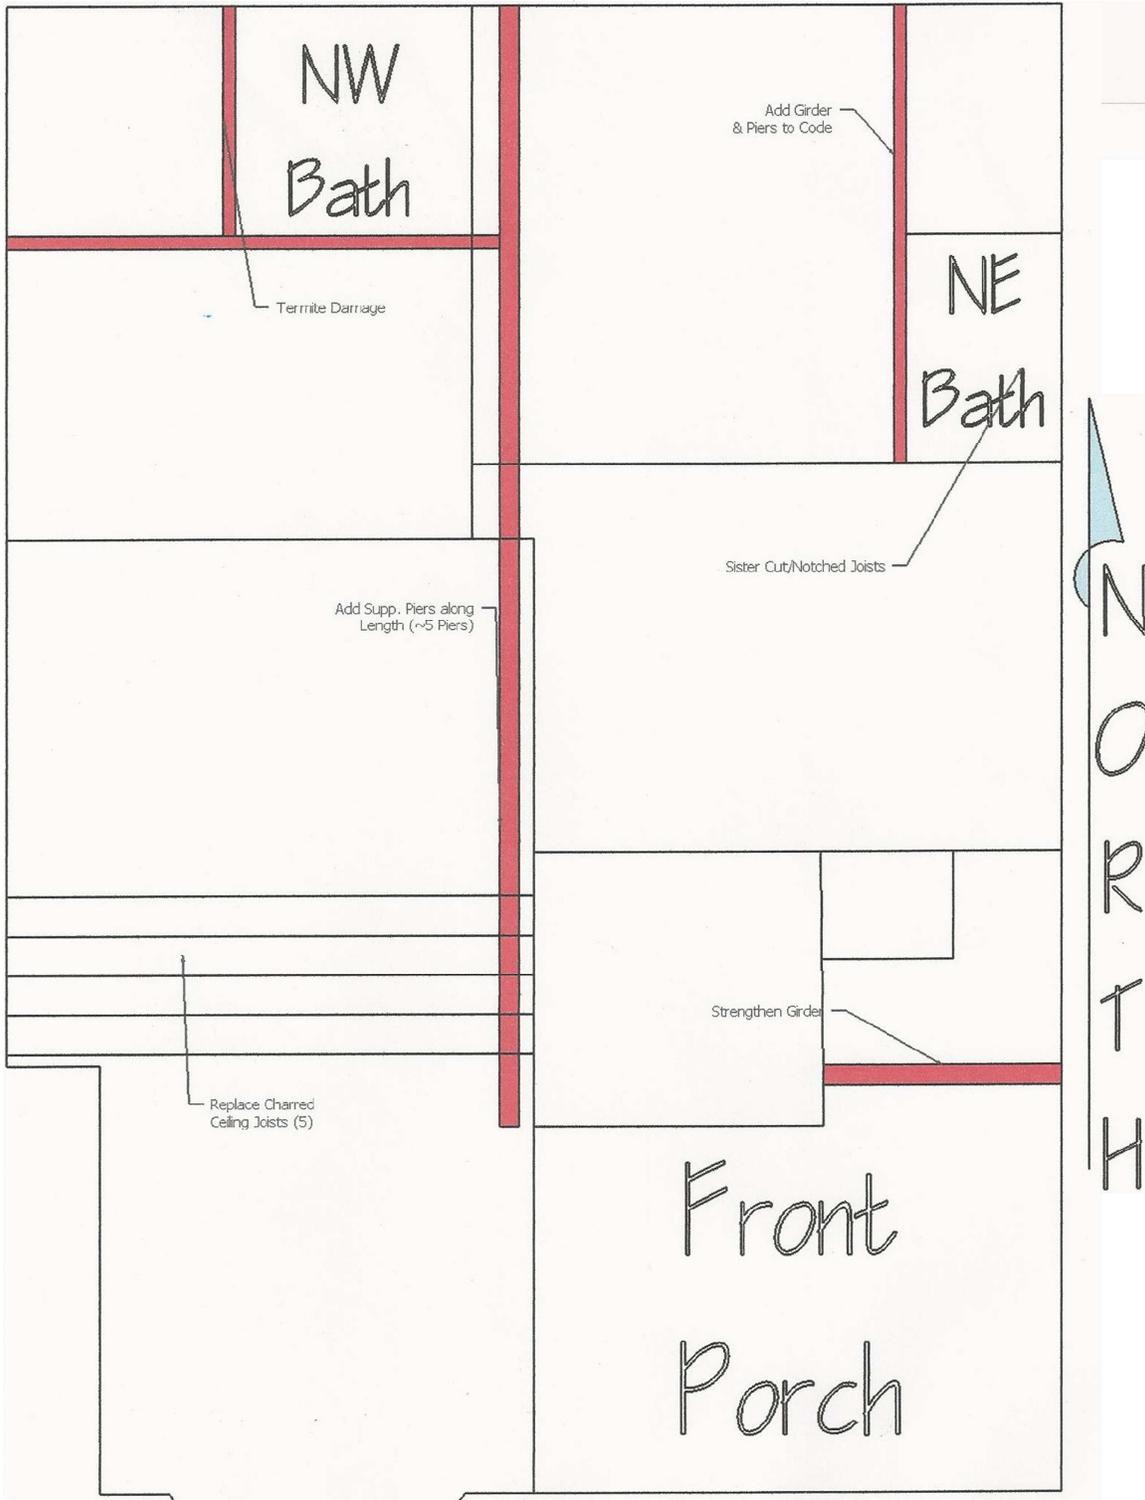
**Appendix A: Sketch of Recommended Non-Fire-Related Repairs**

The existing pier supports for the center girder are in sound condition, but they are well overspanned according to typical design prescriptions. The overspanned girder has sagged (creeped) over time due to improper support. It is recommended to add supplemental piers between each of the existing piers to reduce the girder's span under code limits. This will require five additional piers along the center girder. At the time these piers are installed, it would be prudent to jack and shim the existing girders to recover some of the long-term creep of the girder to make the interior floors more level. The subfloor should be removed from the two small rooms on either side of the termite damage in the wall cavity at the northwest bathroom, at which time all termite-related damage should be replaced. The floor sags along the north/south partition wall at northeast bathroom; a supplemental girder should be installed to code standards under this wall, in addition to sistering any of the cut/notched joists. The girder between the front porch and the south exterior wall is a single 2x10 member that should be sistered with another 2x10 for additional strength. The following Appendix A is a sketch of the house footprint and areas requiring non-fire-related repair to restore the integrity of the structure to a safe and better-than-before condition.

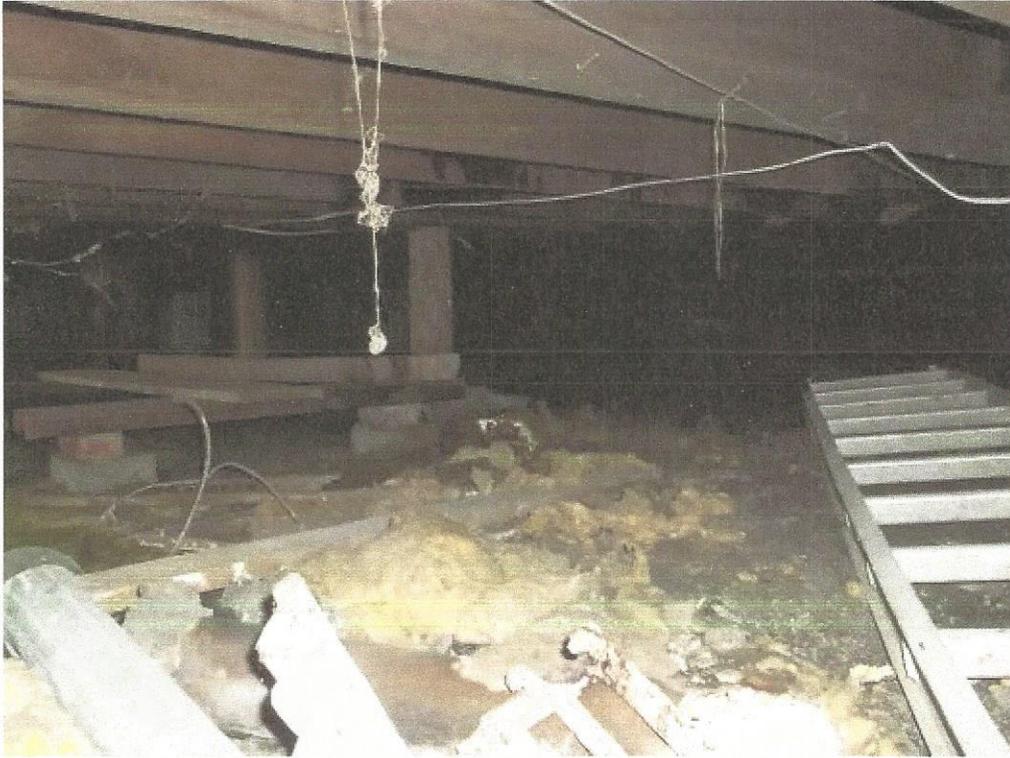
**DSCF3647**

Crawl Space

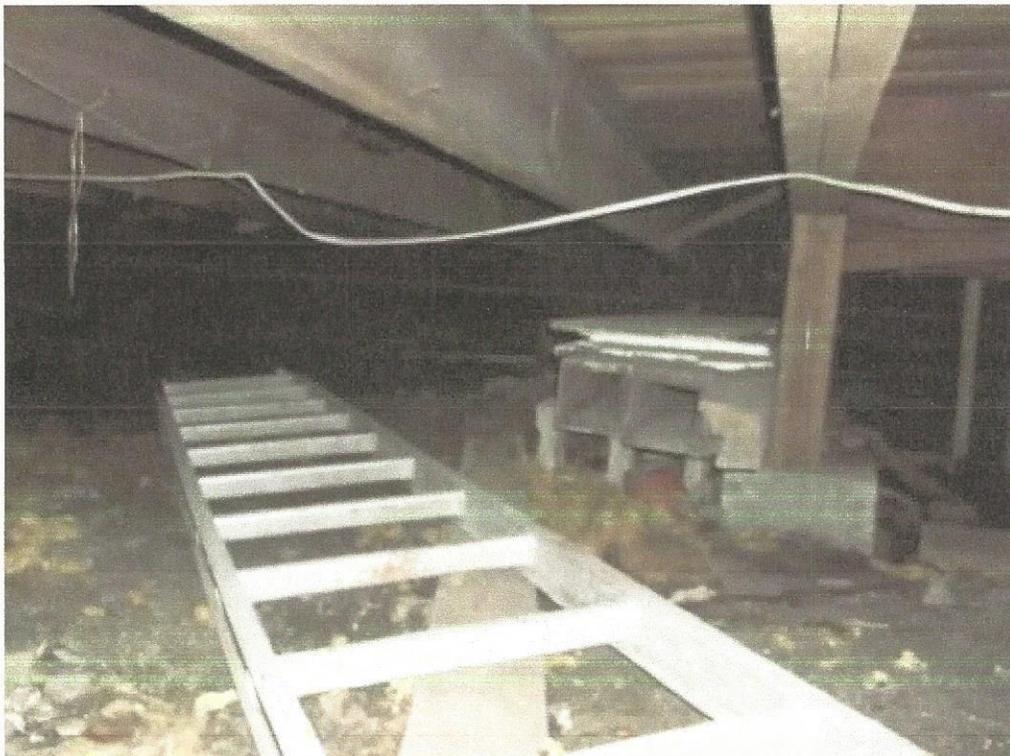
**DSCF3648**

Crawl Space

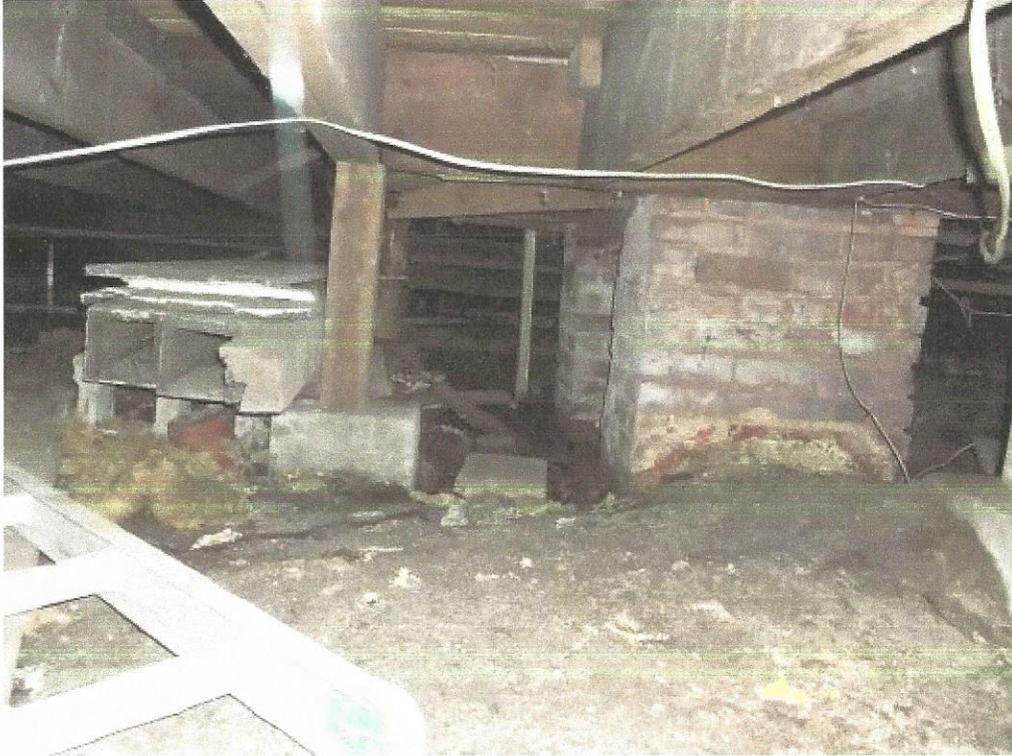
**DSCF3649**

Crawl Space

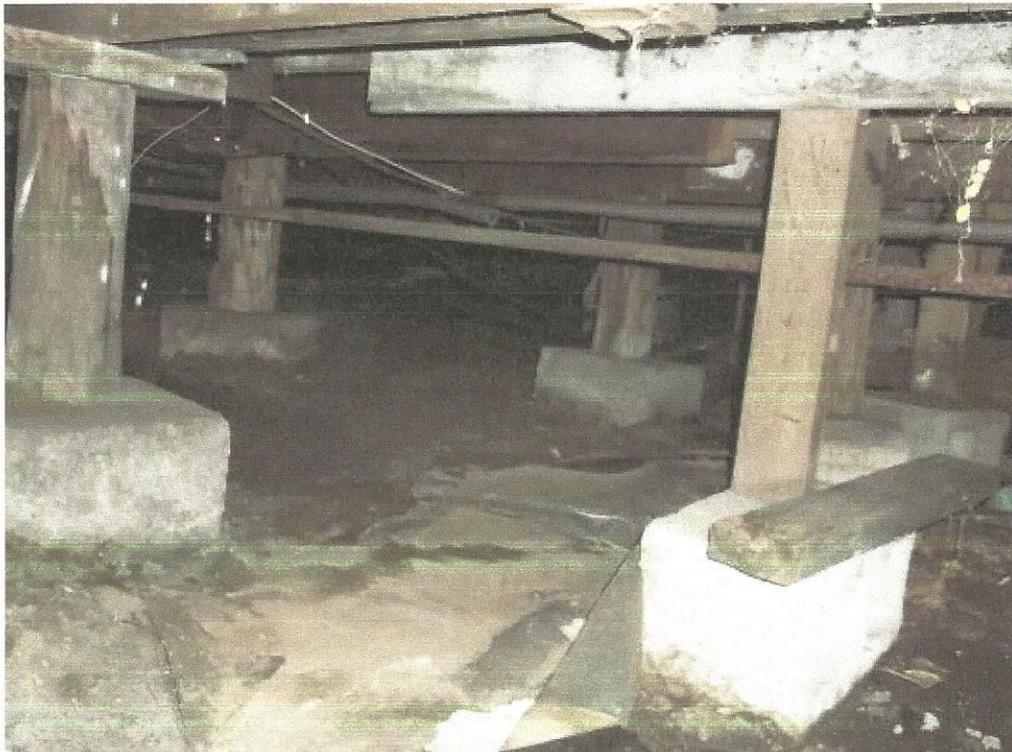
**DSCF3650**

Crawl Space

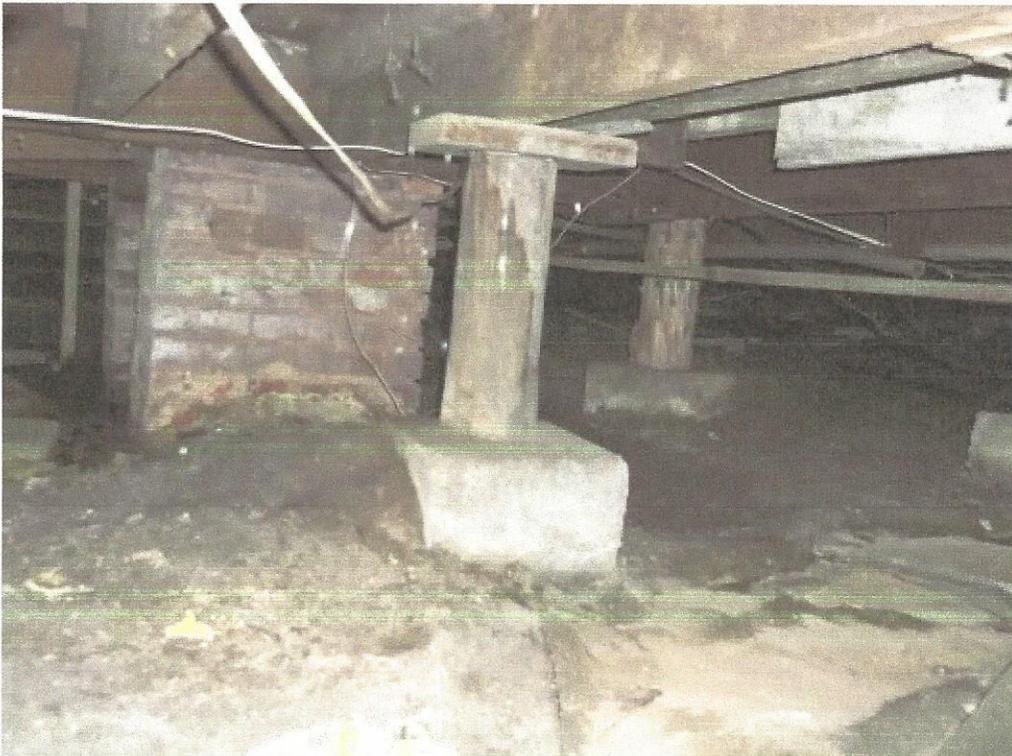
**DSCF3646**

Crawl Space
