STAFF RECOMMENDATION 1107 Boscobel Street August 17, 2016

Application: Demolition
District: Lockeland Springs-East End Neighborhood Conservation Zoning Overlay
Council District: 06
Map and Parcel Number: 083130171.00
Applicant: Chris Seay
Project Lead: Paul Hoffman, paul.hoffman@nashville.gov

**RE: 1107 Boscobel Street / Nashville, Tennessee
EMC Project No. 16674**

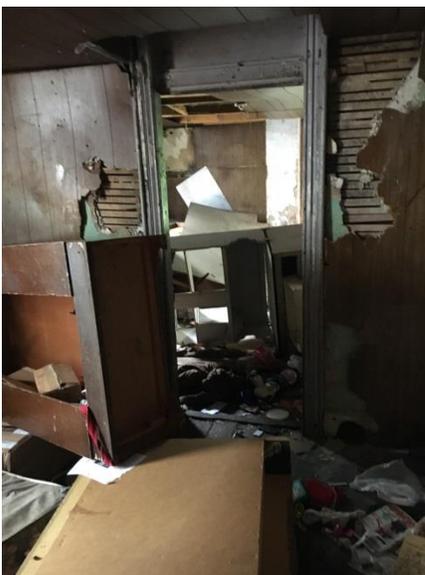
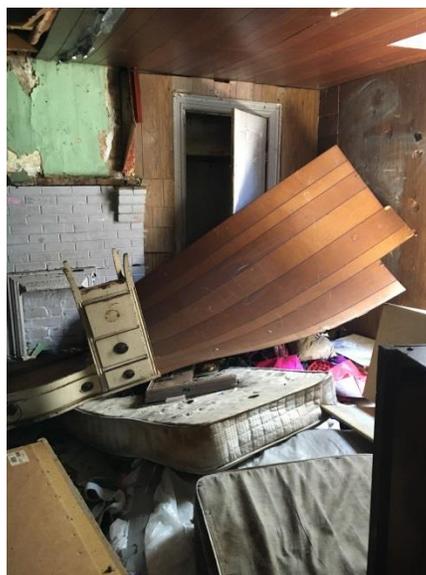
Images 1 and 2 are examples of the condition of the house at the time of inspection.

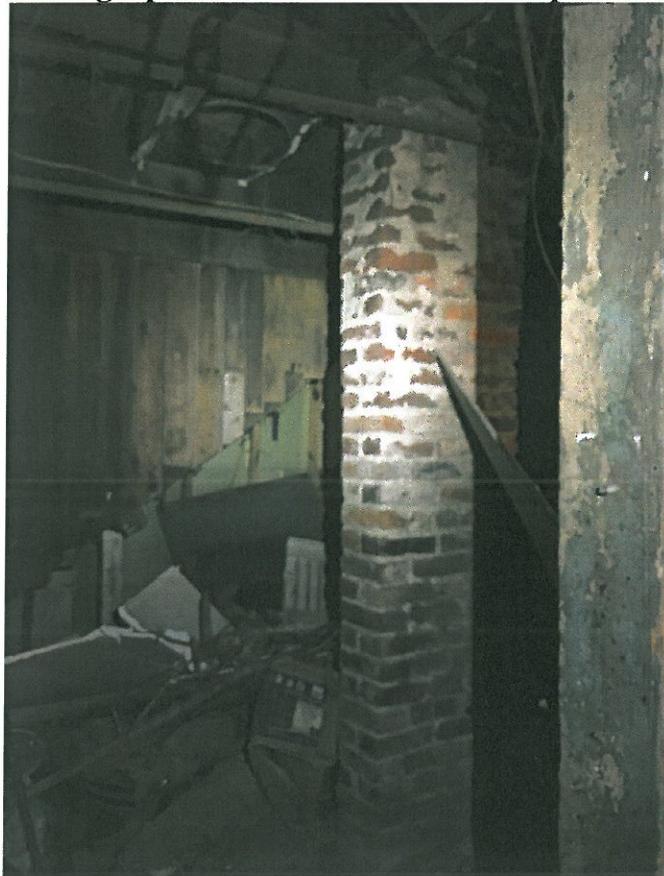
Across the north wall of the basement/crawlspace there is a full-height 8" thick brick wall. This wall turns south for approximately 10' at each end (photograph 4).

Photograph 4: Foundation wall at north elevation.

The house frame should be jacked-up off the existing foundation, the brick piers and damaged and deteriorated basement walls removed, and a new perimeter foundation wall added. The perimeter foundation should consist of 8" split-face concrete masonry units reinforced with #5s at 48" centers, or brick veneer on standard 8" concrete masonry units reinforced with #5s at 48" centers. The continuous footing should be 12" x 24" in cross-section with two #5s top and bottom. Footing bottom should bear on undisturbed earth and be a minimum of 24" below finished grade.

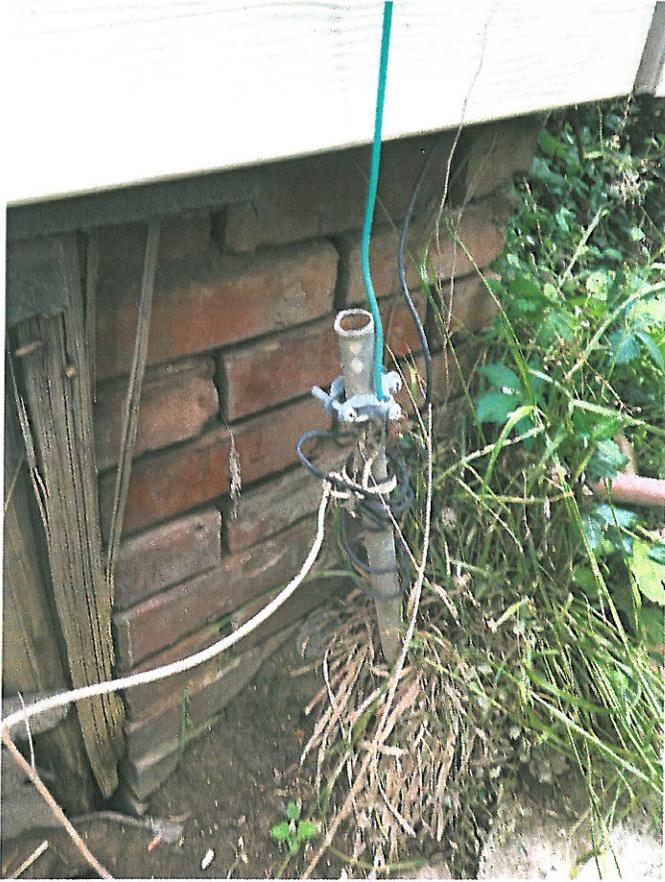
At the northeast corner of the basement area, the brick has been reworked with a cement mortar. There is cracking indicative of settlement at the bottom and top of the foundation walls at this corner (photographs 7 and 8).

Photograph 7: Settlement and patched brick at northeast corner.

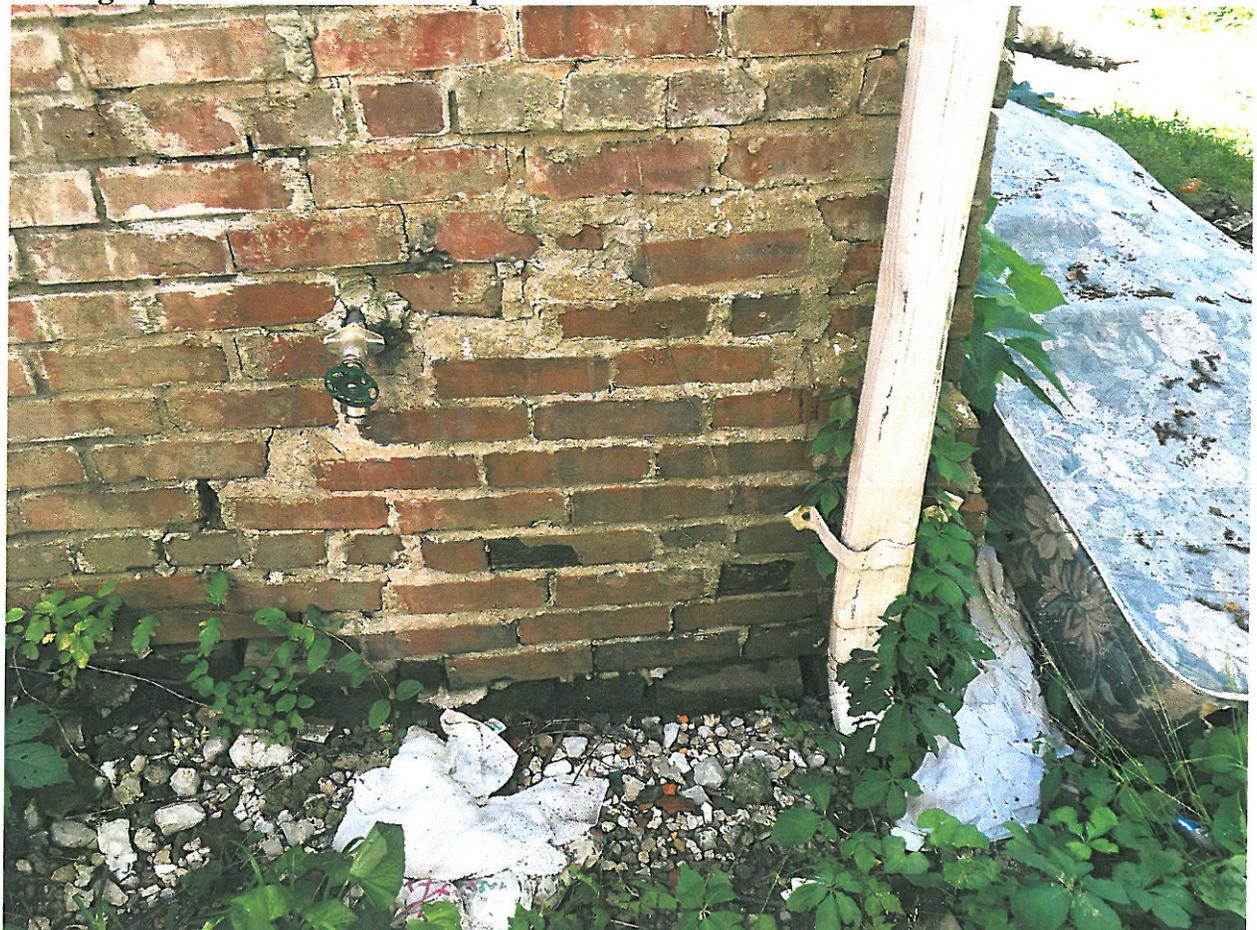
Photograph 8: Settlement and damaged brick at northeast corner.

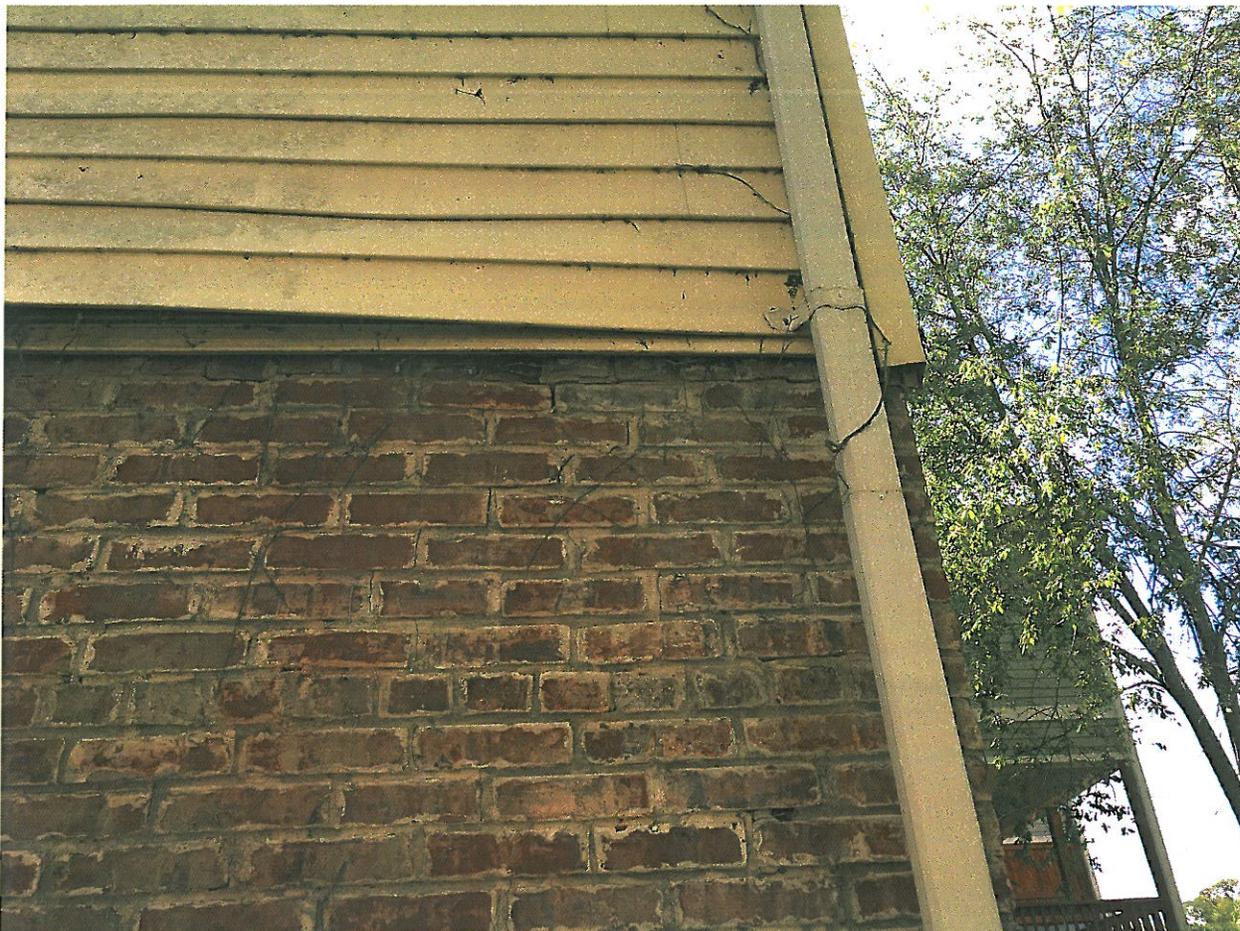
A section of the foundation was excavated near the northeast corner. The brick foundation wall was bearing on clay soils about 18" below grade. There was no concrete footing under the wall. This is typical for houses of this vintage (photograph 9). At this location, the wall had pushed outward 2" to 3" from the plane of the foundation walls (photograph 10).

Photograph 9: Bottom of foundation wall.

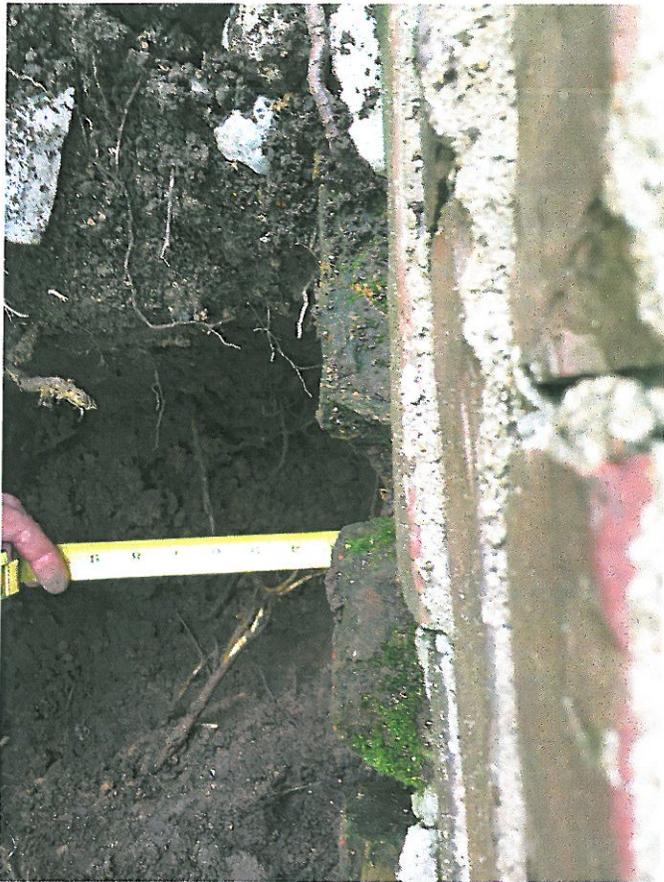
Under the bathroom, kitchen, and hallway, the floor joists show heavy water damage and decay. Some additional supports have been added in this area (photographs 11 and 12). In the hallway, the floor framing has failed and now slopes downward 2" to 3" from the west to the east (photograph 13).

Photograph 11: Damaged floor framing at kitchen/bath.

All floor framing, including girders, joists, and floorboards in the kitchen, bathroom, and hallway, should be removed and replaced. New floor construction should consist of 2x10 floor

joists at 16" centers supporting 3/4" T&G APA rated floor sheathing. New girders should be three 2x12s.

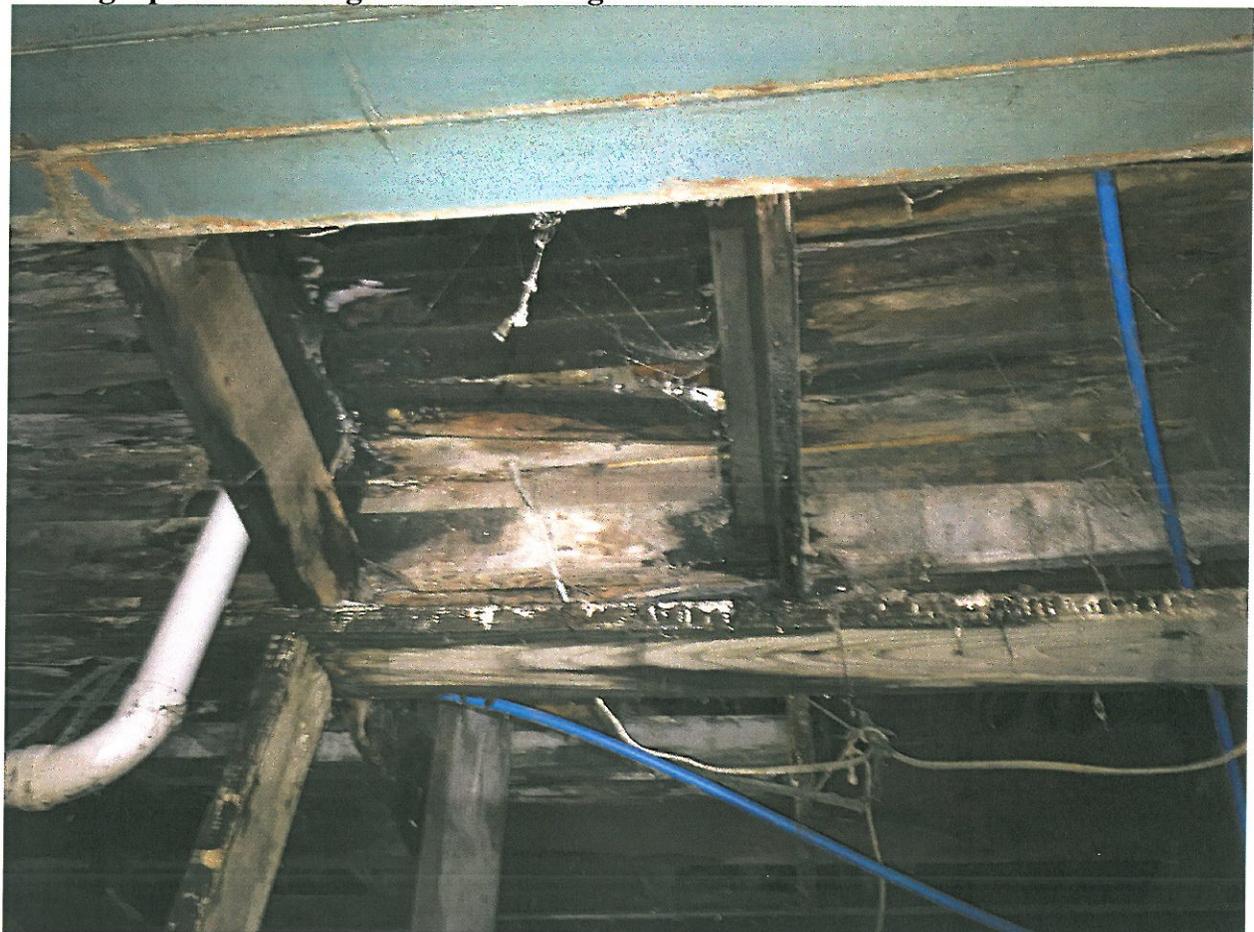
Photograph 12: Damaged floor framing at bath.

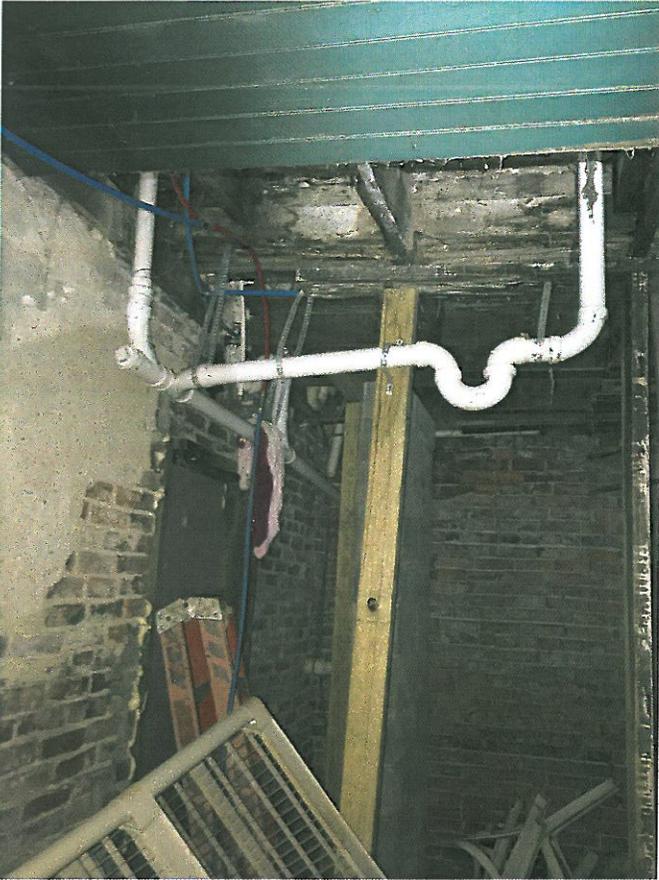
Photograph 13: Sloping failed floor framing under hallway.

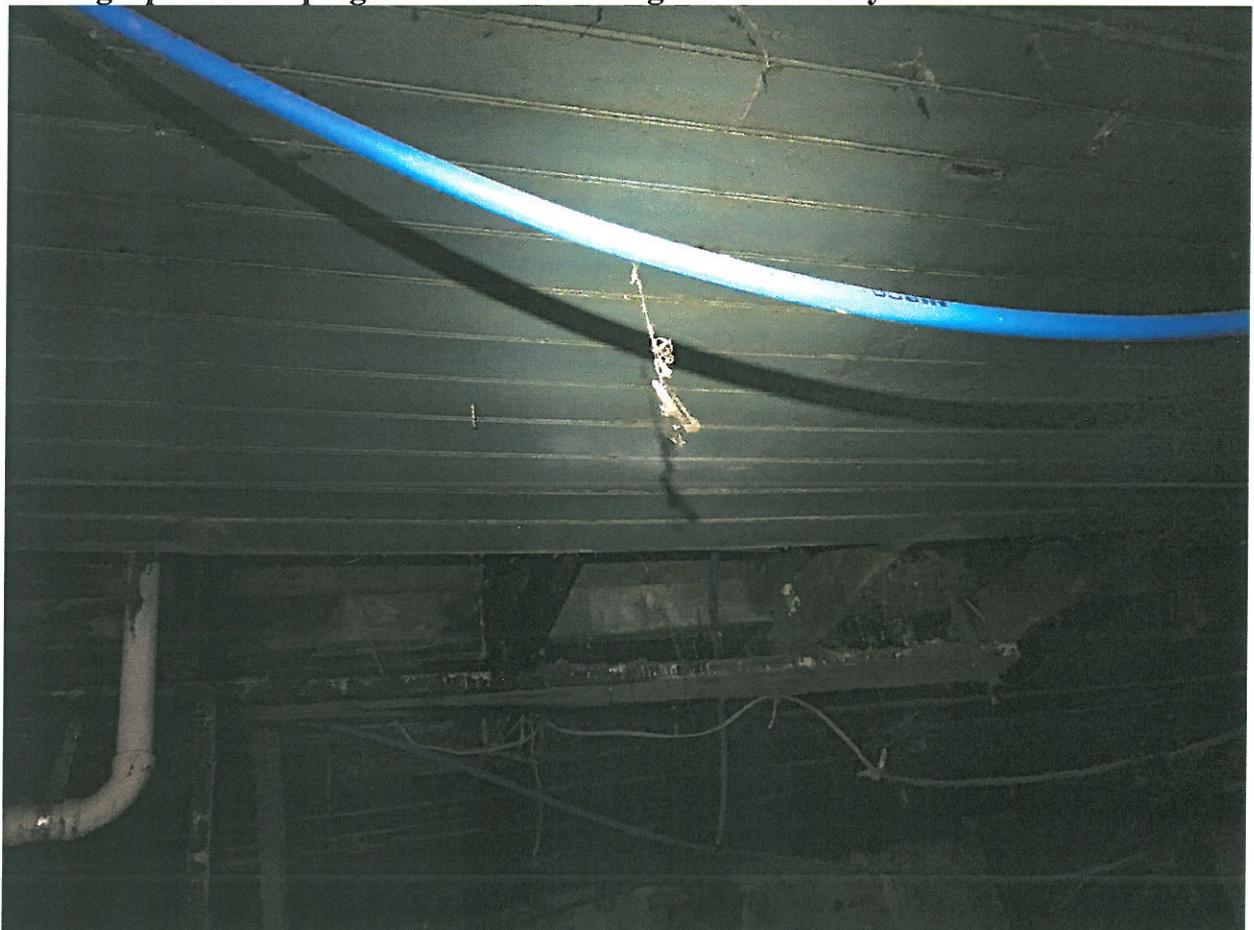
Where wood joists are supported on edge beams between piers, the beams are rotating and the floor joists are pulling away from the ledgers (photograph 14).

Photograph 14: Floor joists pulling away from perimeter beam.

All floor framing should be anchored to the foundation walls in accordance with Code sections.
