## STAFF RECOMMENDATION 1621 Forrest Avenue October 18, 2017

**Application:** Demolition  
**District:** Lockeland Springs-East End Neighborhood Conservation Zoning Overlay  
**Council District:** 06  
**Map and Parcel Number:** 08310016300  
**Applicant:** Todd Austin, owner  
**Project Lead:** paul.hoffman@nashville.gov

## Structural Evaluation of Residence

1621 Forrest Avenue Nashville, TN 37206

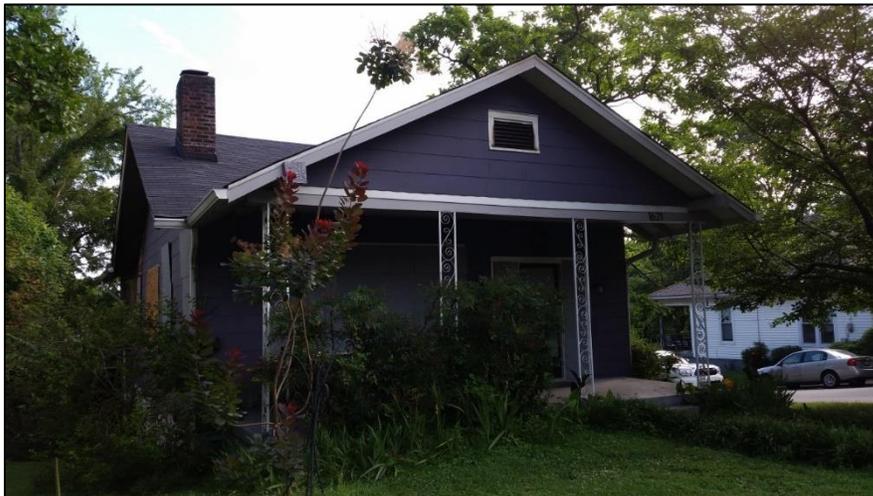
Figure 1. 1621 Forrest Avenue following fire

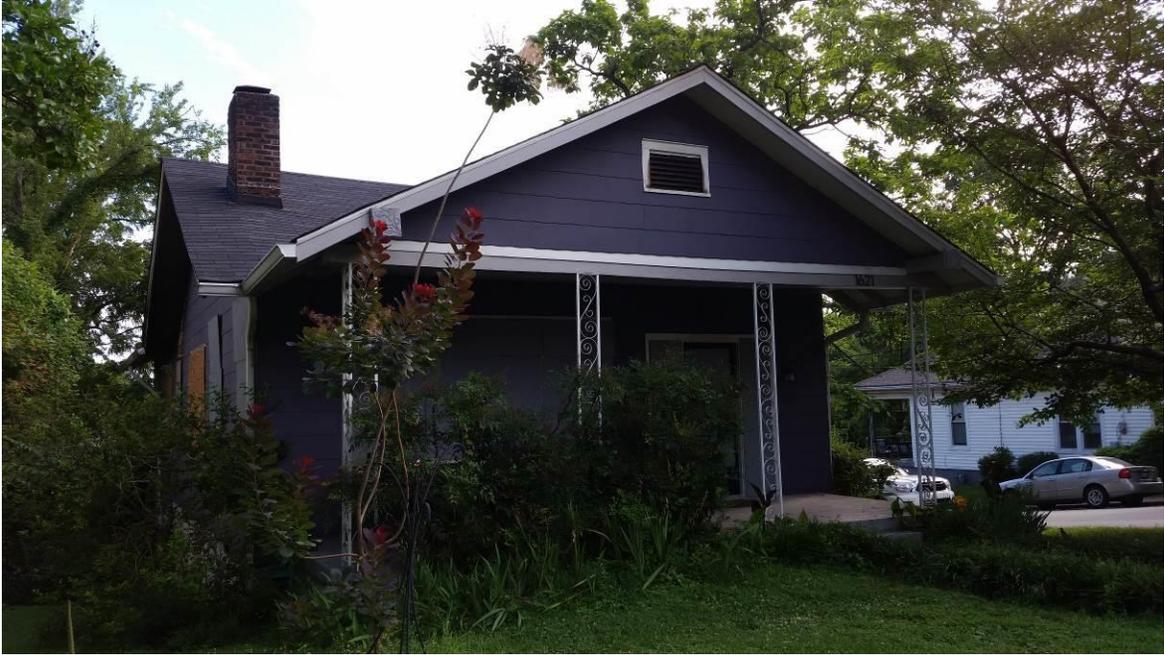
Front of the house after fire damage.

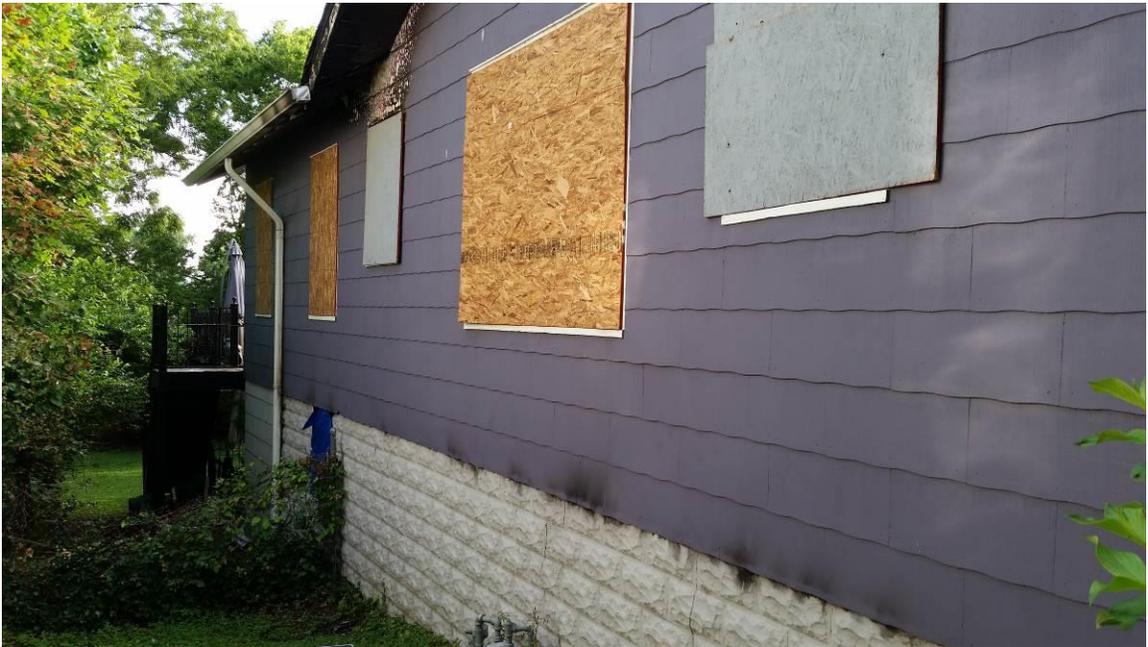
Left side of house after fire damage

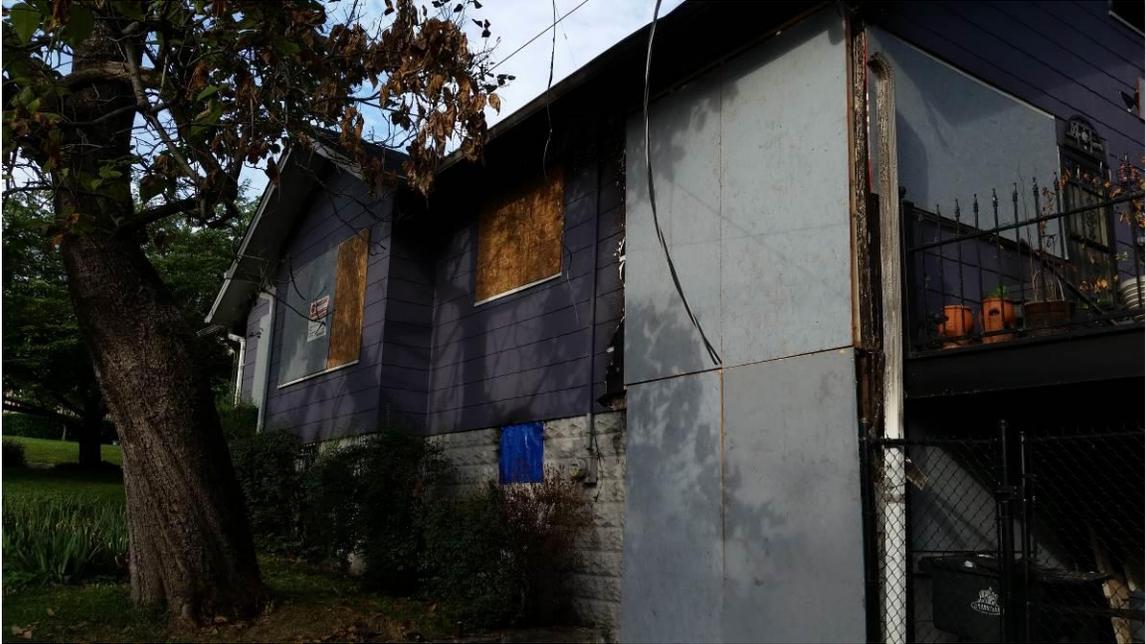
Right side, seen from the rear, after fire damage.

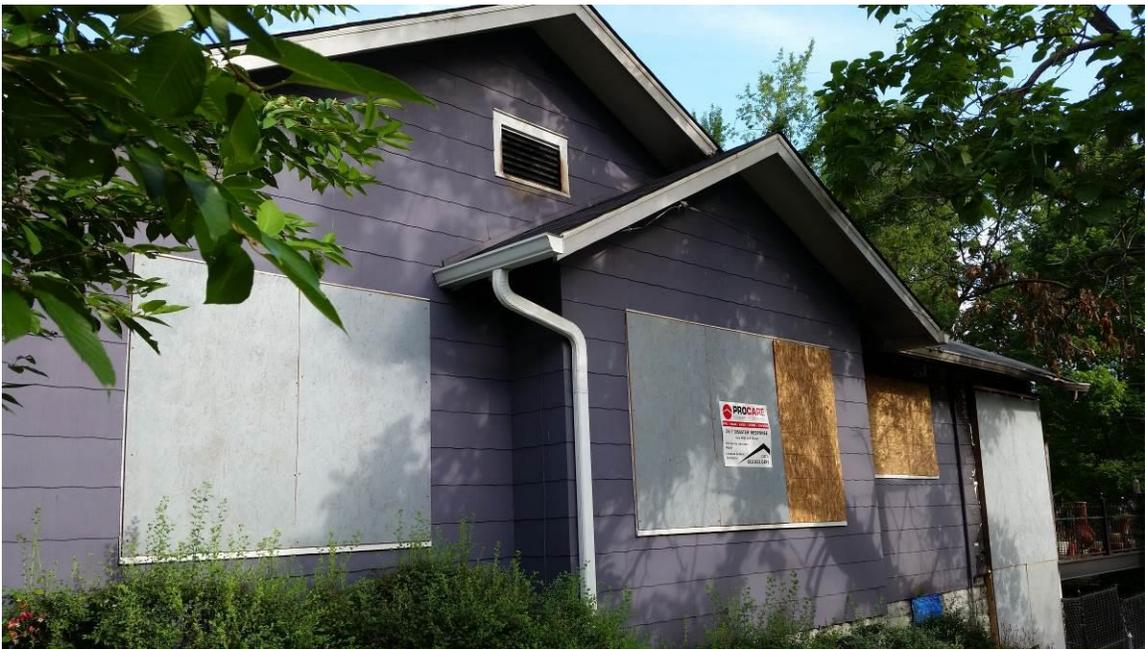
Right side of house seen after fire damage.

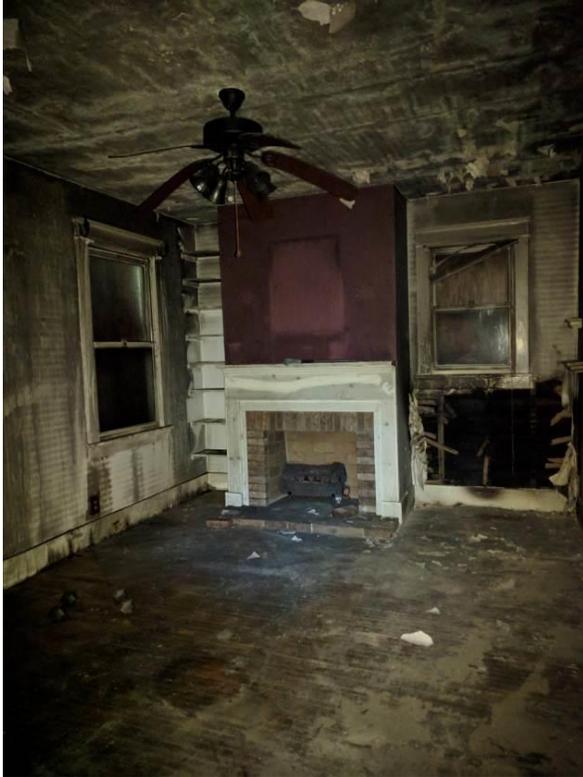
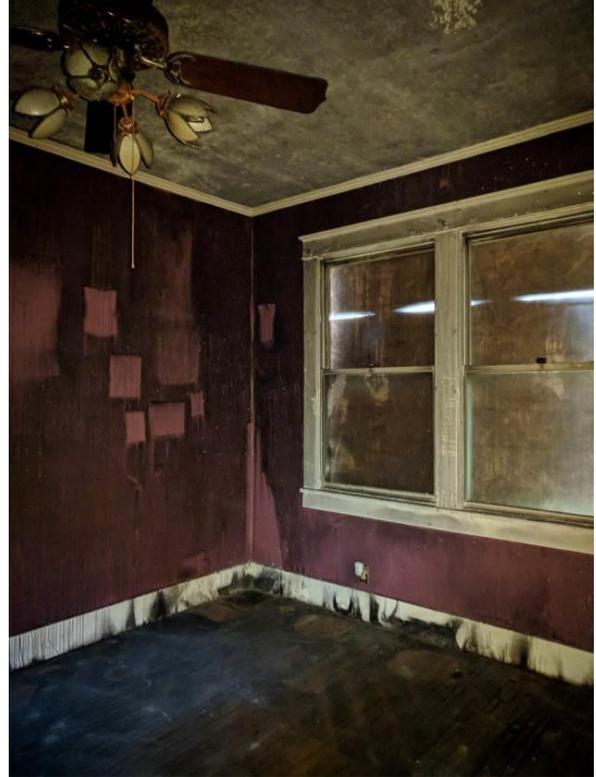
Front room (with chimney) and middle room of the house showing smoke damage but no evidence of fire or structural damage.

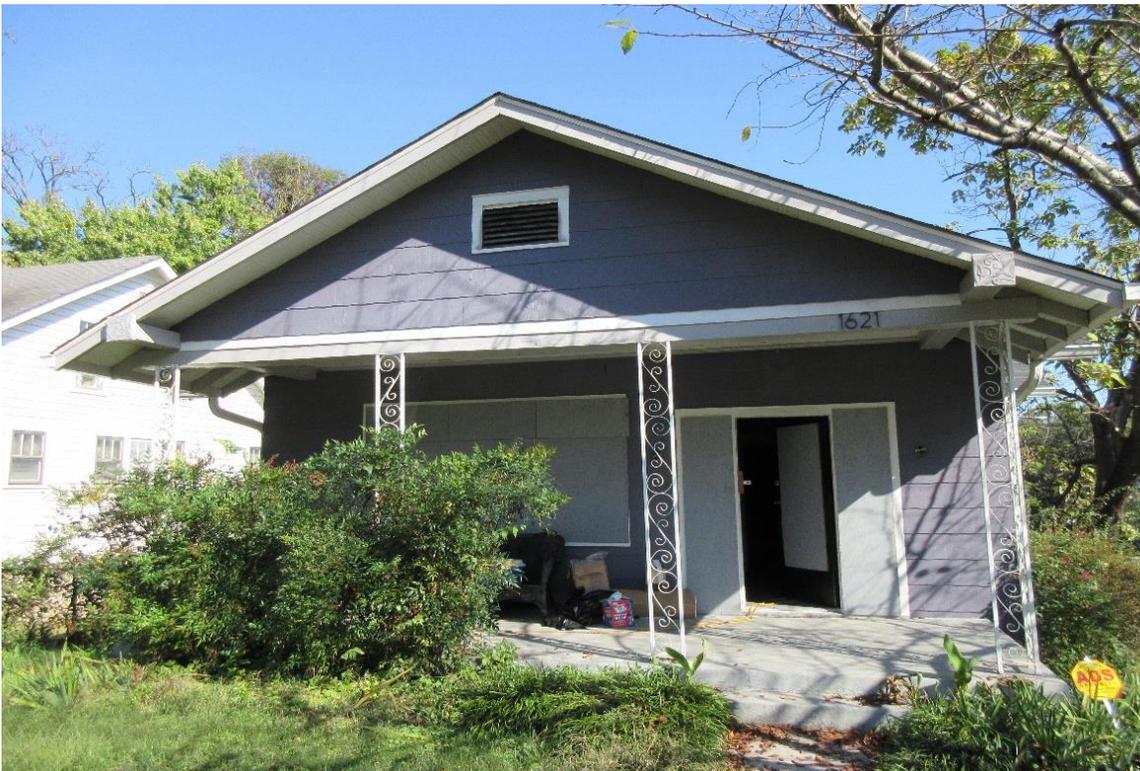
### Front Porch (1)

The front porch slab has not been affected by the fire and is in good condition and will be salvaged.

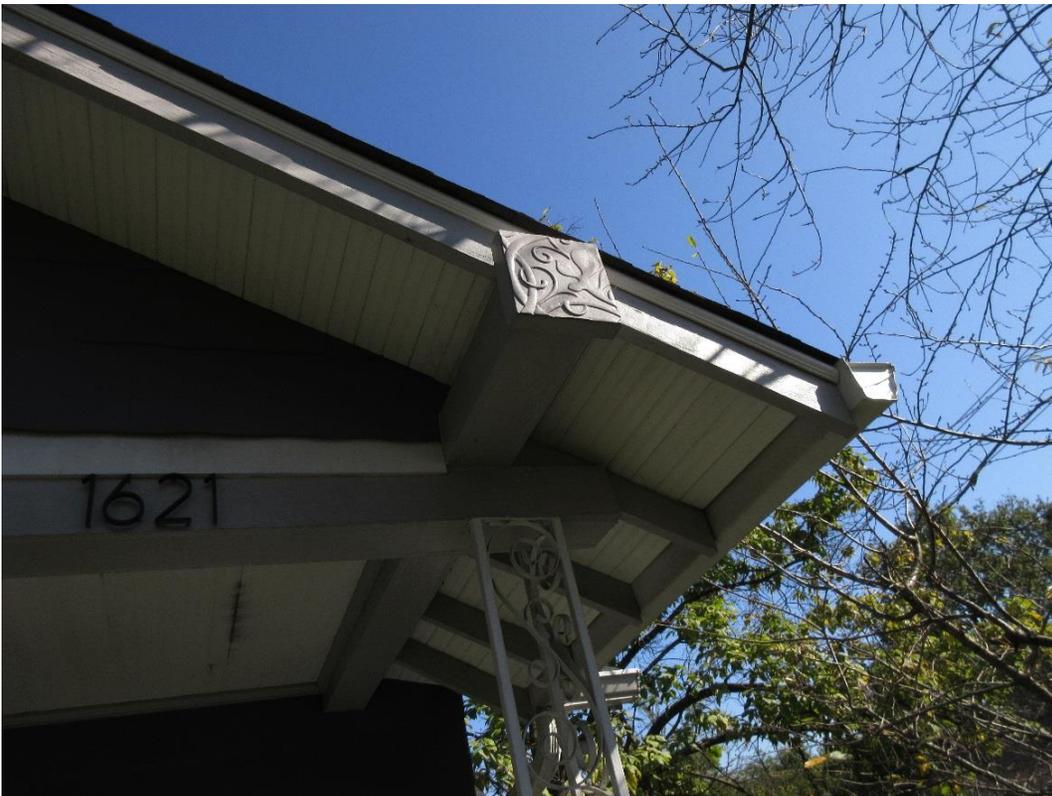
Front Porch (2)

The wrought iron on the front porch has not been affected by the fire and is in good condition and will be salvaged.

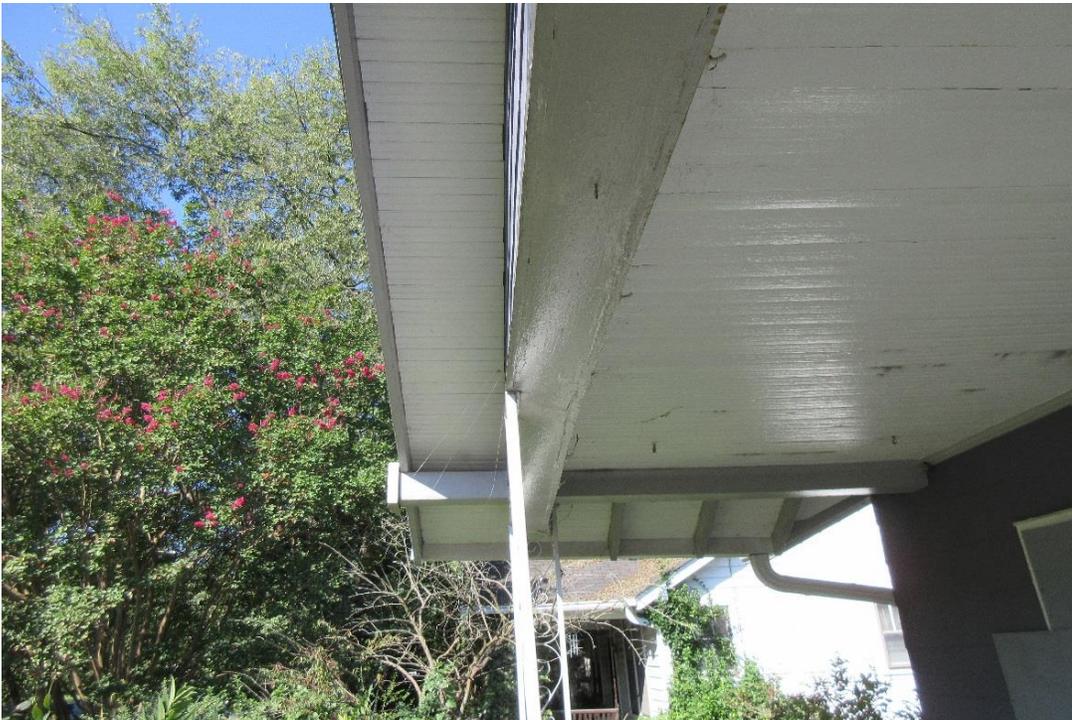
Front Porch (3)

In Part I, the "Front Porch" section, the engineer notes that the main beam has twisted and is in need of replacement. It is unclear if this is related to the fire, or is a result of time and/or deferred maintenance. Deferred maintenance is considered a "self-imposed" hardship and therefore not an expense to be calculated in economic hardship. In addition, at some point the presumably larger front porch posts were replaced with open metal columns. It may be that the beam could be salvaged if sturdier posts replaced the metal columns.

The main beam on the front porch has twisted outward and in need of replacement, see picture "Front Porch (3) & (5)"

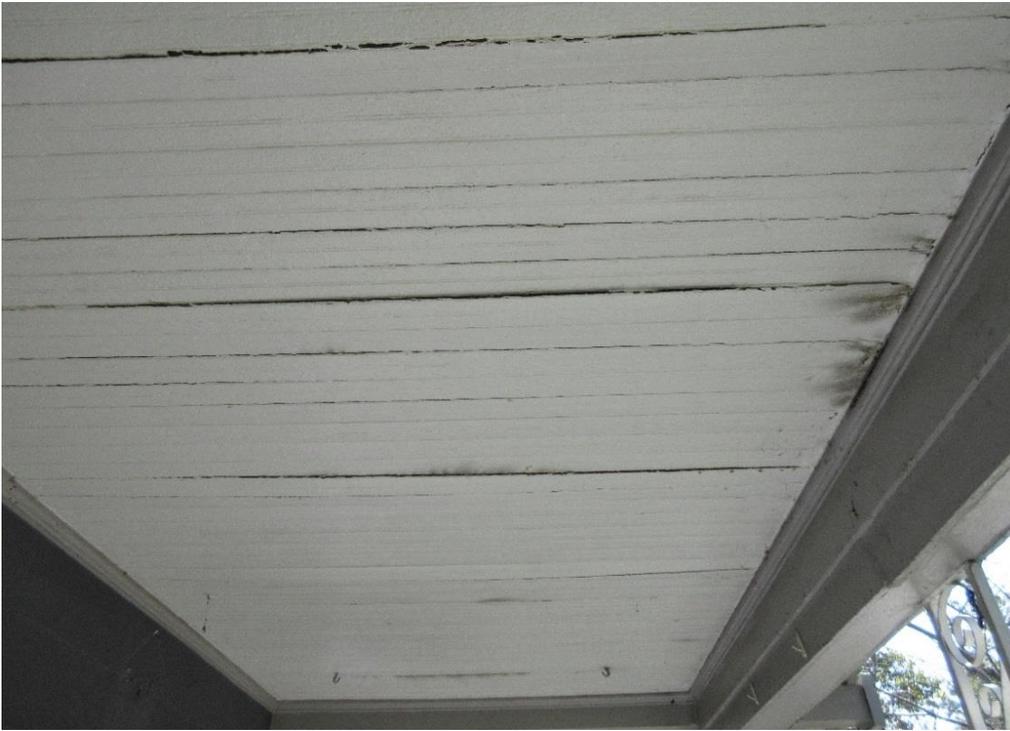
Front Porch (4)

The report notes that the original tongue-and-groove ceiling is in need of replacement but the review of the photograph and staff's review of the building indicate that repair is likely feasible.

The tongue and groove bead board ceiling has been compromised by the fire and water and in need of replacement, see picture "Front Porch 4"

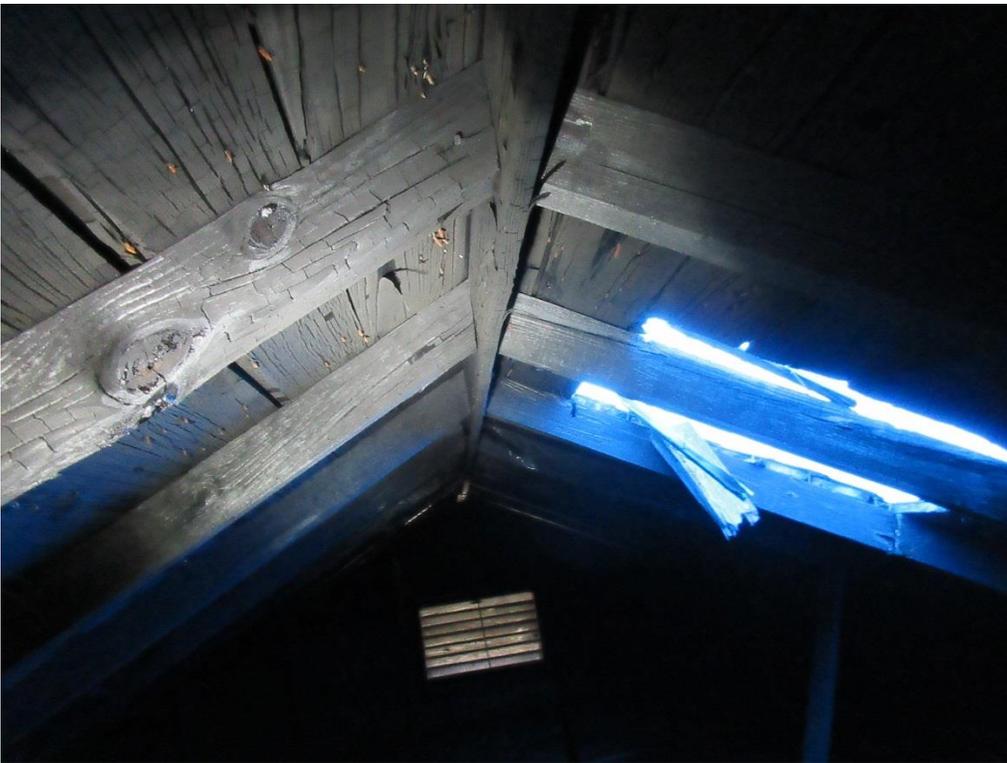
### Roof Framing - Front Section (2)

Framing of roof is not structurally sound and does not meet today's codes requirements. The rafters are made of 2" x 4" and are 24" on center.

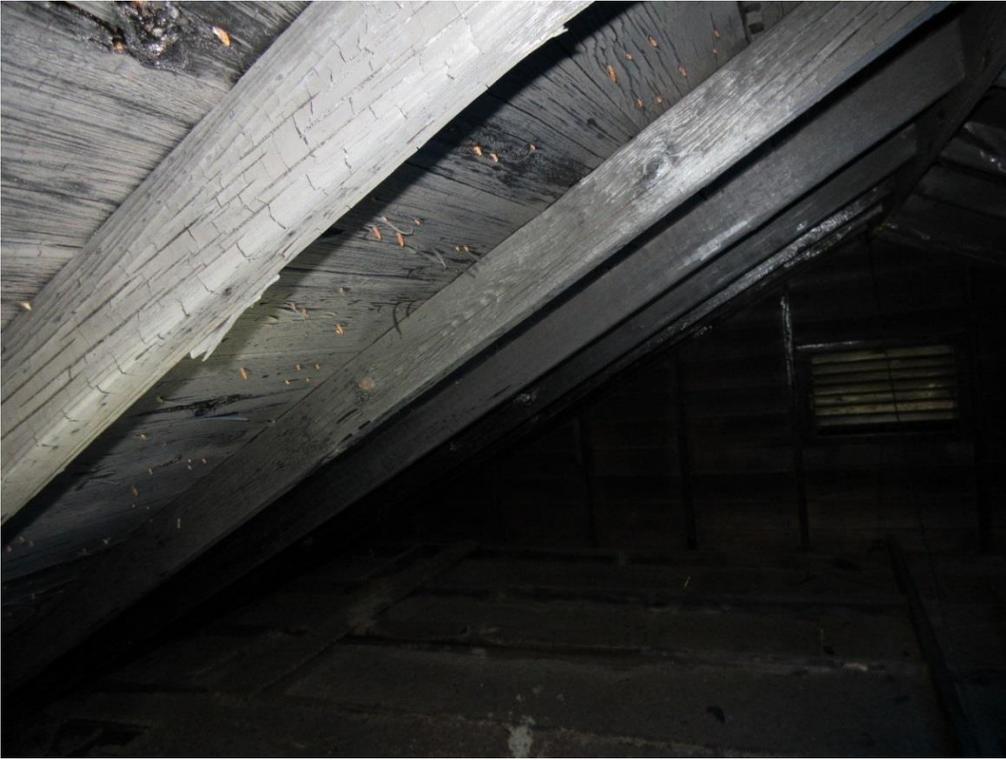
Roof Framing - Front Section (3)

The main ridges are heavily charred and undersized measuring 1" x 6"

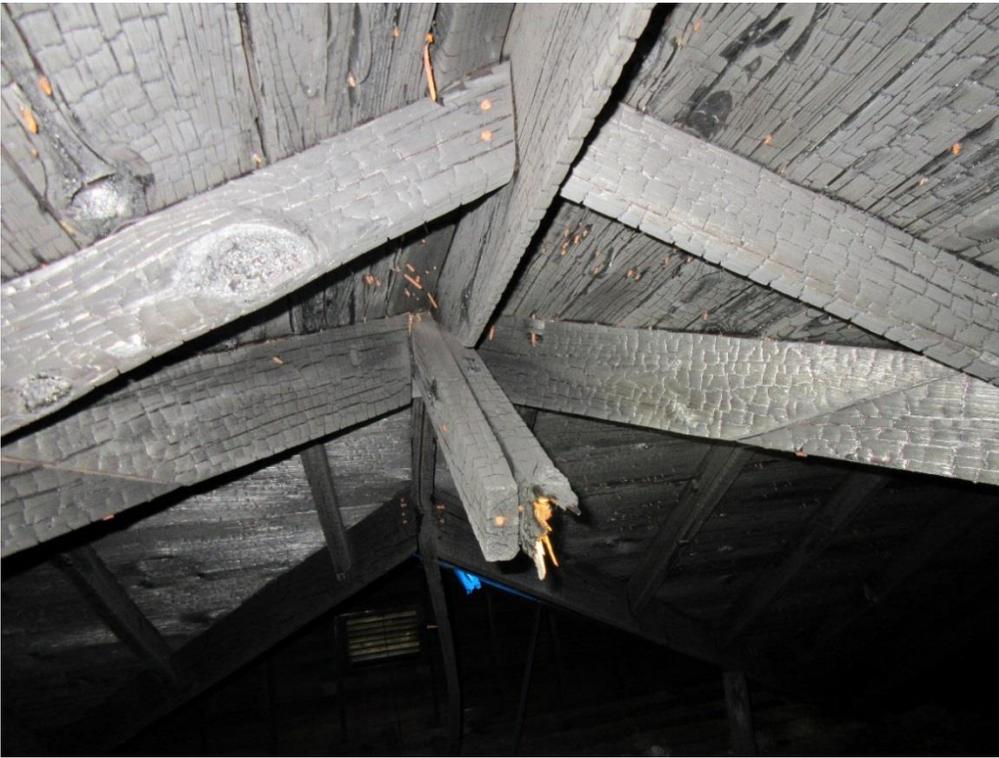
Roof Framing - Middle Section (1)

The rafters are undersized and the span of the rafters is greater than the sized lumber is required.

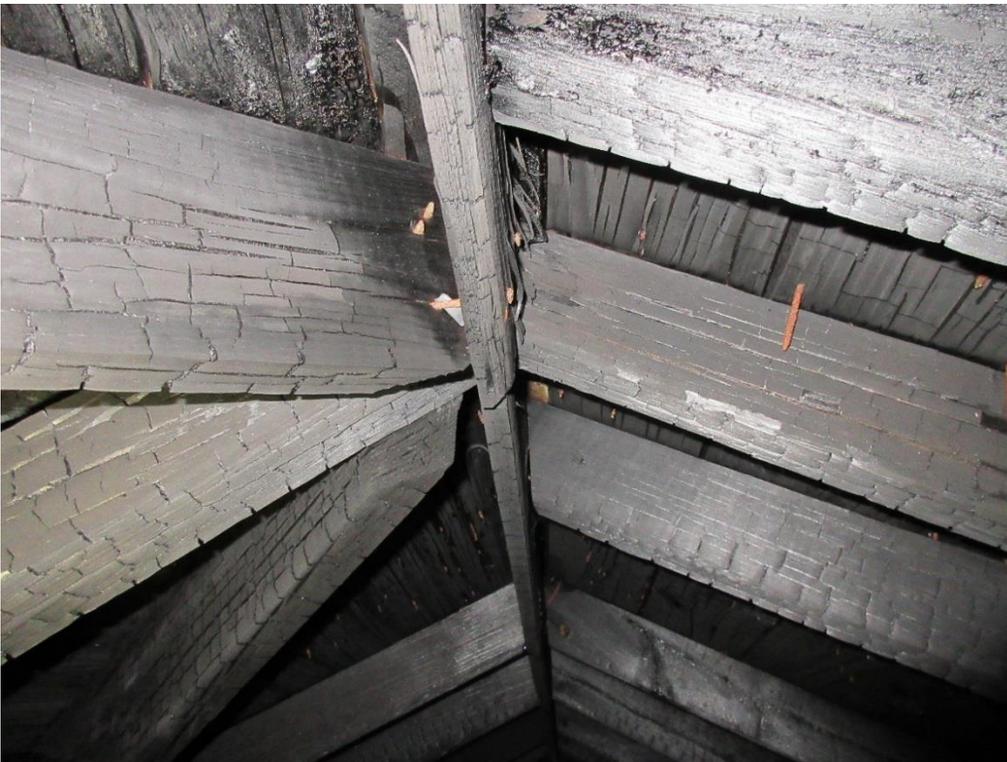
Roof Framing - Middle Section (2)

The front, middle and rear sections of the roof have significant fire / charred and smoke damage.

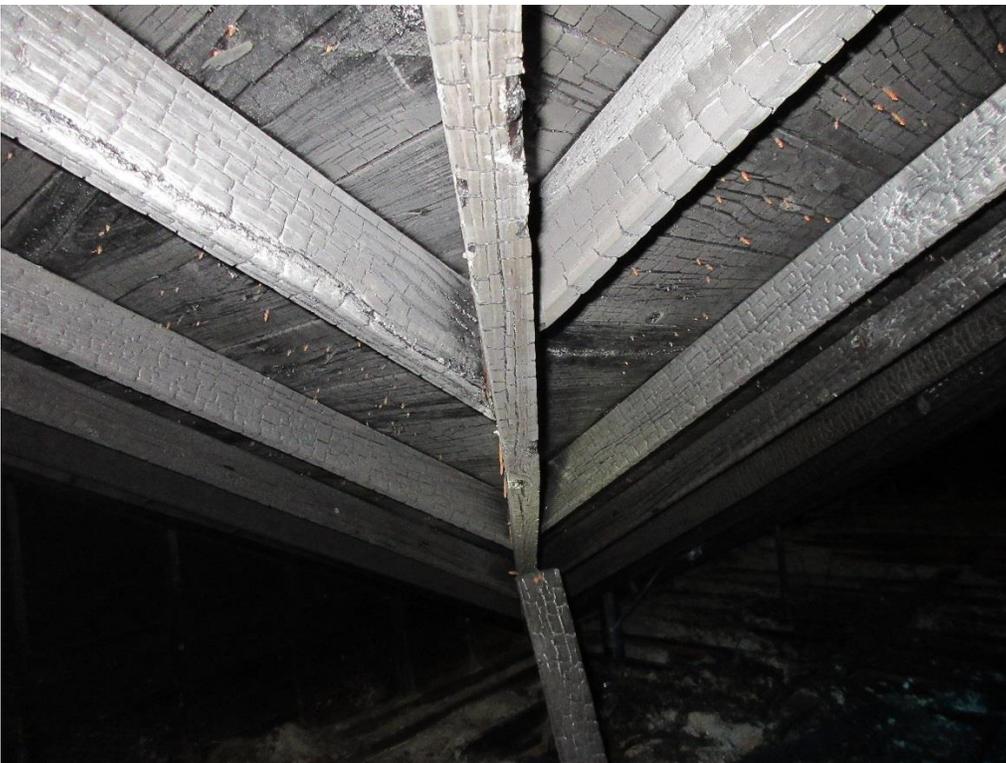
Roof Framing - Middle Section (4)

The damage to the roofing structure makes it highly improbable that any of it can be salvaged.

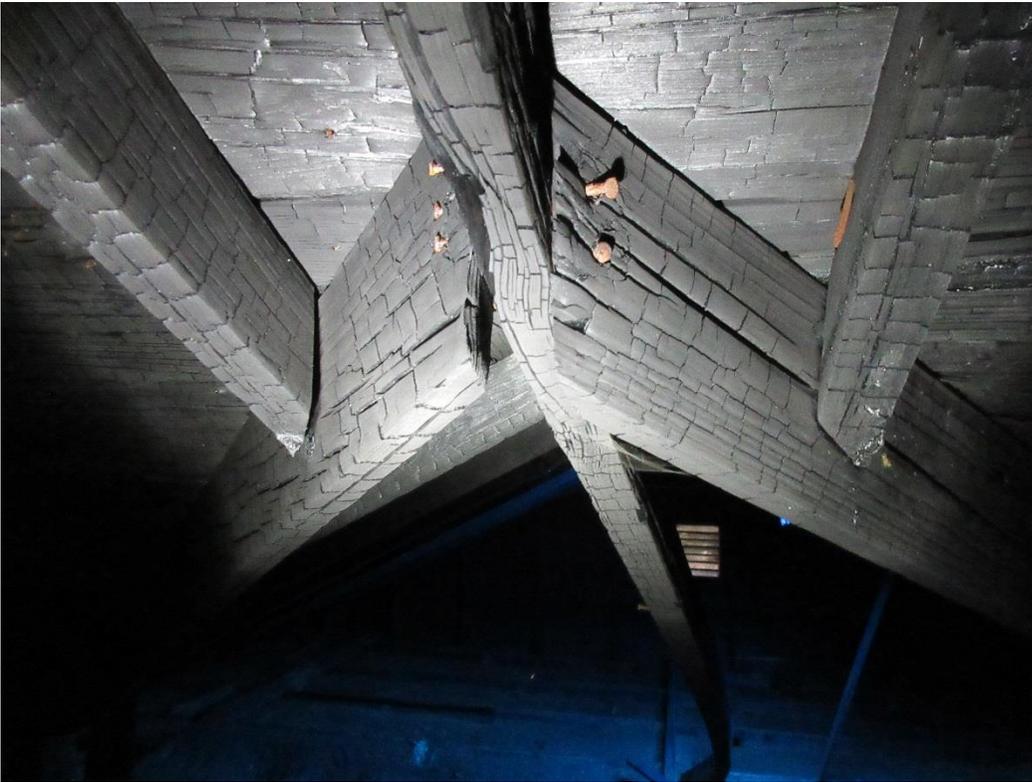
## Roof Framing - Middle Section (5)

The damage of the fire was mostly in the rear section of the structure, but the roof was exposed to considerable fire spread damage

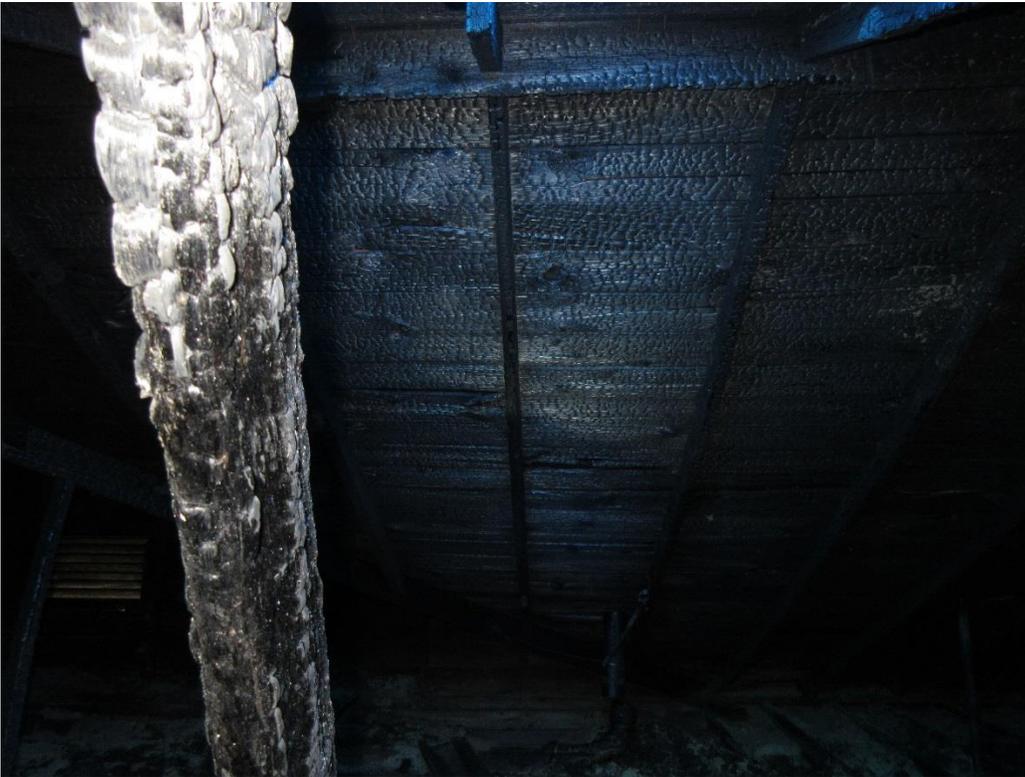
Roof Framing - Rear Section (1)

Charred/  
unsalvageable  
framing.

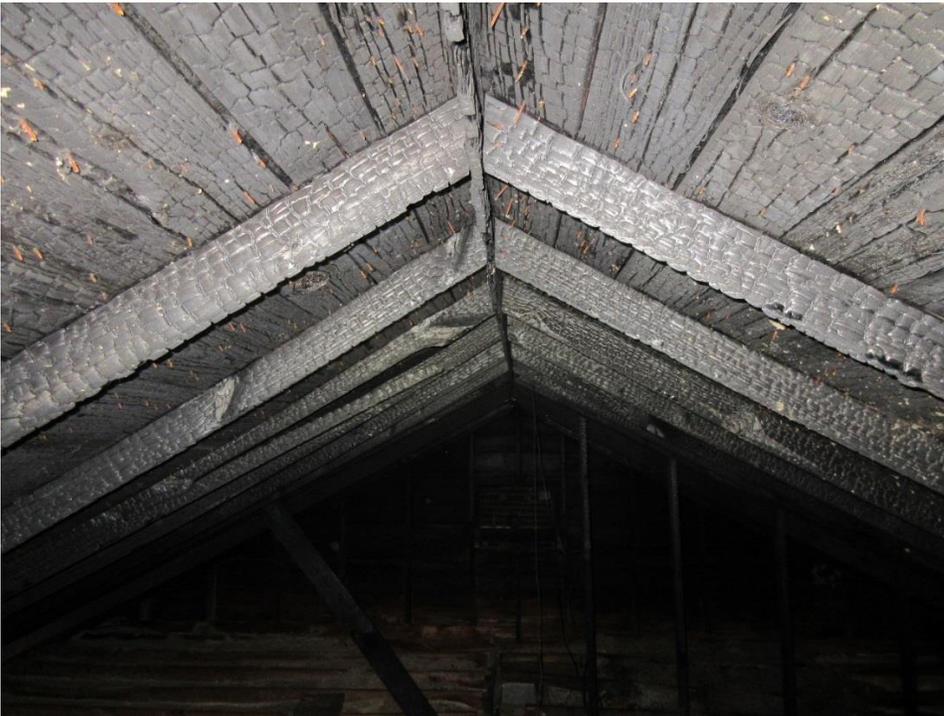
### Roof Framing - Rear Section (4)

Based on the conditions of the observed fire damage the framing and decking for the entire roof should be removed and replaced.

Roof will be replaced with like and kind to today's codes requirements - rafters that are 16" oc, a 2" x 8" main ridge. The pitch and layout of the roof will stay the same as will the asphalt shingles.

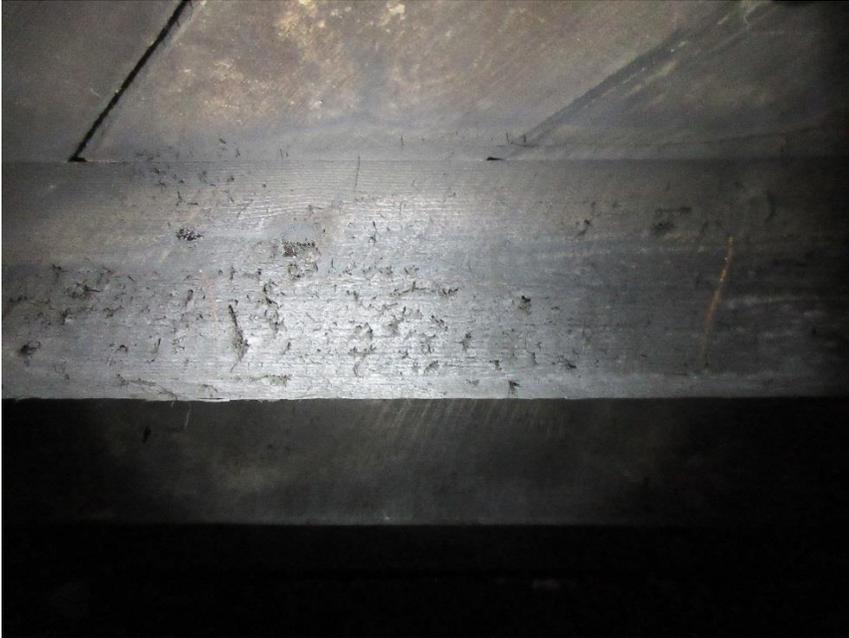
### Floor Framing – Front Section (1)

Smoke has permeated rough sawn wood. It is difficult to warranty and accept the liability of the smoke removal pictured below.

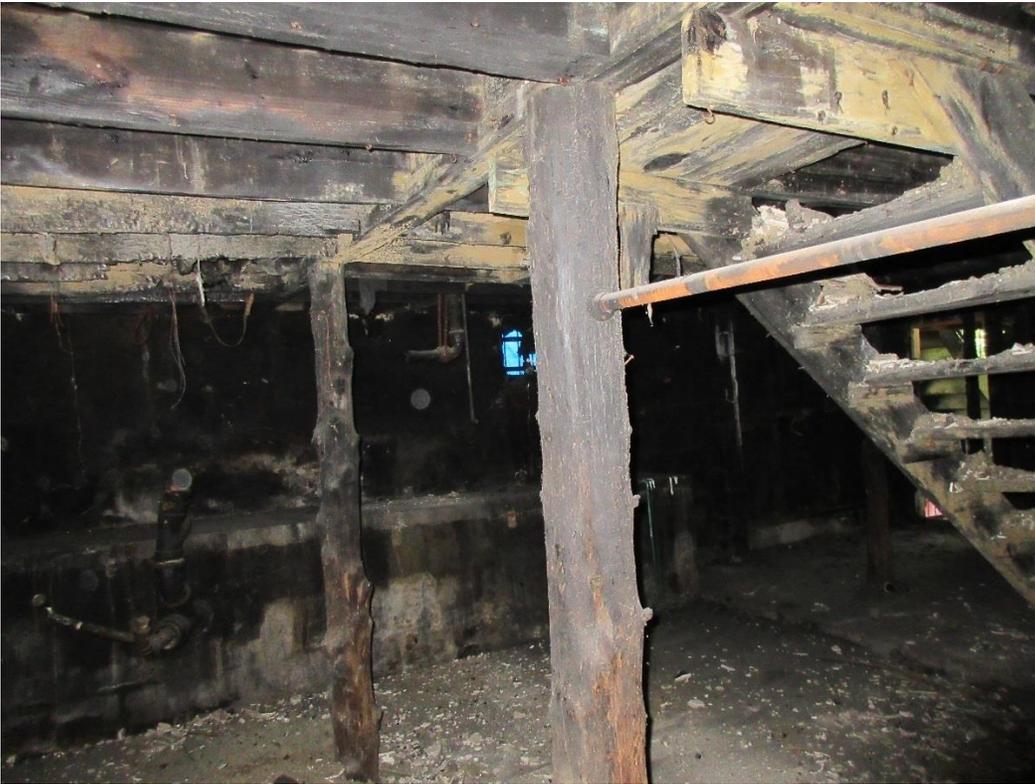
Floor Framing – Front-Middle Section (1)

Presence of excessive mold growth originated from water that extinguished fire.

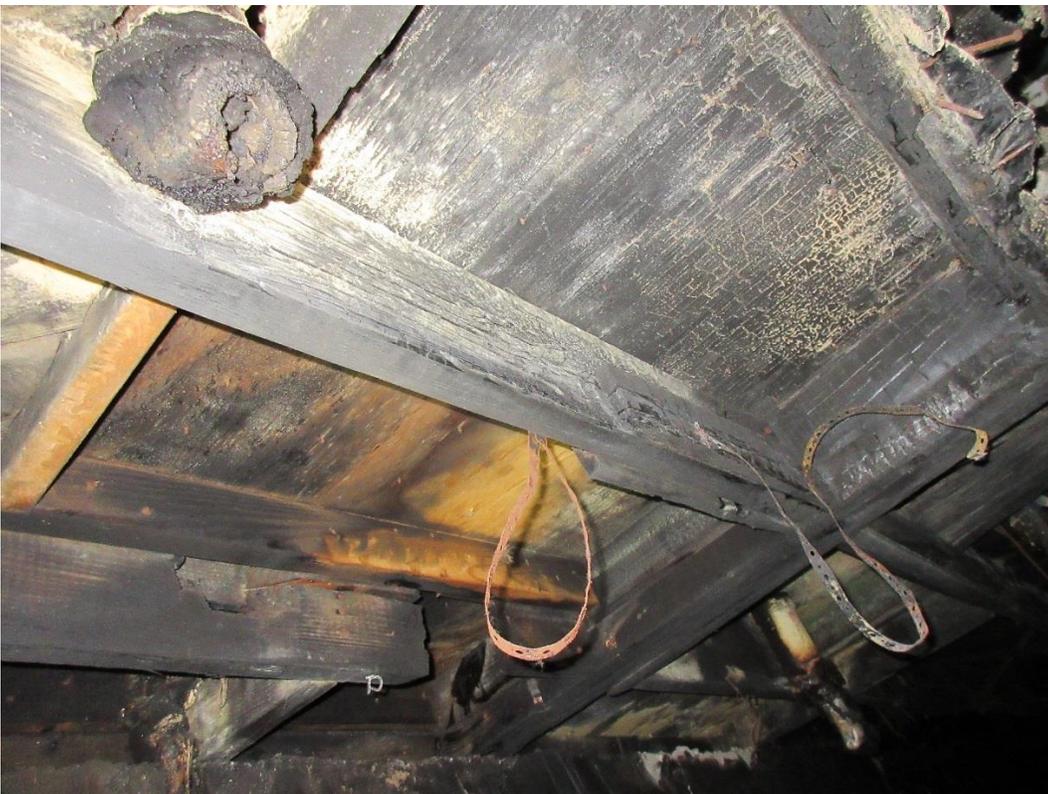
Floor Framing – Front-Middle Section (2)

Mold

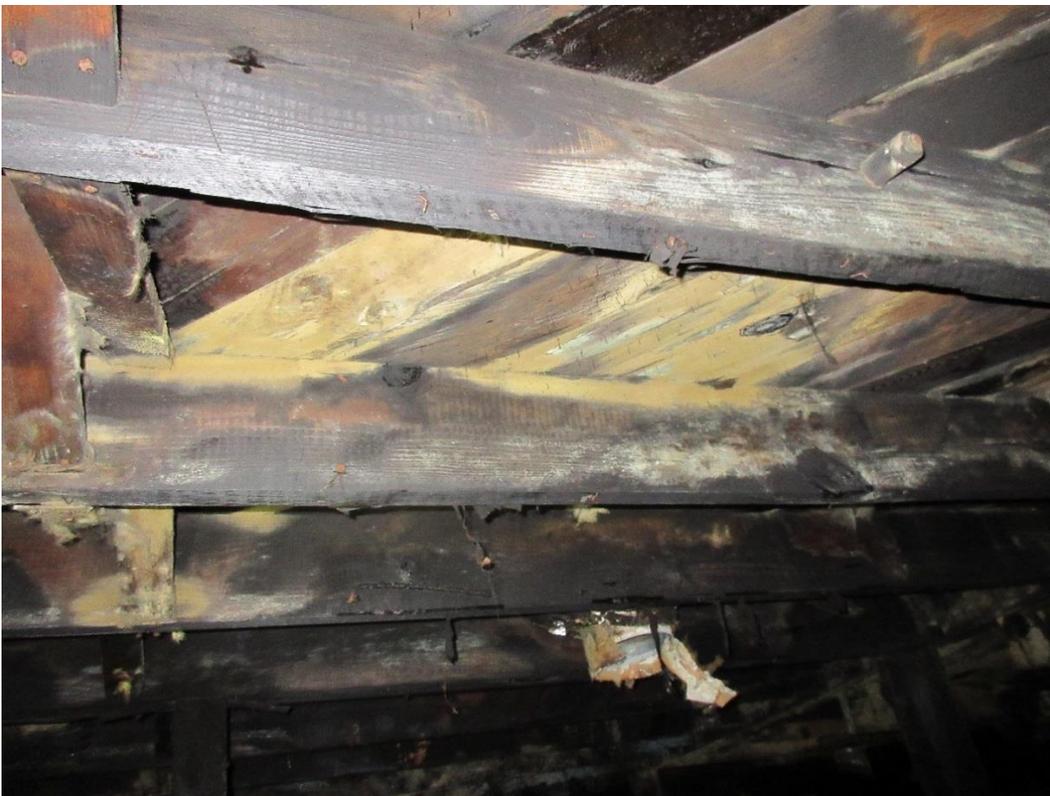
Floor Framing – Front-Middle Section (4)

The water used to put out the fire has exposed the residence and contents to a considerable amount of water damage as a result, mold growth is present in the basement.

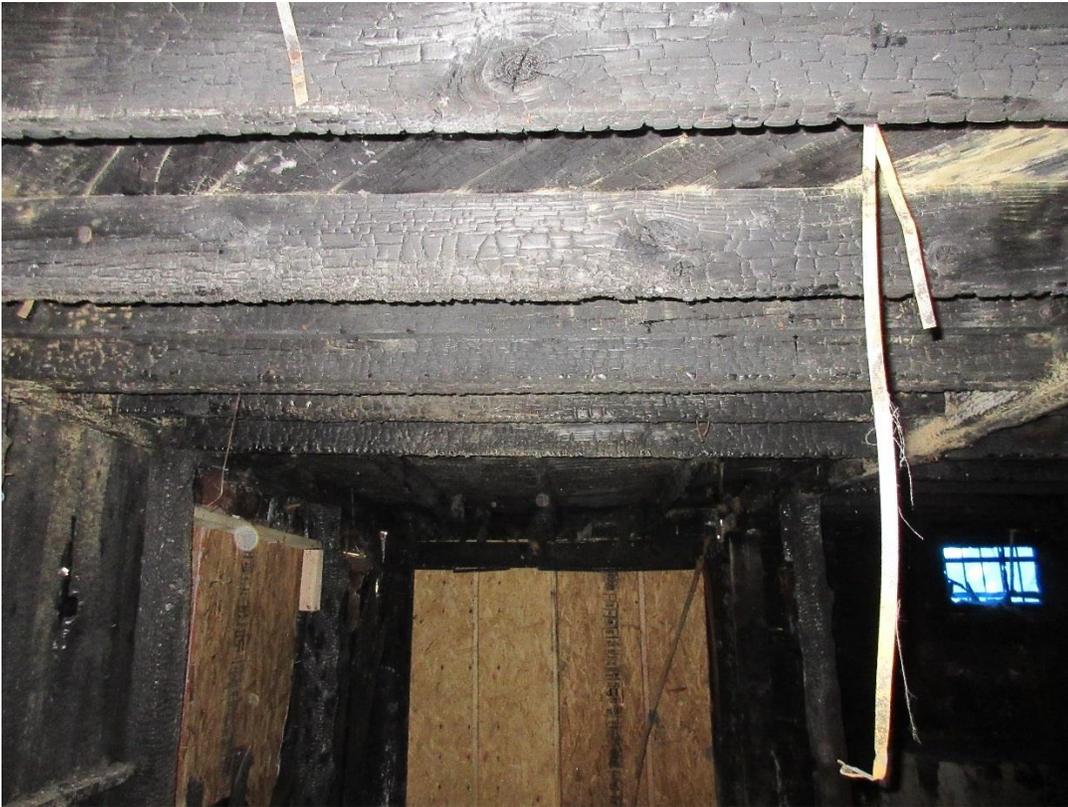
Floor Framing – Rear Section (1)

The main level floor framing and center support piers require replacement for the majority of the structure due to the fire damage.

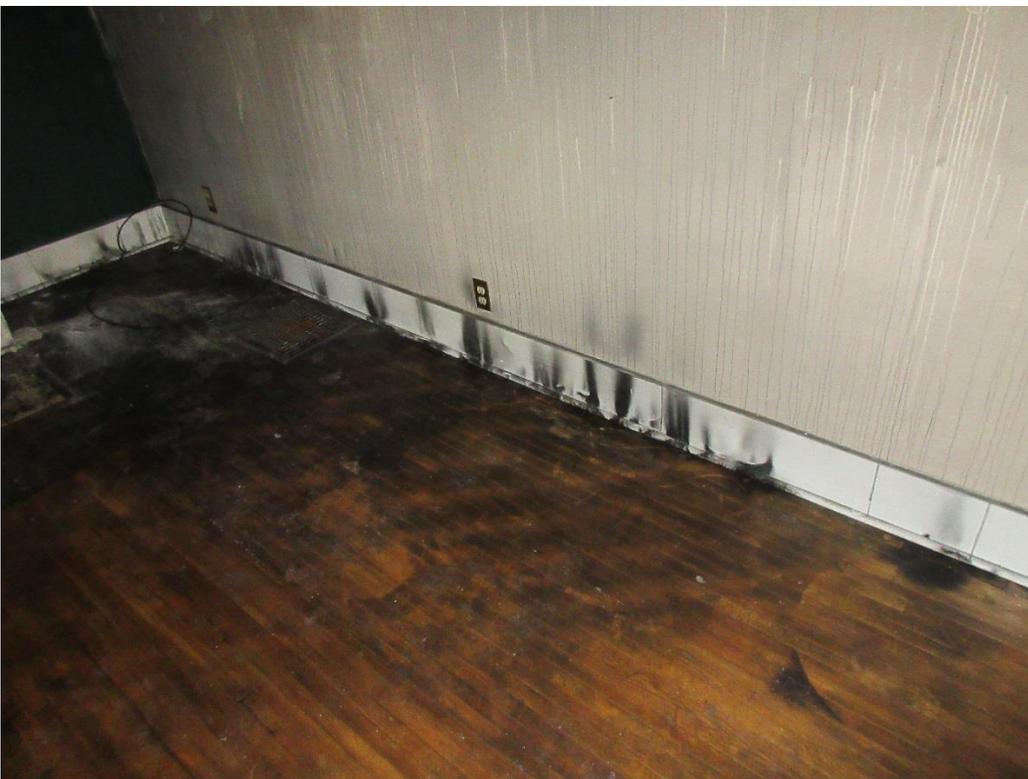
Smoke from basement rose through sub floor, hardwoods, baseboards, spilling in and through all creases, cracks and crevices. The full removal of this extent of smoke is unlikely to be successful.

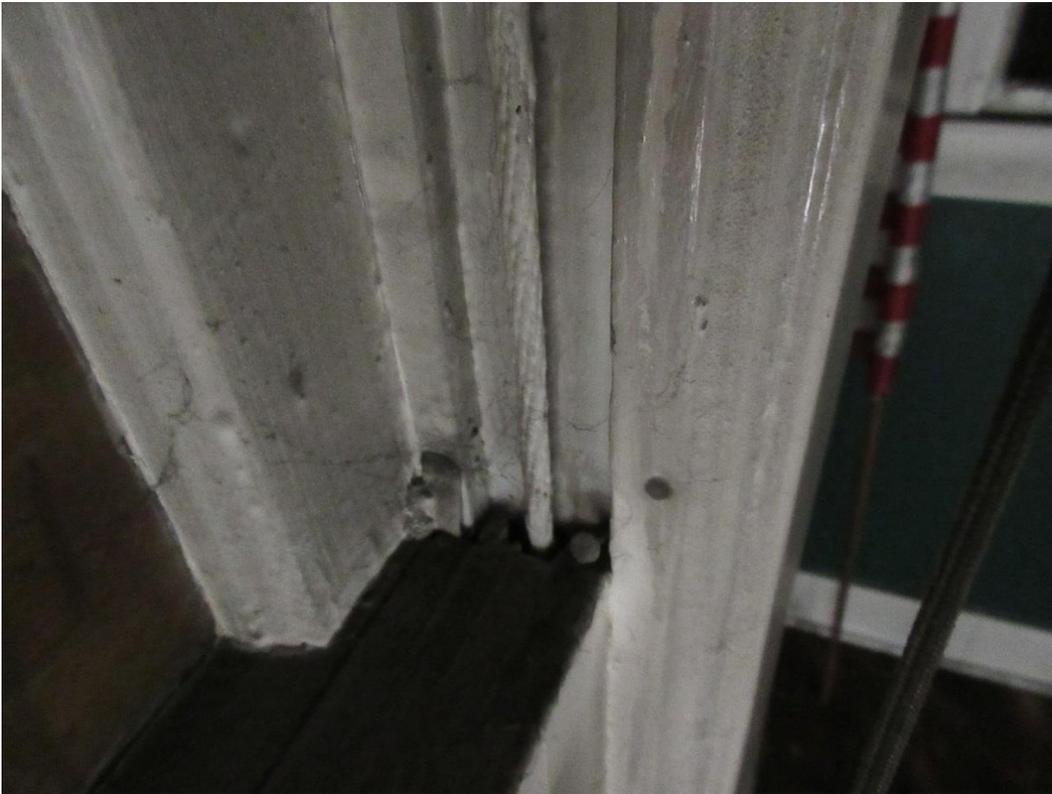
Main floor- Interior Window Frame

Braided pulley wood frame windows. Evidence of smoke in and around frame. Due to construction of window there is no way to guarantee removal of smoke from window cavity.

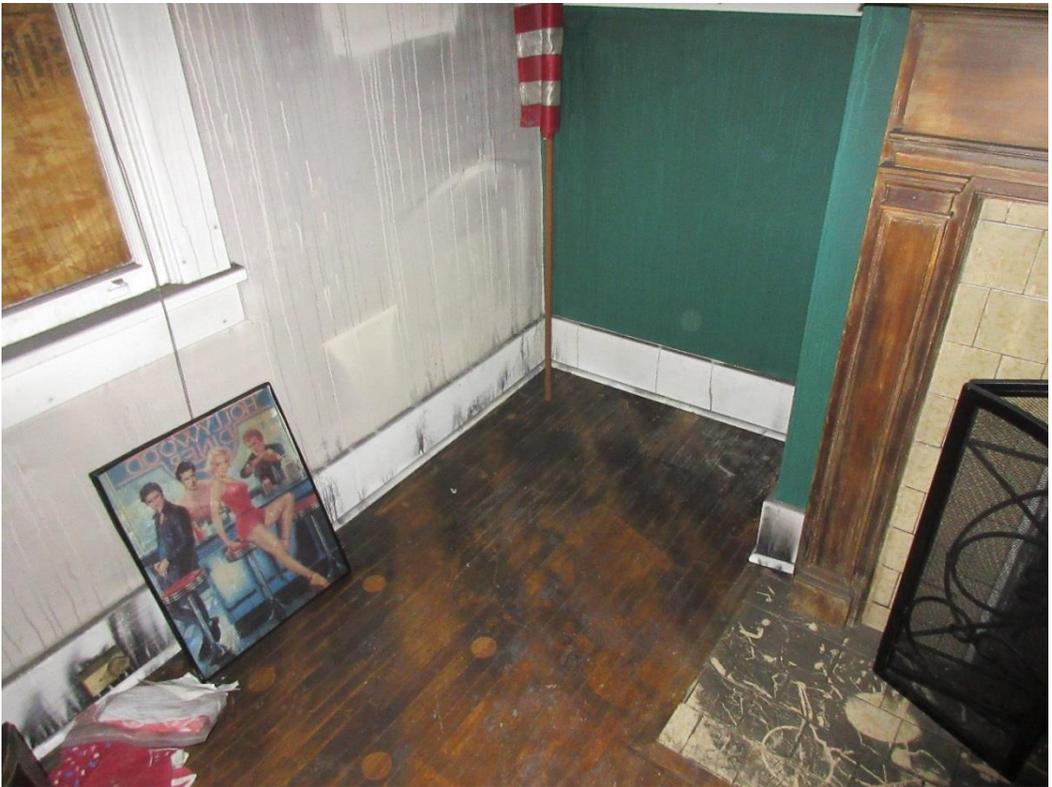
Main floor Interior – flooring corner to left of fireplace

Smoke damage and soot present on floors, baseboards and up walls.

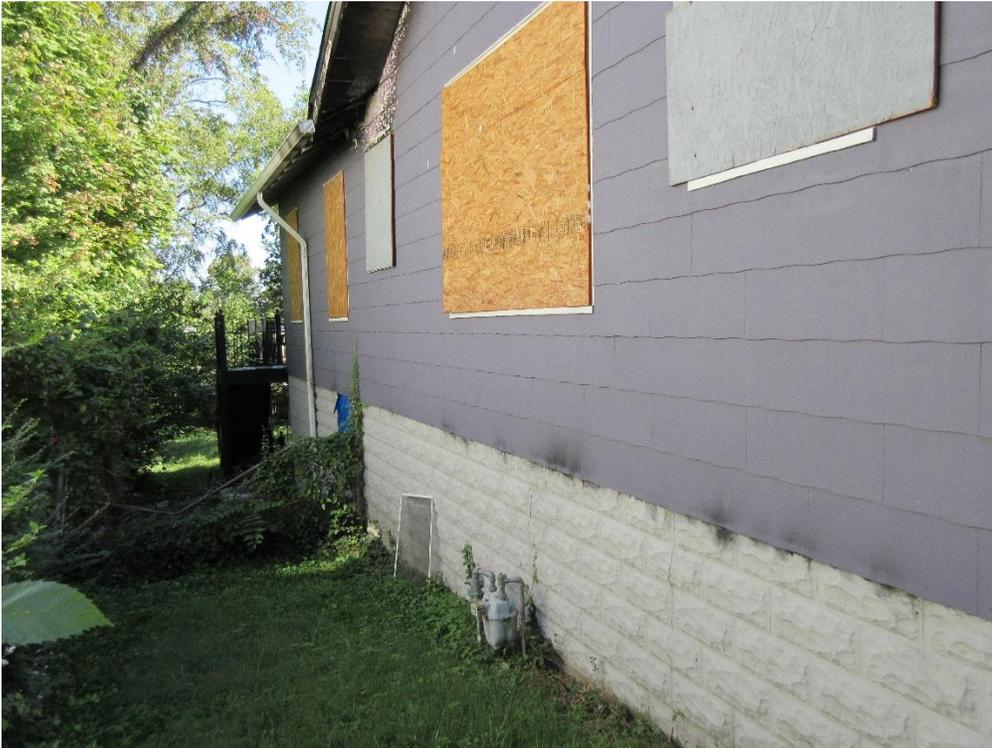
### Exterior Side – Left Side of House

The pressure of the smoke from the basement caused it to exit the home through the walls and siding.

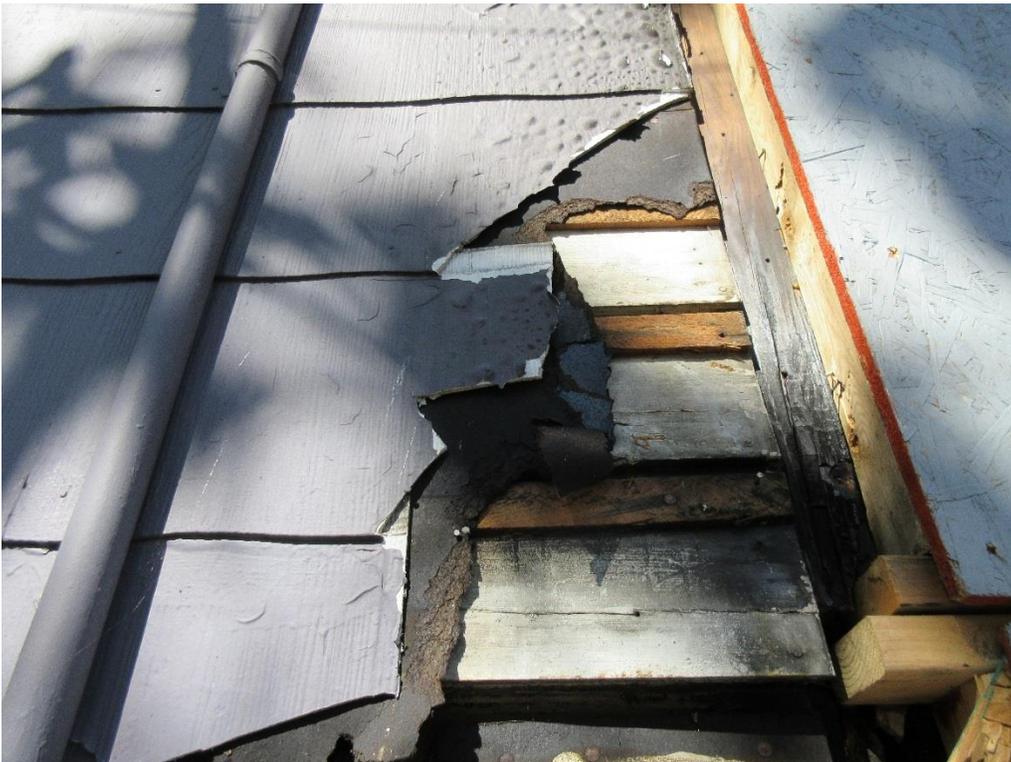
### Exterior – siding close up

The house is currently sheathed in an asbestos siding over the original lap siding. The estimate includes replacement of the both the asbestos and original wood sidings as well as details such as corbels, vents and trim. It does not appear that any exterior features were damaged by fire. Consultant Pierre Howell, noted that Codes would not require that the asbestos be removed. Ms. Zeigler explained that asbestos is not harmful if in good repair. There may be small areas of repair that may be needed because of deferred maintenance, rather than the fire. Another option would be to repair the wood siding.

Smoke and soot present under each layer of asbestos shingles, felt barrier and lap siding.
