## STAFF RECOMMENDATION 1621 Forrest Avenue October 18, 2017

**Application:** Demolition  
**District:** Lockeland Springs-East End Neighborhood Conservation Zoning Overlay  
**Council District:** 06  
**Map and Parcel Number:** 08310016300  
**Applicant:** Todd Austin, owner  
**Project Lead:** paul.hoffman@nashville.gov

## Structural Evaluation of Residence

1621 Forrest Avenue Nashville, TN 37206

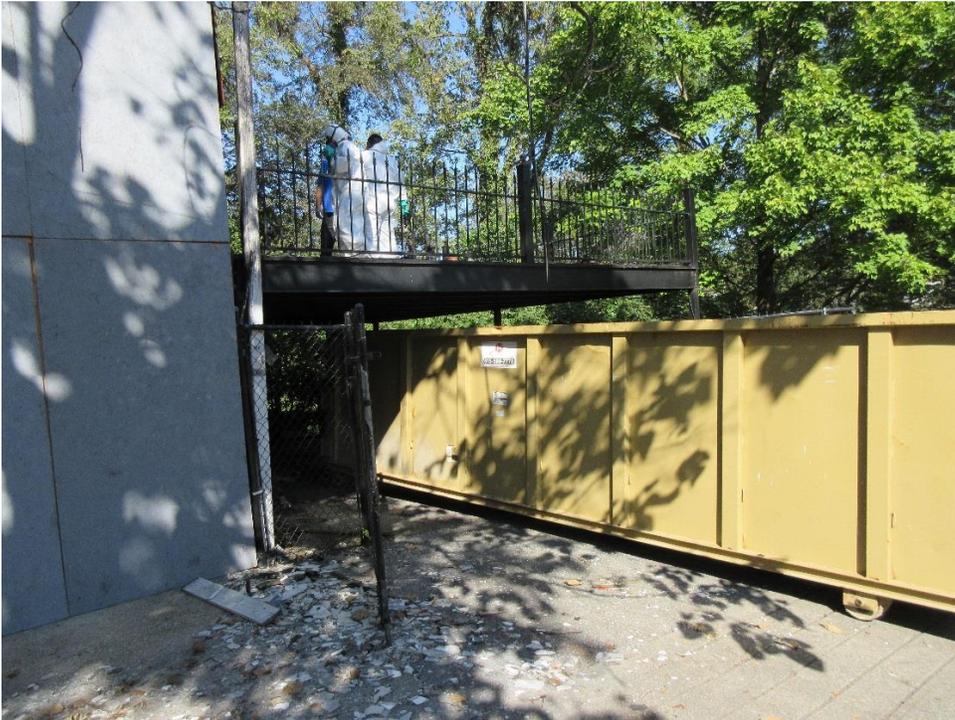
### Elevated Patio – Carport (1)

The perimeter stone foundations, front porch and rear elevated steel deck were observed to be sound and stable for the most part and not compromised by the fire.
