**METROPOLITAN GOVERNMENT OF NASHVILLE AND DAVIDSON COUNTY**

**STAFF RECOMMENDATION**  
**1825 5<sup>th</sup> Avenue North**  
**June 21, 2017**

**Application:** Demolition  
**District:** Salemtown Neighborhood Conservation Zoning Overlay  
**Council District:** 19  
**Map and Parcel Number:** 08108026400  
**Applicant:** Grant Hammond  
**Project Lead:** Paul Hoffman, paul.hoffman@nashville.gov

**SUBJECT: Residential Condition Assessment Letter**  
**1825 5th Avenue North, Nashville, TN**  
**SE&I Project No: 16-1588**

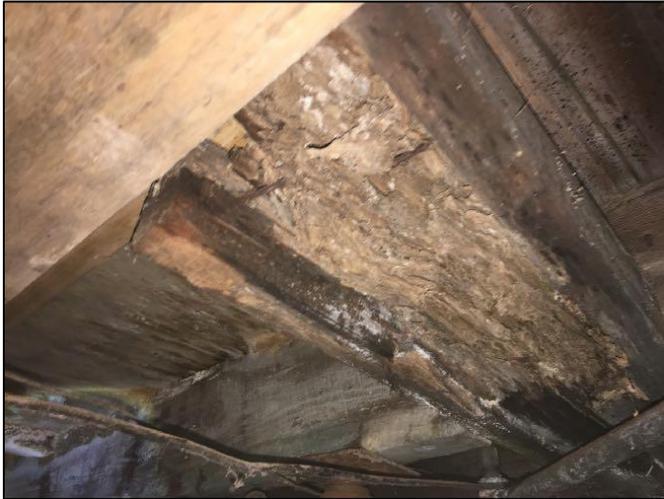
The perimeter of the foundation has been rebuilt, but the blocks were laid without footings. Staff noted deterioration, water intrusion and termite damage to sixty or

seventy percent (60-70%) of the beams and joists, that would likely require replacement. The left side is no longer supporting the house. The engineer's report notes the floor in each room slopes up to an inch and a half (1 ½") to the center of the structure. Floors that have fallen out of level are common in an historic structure, but in this case, a key component that has failed is the central girder. This and the majority of the beams and joists would require removal and replacement. Staff's estimate of floor replacement is at least fifty percent (50%).

Figure 2. Termite damage to central beam

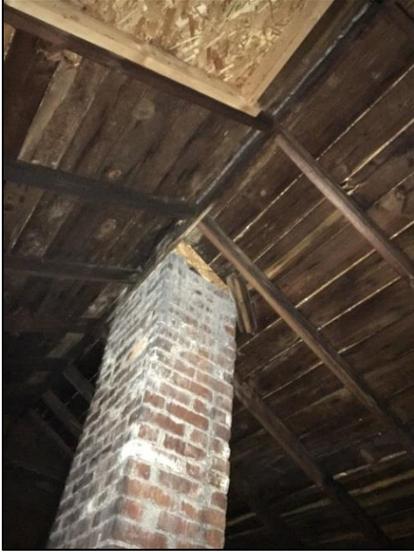
The roof structure sags visibly but is not in poor condition overall. The original rafters, ridgepole and most of the decking are in place. The rafters are 2x4s. The ridge is a 1x6. Decking is tongue-in-groove decking, which has been replaced in areas with plywood. The engineer's report states that the rafters are over loaded. Staff agrees and estimates that the roofing structure requires some augmentation of the support, for example installation of collar ties, but not entire replacement.

Figure 3. Original decking and rafters visible, with decking replaced at top of image

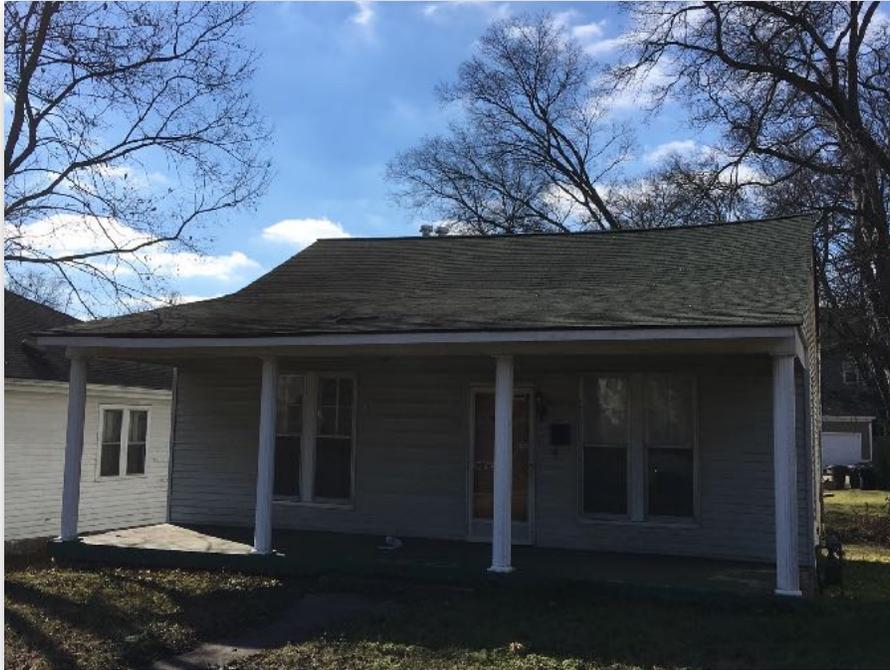
The roof was observed to have a significant sag along the ridge line on the right side of the house especially where the front porch roof ties into the main roof. Access to the attic is limited, but we were able to see that the original roof rafters are rough sawn 2x4 spaced at 24 inches on-center with the original 1x4 wood slats and a layer of new OSB sheathing installed on top of the original slats. The 2x4 rafters have a horizontal span of approximately 13 feet but are only span rated for 8 feet. The front rafters also support the porch rafters, which further over loads the rafters.

**Photo 1: Front view of the subject property. Sag in main roof at intersection of porch roof.**

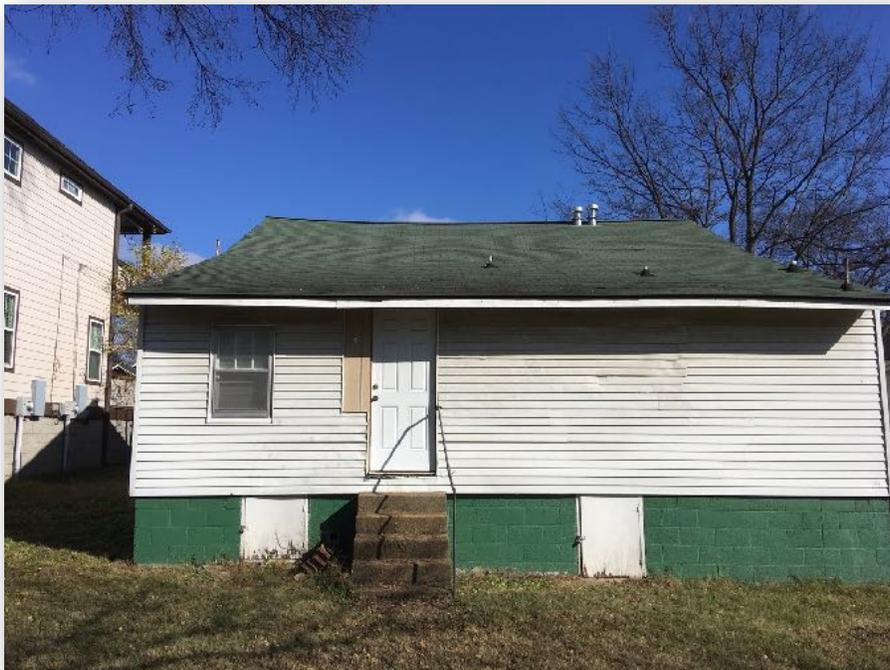
**Photo 2: Rear view of the subject property. Sag in the roof in line with the rear door.**

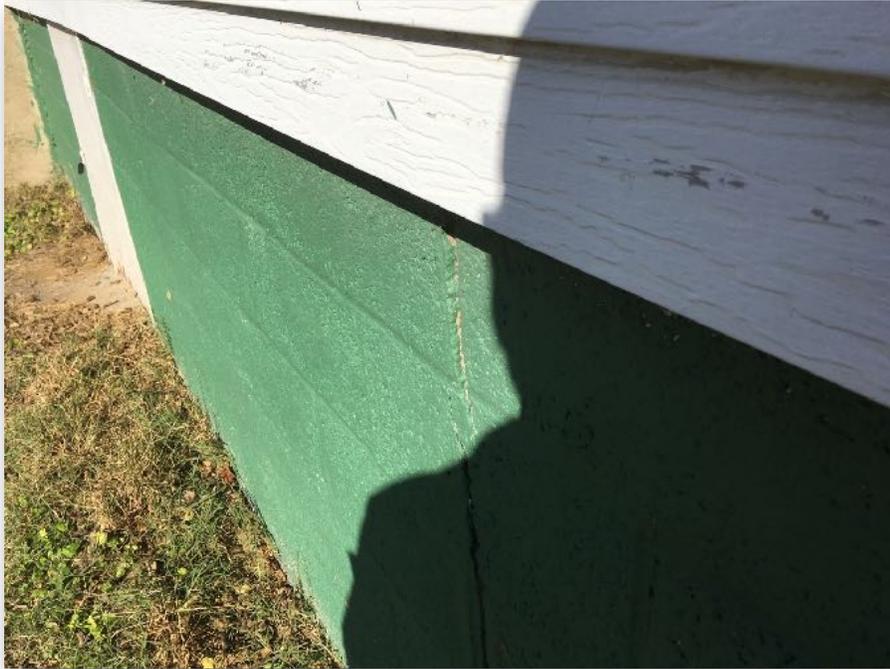
The perimeter foundation wall is constructed out of cinder blocks and were observed to be bearing directly on top of the soil with no concrete footing. The foundation wall has settled along the left side near the left rear corner and is no longer supporting the house. The crawlspace ground has been excavated and has undermined the foundation wall along the left and rear of the house at the left rear corner. The front concrete porch has cracked in the center and appears to have dropped on the left side. The front of the porch slab appears to have had some clay brick placed under the slab with cinder blocks placed on the left side. The cinder blocks and brick are no longer supporting the slab and have settled leaving the slab somewhat suspended.

**Photo 3: Rear foundation wall settling and leaning out near the left rear corner.**

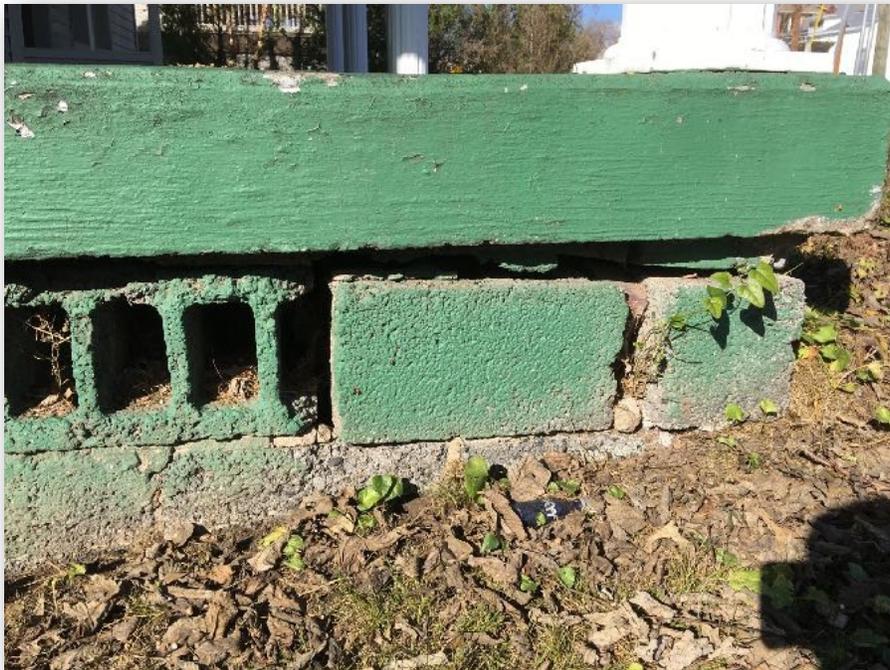
**Photo 4: Foundation blocks loose and not supporting front concrete porch.**

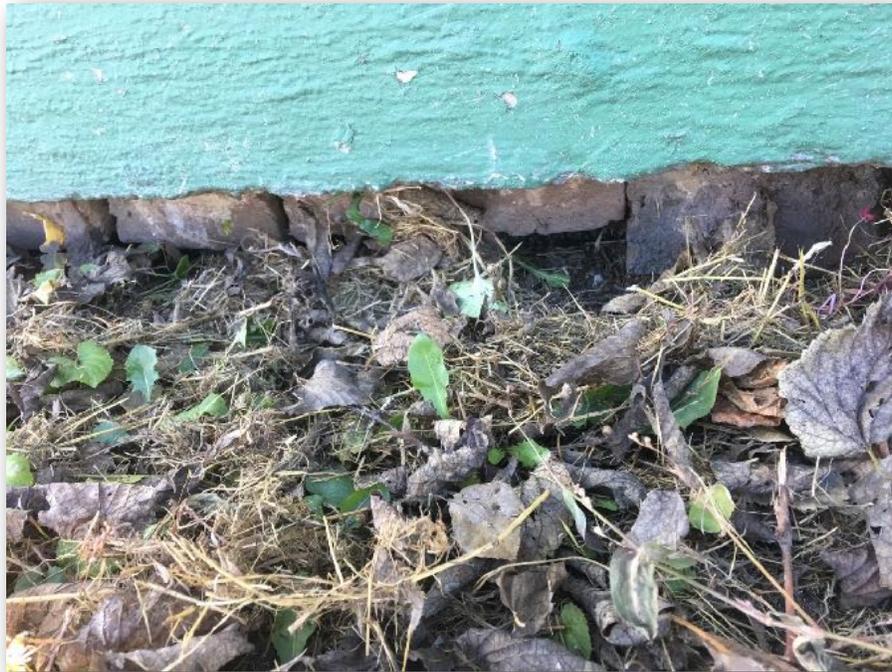
**Photo 5: Front edge of concrete porch not support. Clay brick appear to have been placed directly on top of ground and do not support slab edge.**

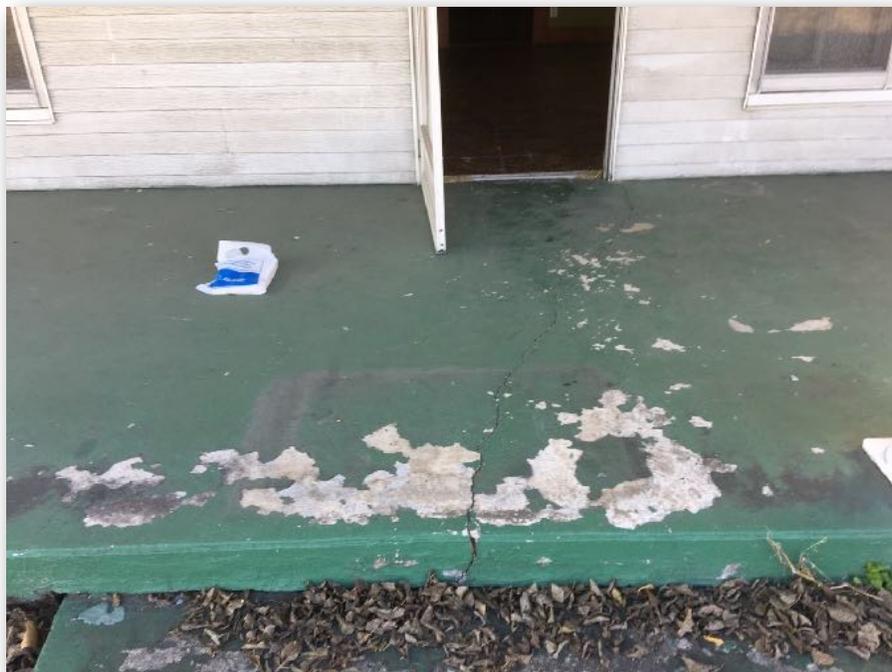
**Photo 6: Front porch slab cracked near center and sloping to the left were the slab is not supported by a foundation.**

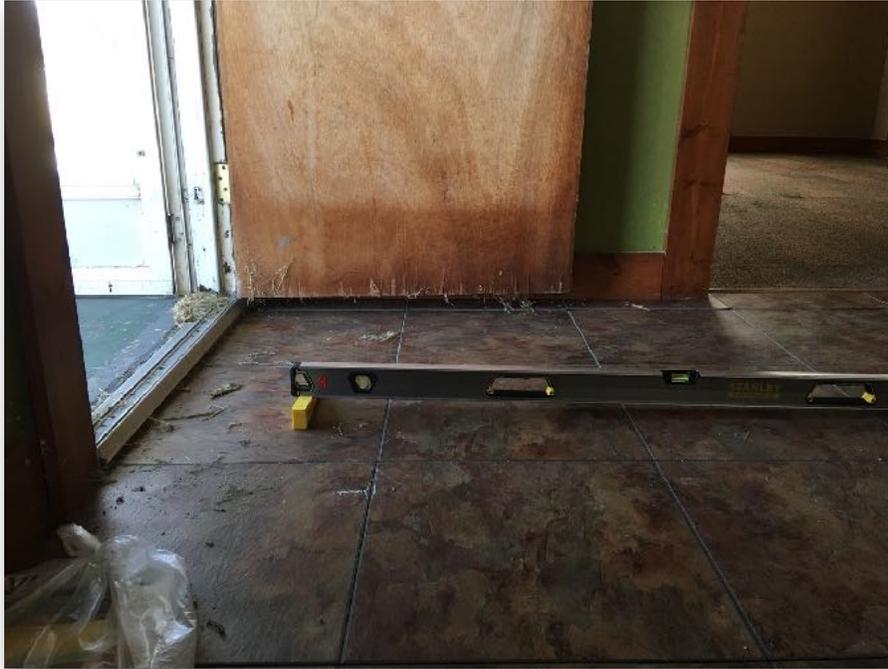
On the interior of the home, the floors in each room were observed to have significant slope in different directions. Each room appears to have a sloped up to 1-1/2 inches sagging towards the center of the house when measured with a five foot level. The vertical deflections though out the house exceed the building code maximum deflection requirements which is 0.75 inches in this case. The floor joists span left to right and are supported by a center flush girder, which was observed to have extensive termite damage. The flush girder would need to be totally removed and replaced. Previous floor framing repair work has been attempted and is not properly supporting the floor framing at the rear of the house. The new beams are not properly supported and are extremely unstable.

**Photo 7: Front foyer floor has dropped approximately 1-1/8 inches.**

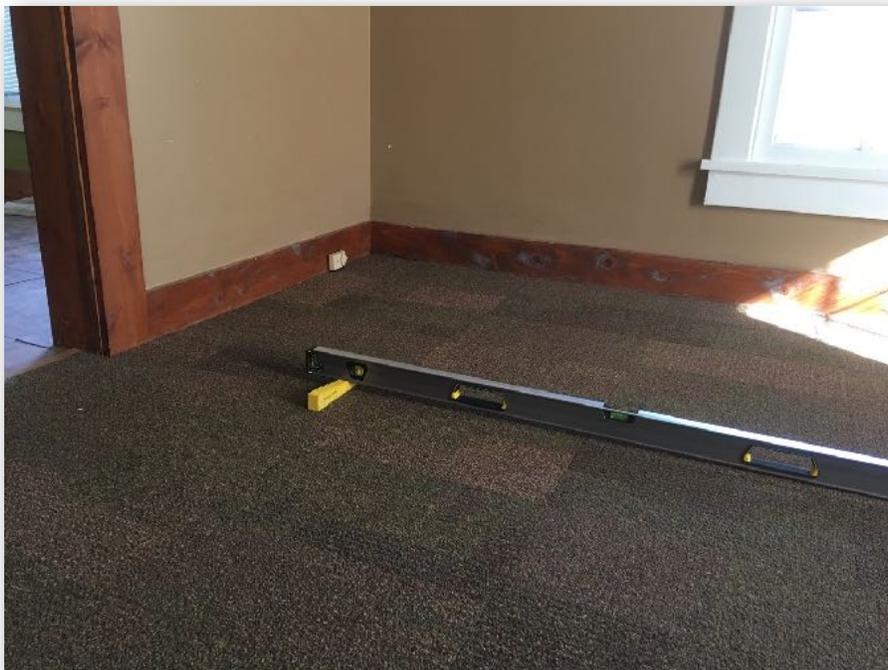
**Photo 8: Front left room sloping in approximately 7/8 of an inch.**

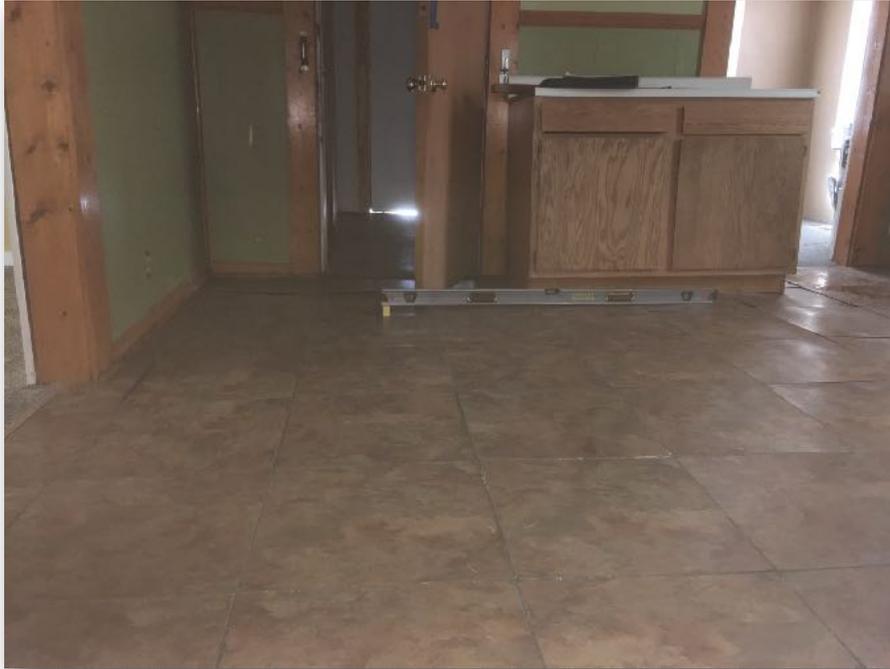
**Photo 9: Kitchen floor dropped toward the center by approximately 1-1/8 inches.**

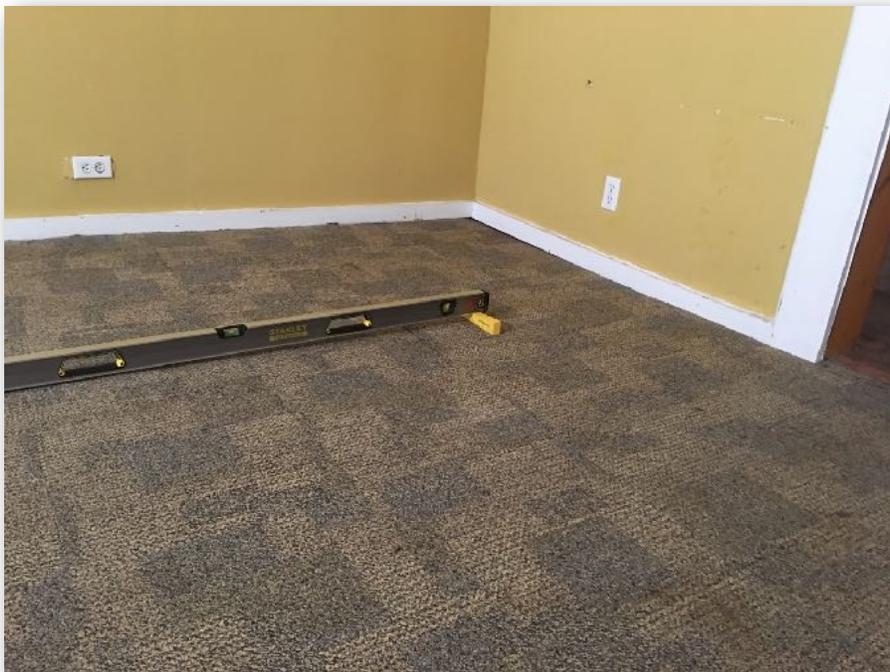
**Photo 10: The left rear room dropped toward the center by approximately 1 inch.**

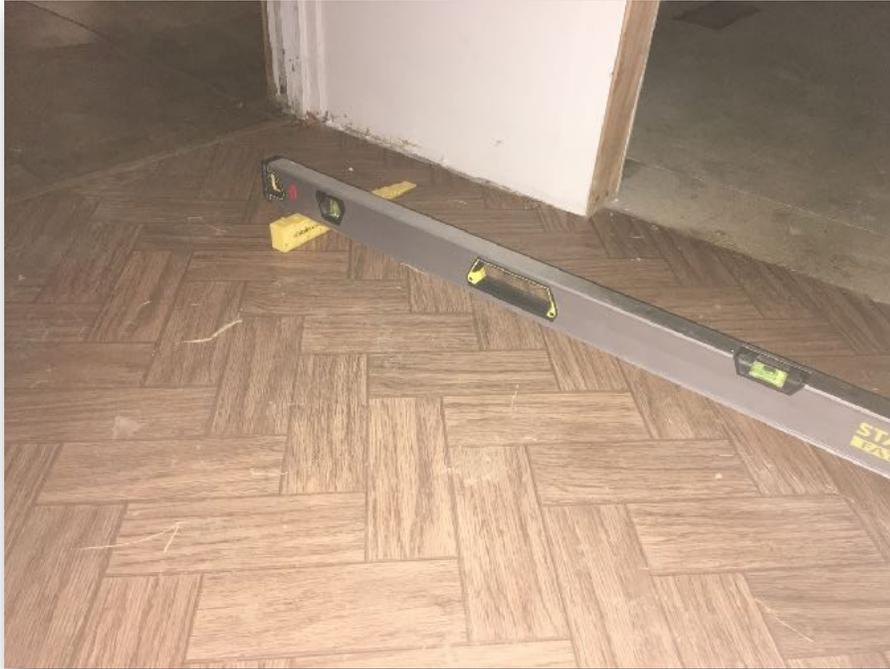
**Photo 11: Rear hallway has dropped toward the front by approximately 1-1/2 inches.**

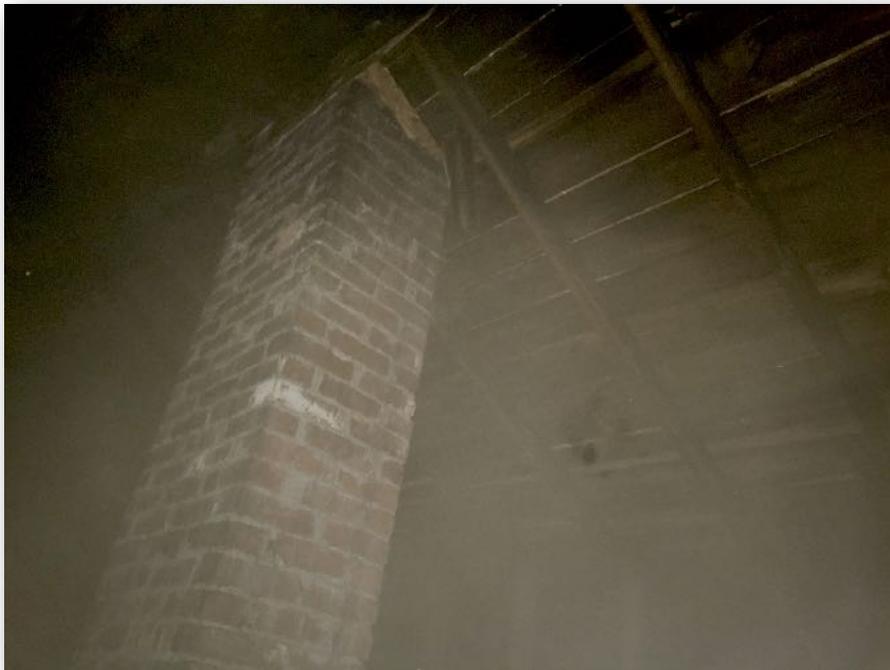
**Photo 12: Rafters appear to be rough sawn 2x4s spaced at 24 inches on-center with new OSB sheathing placed over the original 1x6 roof slats.**

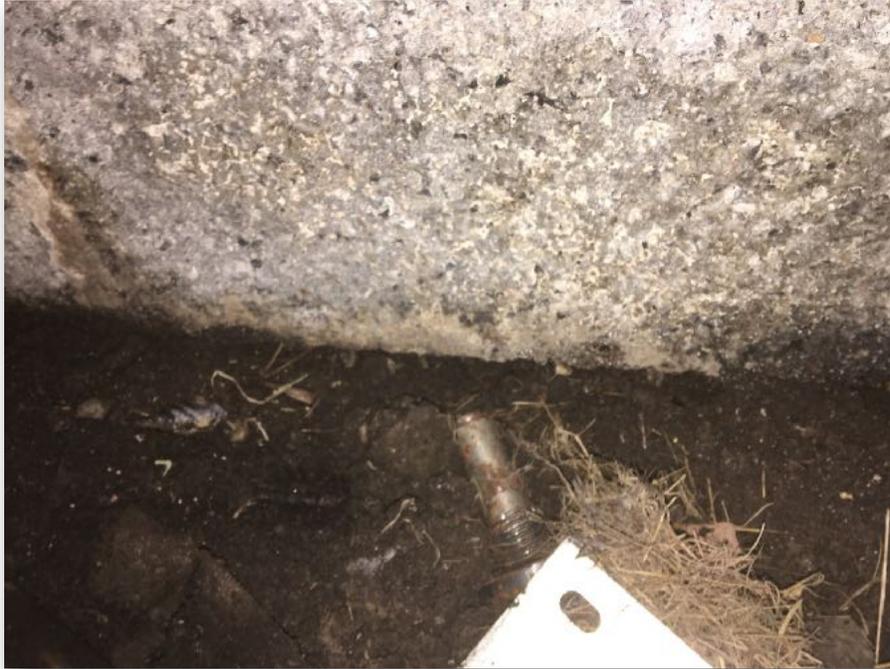
**Photo 13: The cinder block foundation wall bears directly on soil with no footing.**

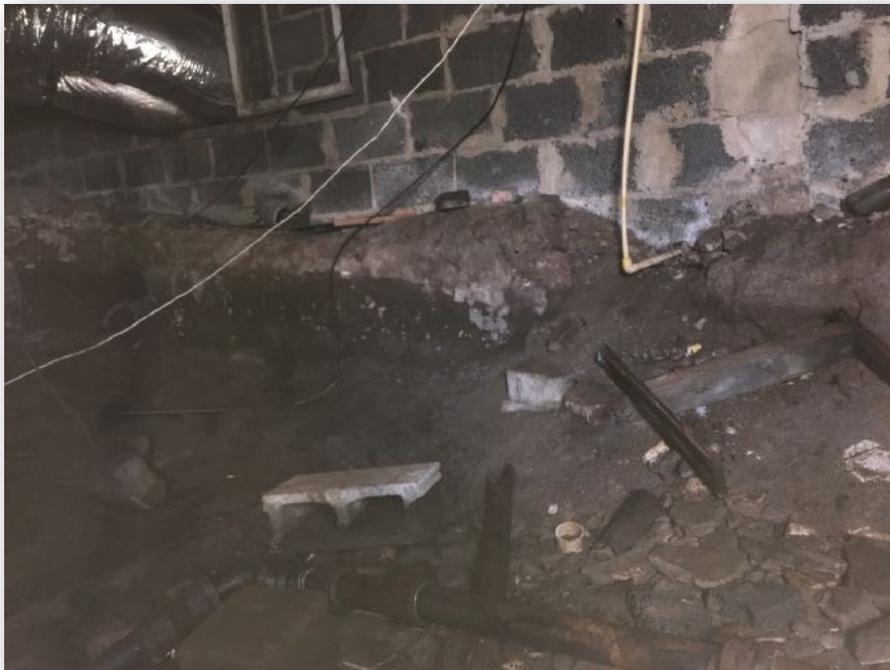
**Photo 14: The left side of the crawlspace has been excavated and undermined the foundation wall.**

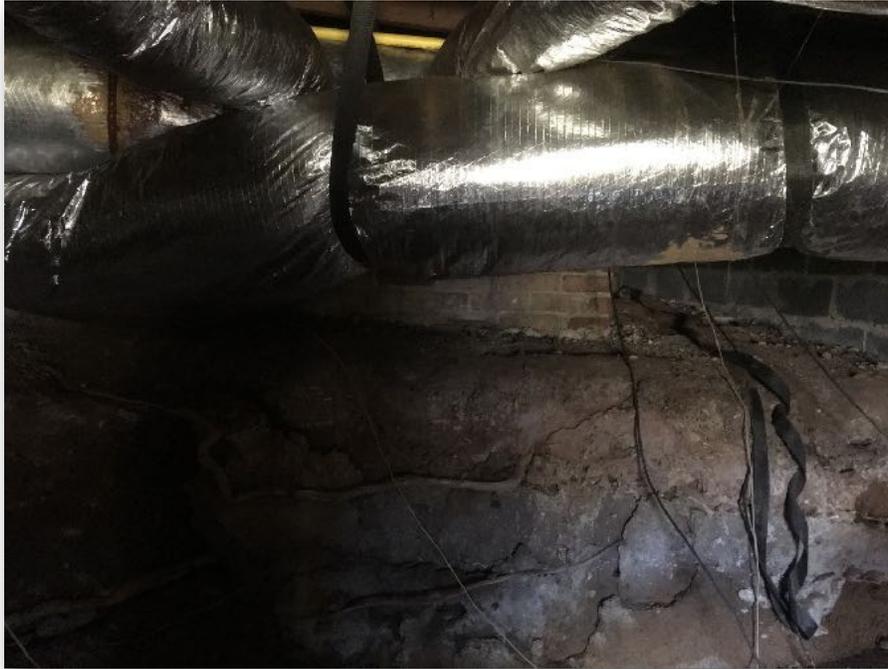
**Photo 15: The left side chimney foundation has been undermined by the excavation.**

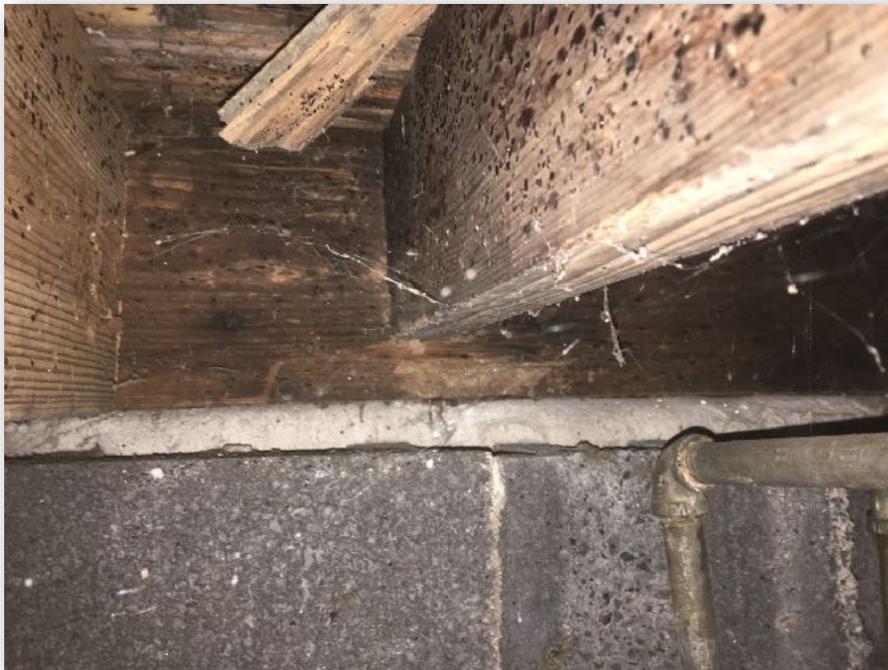
**Photo 16: The foundation wall has settled a couple inches and no longer supports the house framing at the left rear corner of the house where the foundation has been undermined.**

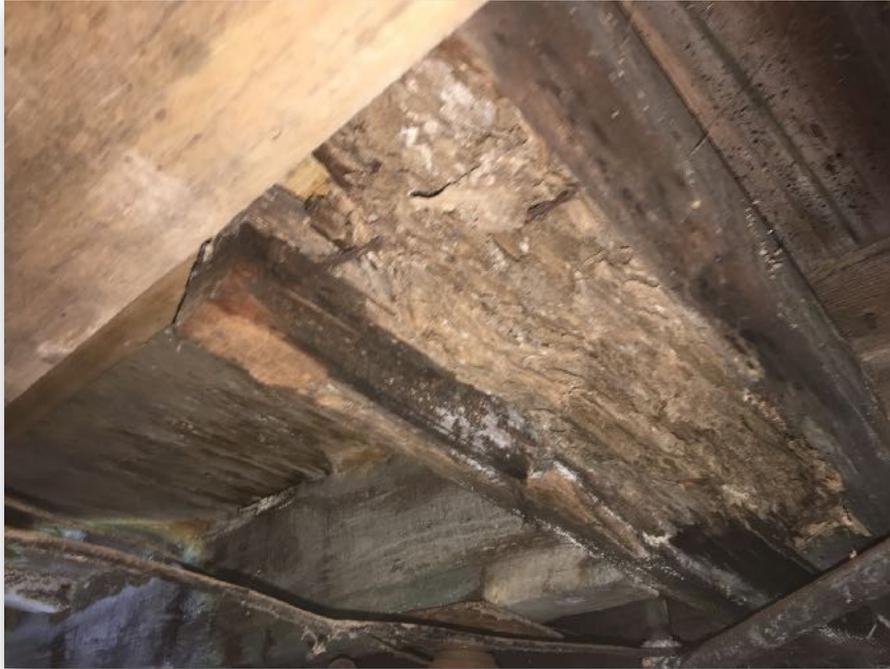
**Photo 17: Extensive termite damage along the main center support girder.**

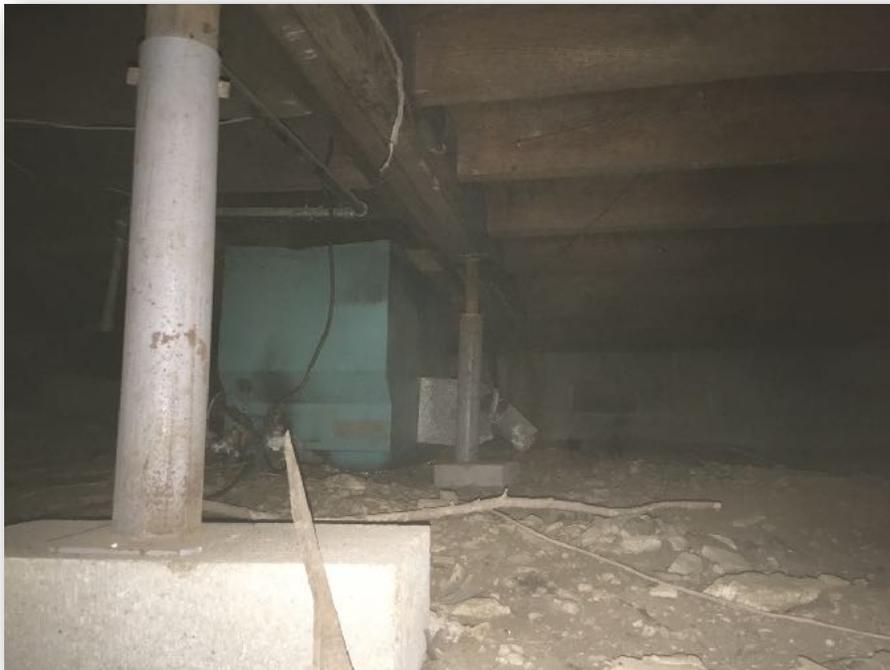
**Photo 18: View of center girder towards the front of house supported by temporary sleeved jack posts.**

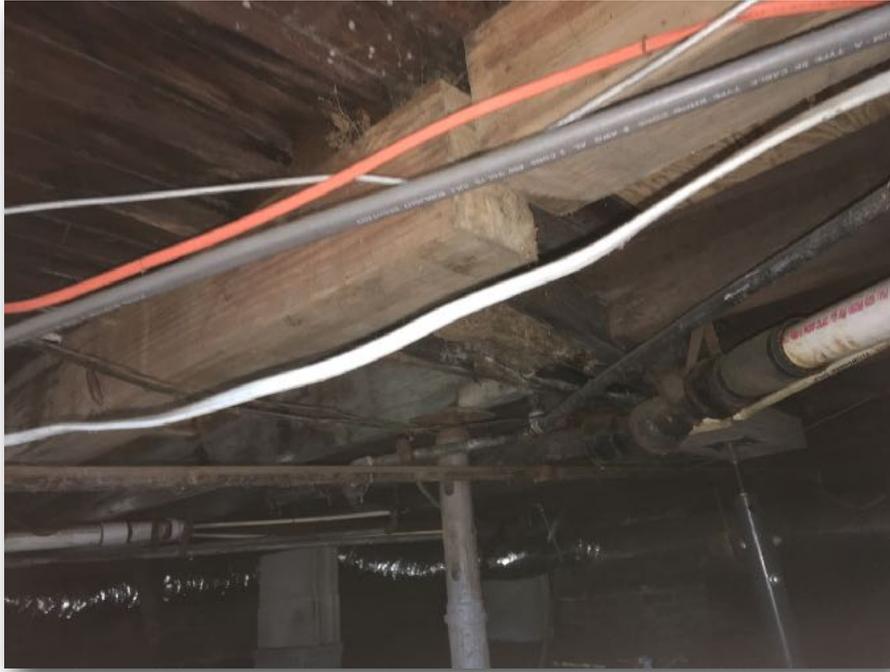
**Photo 19: Prior attempts to support floor is not stable. Note missing posts.**

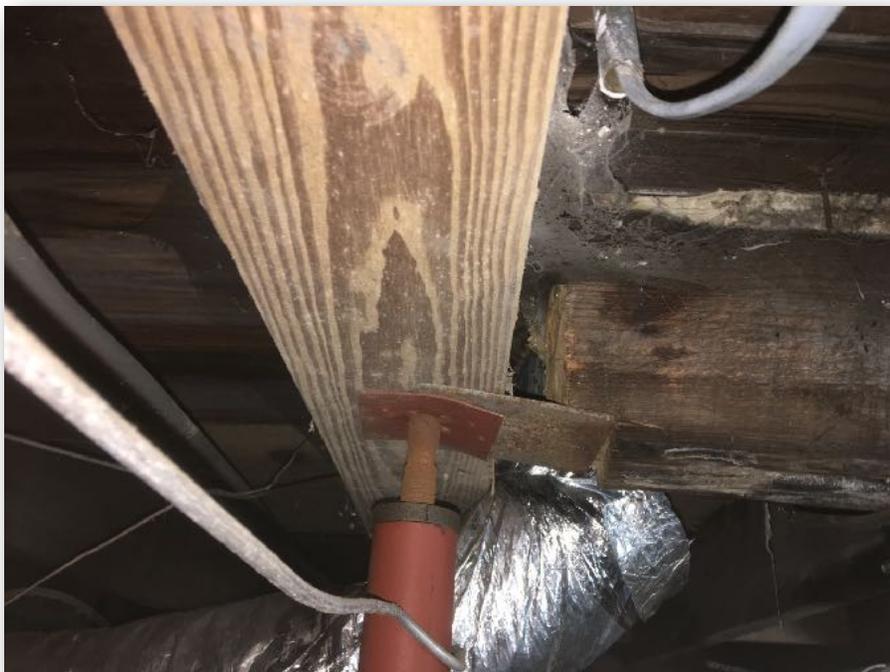
**Photo 20: Unstable beam support near the rear of the house.**

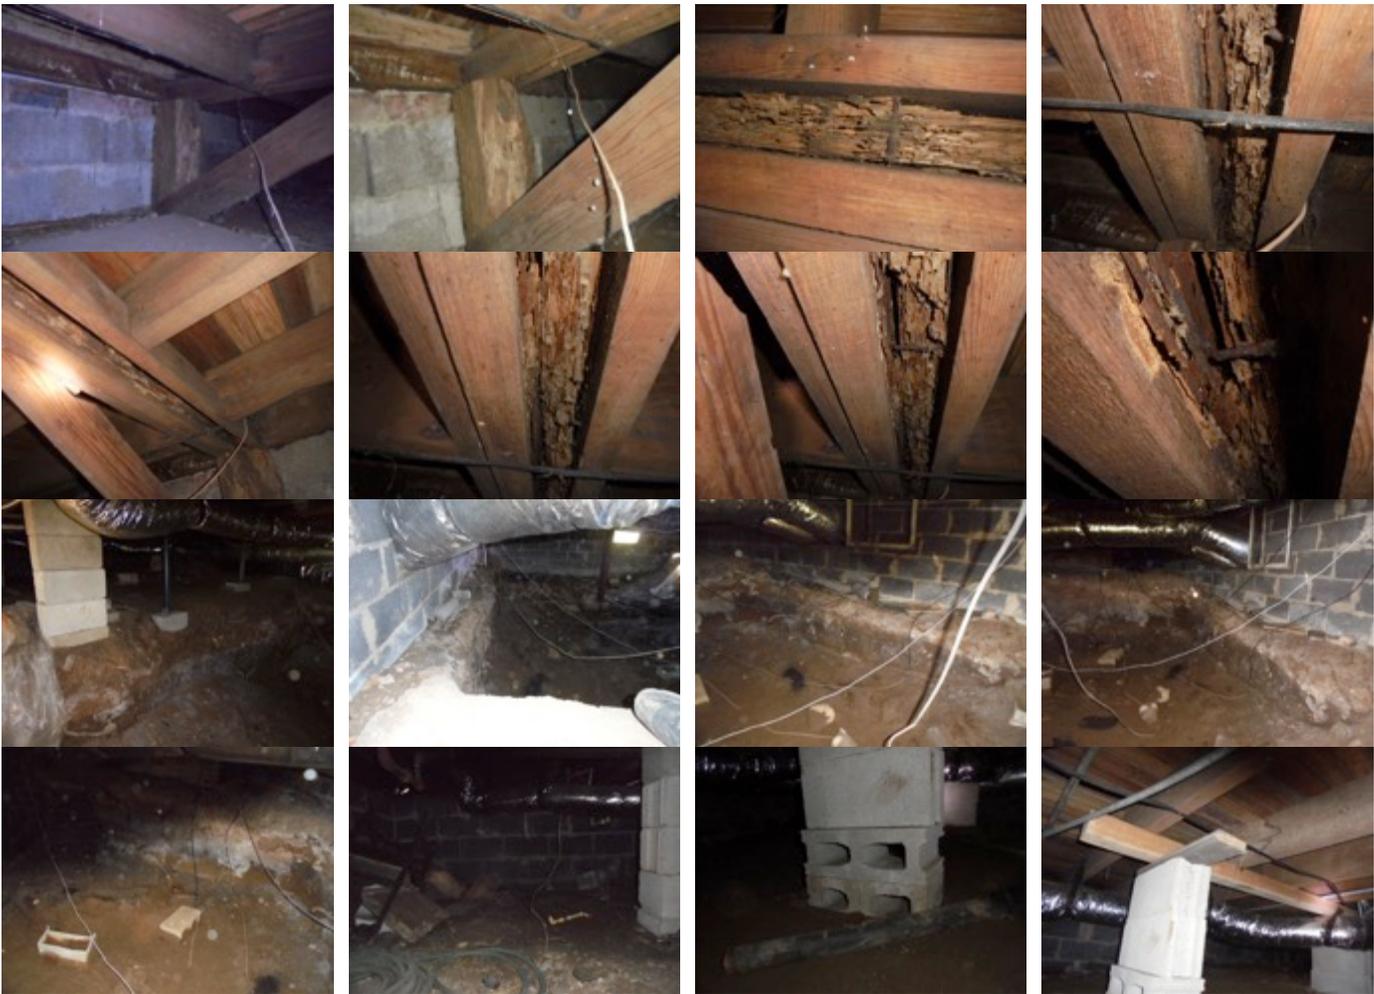
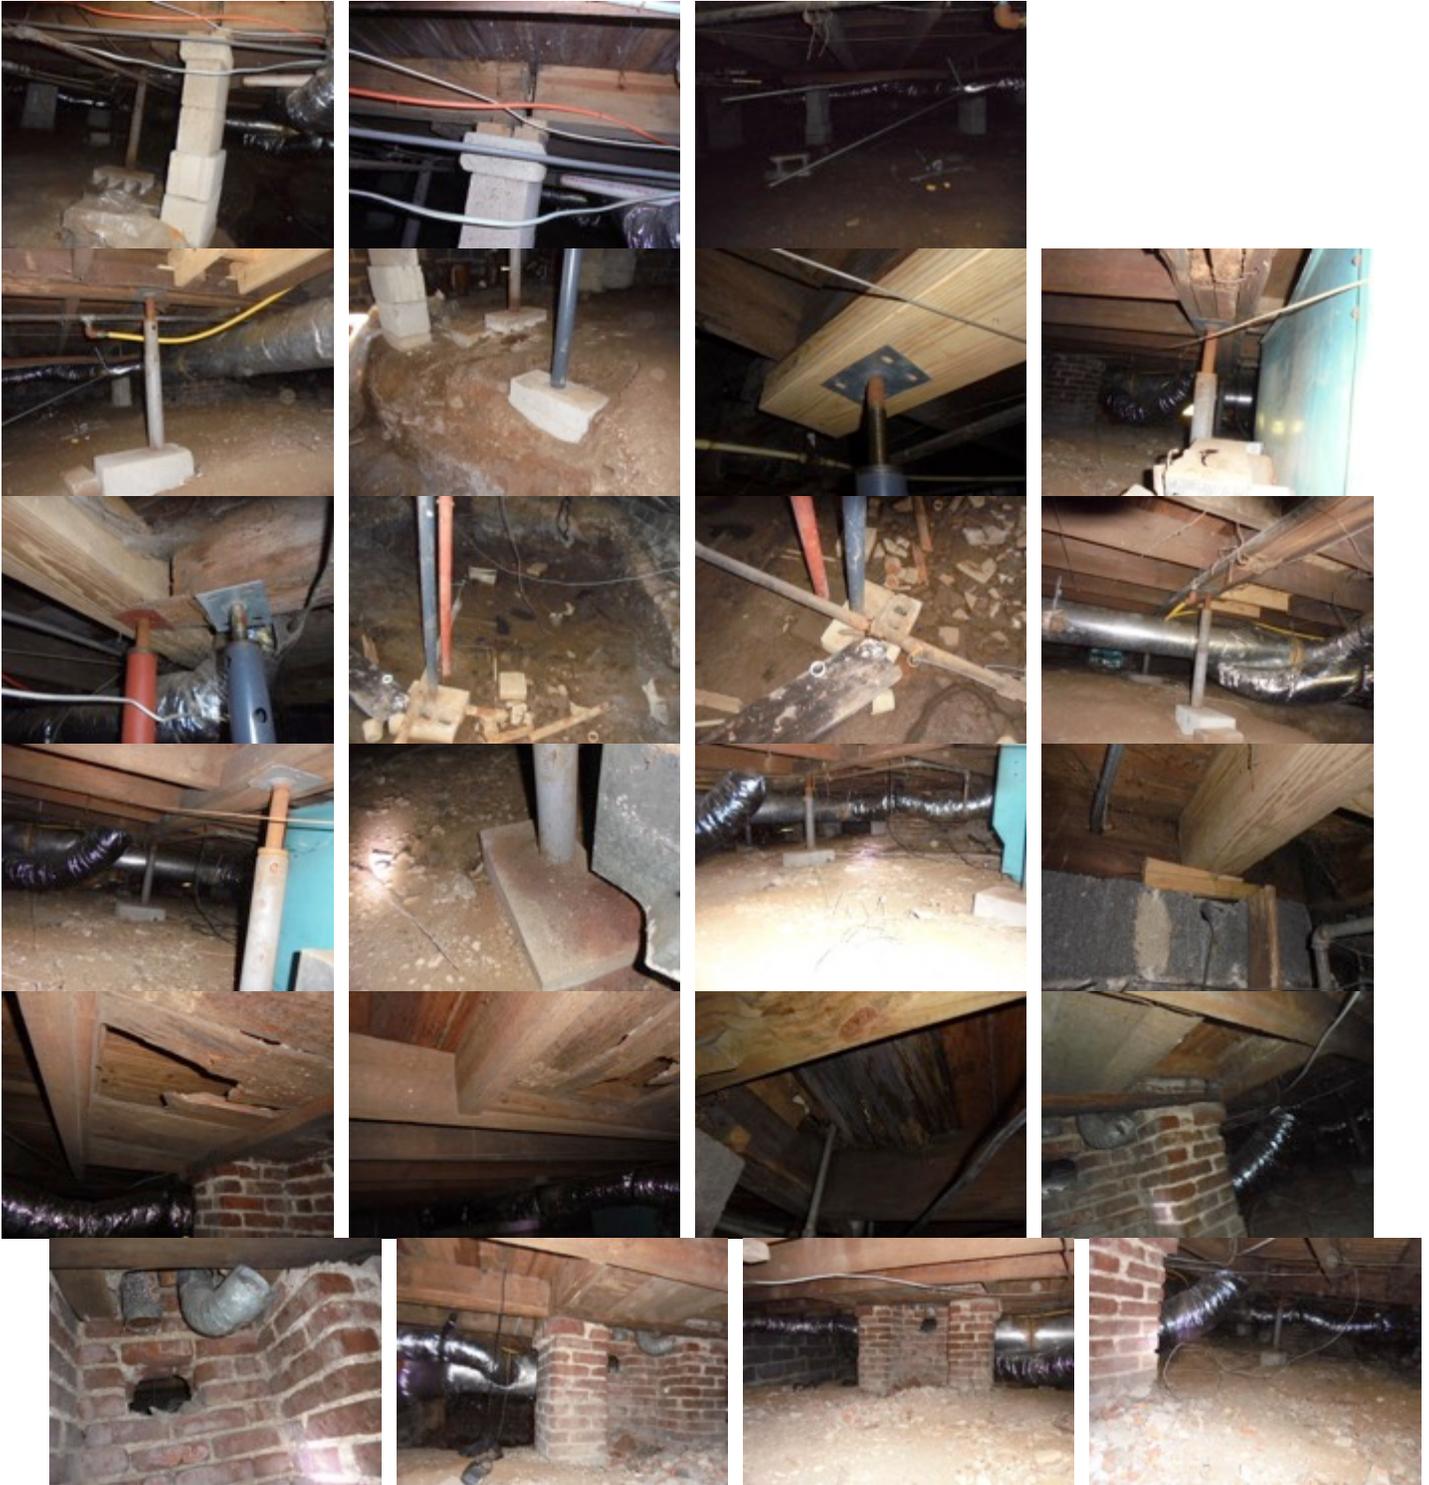
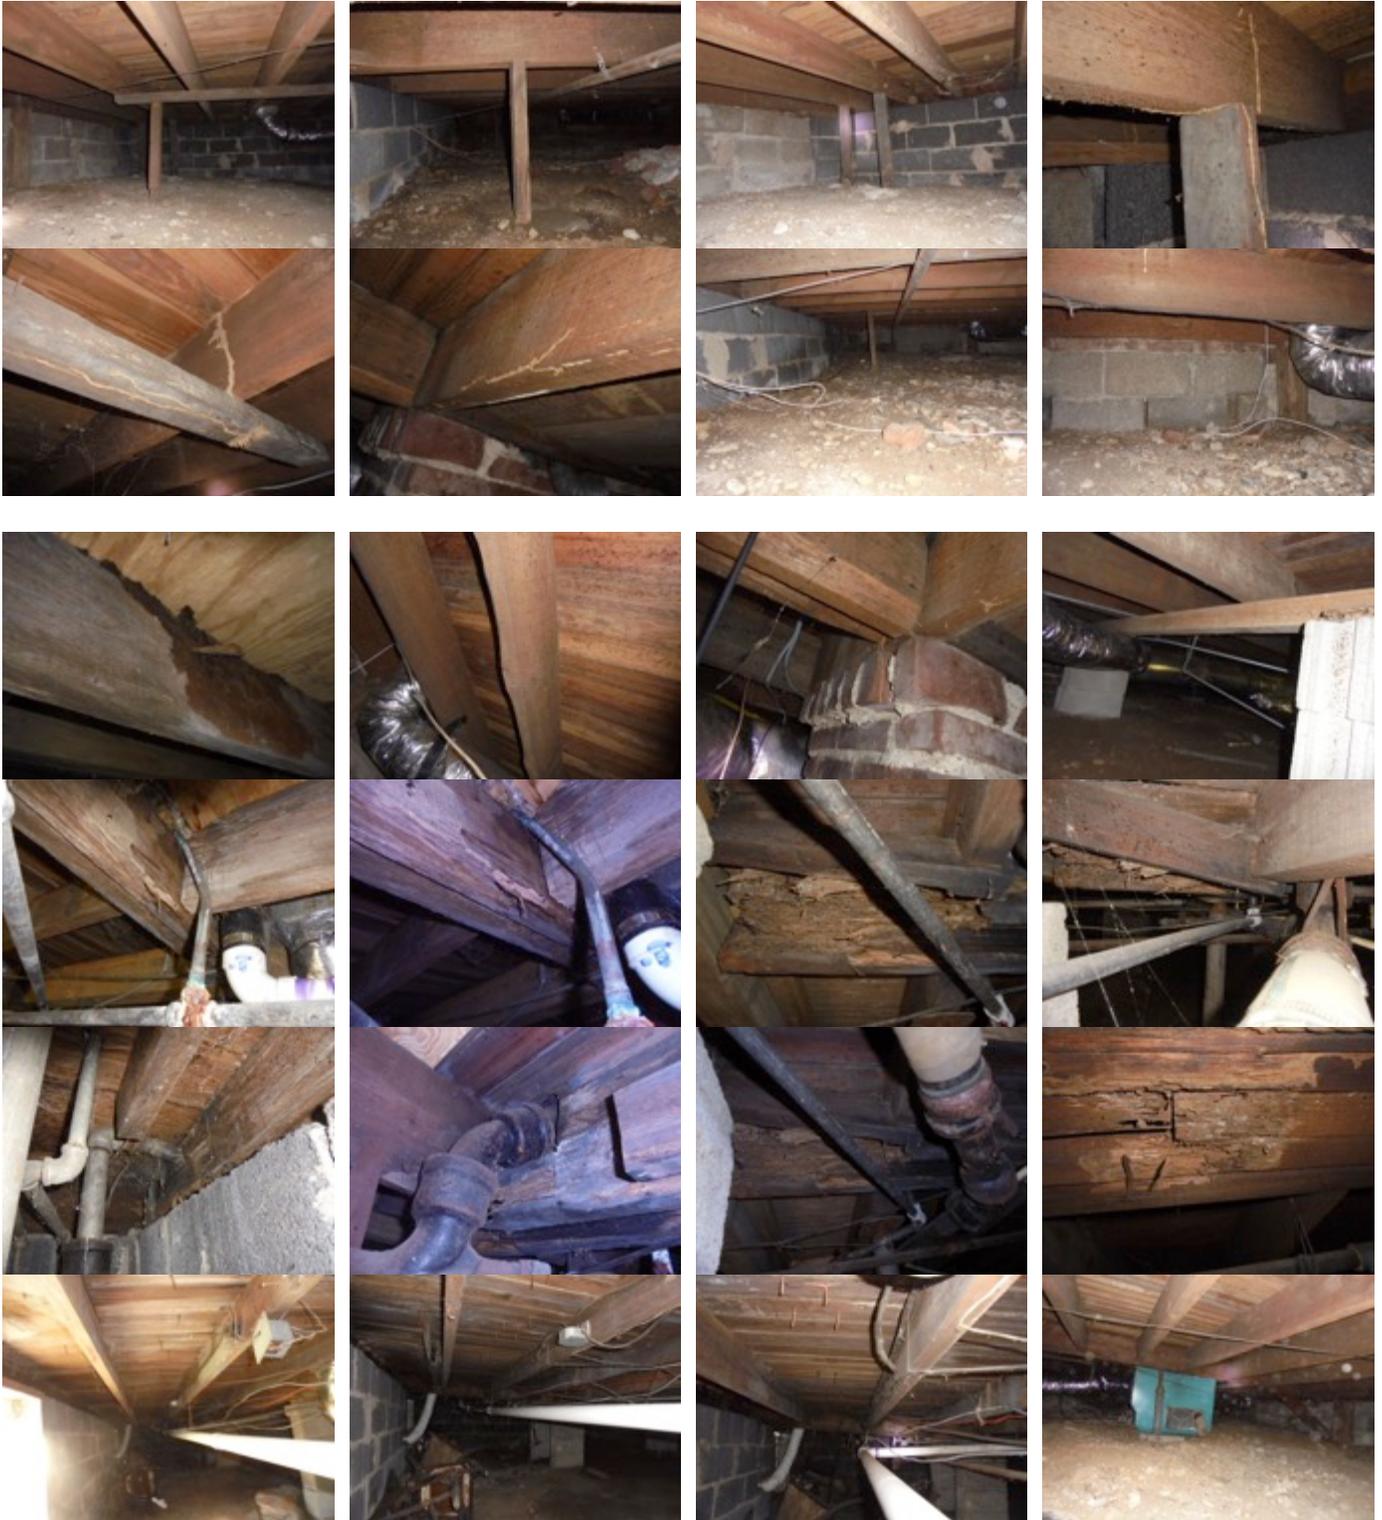
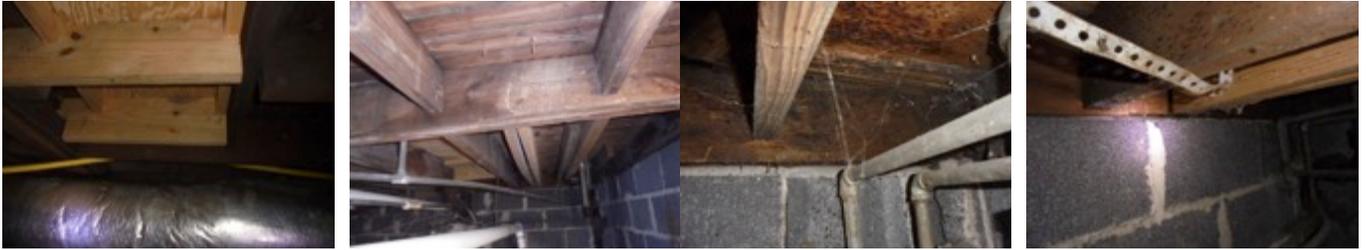
1. **Several structural concerns were seen in the crawl space.** Main wood girder beam that runs front-to-back under the center of the house is destroyed by termites under front rooms and back of house, and could fail at anytime. Main wood girder beams are deteriorated and separating. Dirt termite shelter tubes and damage found down center wood girder beam that runs from front to back in the crawl space. In the crawl space, wood girder beams are sitting directly on concrete block piers. Normally, codes require a plastic vapor barrier to separate this untreated wood from any masonry. Wood boards are

rotted out under both fireplace hearths. Fungus noted on side of at least one floor joist. Some concrete block piers are dry stacked with their blocks turned the wrong (weak) way on their sides. Per code 606.5.1, hollow concrete block piers should be capped with 4 inches of solid masonry or concrete or shall have cavities of the top course filled with concrete or grout or other approved methods. In the crawl space, concrete block piers are spaced far apart which has caused sagging in floors, walls and ceilings. In the crawl space, I see several adjustable steel jack posts used for support. Some floor joists are spaced unevenly. Ends of some floor joists are not supported in rear center crawl space where center beam and its side ledger strips are deteriorated at plumbing pipes. Floor and rear cabinet in kitchen slopes badly toward the rear where main wood girder beam is destroyed and floor framing is about to fall. In the crawl space, some wood floor joists are notched out. Codes only allow a notch of 1/6 the depth of the joist. Some joints in wood beams are not supported. Some wood sill plates are deteriorated, leaving ends of some floor joists unsupported. Left rear concrete block foundation wall has a vertical crack outside. This is the low corner under the house where water runs to and it is muddy and water stands in the crawl space during rain. Substantial repairs or demolition is required to the home. Reference pictures below:

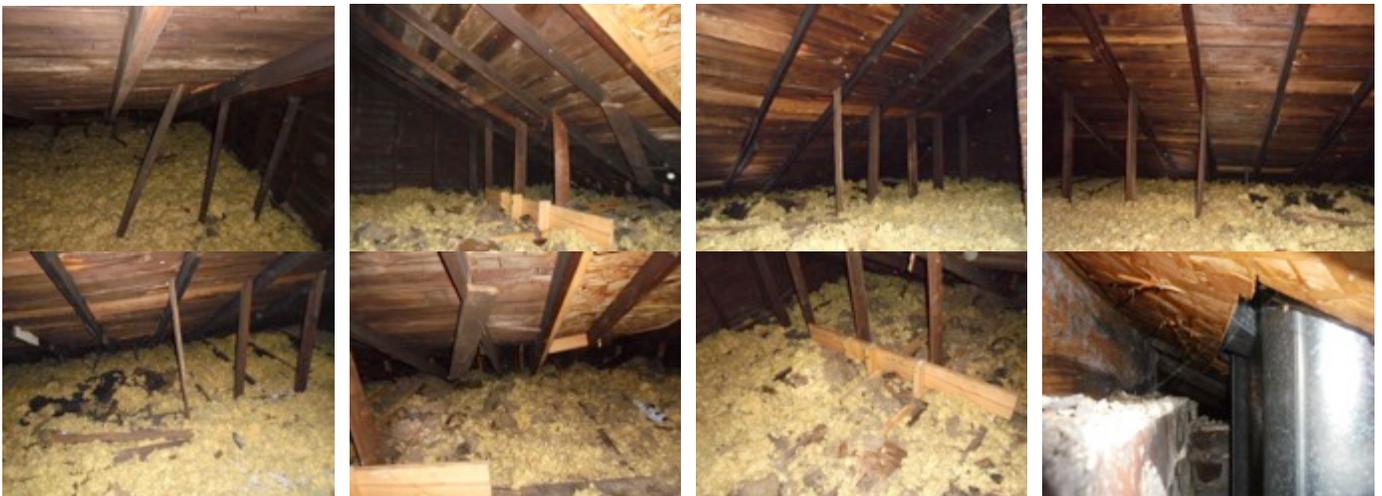
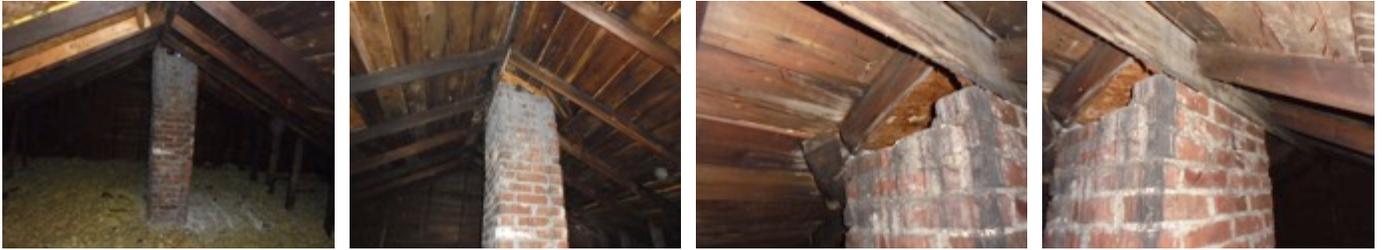
2. **Several structural concerns were seen in the attic.** Roof ridge is sagged badly in the middle. Front porch ceiling sags in places. In the attic, collar ties (collar beams) are missing. Collar ties are the horizontal boards nailed across the upper third of the roof rafters. They are supposed to be on every 3<sup>rd</sup> rafter. Code 2320.12.6 and 802.3 require rafter ties (collar ties/collar beams) at least every 4 feet, which is usually every third set of rafters. A continuous strong back is recommended under mid-span of these small roof rafters. Any brace exceeding 6-feet in length must be T-blocked 2/3 the length. Most of the roof rafters are small members and spaced far apart, causing them to sag. Per seller, a front roof dormer was removed when the roof was replaced because it was leaking. Old brick chimneys are sealed off under roof.

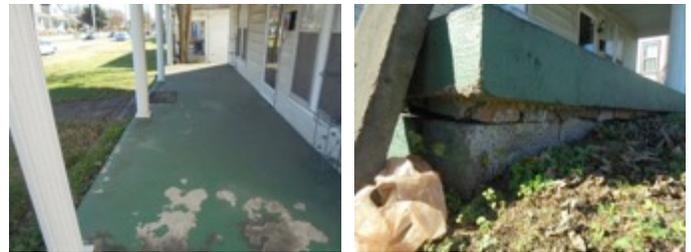
3. **Front porch has settled and cracked.** I couldn't see under it to see how it is supported. Left front corner of concrete porch needs supporting better. Tuck-point gaps in foundation.
