**METROPOLITAN GOVERNMENT OF NASHVILLE AND DAVIDSON COUNTY**

**STAFF RECOMMENDATION**  
**1825 5<sup>th</sup> Avenue North**  
**June 21, 2017**

**Application:** Demolition  
**District:** Salemtown Neighborhood Conservation Zoning Overlay  
**Council District:** 19  
**Map and Parcel Number:** 08108026400  
**Applicant:** Grant Hammond  
**Project Lead:** Paul Hoffman, paul.hoffman@nashville.gov

**SUBJECT: Residential Condition Assessment Letter**  
**1825 5th Avenue North, Nashville, TN**  
**SE&I Project No: 16-1588**

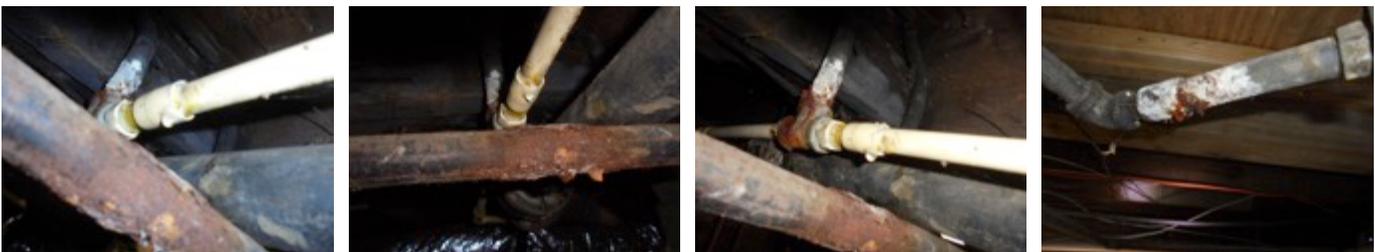
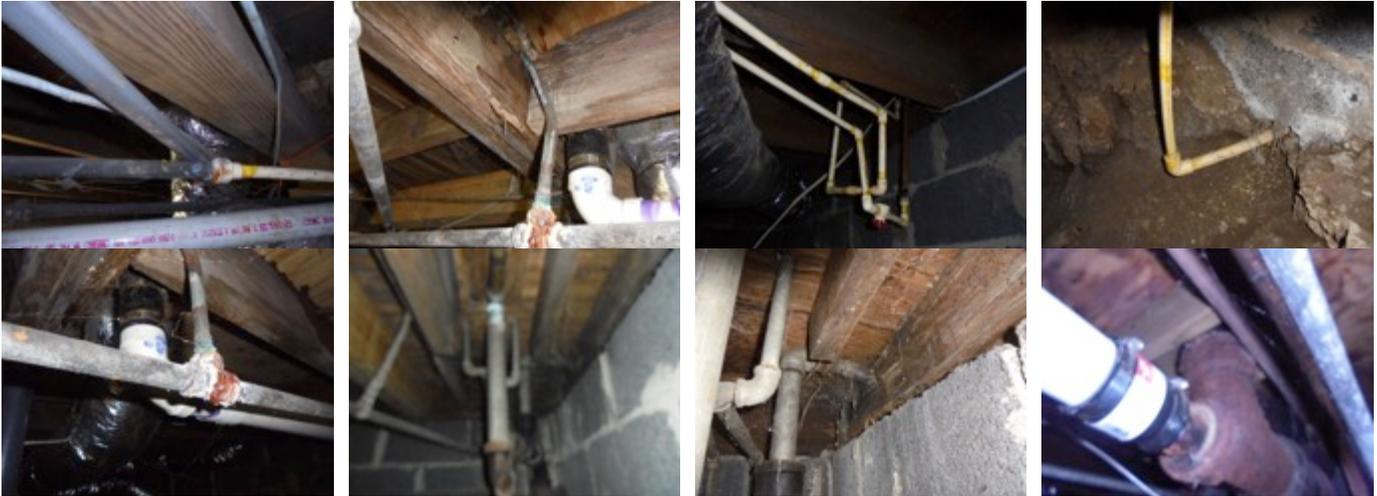
5. **Some old galvanized pipes are rusted badly and leaking.** Several drain pipes are rusted badly too.
