STAFF RECOMMENDATION
628 Shelby Avenue
December 19, 2018

Application: Demolition
District: Edgefield Historic Preservation Zoning Overlay
Council District: 17
Map and Parcel Number: 09304004000
Applicant: Crystal Love
Project Lead: Paul Hoffman, paul.hoffman@nashville.gov

Structural Observance for 628 Shelby Ave., Nashville, TN 37206

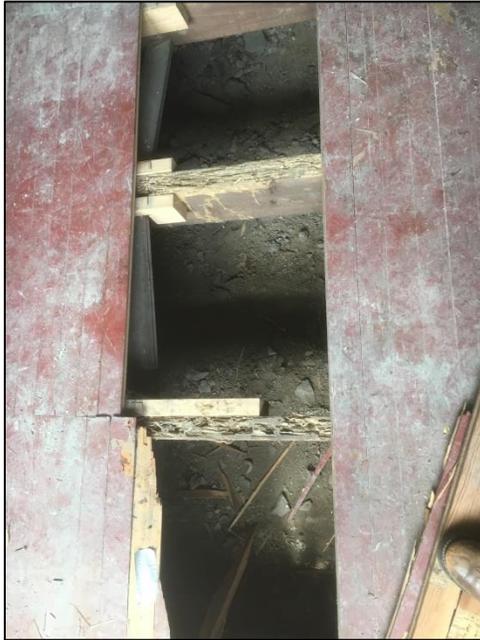
Figure 2. Termite-damaged floor joists

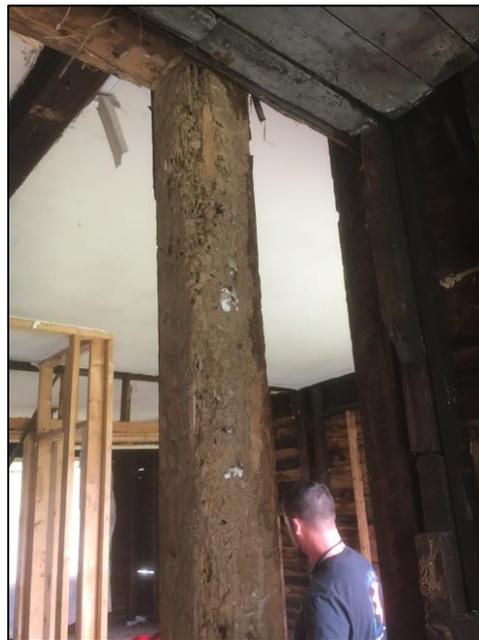
Figure 3. Termite activity carries up to ceiling joists

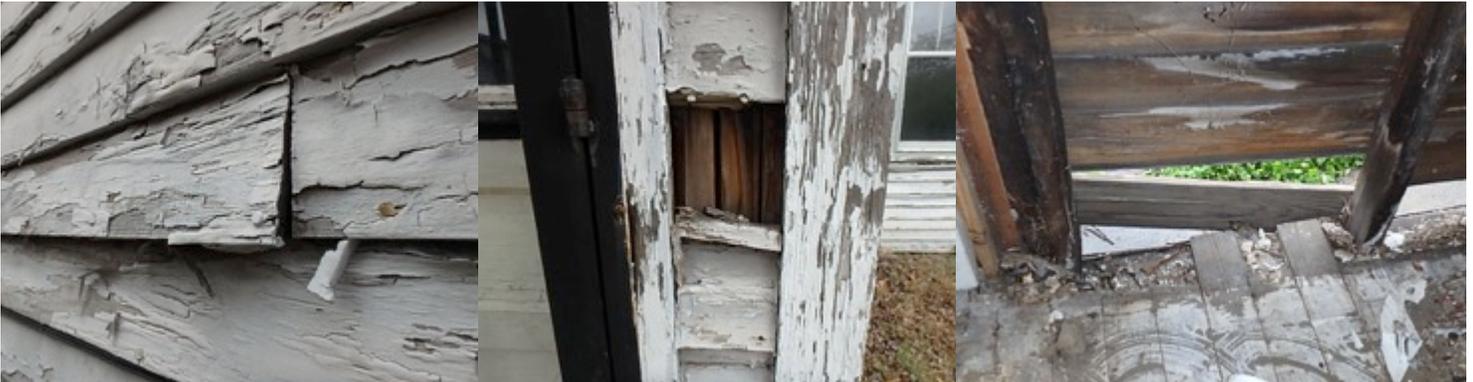
- The wood cladding on the exterior walls, trim at doors and windows, soffits and fascia appear to be beyond repair. Several areas of gaps were noted in the wood cladding, trim, soffits and fascia. Much of the siding is loose and cracked. Areas of the framing are exposed. Evidence of moisture intrusion was noted. Replacement is recommended by a licensed contractor.

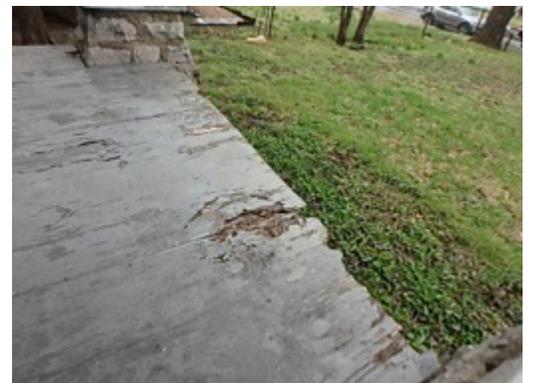
- Soft wood was noted on the front porch. The front porch is falling in and is unsafe. Replacement is recommended by a licensed contractor.

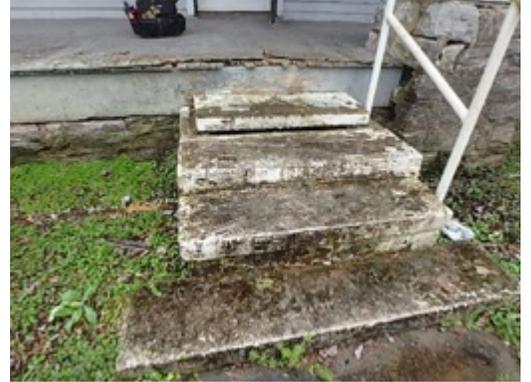
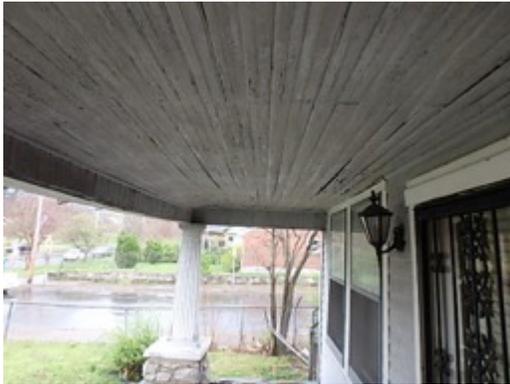
- **The front porch steps have settled. The risers have different heights. This is presenting a fall hazard. Replacement is recommended by a licensed contractor.**

- **The front porch ceiling is damaged and appears to be sagging. Repairs/replacement should be made as needed by a licensed contractor.**

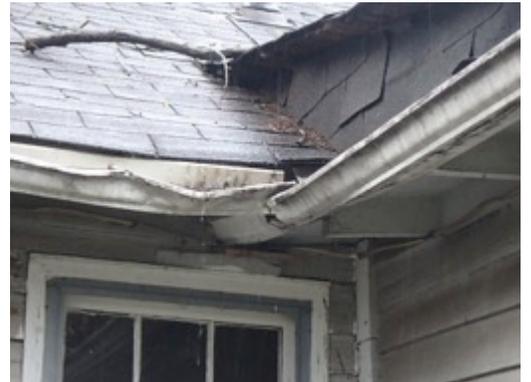
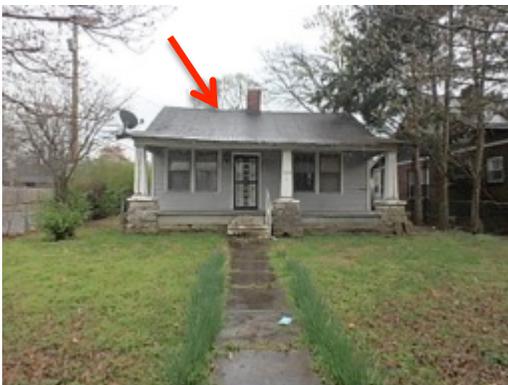
- **Missing and damaged gutters and downspouts were noted at the roof eaves. Gutters and proper downspouts are recommended by a licensed contractor to maintain proper drainage/moisture control.**

- **Cracking and low spots were noted in the sidewalk. This is causing a potential trip/fall hazard. Replacement is recommended by a licensed contractor.**

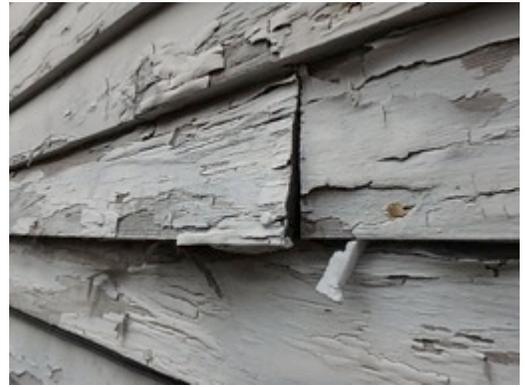
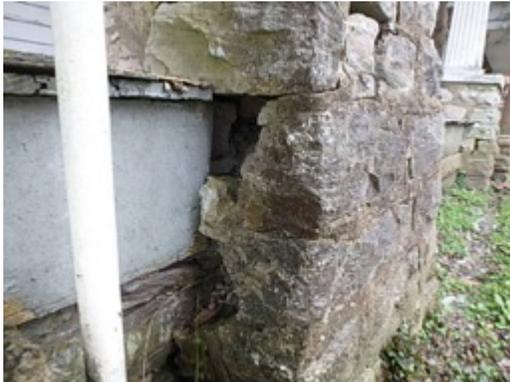
- **Lead base paint testing is outside the scope of this inspection. The paint on the exterior of the home has cracked and falling off. There is possibly lead in the paint due to the age of the home. It is recommended to have the paint tested by a qualified professional with remediation performed as needed by a qualified specialist.**

- **Missing stones and cracks were noted in the columns on the front porch. Repairs should be made as needed by a licensed contractor.**

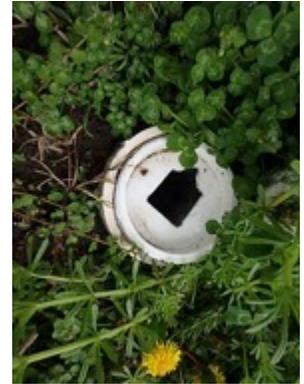
- **A damaged sanitary drain cleanout was noted in the rear yard. Replacement of the cap is recommended.**

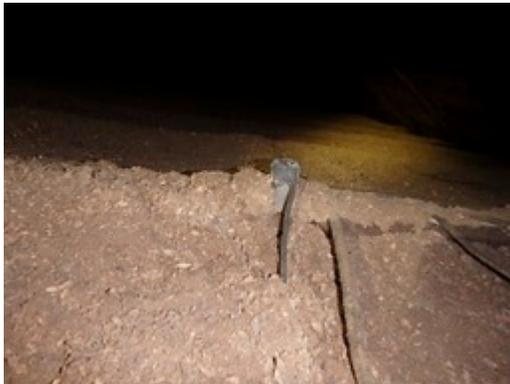
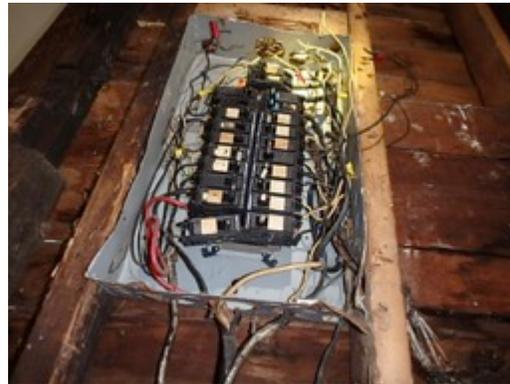
- **Knob and tube wiring was visible in the attic and interior walls. Knob and tube wiring should be removed to maintain safety. The service panel does not appear to be serviceable. The wires at the breakers in the service panel have been cut. Power was noted at the main breaker. There was not faceplate installed. This is a latent electrocution and fire hazard. A faceplate should be installed as soon as possible. No outlets were noted. Exposed wires were noted on the rear eve. The exposed wire should be contained in proper conduit. It is recommended to have the existing electrical components removed and replaced as needed by a licensed electrical contractor to maintain safety and function.**

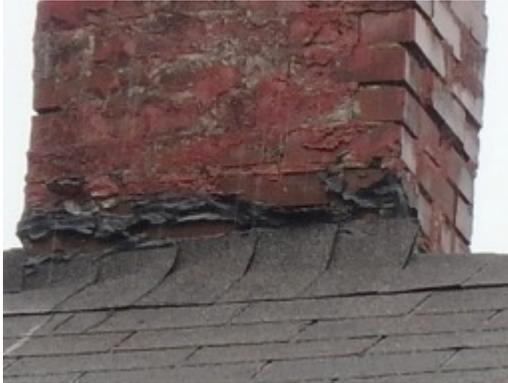
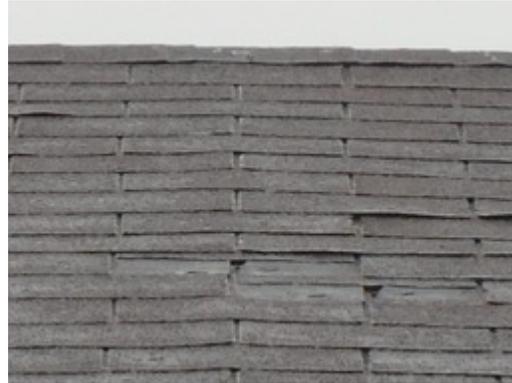
- **The roof is in poor condition. Damaged, lifted and missing shingles were noted. No flashings were noted at the chimney. Moisture intrusion was visible in the attic. Damaged roof sheathing was noted in the attic. Areas of deflection were noted in the roof structure. Replacement of the roof covering and areas of the roof decking should be expected. Further investigation of the roof and components is recommended by a licensed roofing contractor with corrections made as needed.**

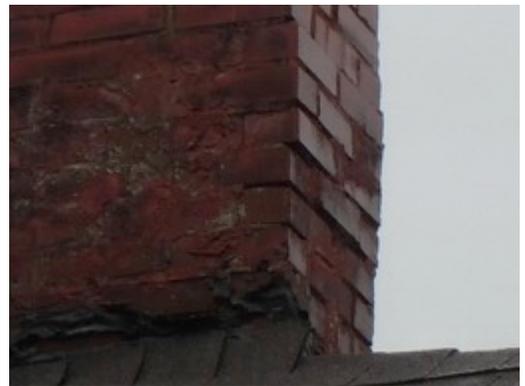
- **The chimney over the roof is damaged. No proper cap was noted. The liner in the visible area of the chimney in the house is damaged. It is recommended to replace the chimney. Further investigation of the chimney is recommended by a licensed chimney specialist with corrections made as needed.**

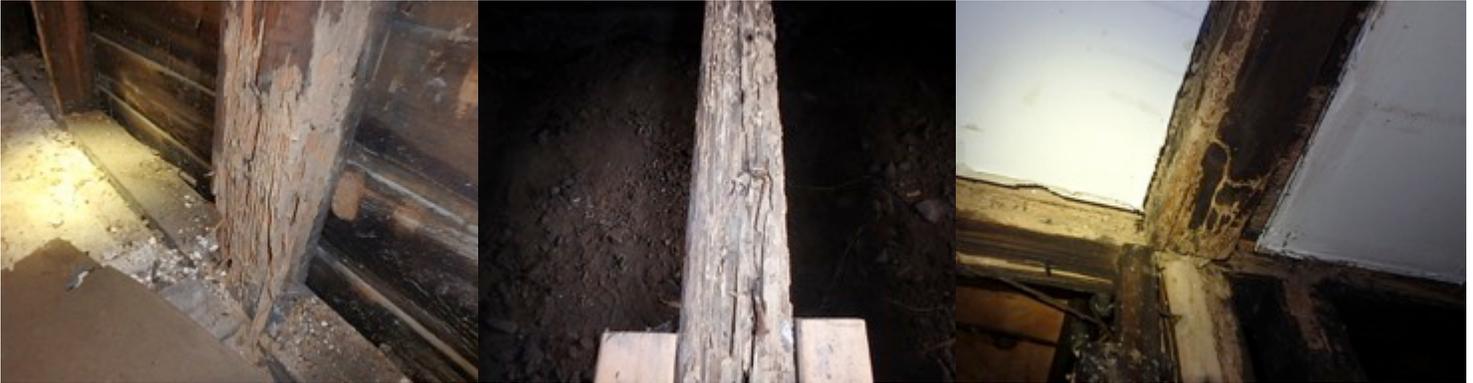
- **The structure of this house in very poor condition. Extensive damage from wood destroying insects was visible on the exposed floor joists, wall studs and areas of the ceilings. Replacement of much of the framing should be expected. Sagging was noted in areas of the floors, ceilings and walls. Deflection was noted in the ridge on the roof. Cracks were noted in areas of the foundation walls. Further investigation of the home is recommended by a structural engineer with corrections made as needed.**

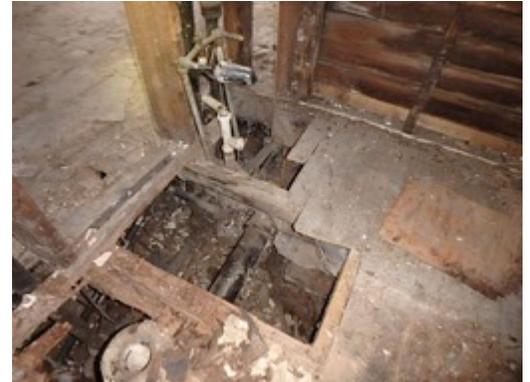
- **No plumbing fixtures or appliances were installed. The visible areas of the plumbing drains and supply piping do not appear to be serviceable. Replacement is recommended by a licensed plumbing contractor.**

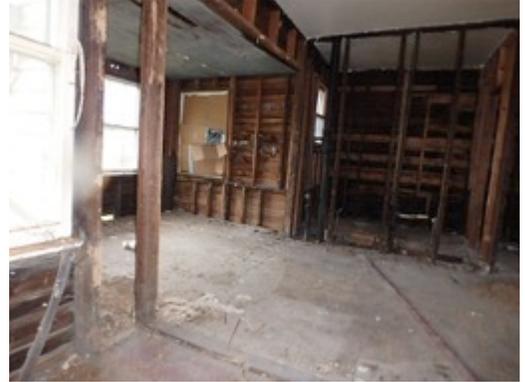
- **No wall coverings were noted on the interior walls. Missing floor coverings were noted throughout the home. Damaged and missing ceiling coverings were noted. Missing doors were noted. Repairs/replacement should be made as needed by a licensed contractor.**

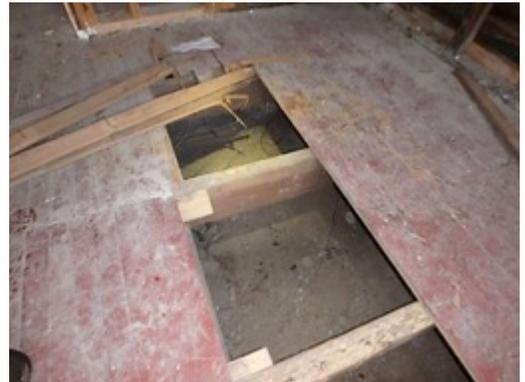
- **The crawlspace was not accessible for inspection. The opening at the rear wall is too small to enter. The only areas of the crawlspace visible were from the areas of missing floor coverings in the interior. Most of the crawlspace was not accessible/visible. It is recommended that the crawlspace be made accessible. Further investigation is recommended by a licensed contractor with corrections made as needed.**

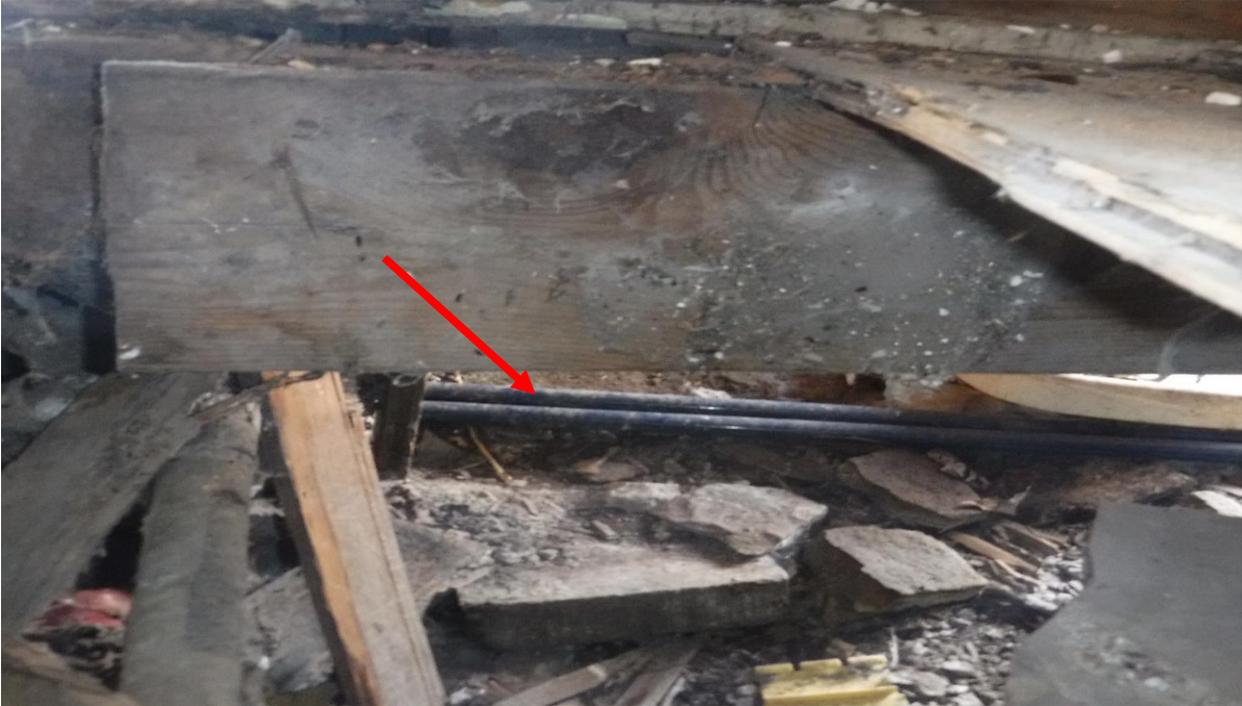
- a. There were sections at the rear of the house that did not appear to have a foundation (See Photo #1). Gaps in the foundation do not provide adequate support for the structure.

Photo #1: Missing Section of Foundation

Recommended Action: Due to the extent of damage to the existing foundation, missing sections and gaps in the foundation, lack of lateral restraint for the foundation, lack of crawl space clearance, rotating of the porch piers and undermining of the foundation, I recommend to replace the foundation of the house and porch in its entirety with a new foundation.

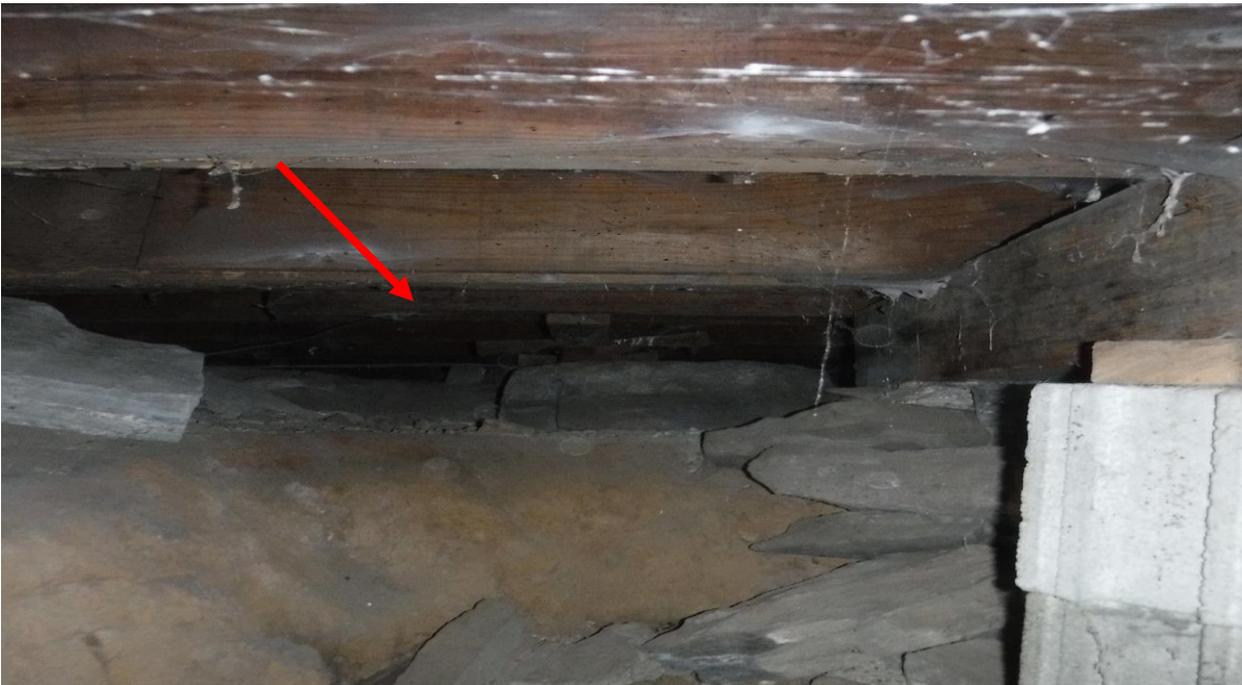
- b. There was minimal crawl space clearance that prevented access to some areas of the crawl space (See Photo #2). This condition can cause dry rot, and termite intrusion to the floor framing.

Photo #2: Minimal Clearance Height of Crawl Space

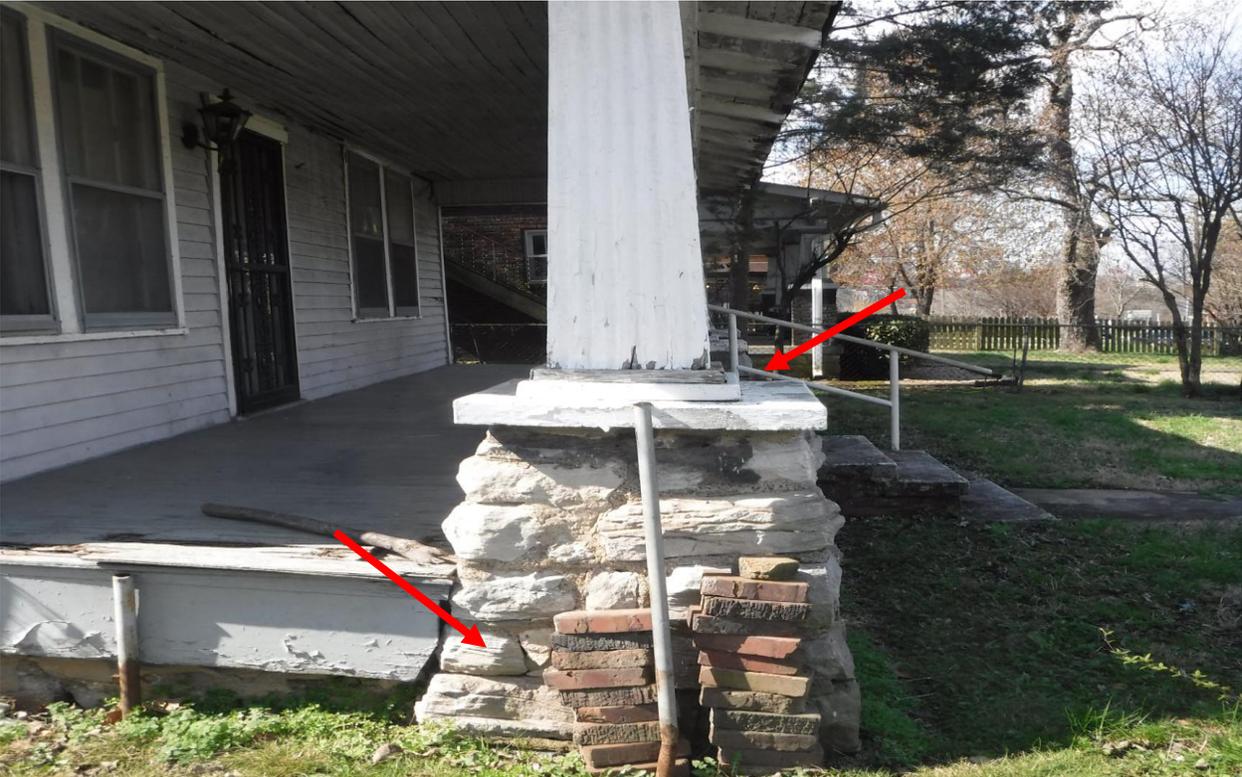
- c. The front porch piers have settled and rotated (See Photo #3). This has caused issues to the framing above.
- d. The floor elevation was measured throughout with a liquid high-precision altimeter "zip level" to compare the floor elevation for flatness. This is important to check because in some situations floors can settle, due to varying causes, usually stemming from soil settlement in parts or entirely throughout foundations. These floor measurements showed the floor diaphragm to be drastically outside the normal, acceptable tolerances of 1" of vertical displacement to every 20' lateral feet of distance. From the front to the rear of the structure, the foundation has settled approx. 3-1/2". This is most likely due to the issues noted above with the floor frame structure, support framing and site/crawl space drainage. This has even caused the front wall of the house to rotate (See Photo #4).

Photo #3: Settlement/Rotation of Porch Piers

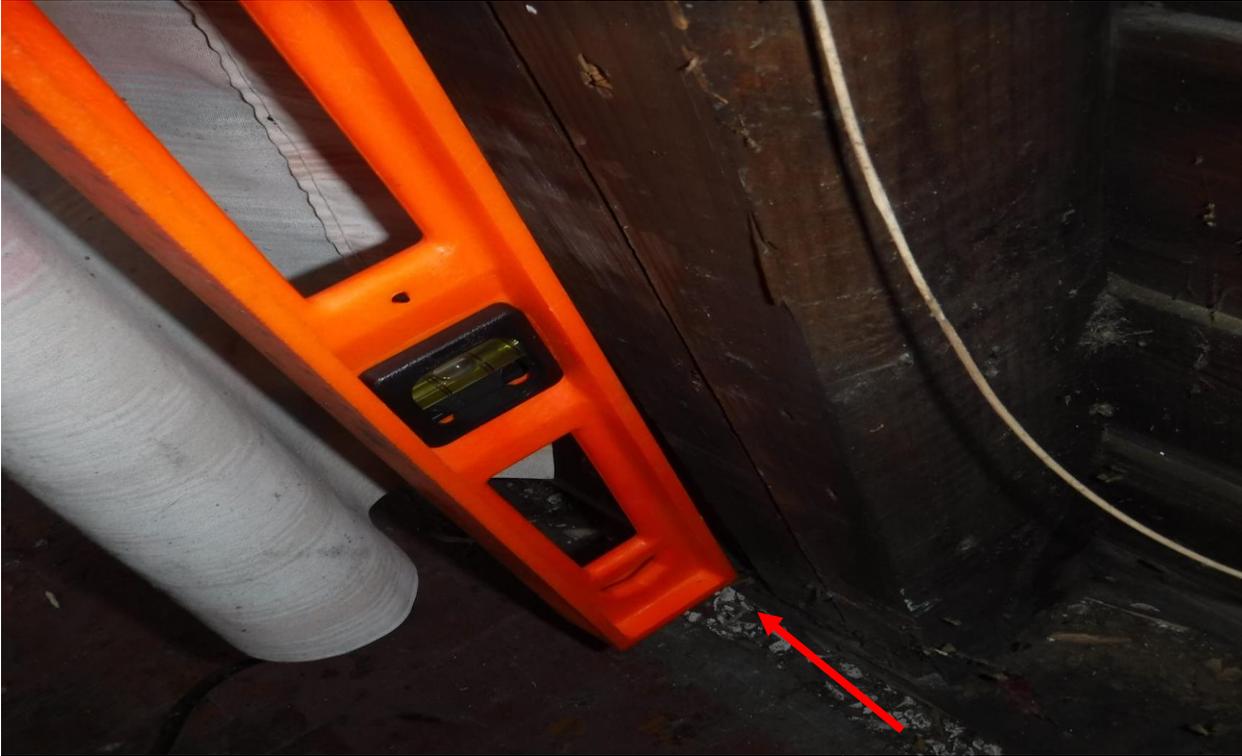
Photo #4: Wall out of Plumb

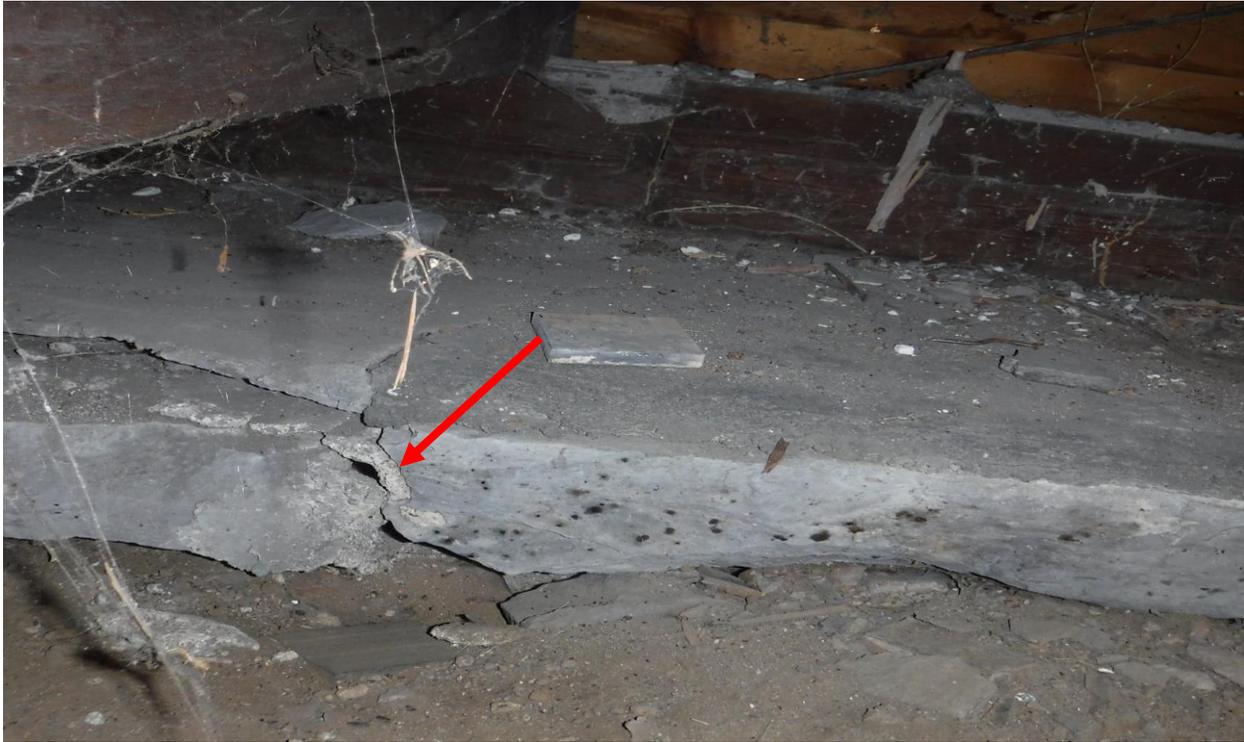
- f. There were multiple settlement cracks through the foundation (See Photo #5). This settlement had caused structural damage to the foundation.
- g. There were multiple gaps between the stones in the foundation (See Photo #6). These gaps create weak spots in the foundation, which can cause settlement of the structure and allow pests to enter the crawl space.

Photo #5: Settlement Cracking of Foundation

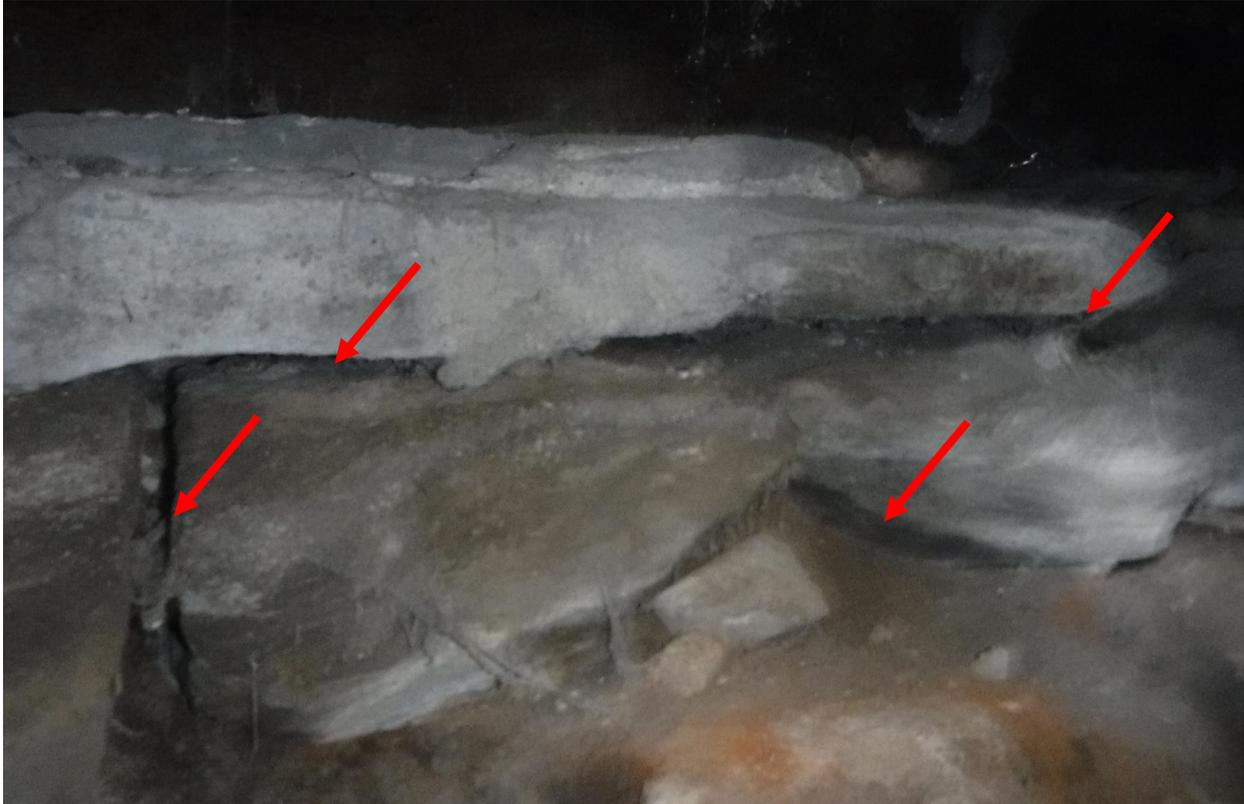
Photo #6: Gaps in Foundation

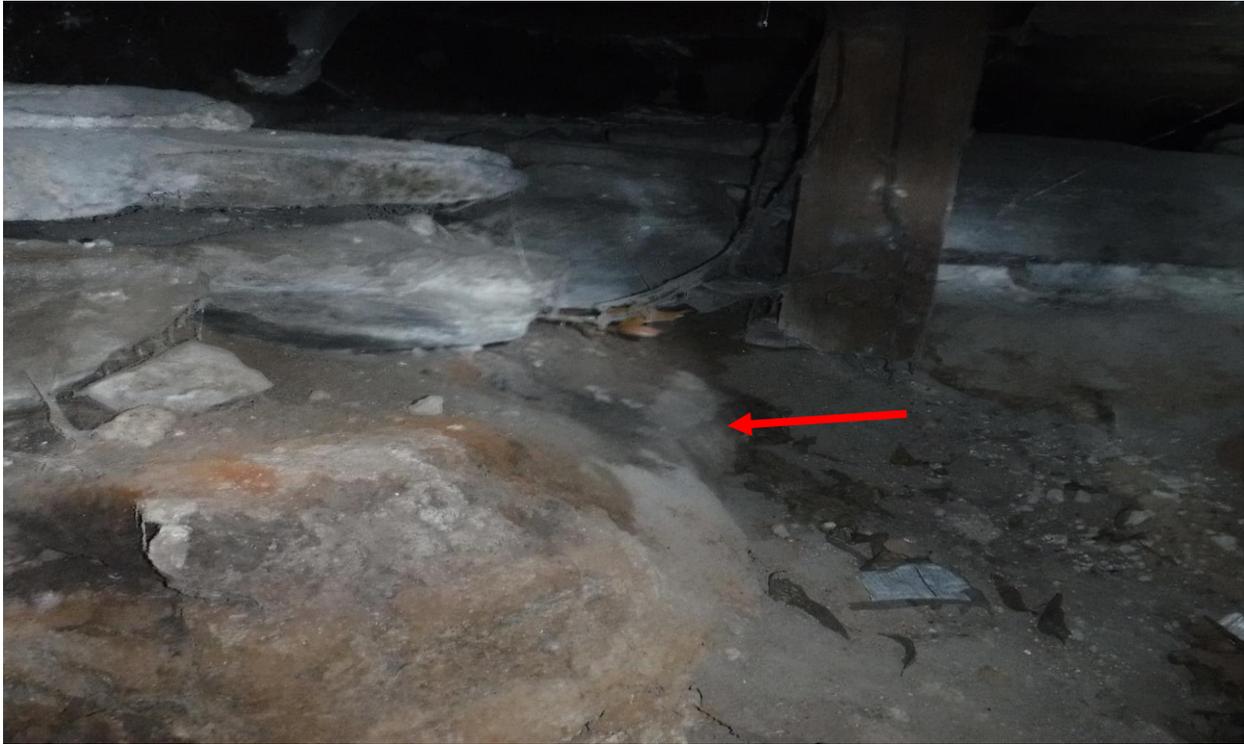
- h. Sections of the crawl space were excavated next to the foundation (See Photo #7). This excavation undermines the foundation and can cause settlement and structural damage to the structure.

Photo #7: Excavated Soil and Undermining of Foundation

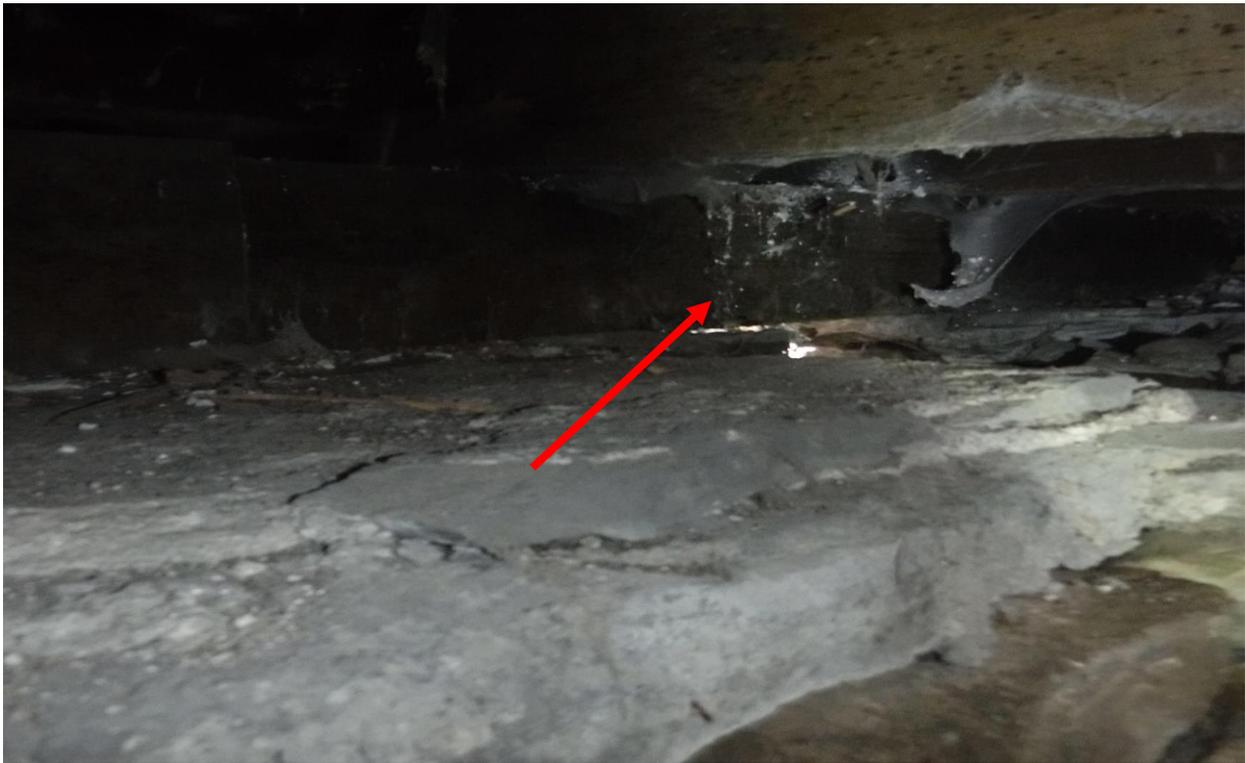
- a. The rim joist alone support the exterior walls and roof (See Photo #8). This condition marginally supports the structure. A lateral event, such as a strong wind event, could cause overturning of the structure at this location.

Photo #8: Rim Joist Supporting Structure

Recommended Action: Due to the extent of mold, damage, poor design and construction, it is recommended that the entire framing system be removed and replaced. Professionally engineer and install all new framing.

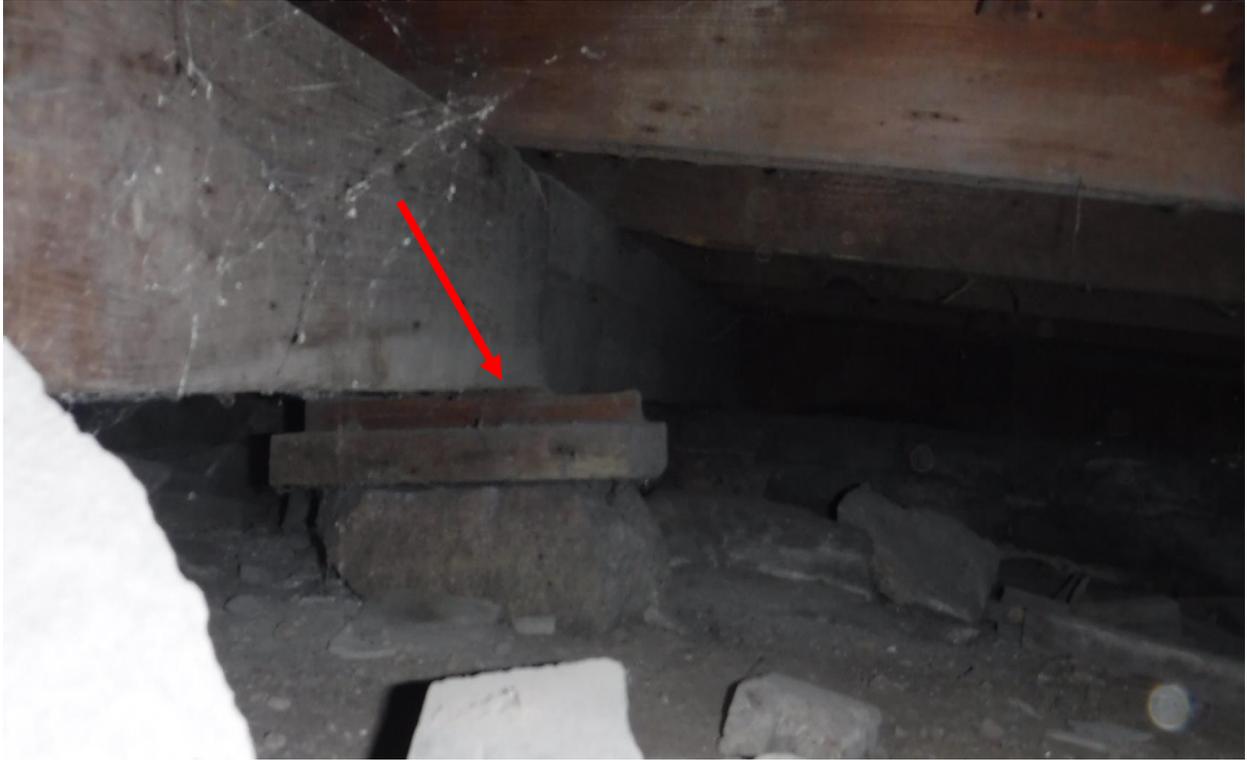
- b. Most of the floor piers have multiple shims supporting the floor girders (See Photo #9). This condition does not properly attach the floor girder to the piers and can cause settlement of the floor.

Photo #9: Shimmed Post

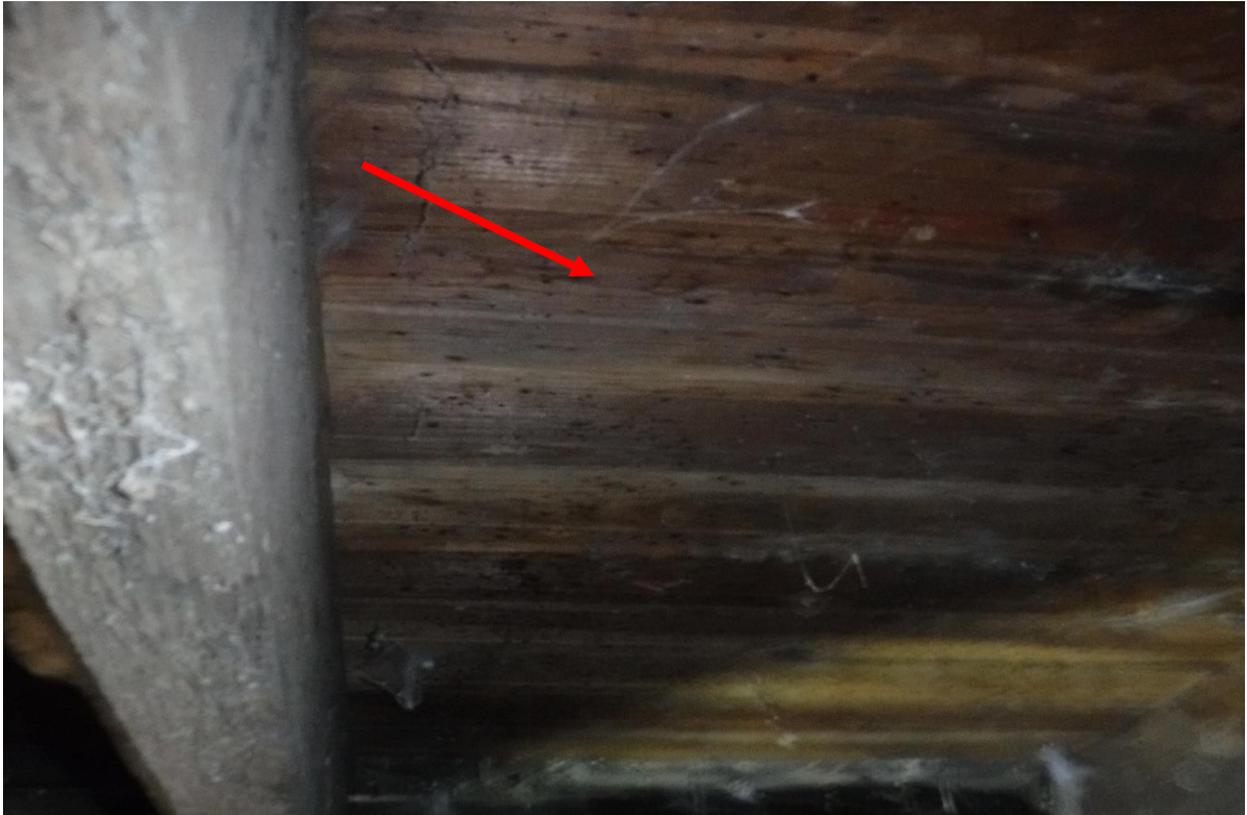
- c. Mold on the floor framing was seen in the crawl space (See Photo #10). This can cause health issues and deterioration of the framing.
- d. Through the majority of the framing of the house, there was either fire damage, termite damage or water damage (See Photos #11-20). The fire damage was located next to the chimney. Termite damage was seen on the floor framing, wall framing and ceiling framing at almost every part of the house. Water damage was seen on the flooring and floor joists, exterior siding, eaves, rafter and soffits, exterior porch subfloor and roof, interior ceiling and ceiling joist and roof sheathing.

Photo #10: Mold on Framing

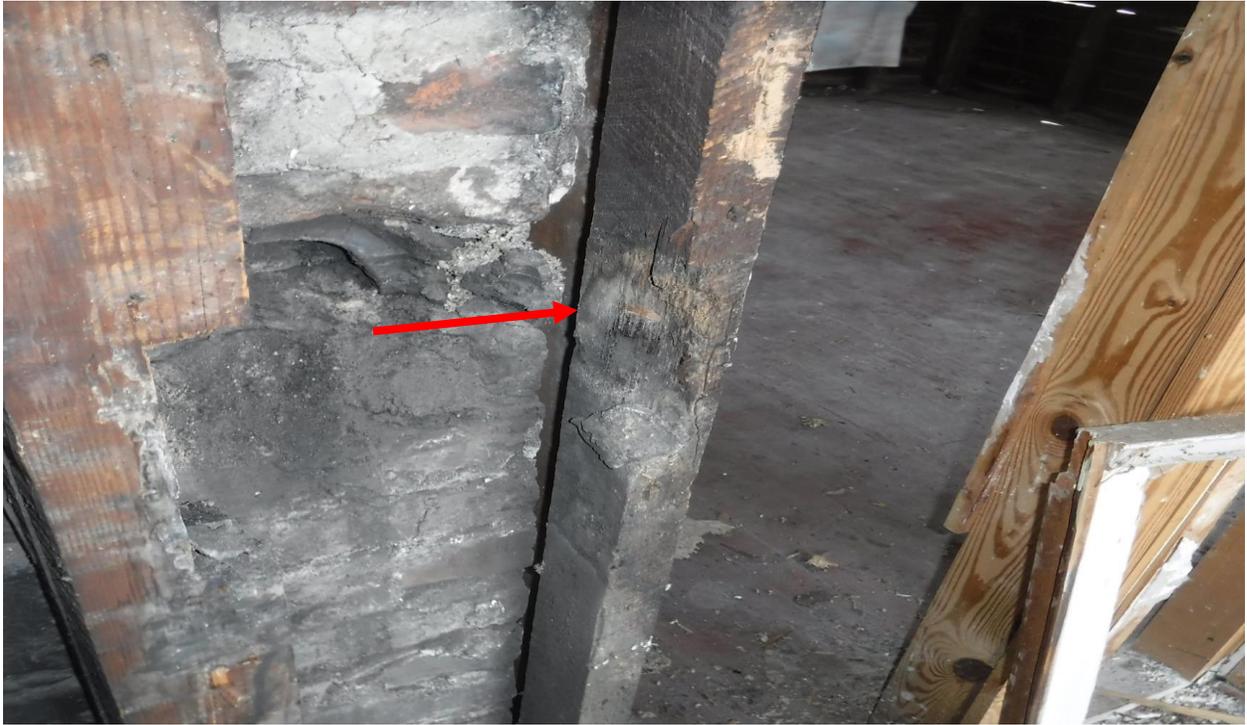
Photo #11: Fire Damage on Wall Stud

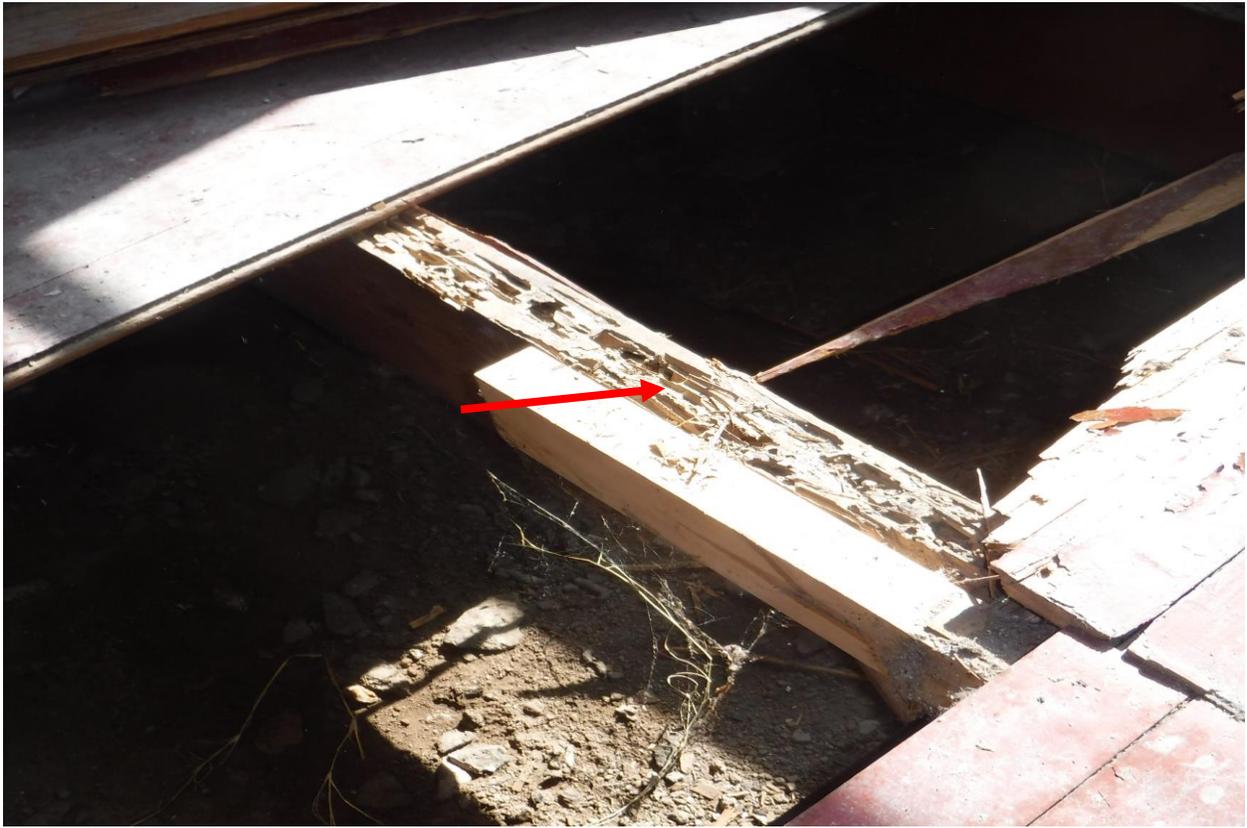
Photo #12: Termite Damage on Floor Joist

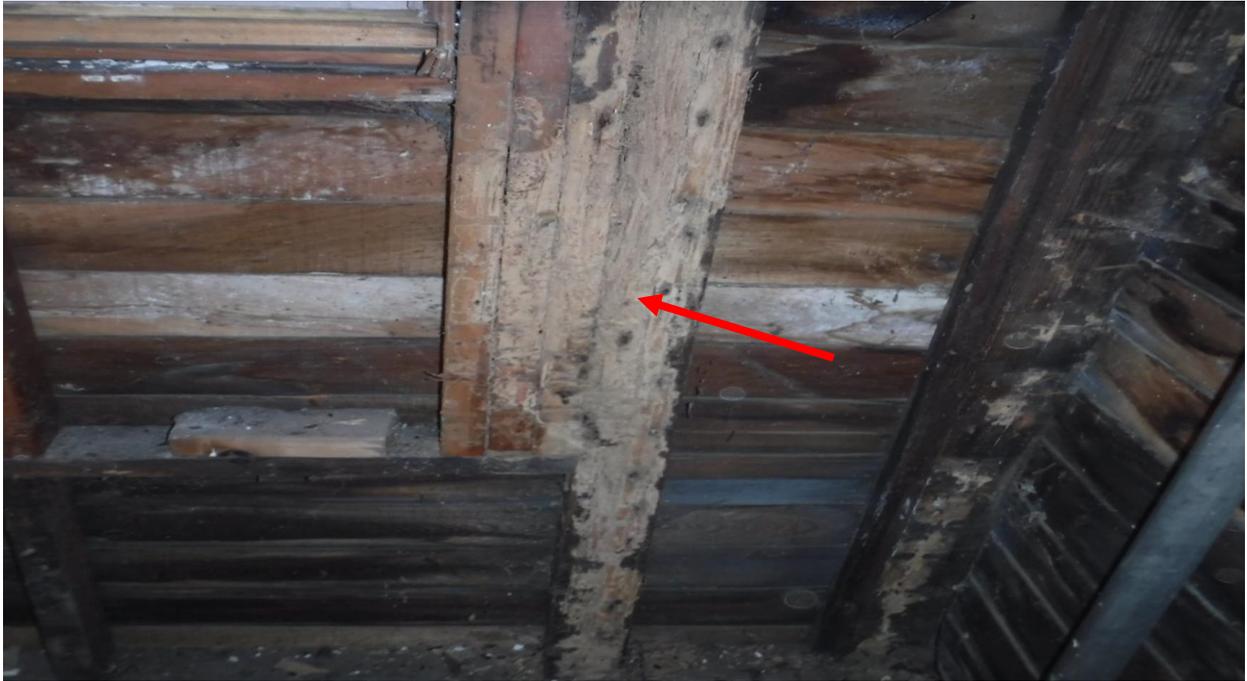
Photo #13: Termite Damage on Wall Stud

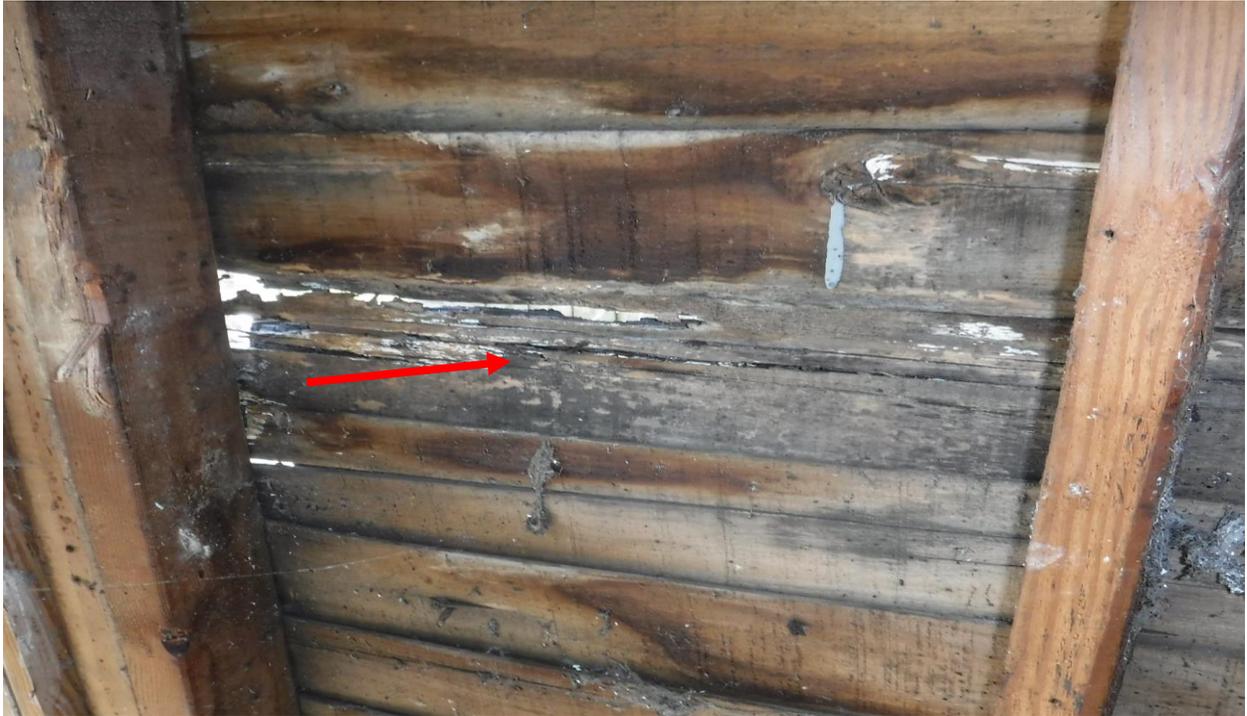
Photo #14: Dry Rot on Siding

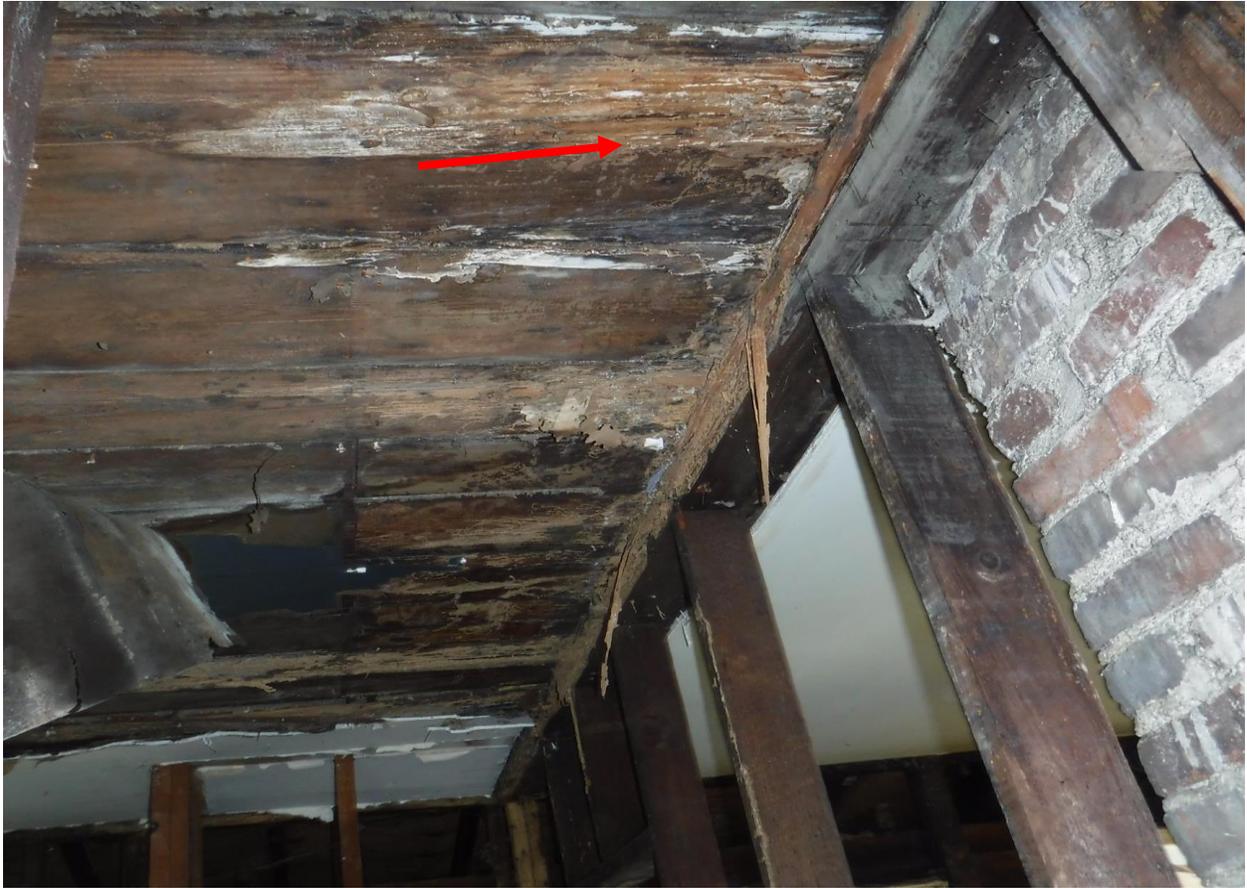
Photo #15: Water Damage on Ceiling

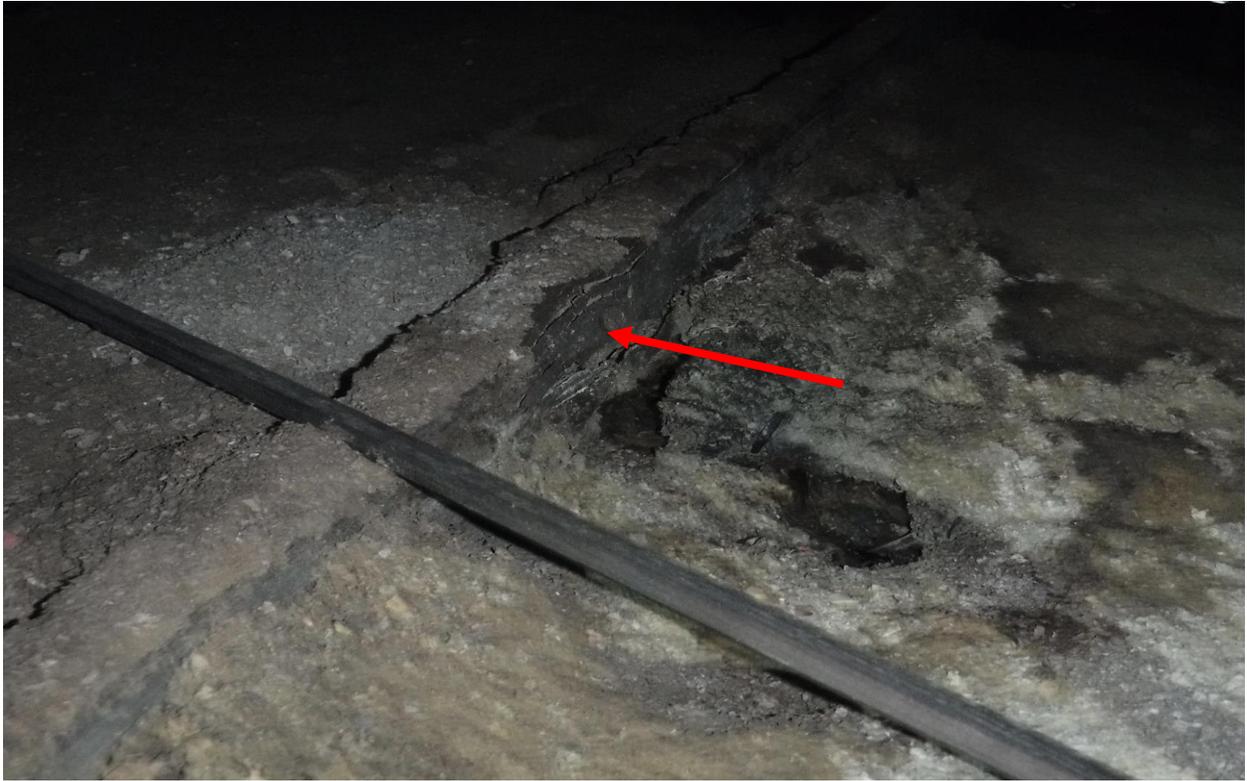
Photo #16: Water Damage on Ceiling Joist
