STAFF RECOMMENDATION
628 Shelby Avenue
December 19, 2018

Application: Demolition
District: Edgefield Historic Preservation Zoning Overlay
Council District: 17
Map and Parcel Number: 09304004000
Applicant: Crystal Love
Project Lead: Paul Hoffman, paul.hoffman@nashville.gov

Structural Observance for 628 Shelby Ave., Nashville, TN 37206

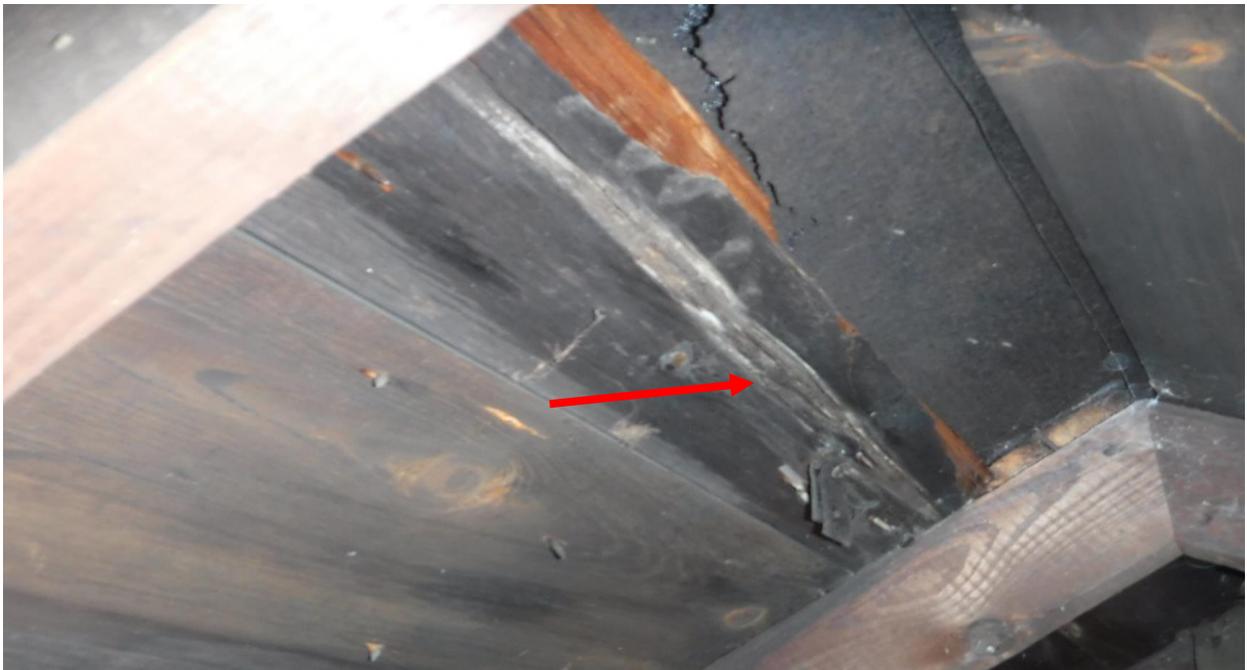
Photo #17: Water Damage on Roof

Recommended Action: Due to the extent of mold, damage, poor design and construction, it is recommended that the entire framing system be removed and replaced. Professionally engineer and install all new framing.

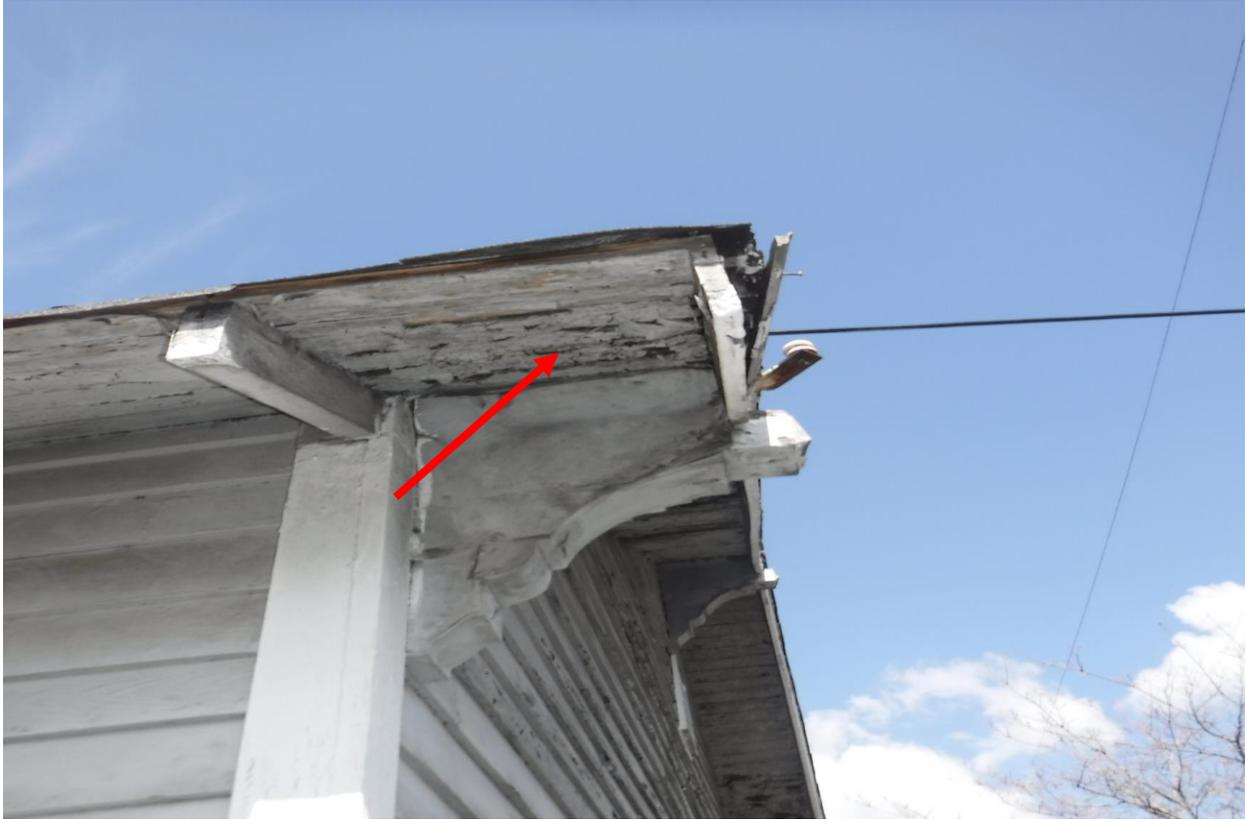
Photo #18: Exterior Dry Rot

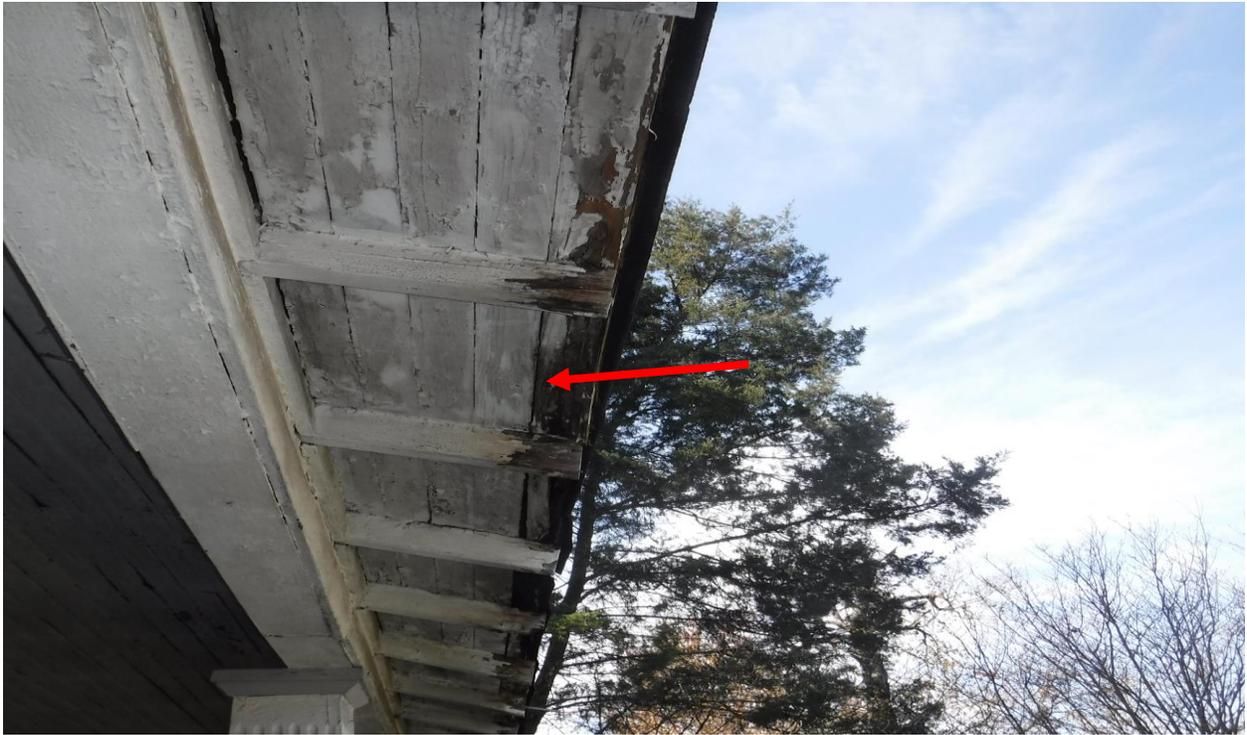
Photo #19: Exterior Dry Rot at Porch

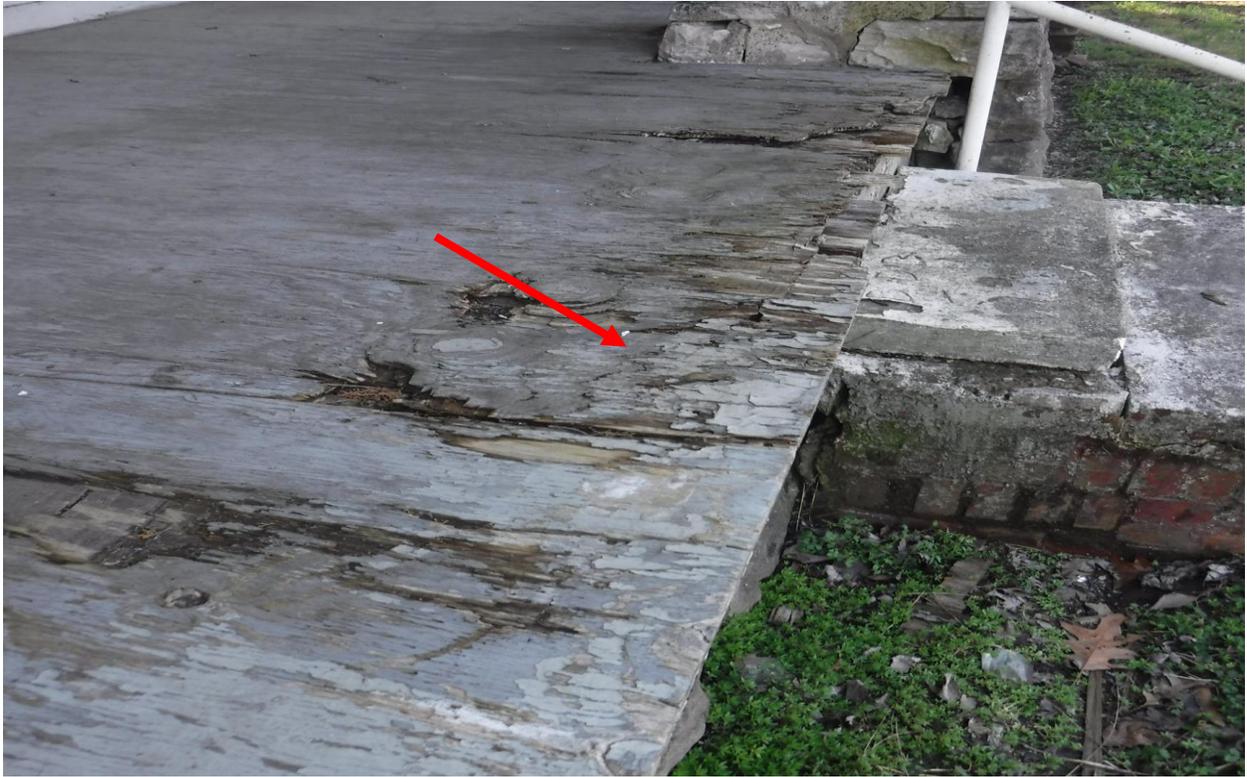
Photo #20: Dry Rot on Porch

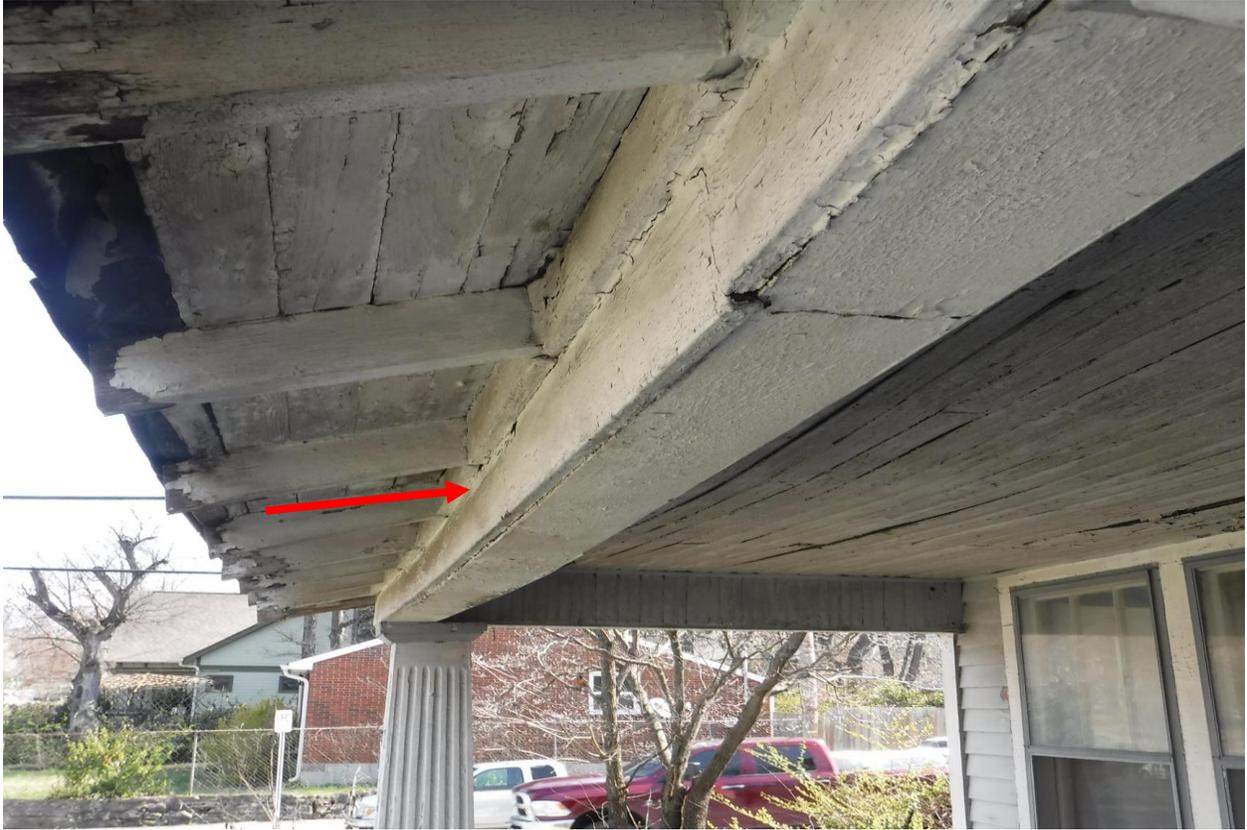
e. Multiple area of the house were framed with under-designed and overstressed structural members (See Photo #21-23). The front porch beam, header beams and roof rafters are all overstressed and excessively sagging.

Photo #21: Excessive Sagging of Porch Beam

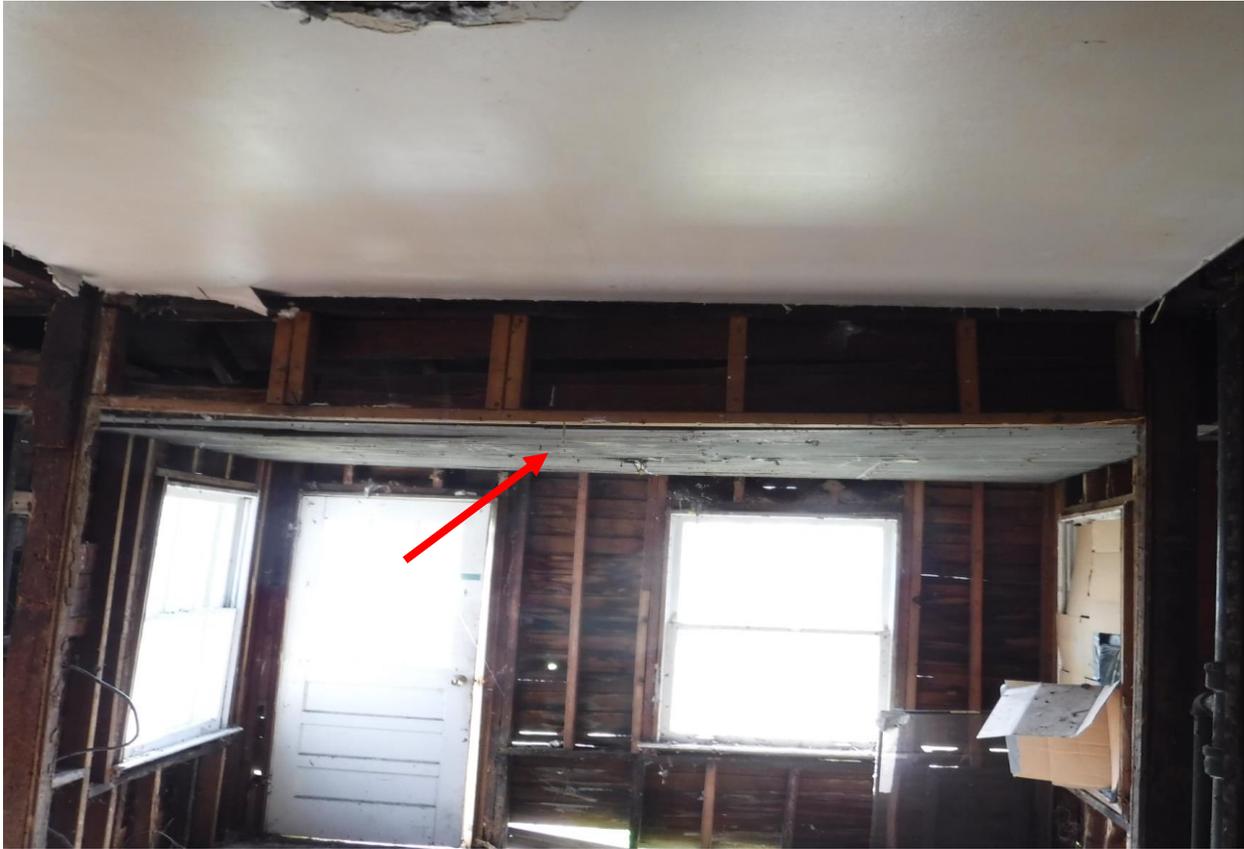
Photo #22: Sagging of Header

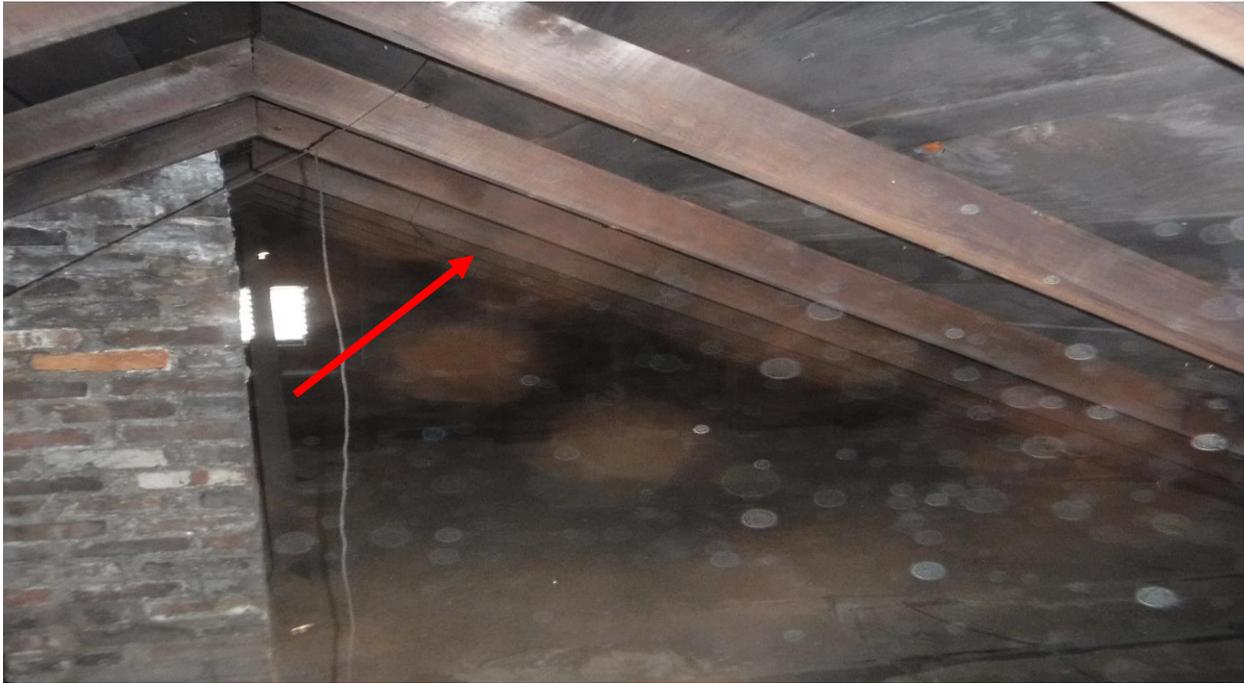
Photo #23: Roof Sagging
