**STAFF RECOMMENDATION**  
**126 Second Avenue South**  
**August 21, 2019**

**Application:** Demolition  
**District:** Second Avenue Historic Preservation Zoning Overlay  
**Council District:** 19  
**Base Zoning:** DTC  
**Map and Parcel Number:** 09306208000  
**Applicant:** Larry Papel, owner  
**Project Lead:** Robin Zeigler, [robin.zeigler@nashville.gov](mailto:robin.zeigler@nashville.gov)

**RE: 126 Second Avenue South  
EMC Project No. 19666**

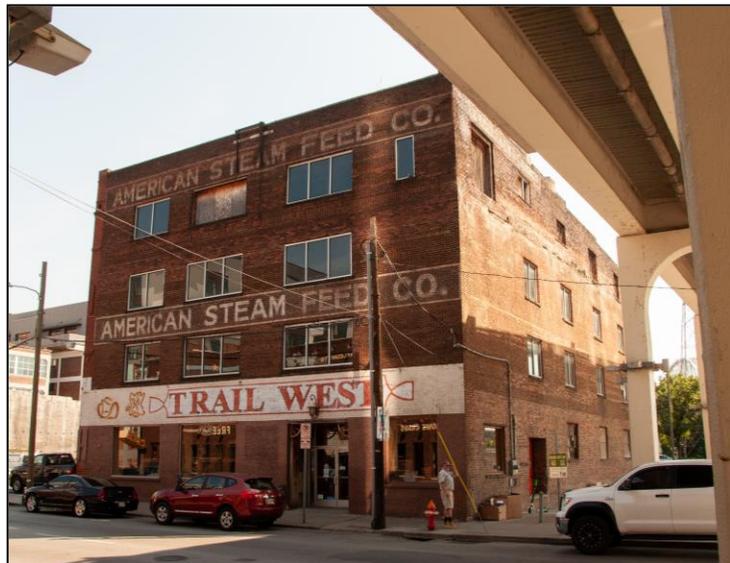
Figure 1: wide shot of the building as seen from Second Avenue South.

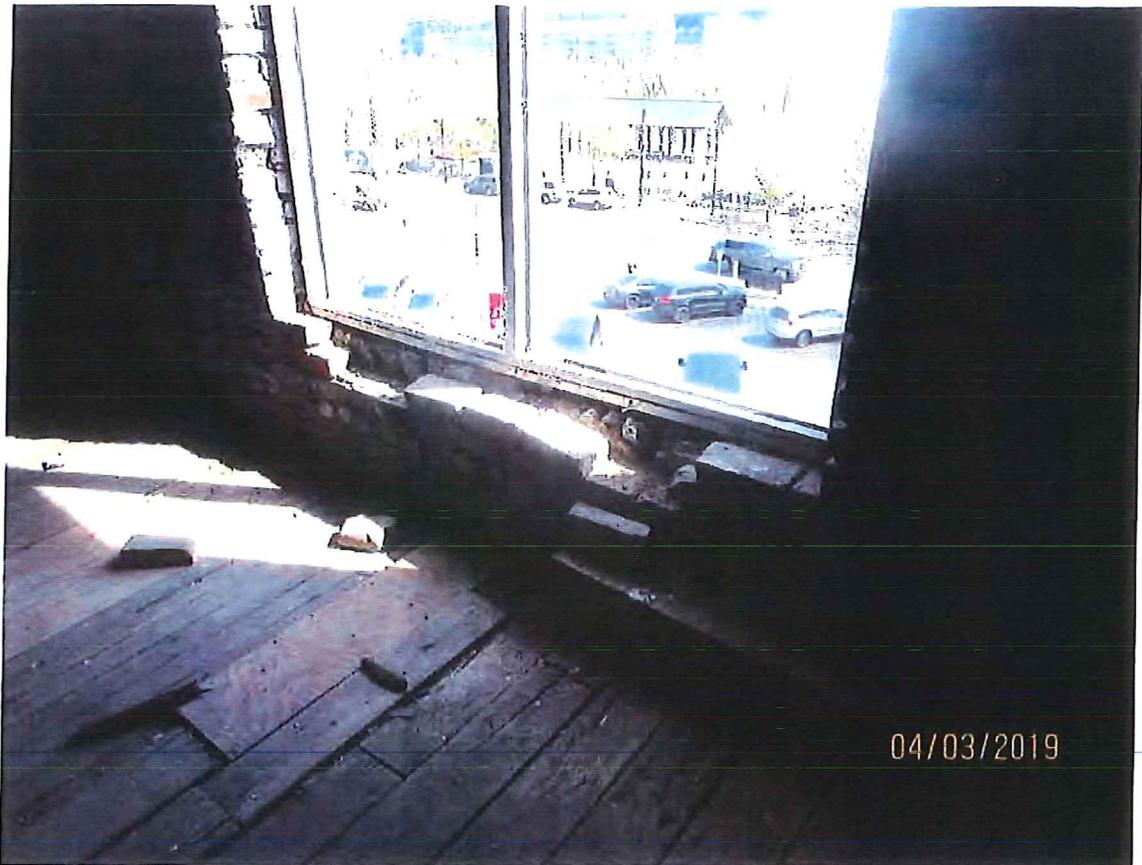
**Photograph 1: Typical bricks at windows on fourth floor.**

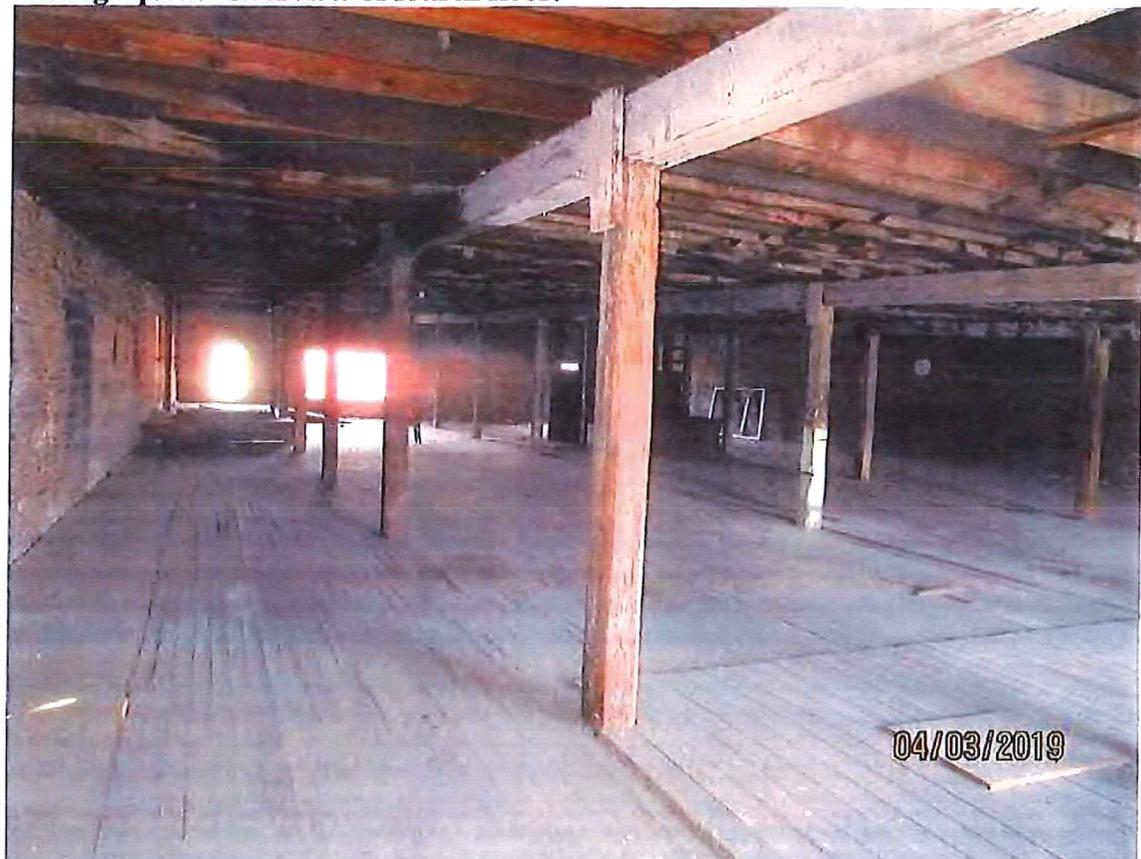
**Photograph 2: Overview of fourth floor.**

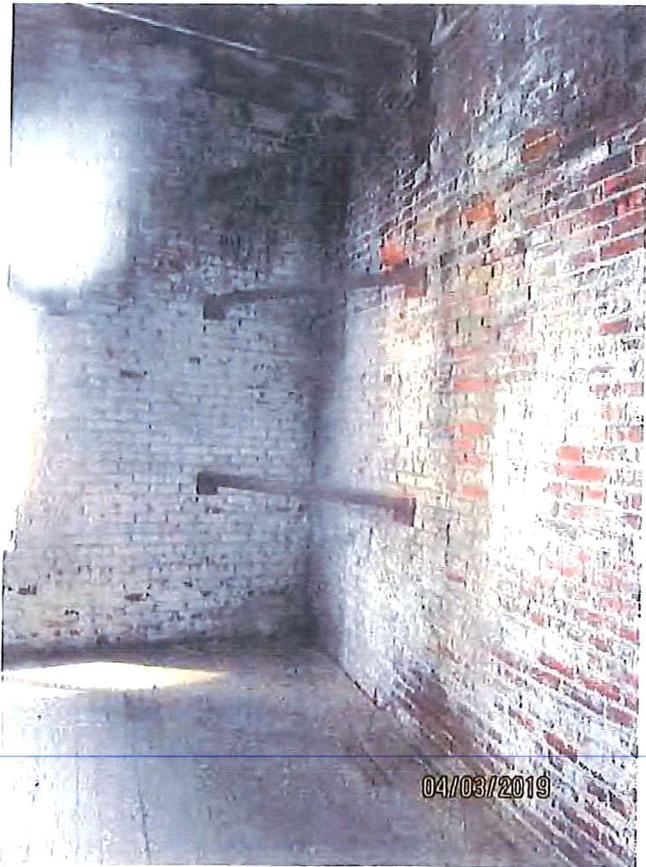
**Photograph 3: Typical repair, 1999 timeframe.**

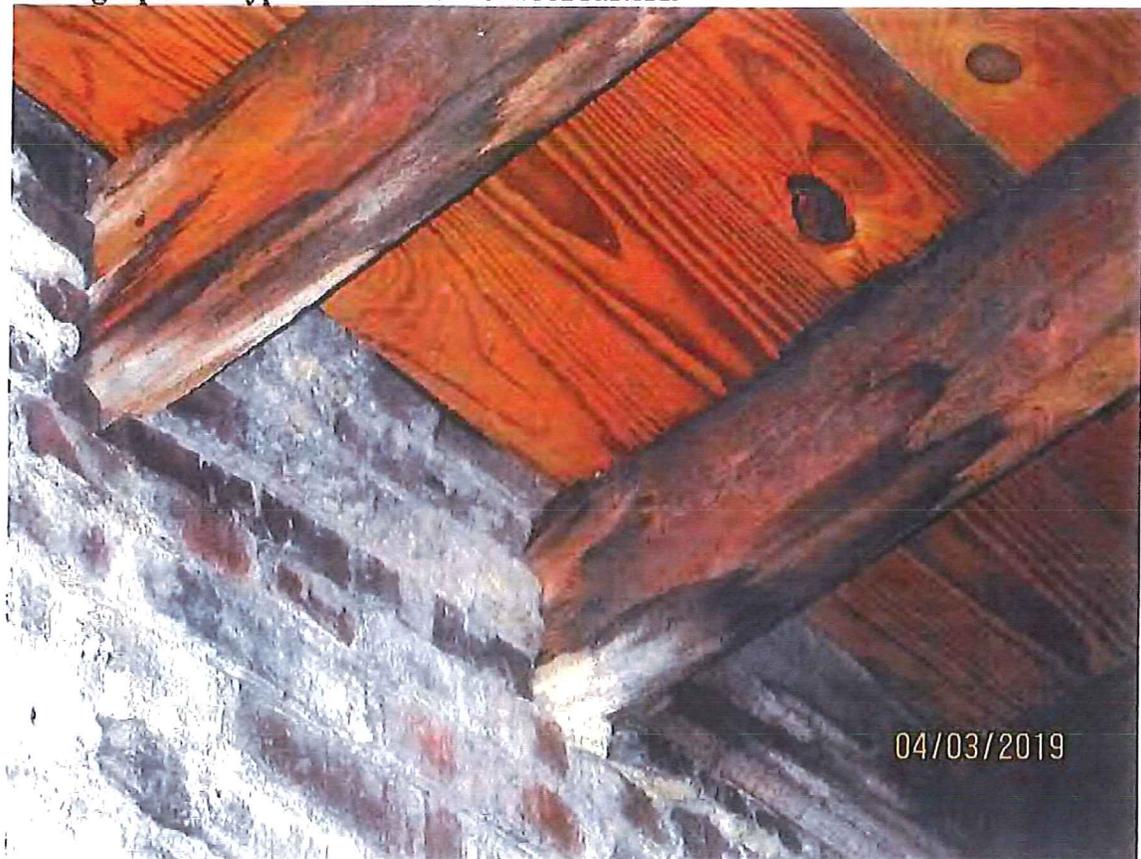
**Photograph 5: Typical open masonry.**

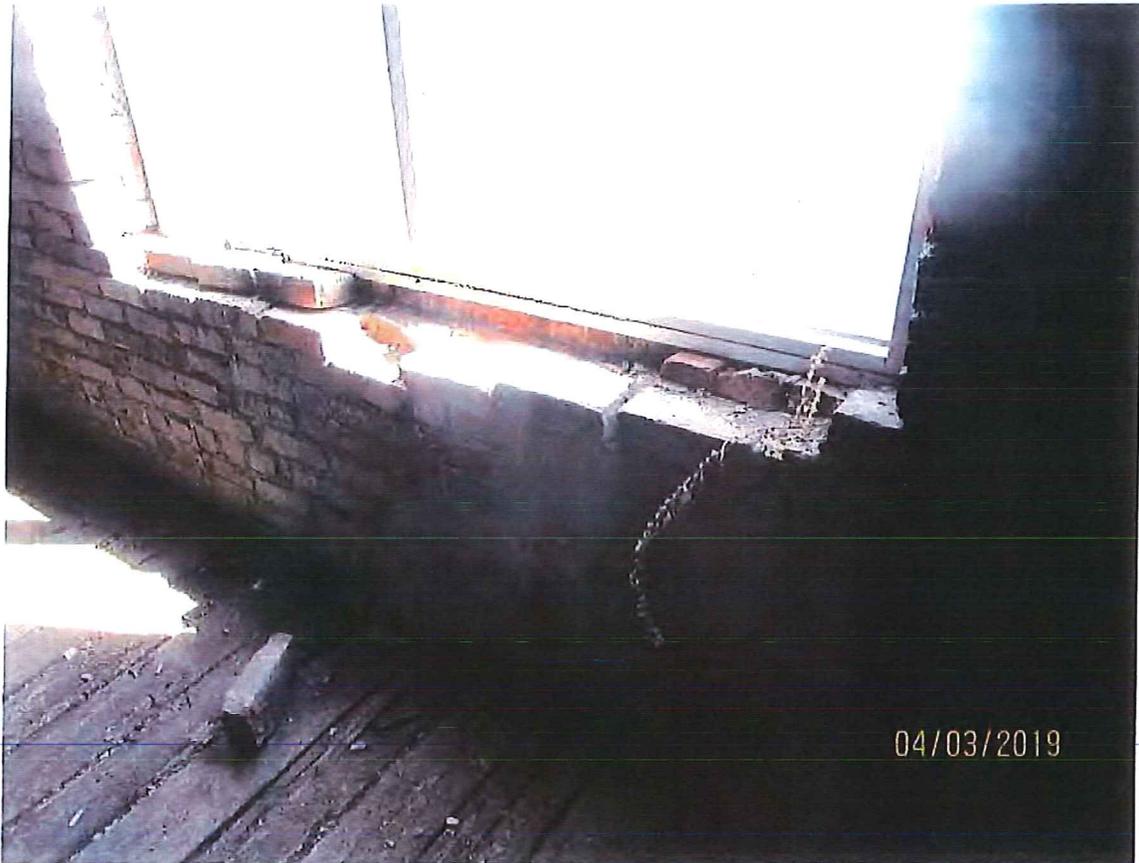
**Photograph 8: Close-up of original brick pockets at left sidewall on third floor.**

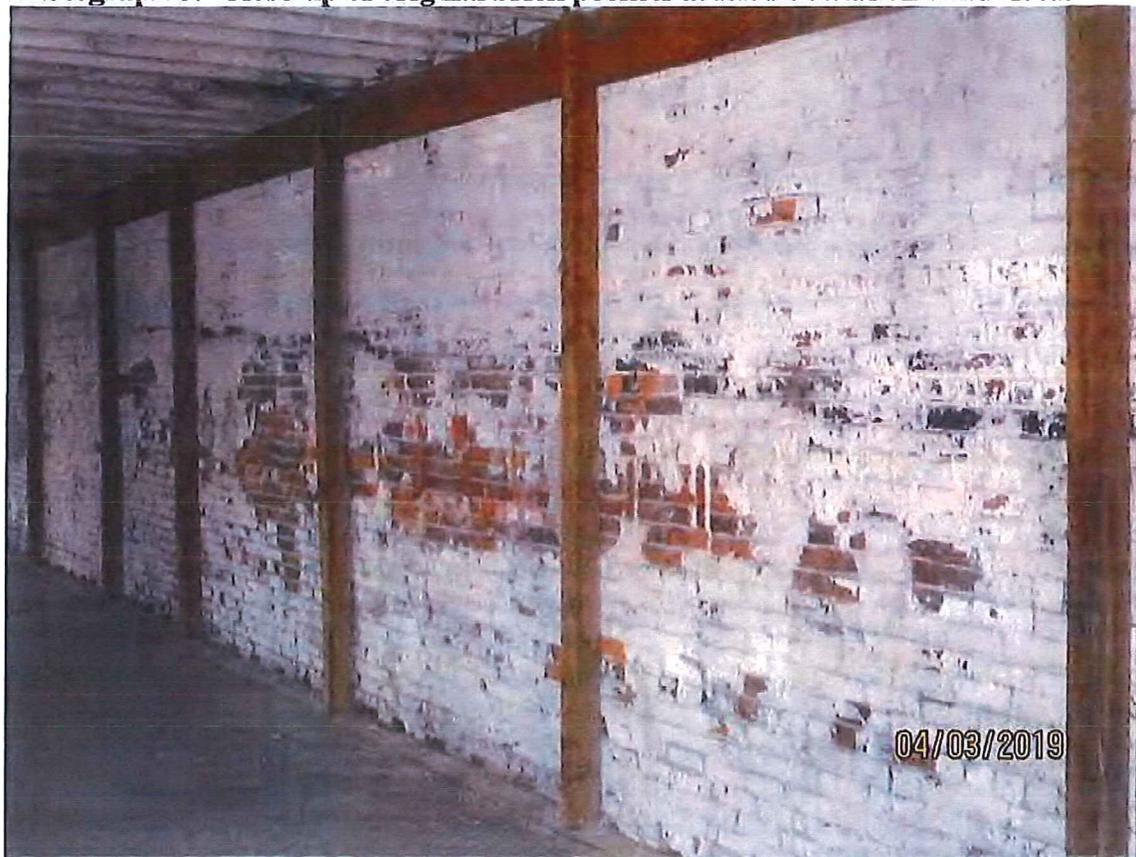
**Photograph 9: Typical wall movement at left sidewall on third floor.**

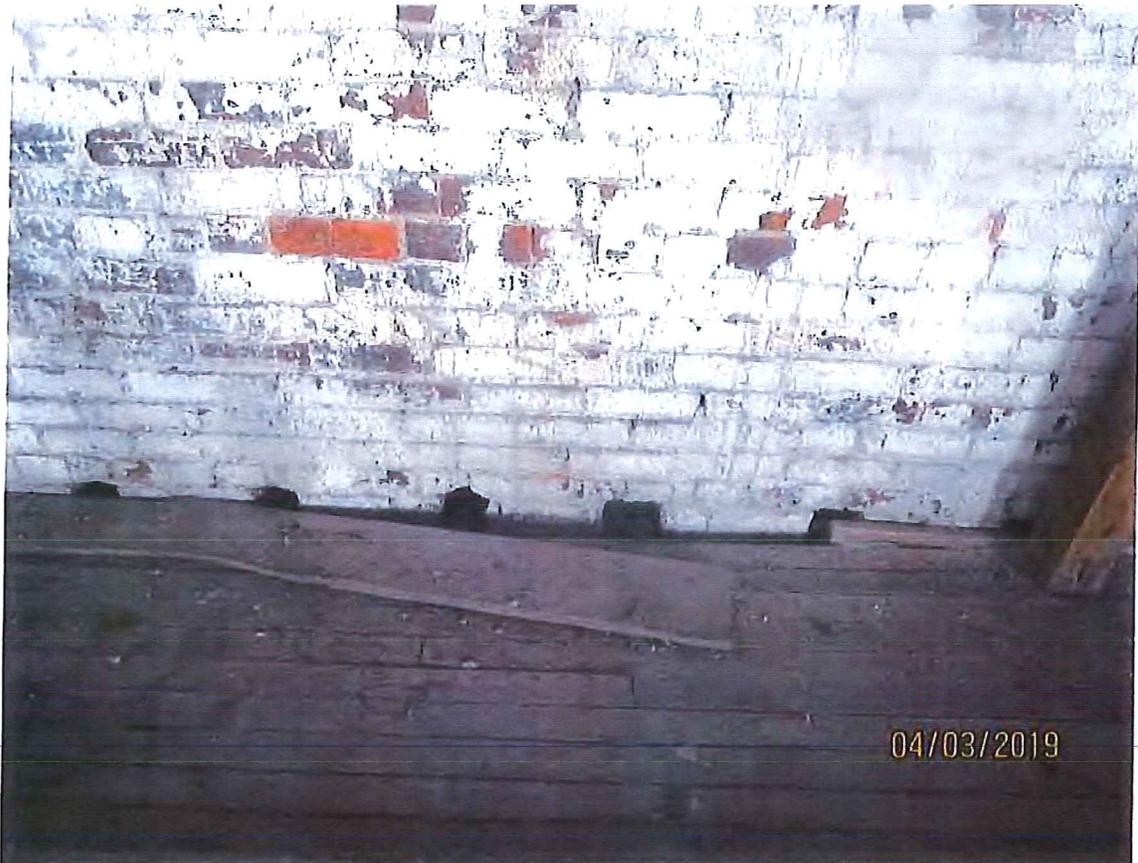
**Photograph 10: Typical wall movement at left sidewall on third floor.**

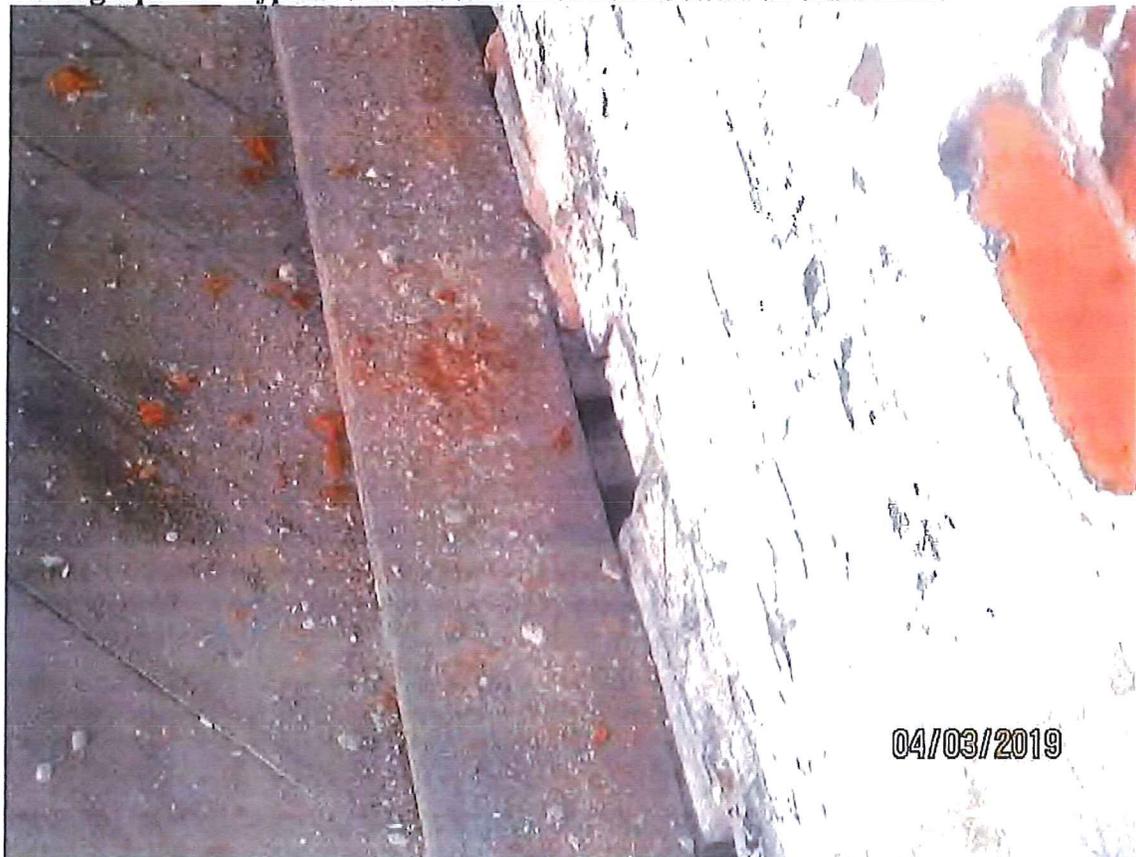
**Photograph 11: Typical floor joist movement.**

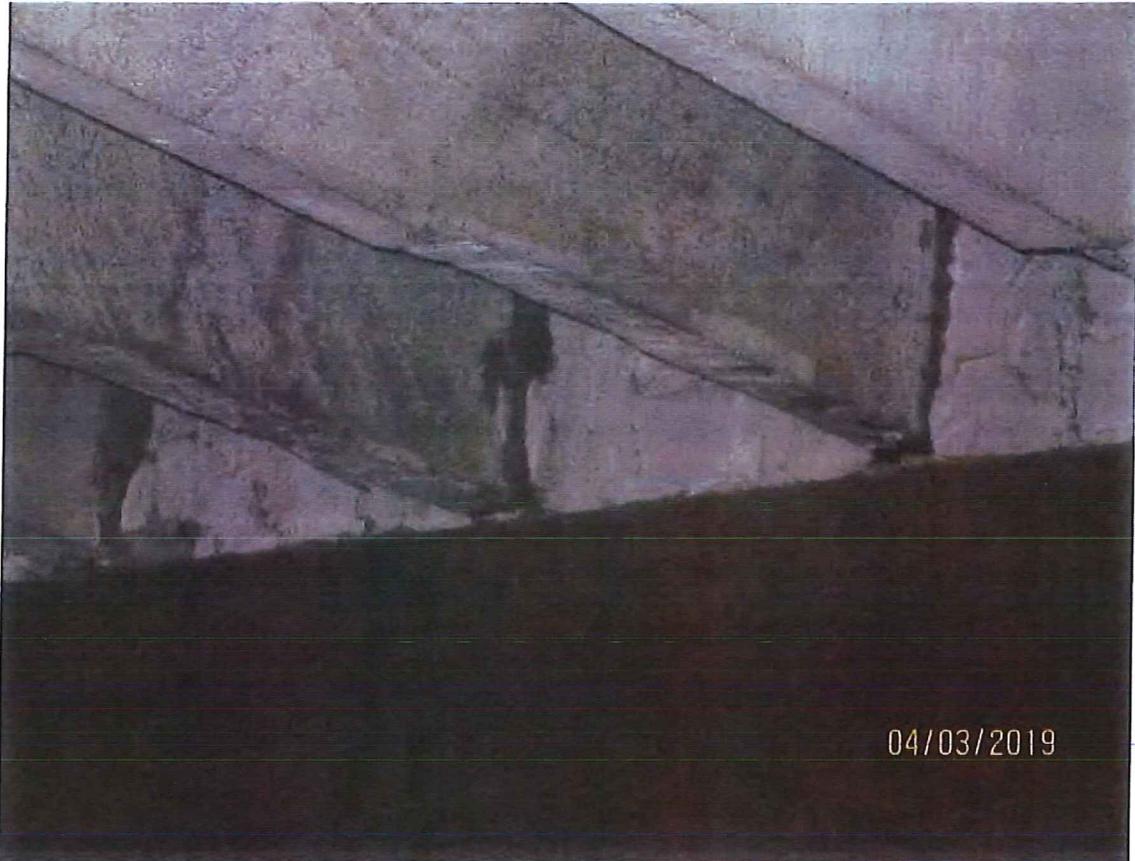
**Photograph 12: Lack of bearing of floor joists at left sidewall on third floor.**

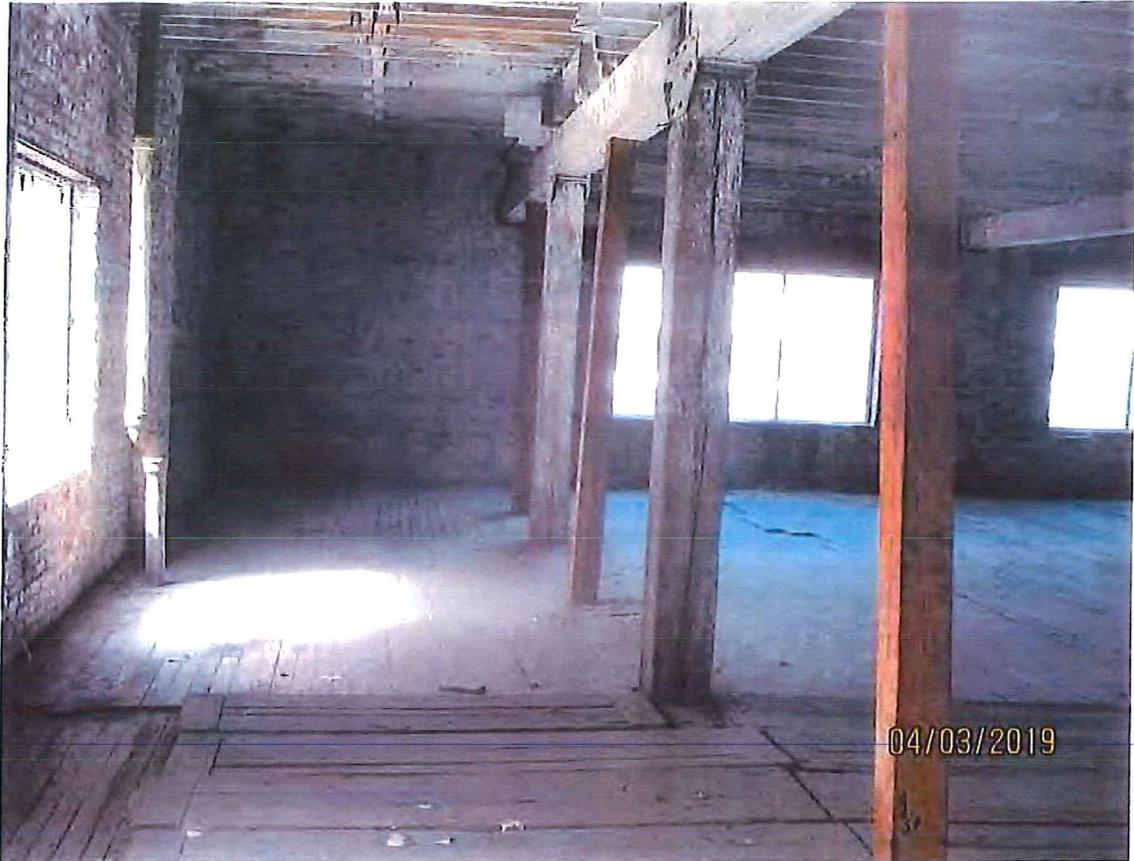
Another observation during our initial walk-through was that the majority of the wood-framed floor system has deteriorated to the point that additional repairs are needed to support any intended use. I will point out that due to the openings and voids in the floor system, a plastic barrier has been placed beneath the floors to prevent debris from falling to the usable space that is currently the first floor. An interesting observation is that the original first floor is not bearing on a concrete slab-on-grade, which is typically the case for floor systems that do not contain basements. As a result of this floor framing construction, the floods of May 2010 created additional distress for this wood-framed floor system. One only has to walk across the floor system to realize the inadequacies created when the floor was built within close proximity to the grade. Examples of the wood flooring issues can be seen in photographs 13, 54, 55, 57, 60, 61, 63, and 68.

**Photograph 13: Typical flooring issues (throughout building).**

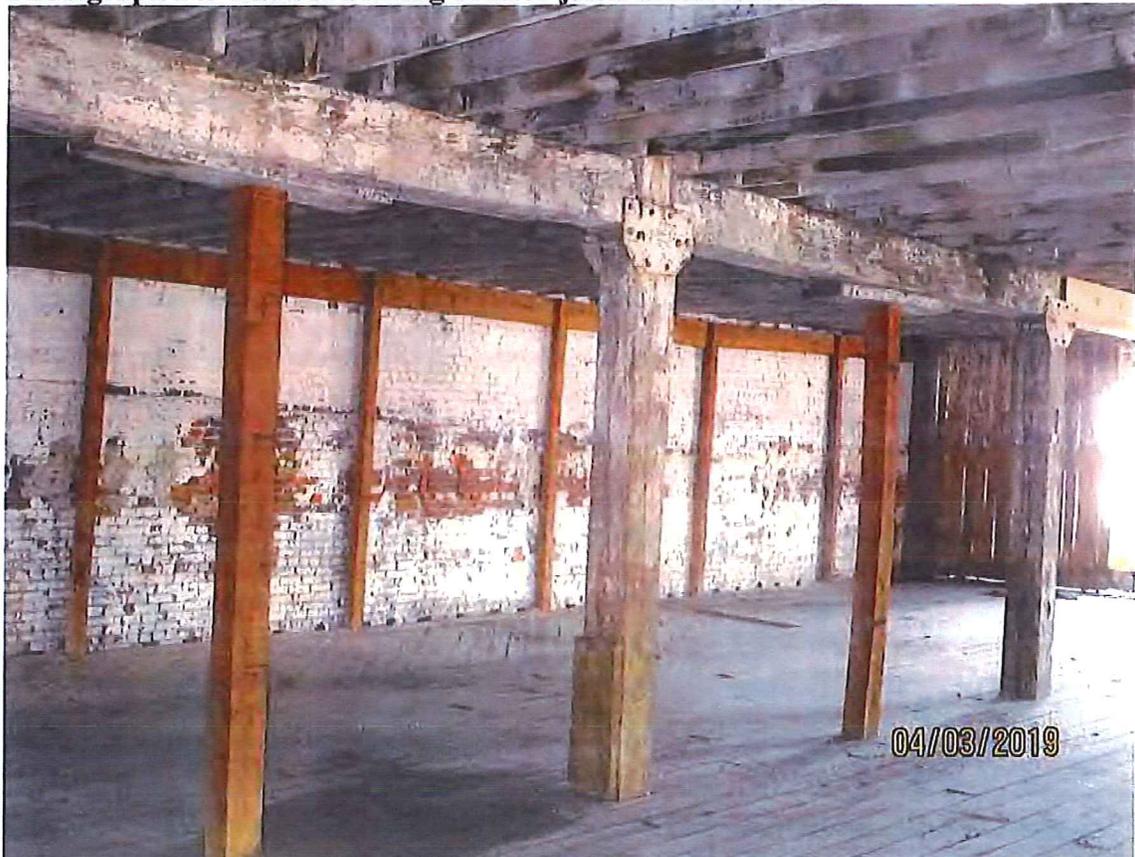
**Photograph 15: Typical column on second floor.**

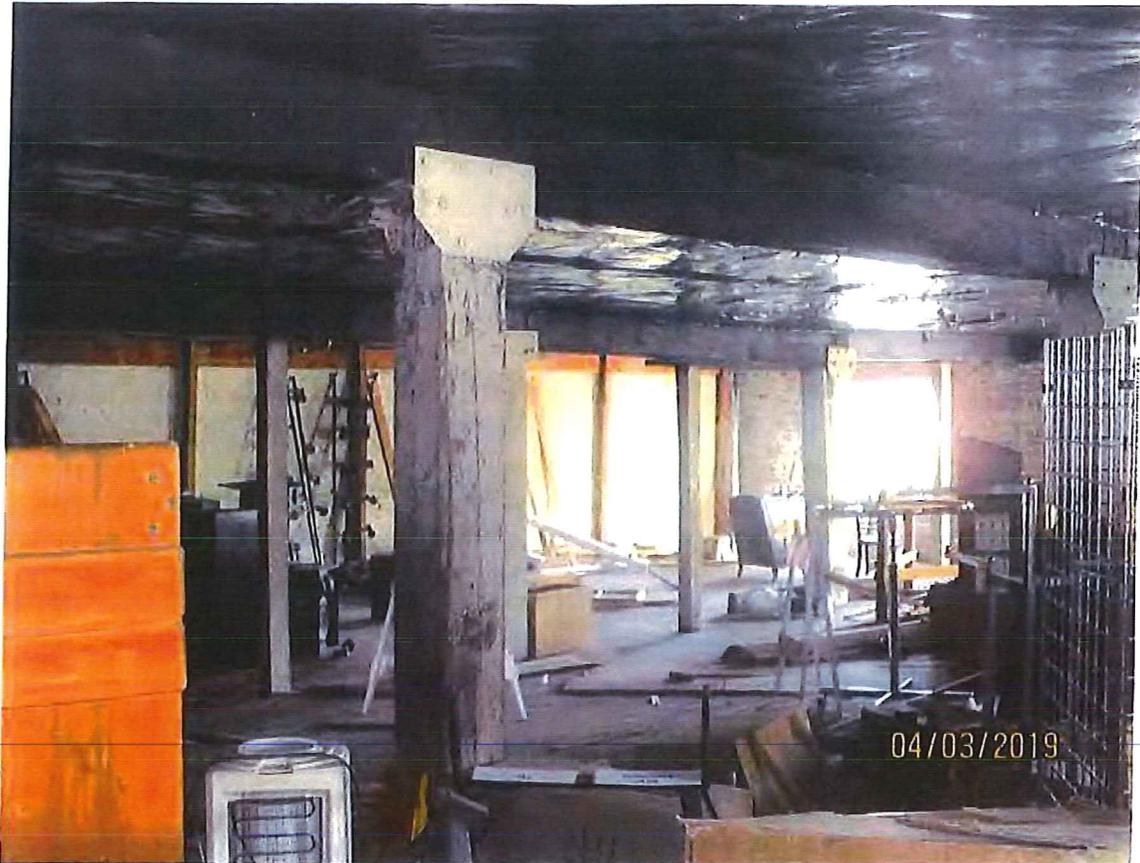
**Photograph 16: Typical flooring issues (throughout building).**

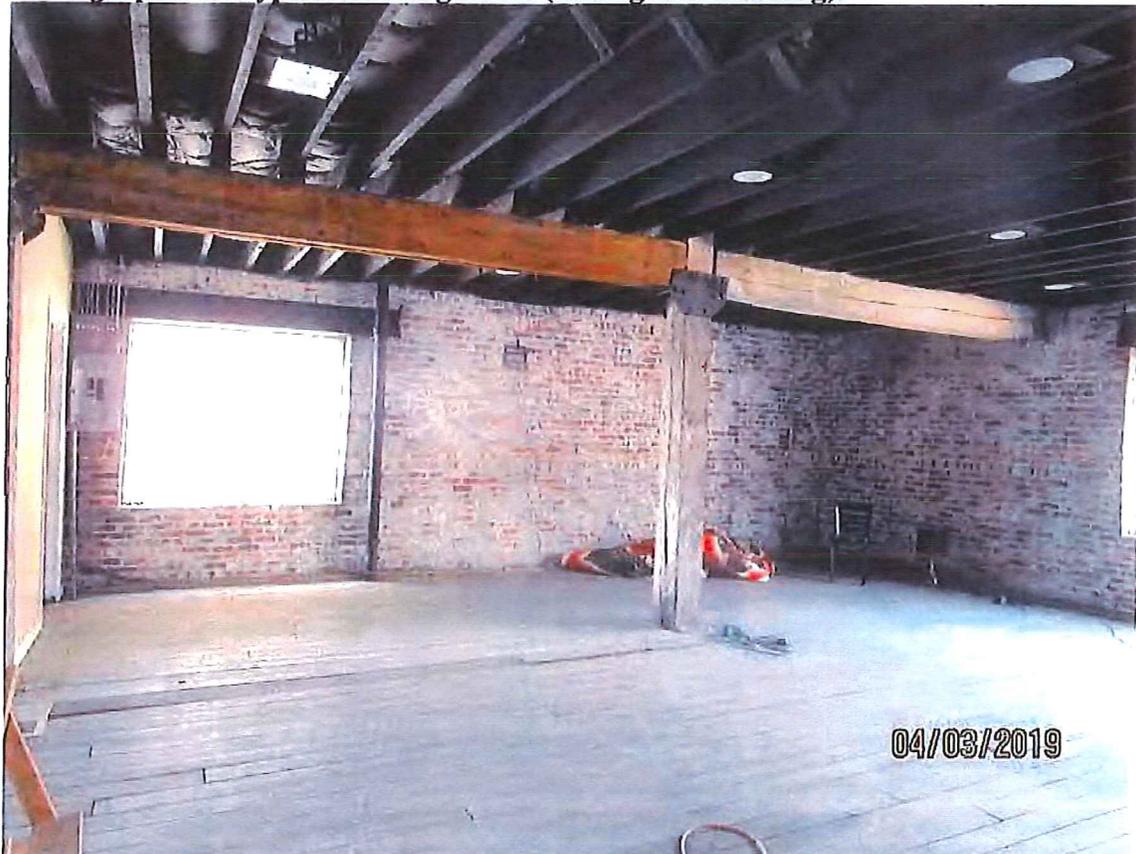
**Photograph 17: Typical floor joist movement.**

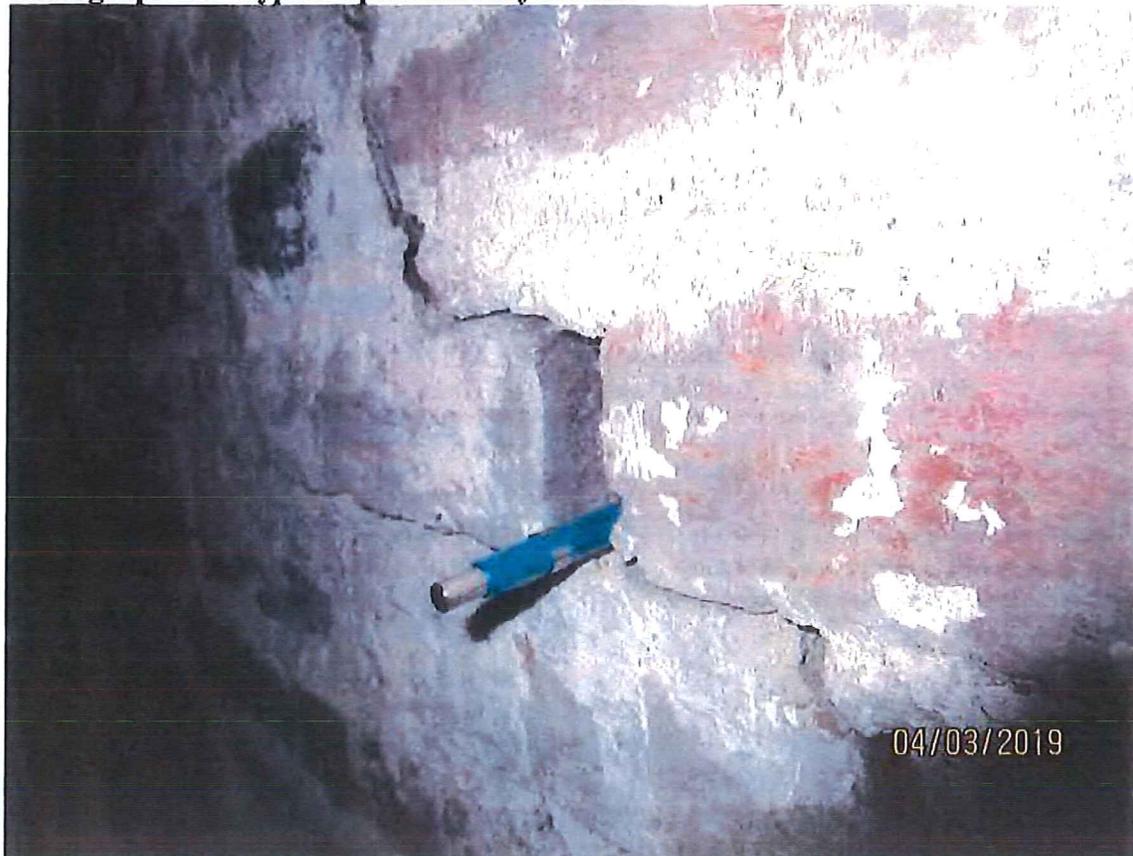
**Photograph 19: Typical open masonry cracks.**

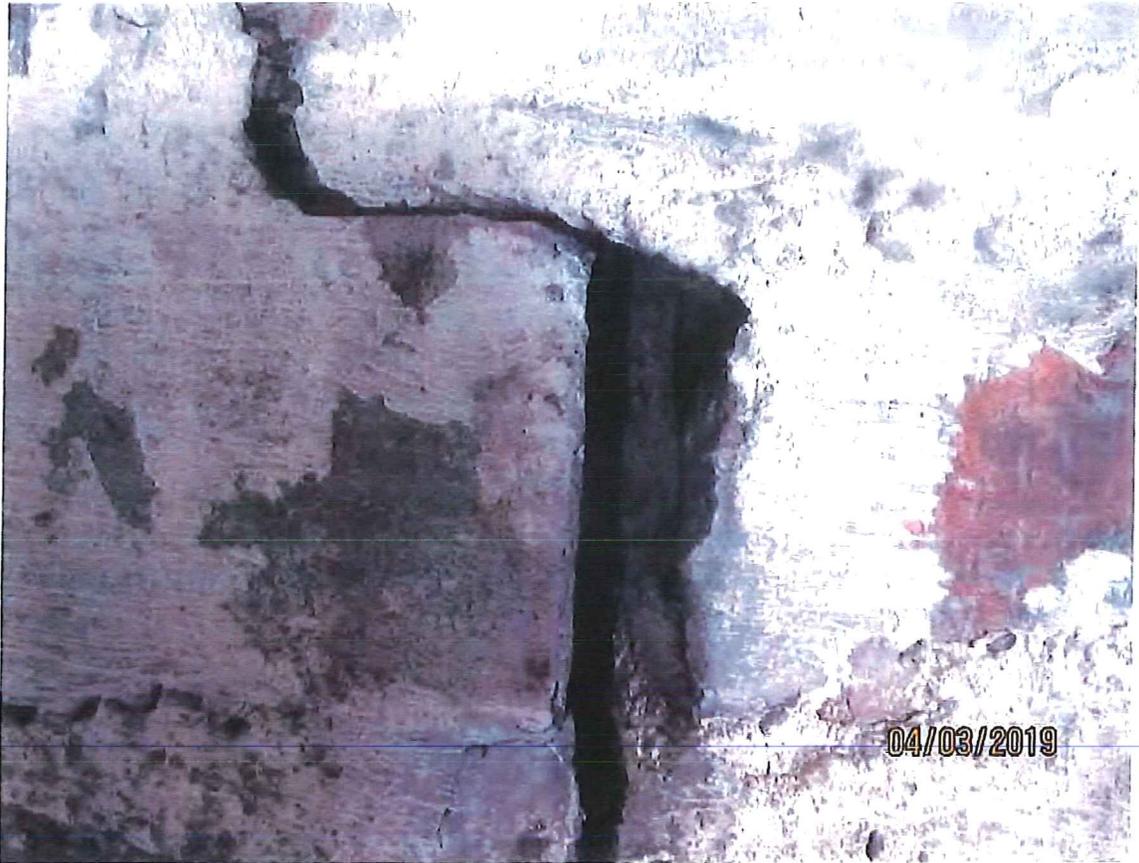
**Photograph 20: Typical floor joist movement at left sidewall.**

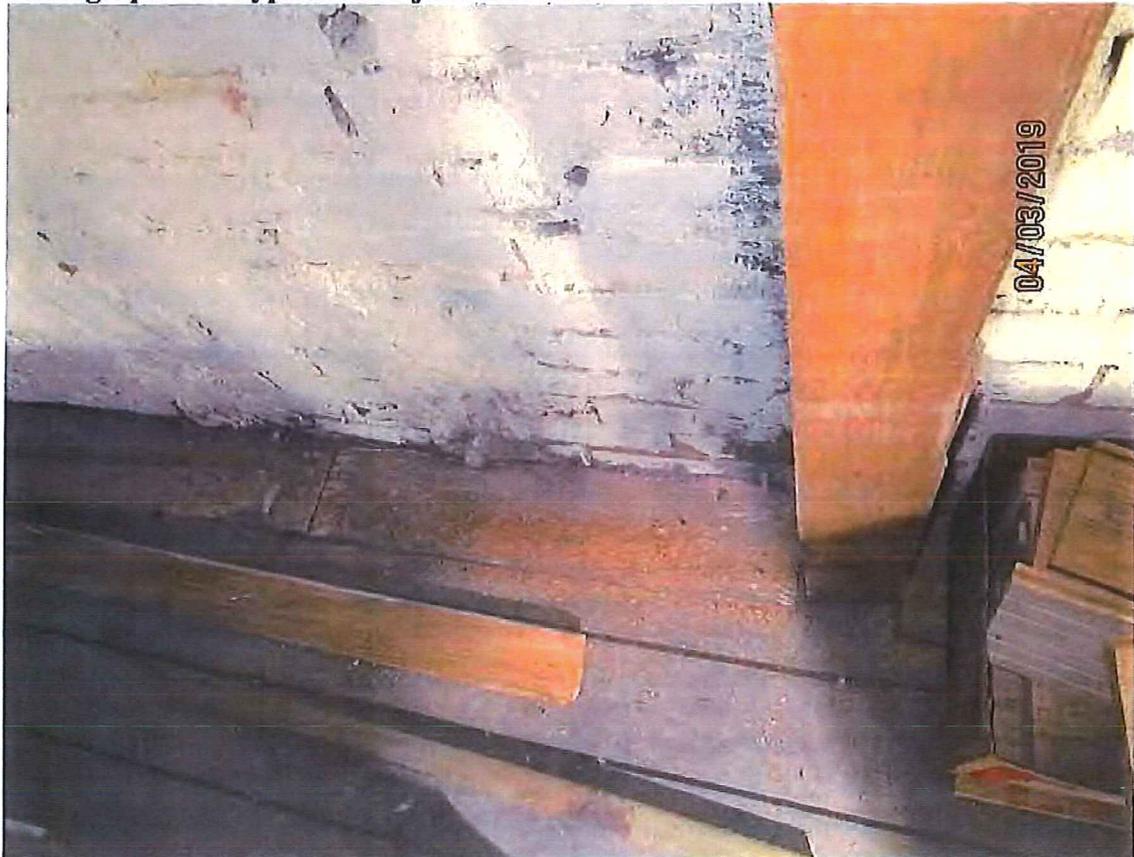
**Photograph 21: Typical floor joist movement at left sidewall.**

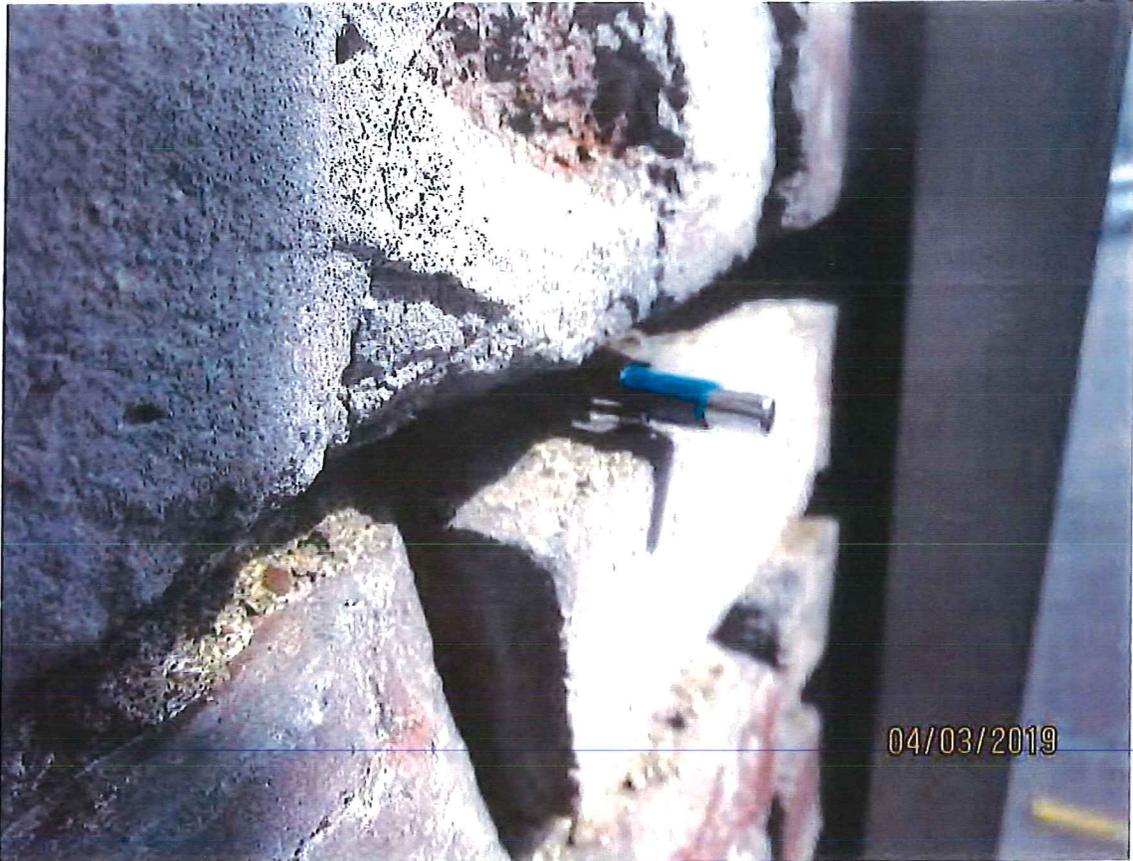
**Photograph 23: Typical mortar joints at interior of building.**

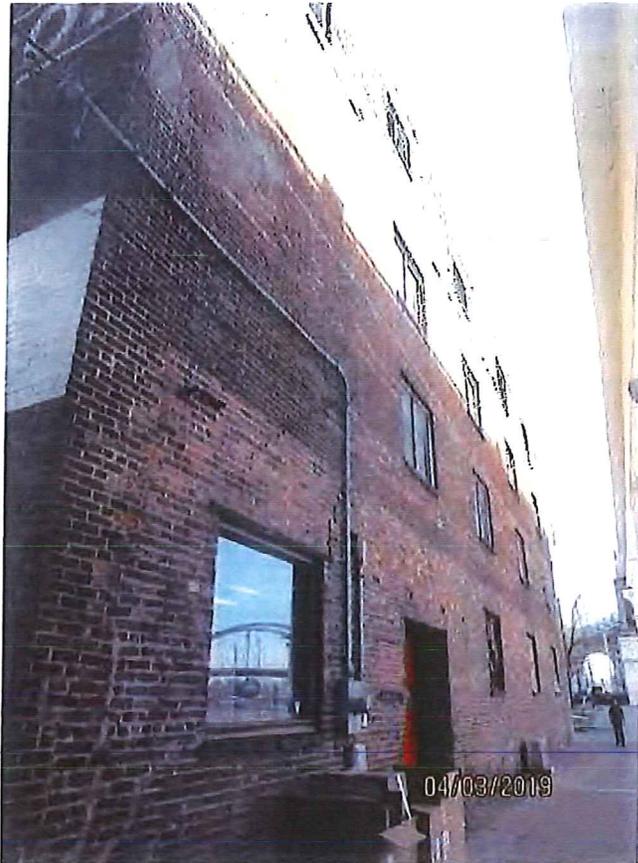
**Photograph 28: Masonry cracks at right sidewall.**

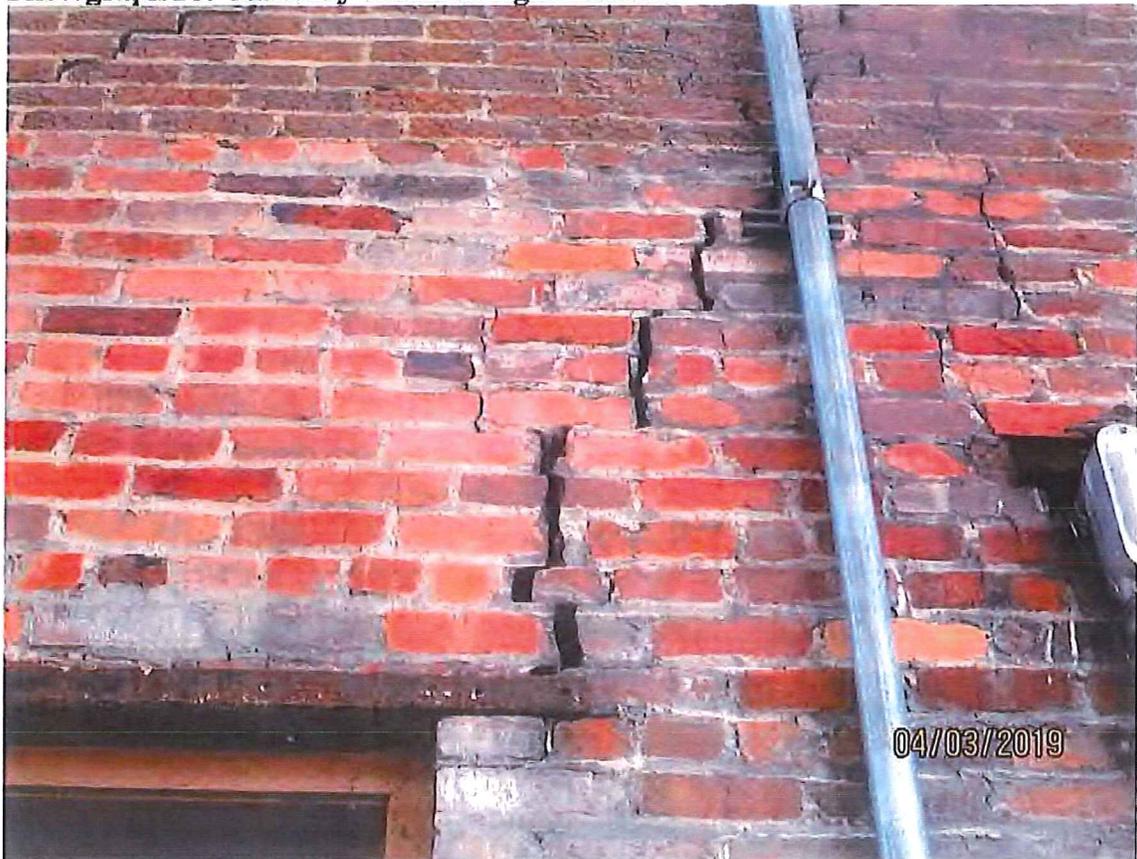
**Photograph 29: Masonry cracks at right sidewall.**

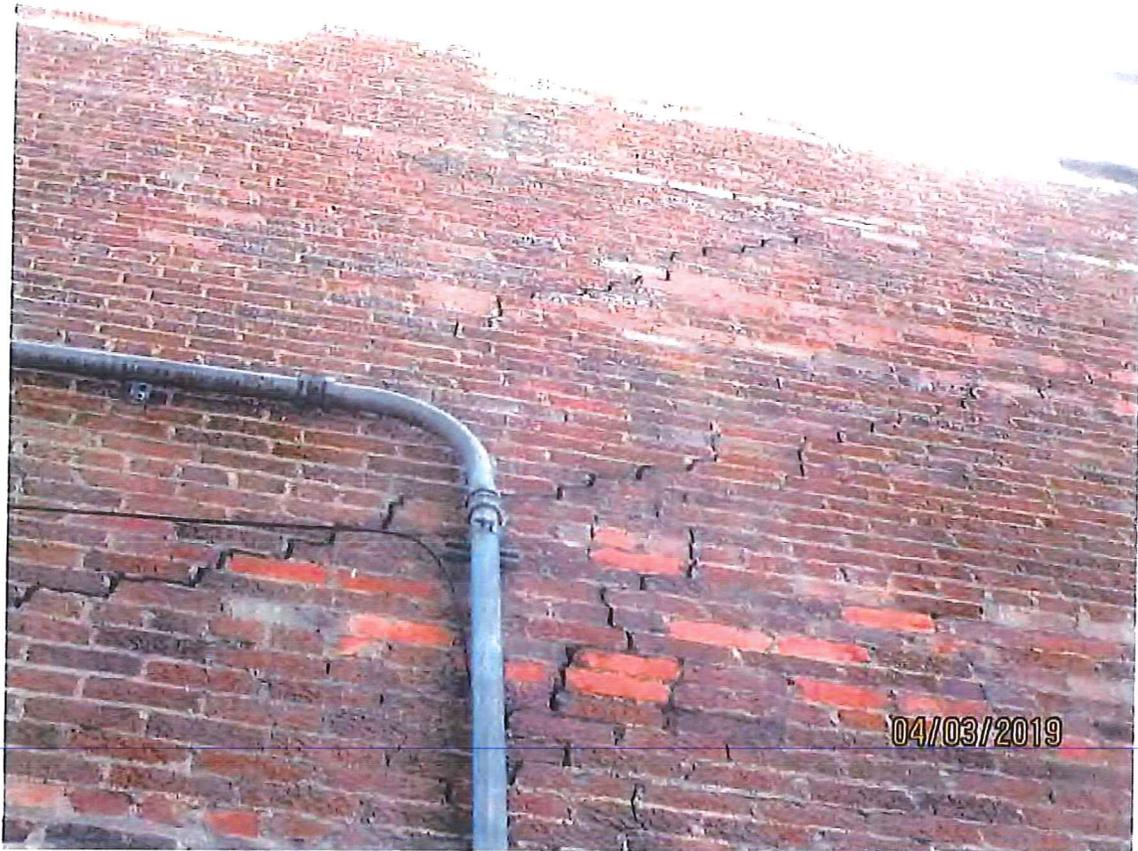
**Photograph 30: Masonry cracks at right sidewall.**

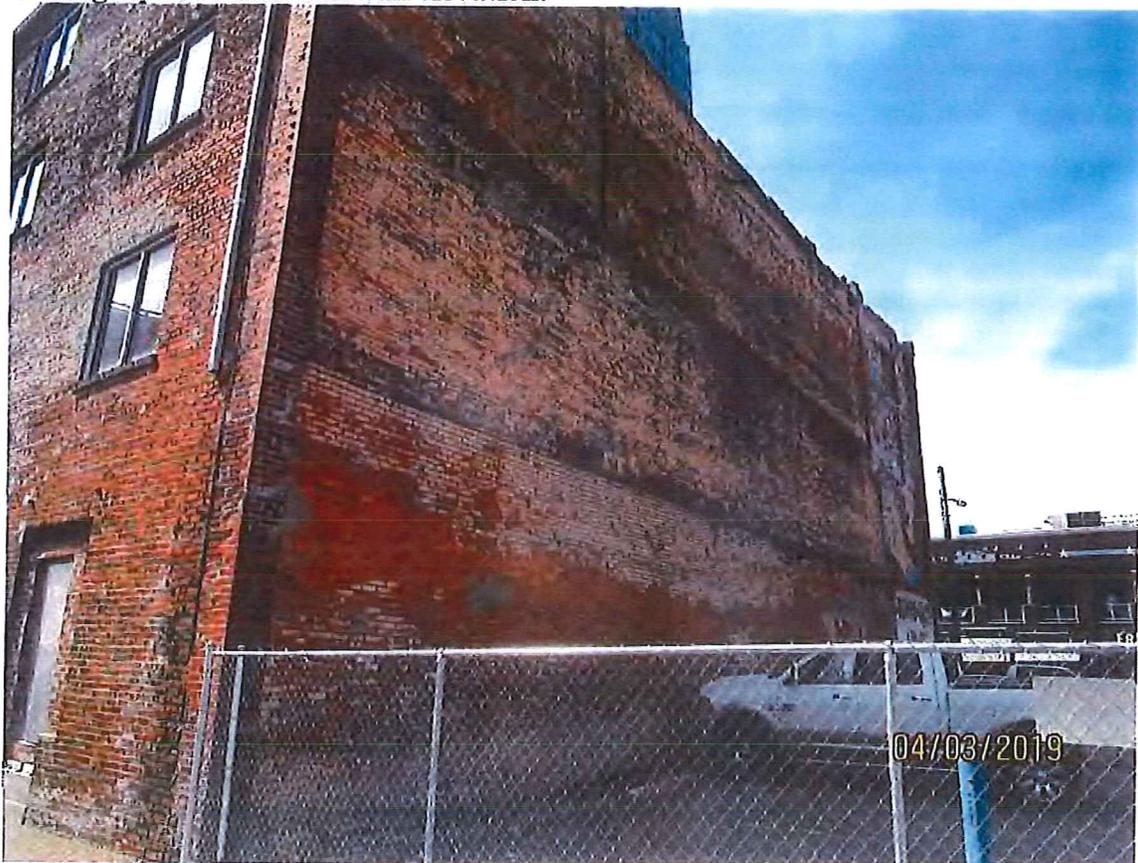
**Photograph 33: Left sidewall elevation.**

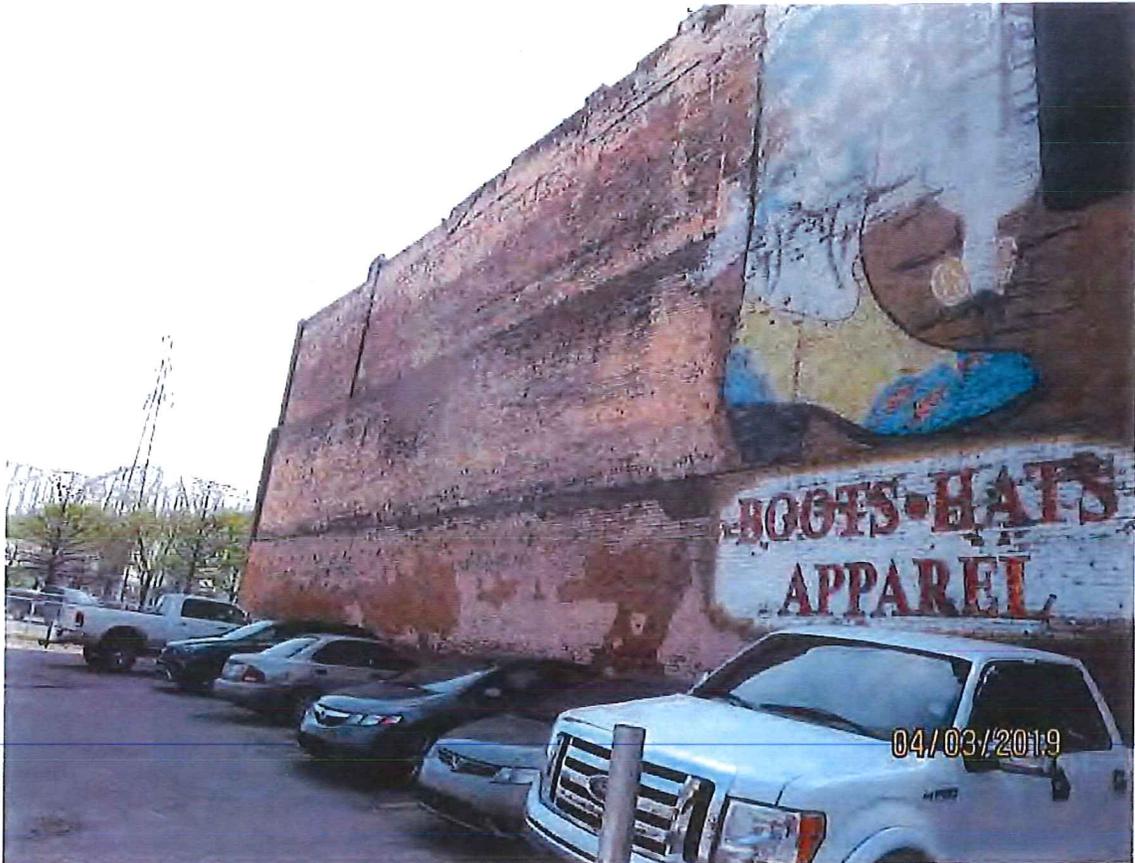
**Photograph 34: Typical masonry at left sidewall.**

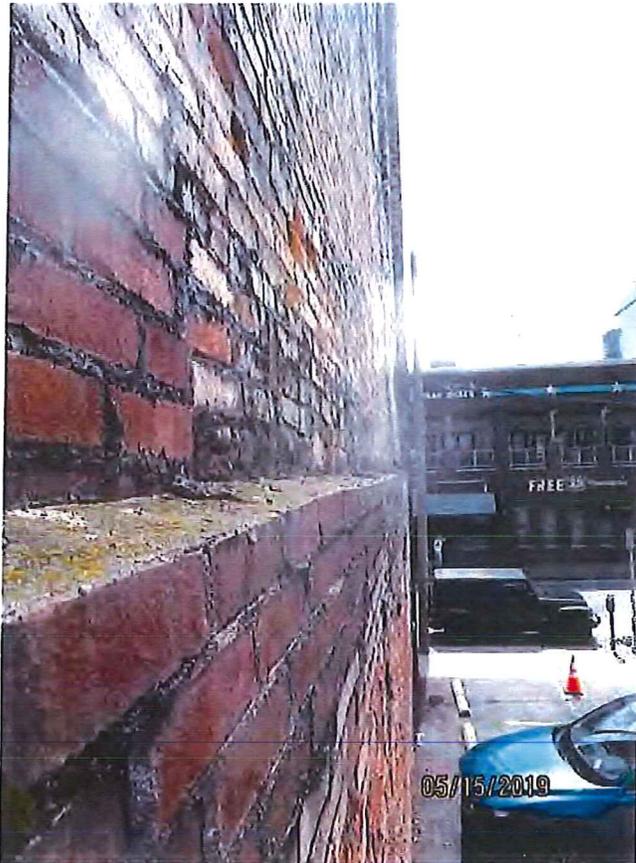
**Photograph 38: Typical brick condition at left wall.**
