**STAFF RECOMMENDATION**  
**126 Second Avenue South**  
**August 21, 2019**

**Application:** Demolition  
**District:** Second Avenue Historic Preservation Zoning Overlay  
**Council District:** 19  
**Base Zoning:** DTC  
**Map and Parcel Number:** 09306208000  
**Applicant:** Larry Papel, owner  
**Project Lead:** Robin Zeigler, [robin.zeigler@nashville.gov](mailto:robin.zeigler@nashville.gov)

**RE: 126 Second Avenue South  
EMC Project No. 19666**

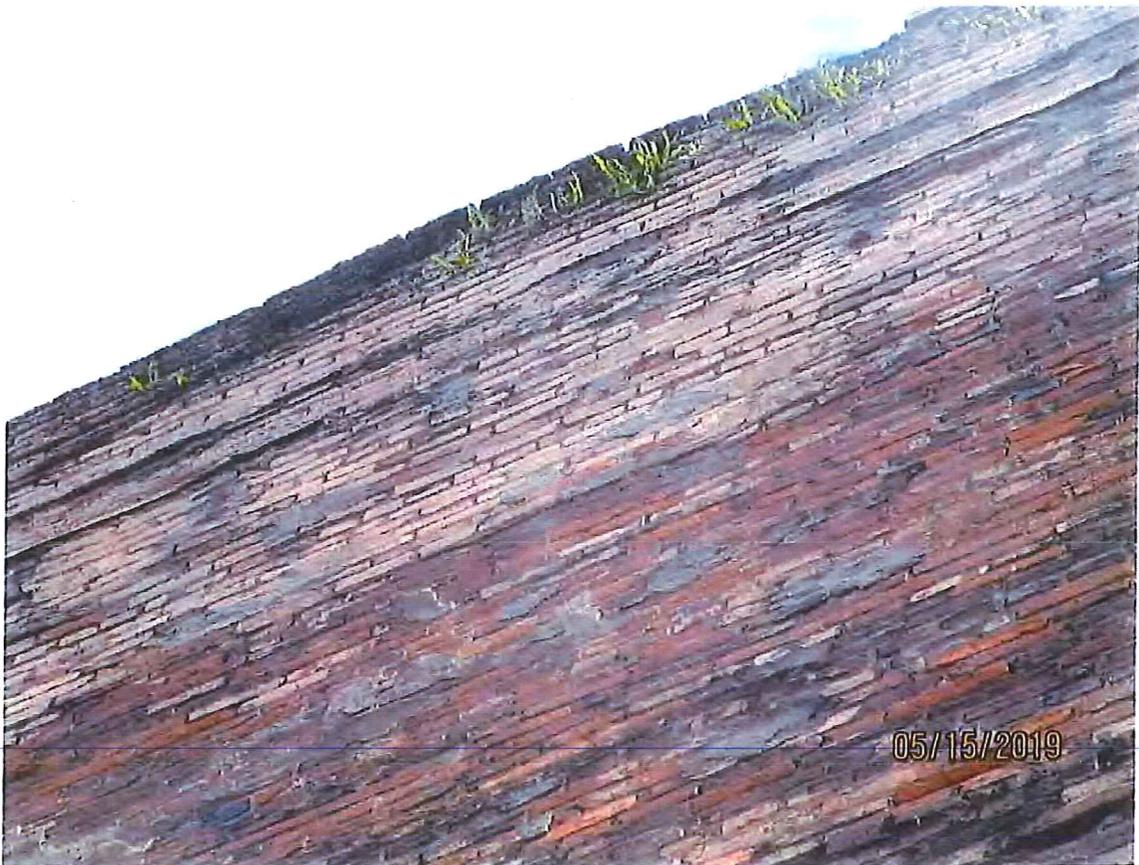
As seen in photograph 44, the north wall (left wall when facing the front of the building) had once been an interior wall. This is obvious by the flashing that is left in place and the brick pockets that have been infilled. It is also obvious that the original roofline for this building was at the approximately third-floor line, which is evidenced by the original brick pocket in the wall (photograph 51).

**Photograph 44: View of first offset at left wall.**

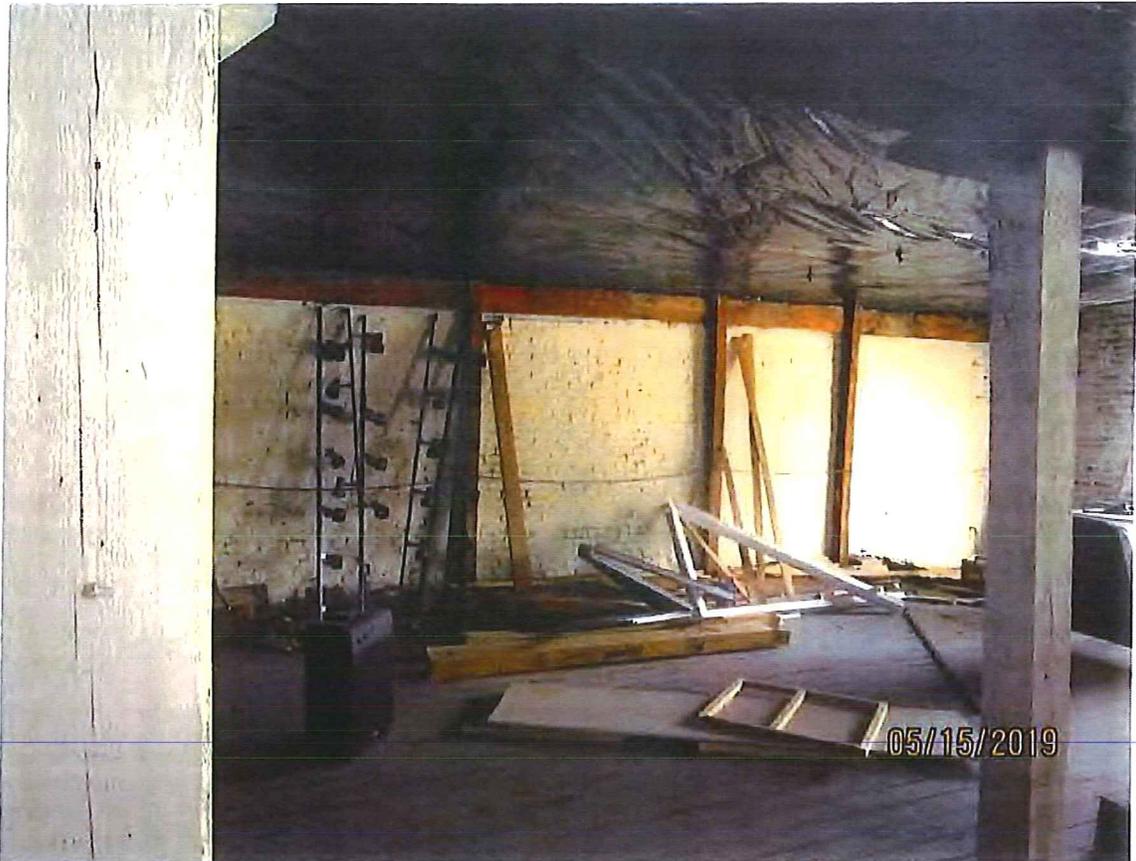
**Photograph 48: Floor movement / brick deterioration at left wall on second floor.**

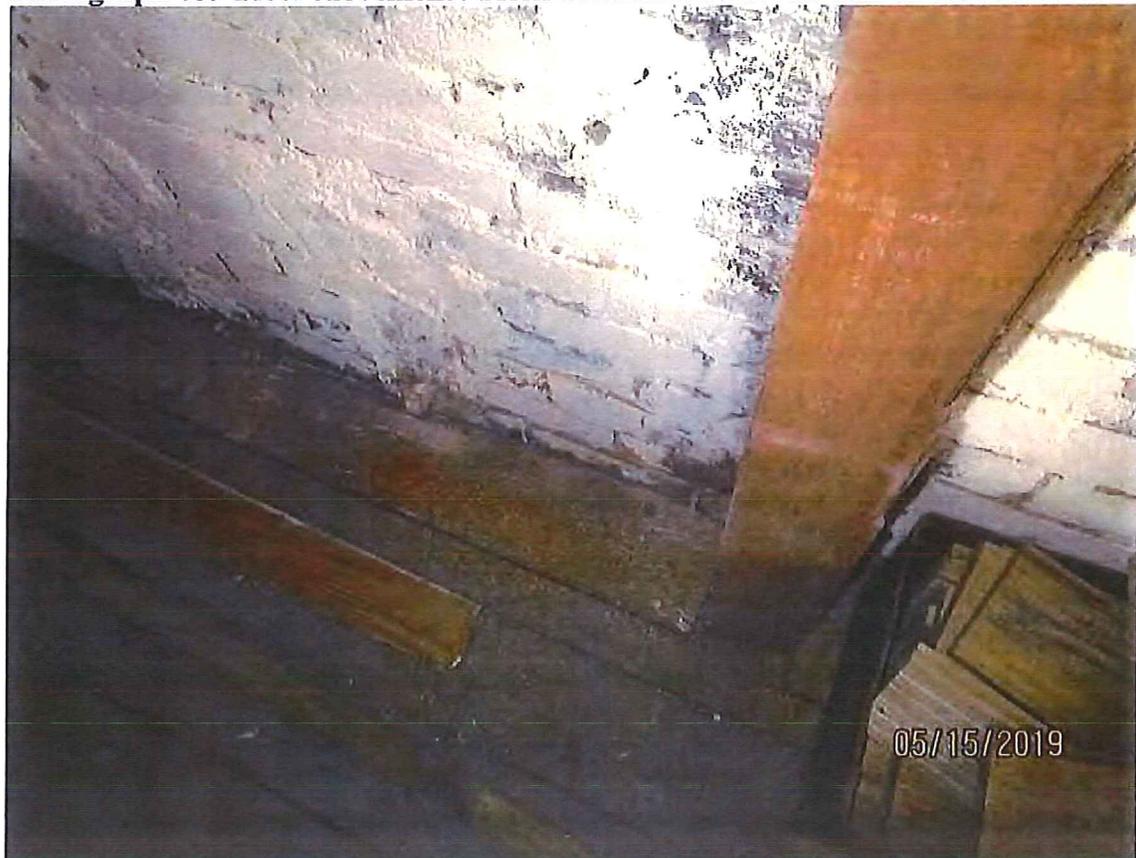
**Photograph 49: Floor movement / brick deterioration at left wall on second floor.**

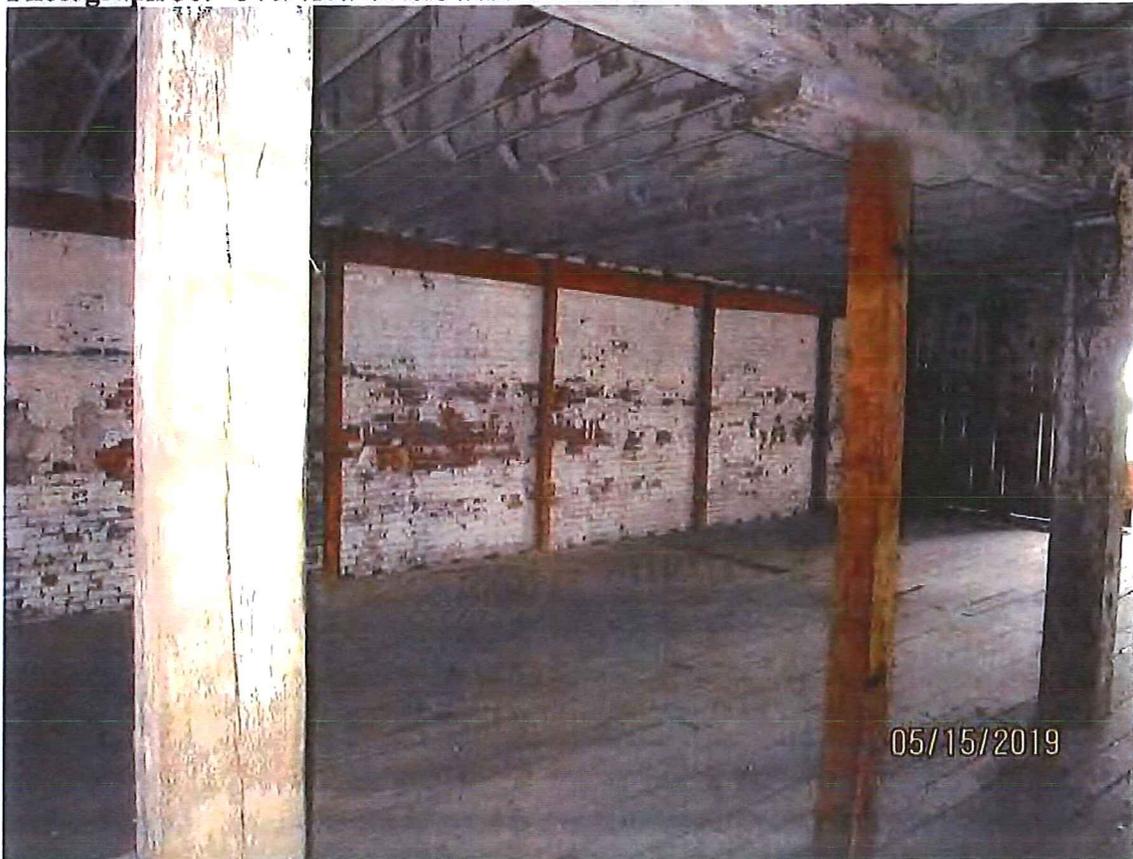
**Photograph 51: Original brick pockets at left wall on third floor.**

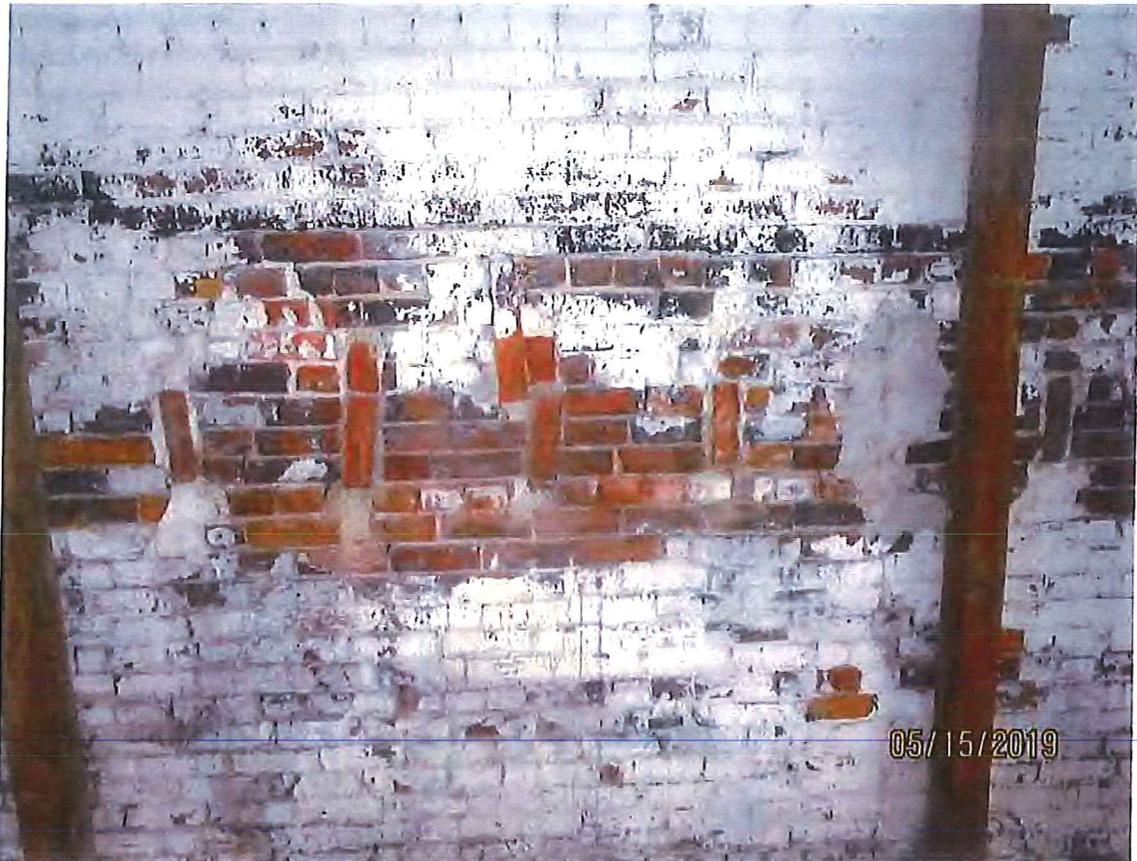
**Photograph 52: Floor joist movement at left wall on third floor.**

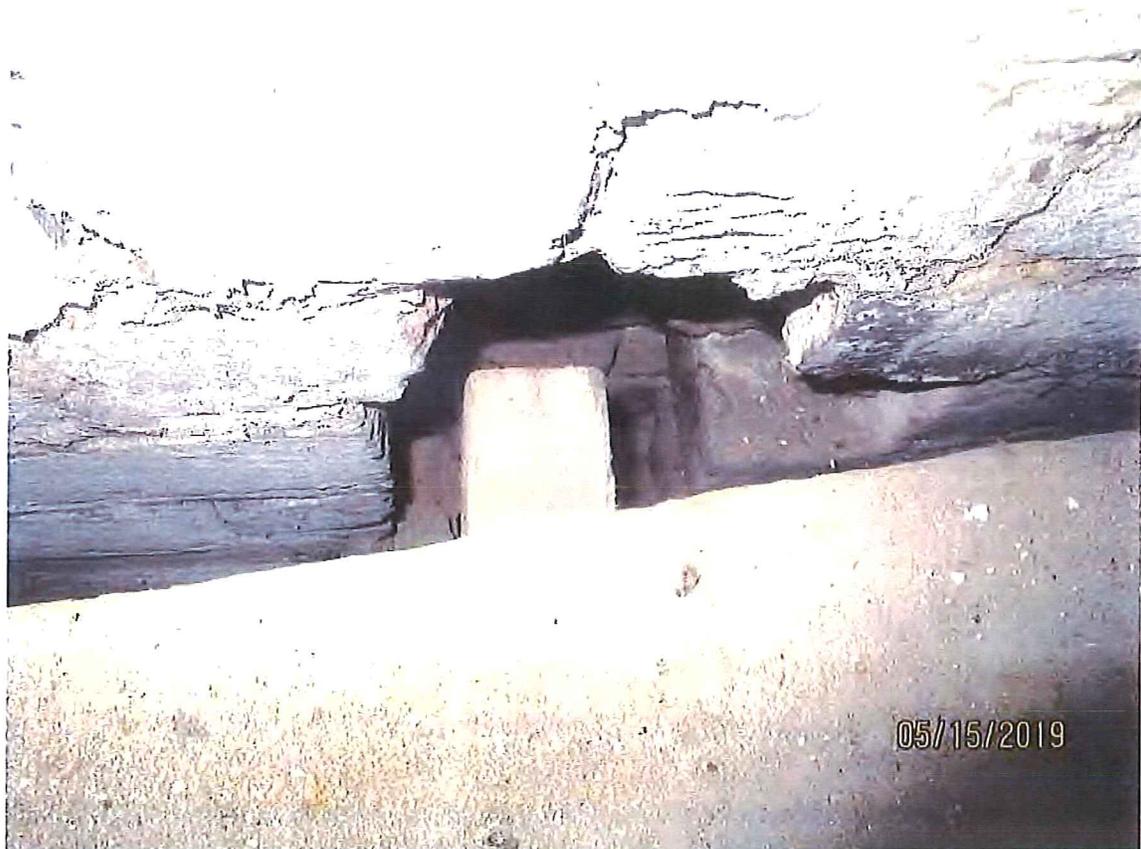
**Photograph 53: Floor joist movement at left wall on third floor.**

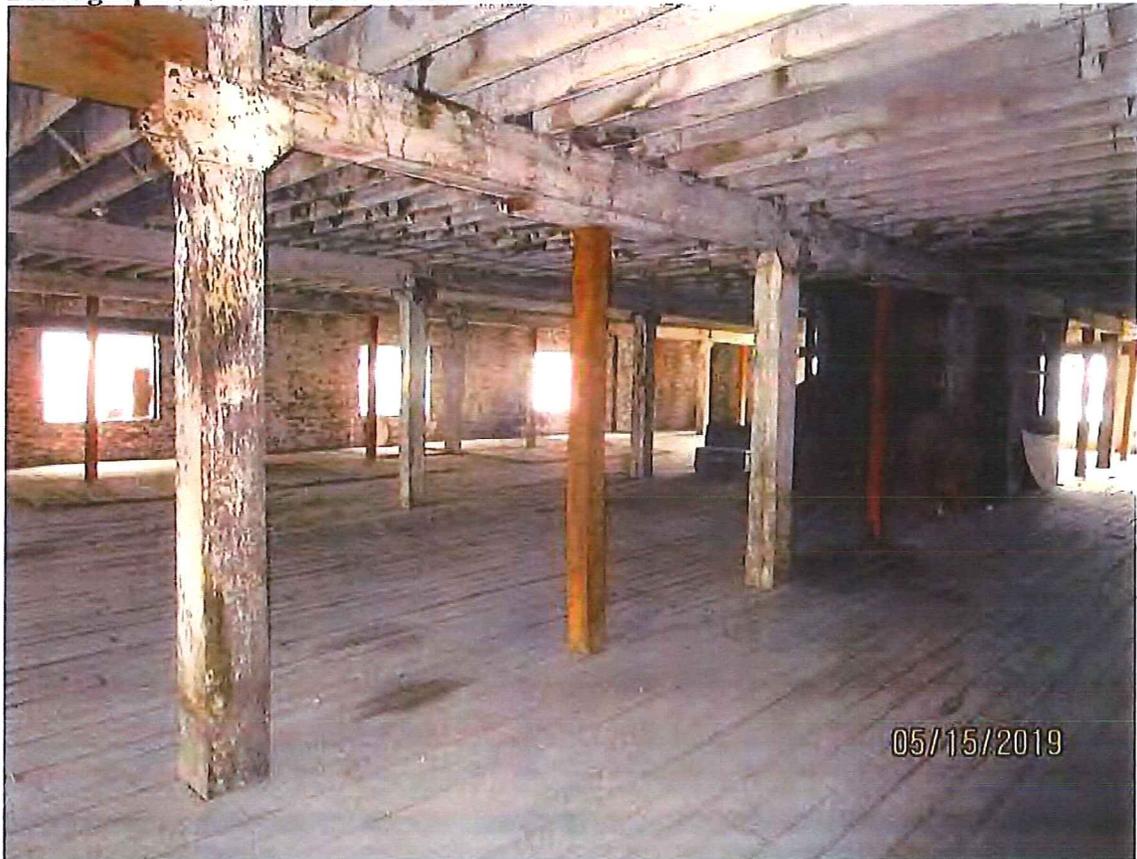
Another observation during our initial walk-through was that the majority of the wood-framed floor system has deteriorated to the point that additional repairs are needed to support any intended use. I will point out that due to the openings and voids in the floor system, a plastic barrier has been placed beneath the floors to prevent debris from falling to the usable space that is currently the first floor. An interesting observation is that the original first floor is not bearing on a concrete slab-on-grade, which is typically the case for floor systems that do not contain basements. As a result of this floor framing construction, the floods of May 2010 created additional distress for this wood-framed floor system. One only has to walk across the floor system to realize the inadequacies created when the floor was built within close proximity to the grade. Examples of the wood flooring issues can be seen in photographs 13, 54, 55, 57, 60, 61, 63, and 68.

**Photograph 55: Condition of floor at third level.**

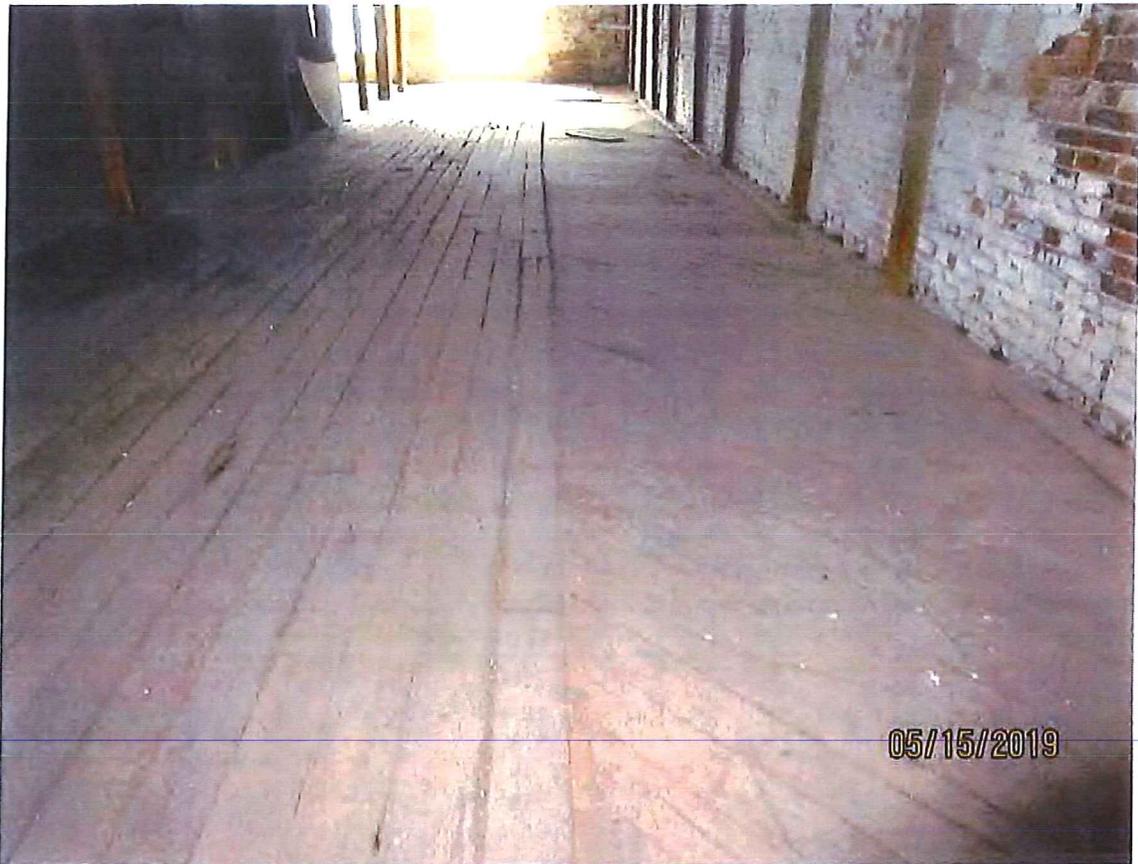
**Photograph 56: Bowed left wall on third floor.**

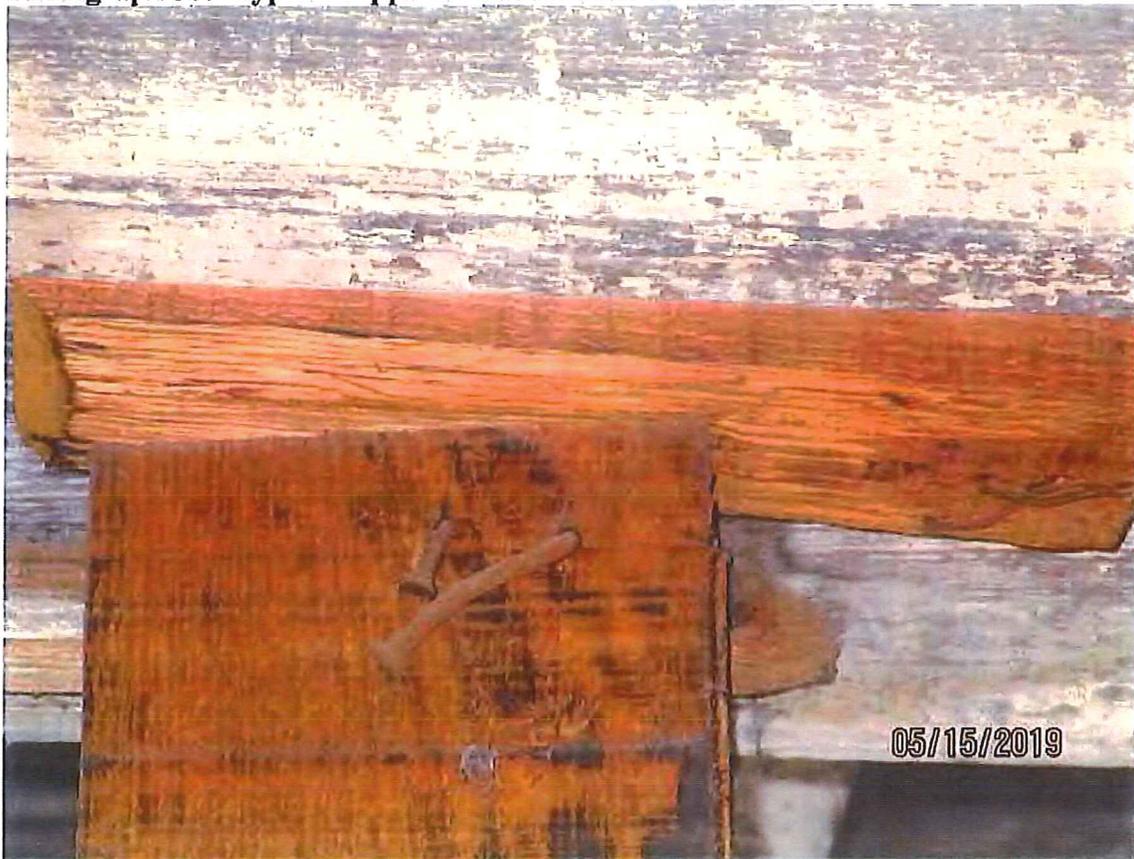
**Photograph 59: Typical supplemental columns on third floor.**

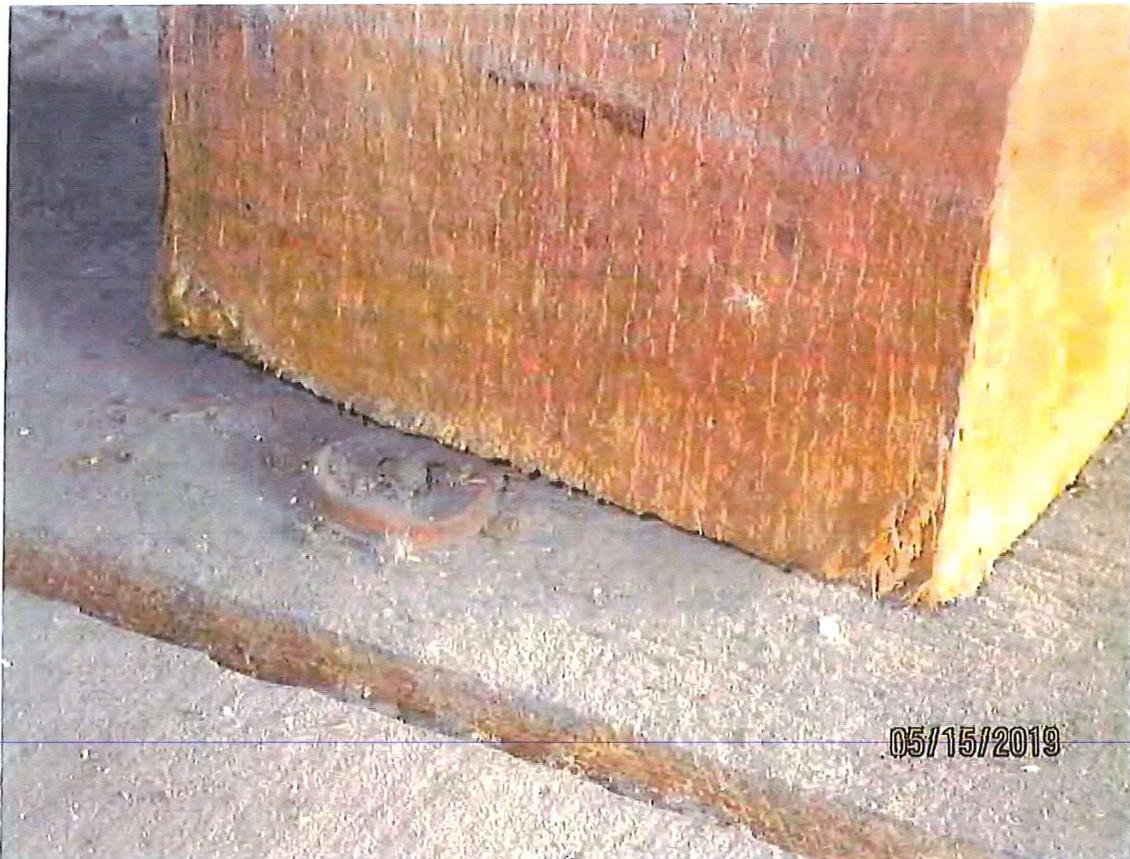
**Photograph 60: Supplemental columns / floor condition at third floor.**

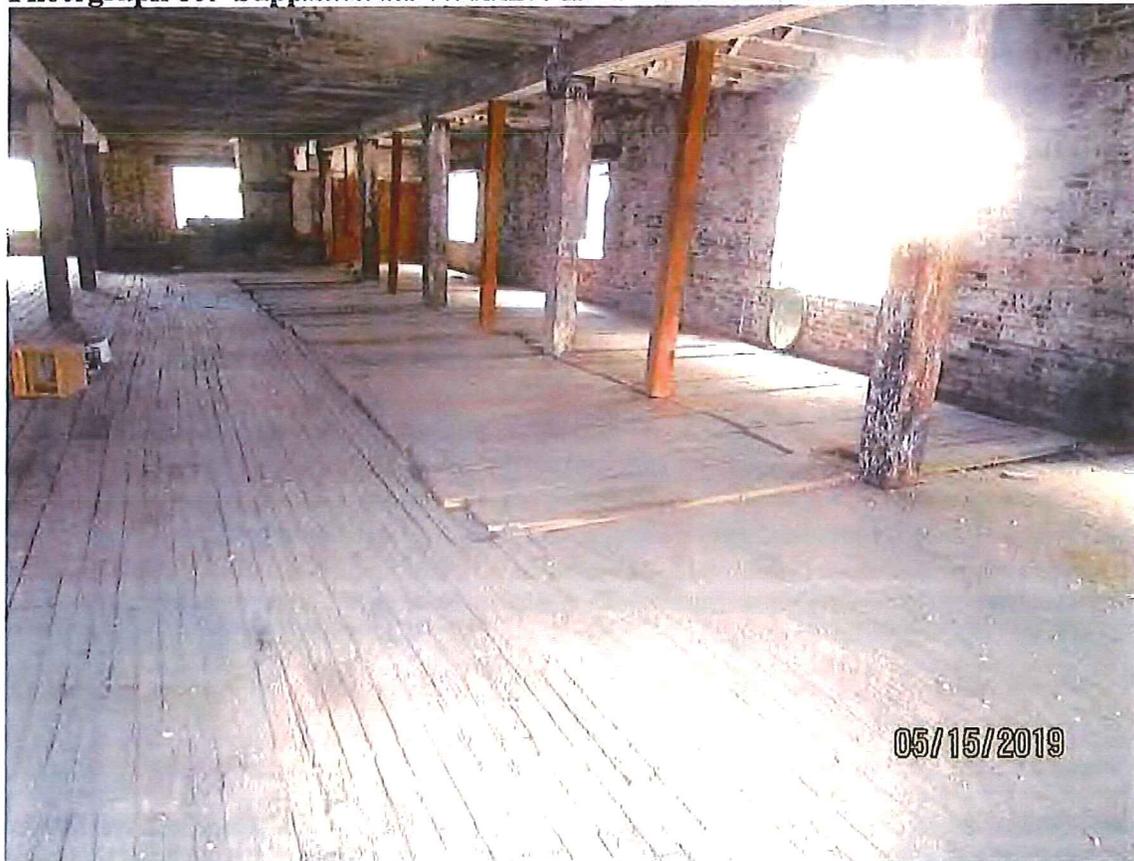
**Photograph 61: Supplemental columns / floor condition at third floor.**

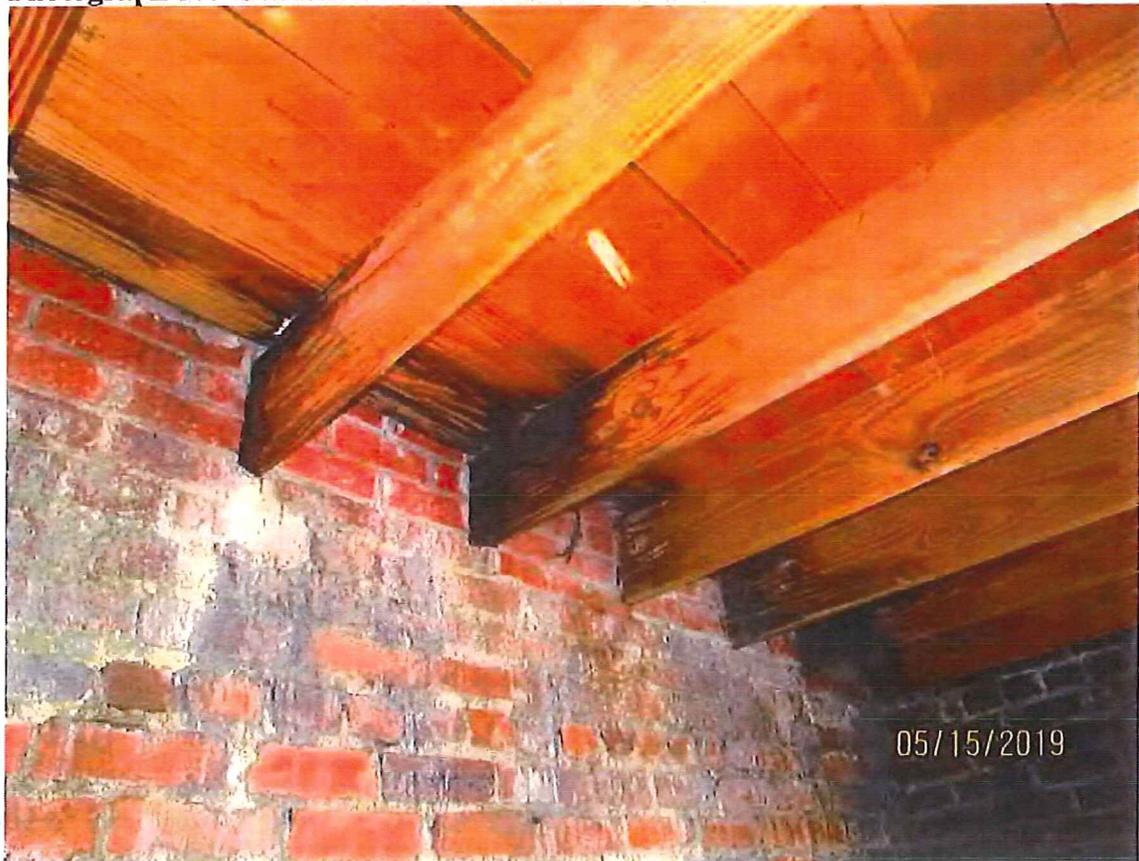
**Photograph 65: Condition of roof rafters at left wall.**

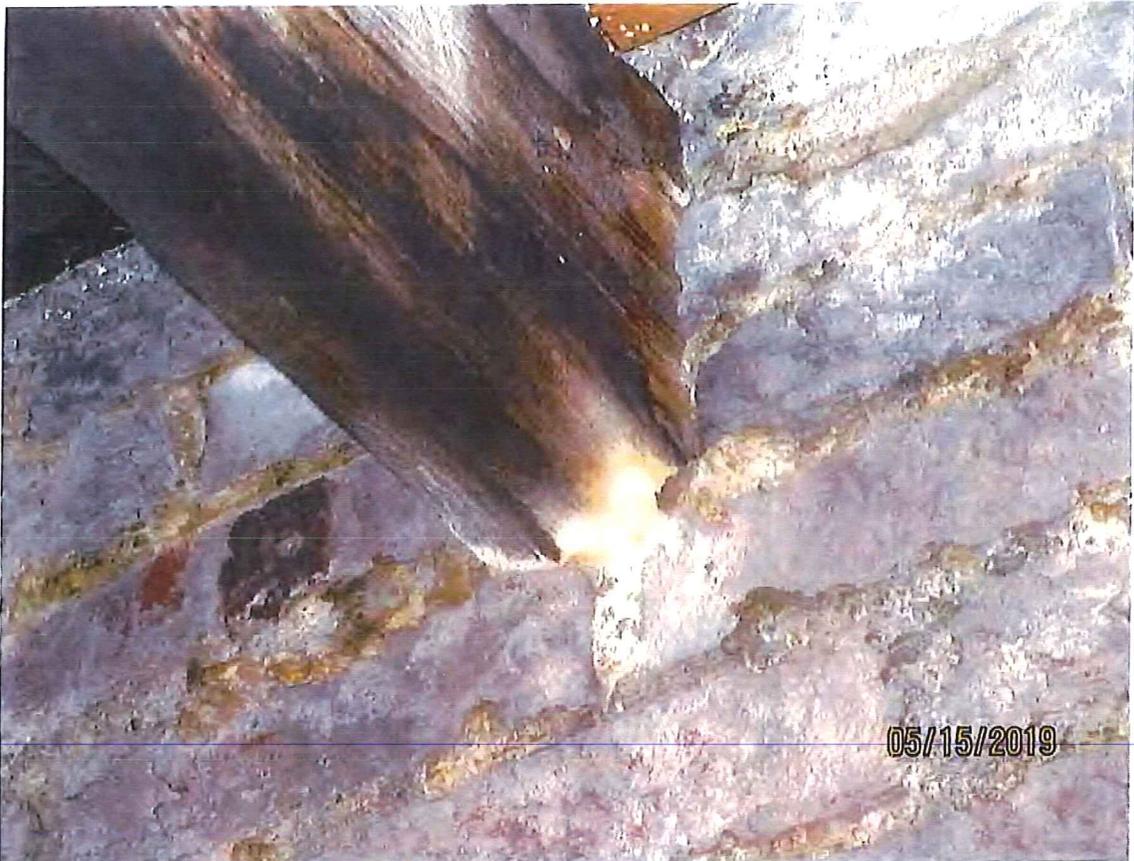
**Photograph 66: Deterioration of bricks / mortar at left wall on fourth floor.**

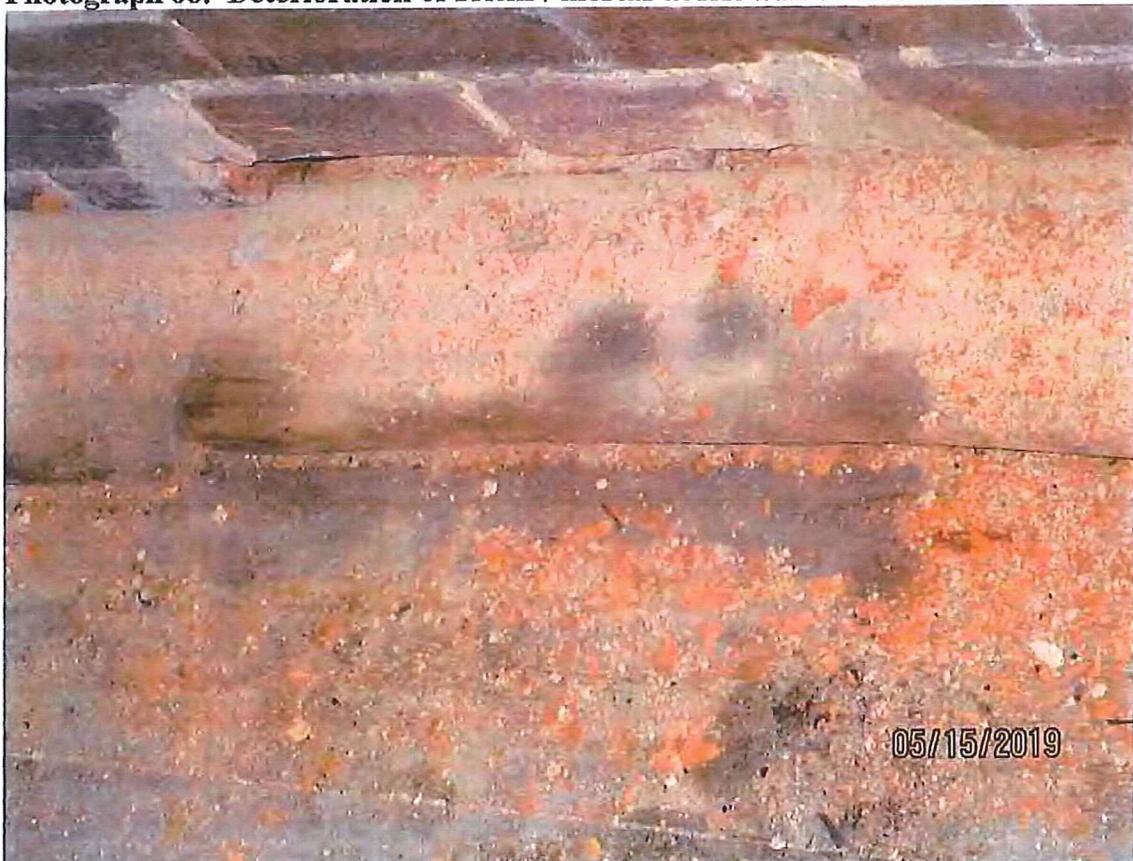
**Photograph 67: Deterioration of bricks / mortar at left wall on fourth floor.**

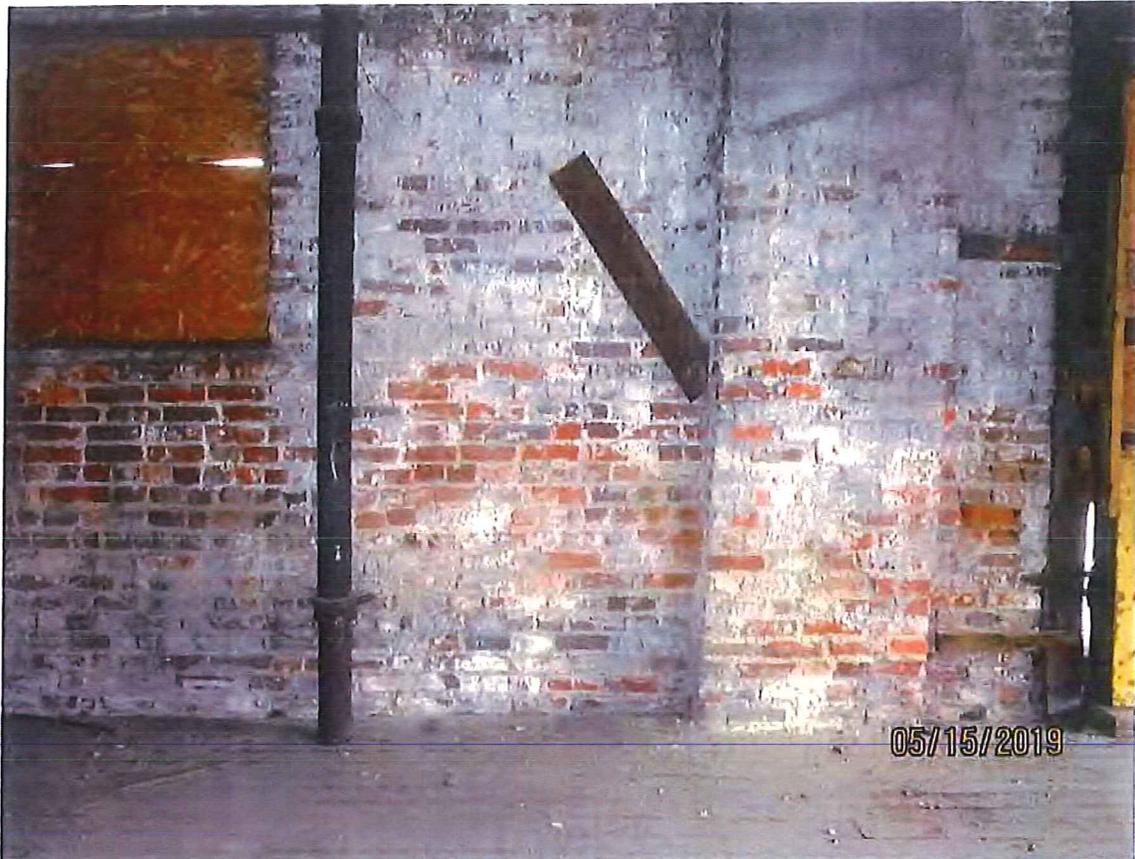
**Photograph 70: Deterioration of bricks / mortar at right wall on fourth floor.**

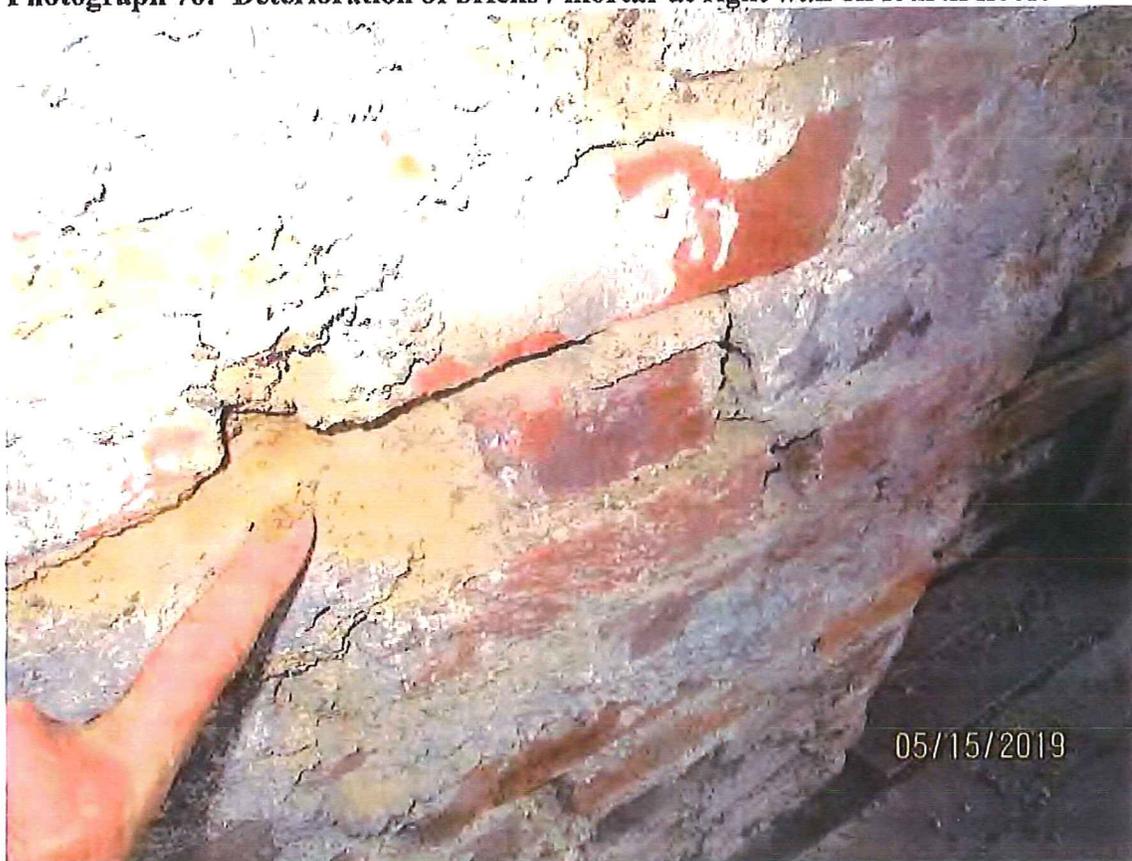
**Photograph 71: Deterioration of bricks / mortar at right wall on fourth floor.**

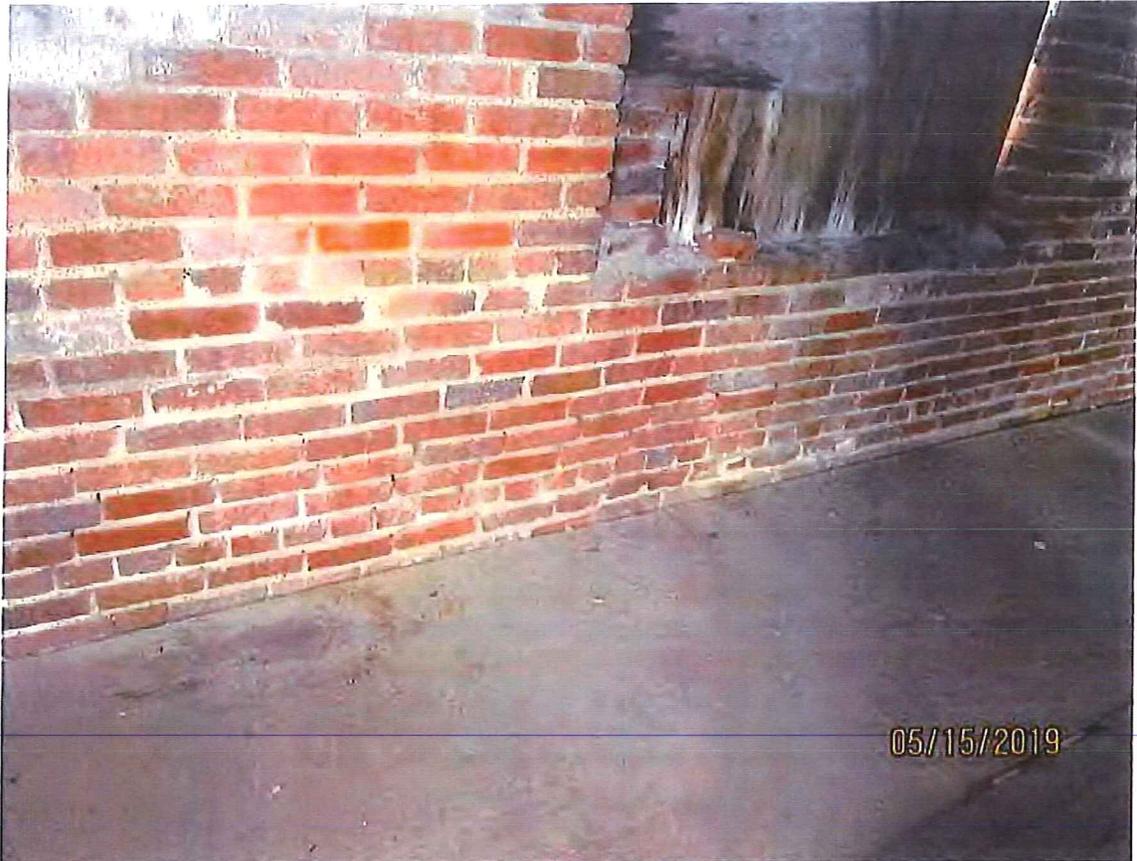
**Photograph 72: Deterioration of bricks / mortar at right wall on fourth floor.**
