STAFF RECOMMENDATION
1501 Fatherland Street
January 15, 2020

Application: Demolition
District: Lockeland Springs-East End Neighborhood Conservation Zoning Overlay
Council District: 06
Base Zoning: R6
Map and Parcel Number: 08313041400
Applicant: Laura Magliochetti
Project Lead: Paul Hoffman; paul.hoffman@nashville.gov

Structural Observance for 1501 Fatherland St., Nashville, TN 37206

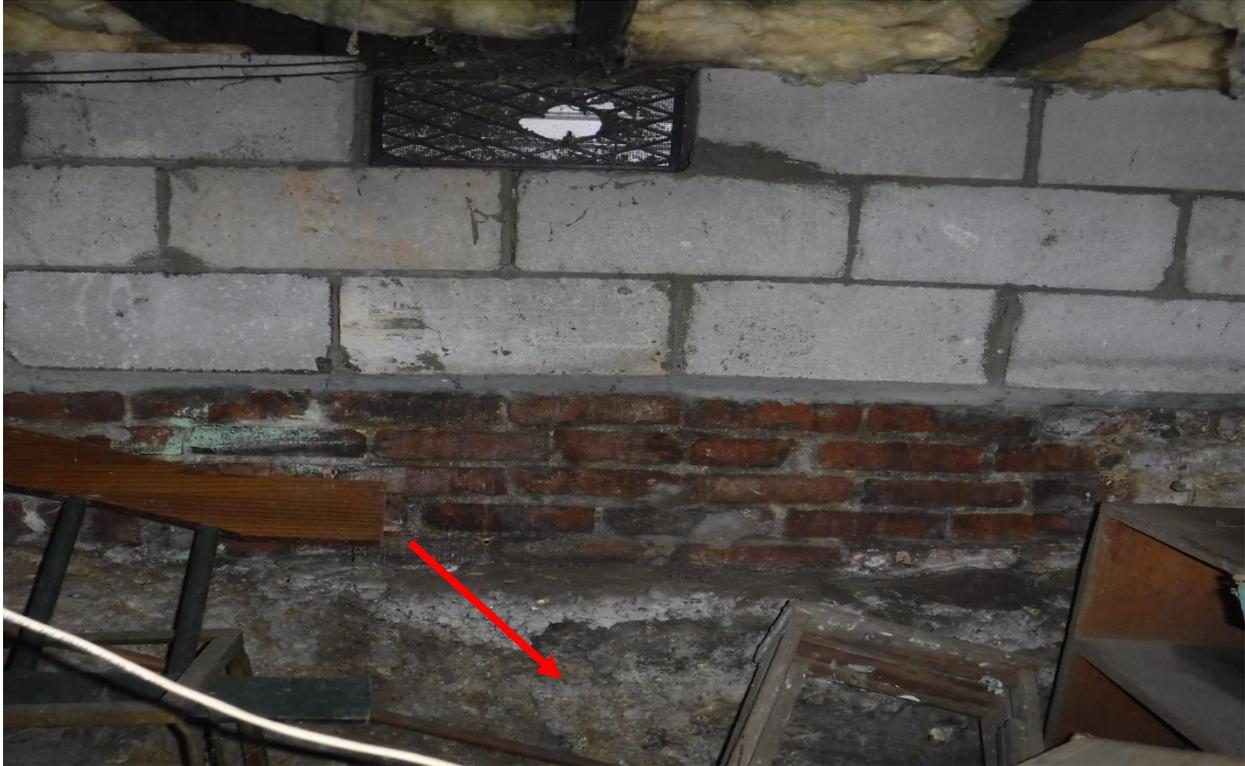
- a. There was a section at the left-side of the house that did not appear to have a retaining wall (See Photo #1). Gaps in the foundation do not provide adequate support for the structure. A proper foundation will have to be installed in this area.

Photo #1: Missing Section of Foundation Retaining Wall

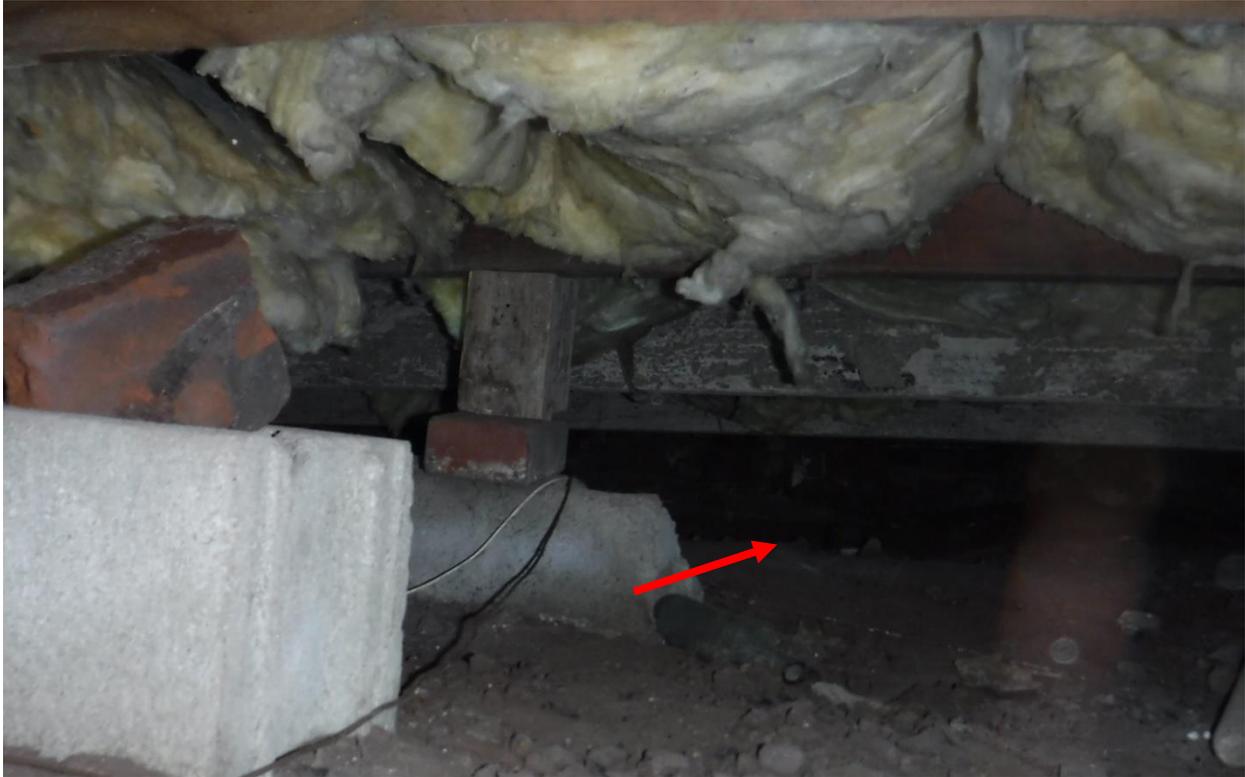
- b. There was minimal crawl space clearance that prevented access to some areas of the crawl space (See Photo #2). This condition can cause dry rot, and termite intrusion to the floor framing. The grade will have to be excavated and the framing repaired or replaced.

Photo #2: Minimal Clearance Height of Crawl Space

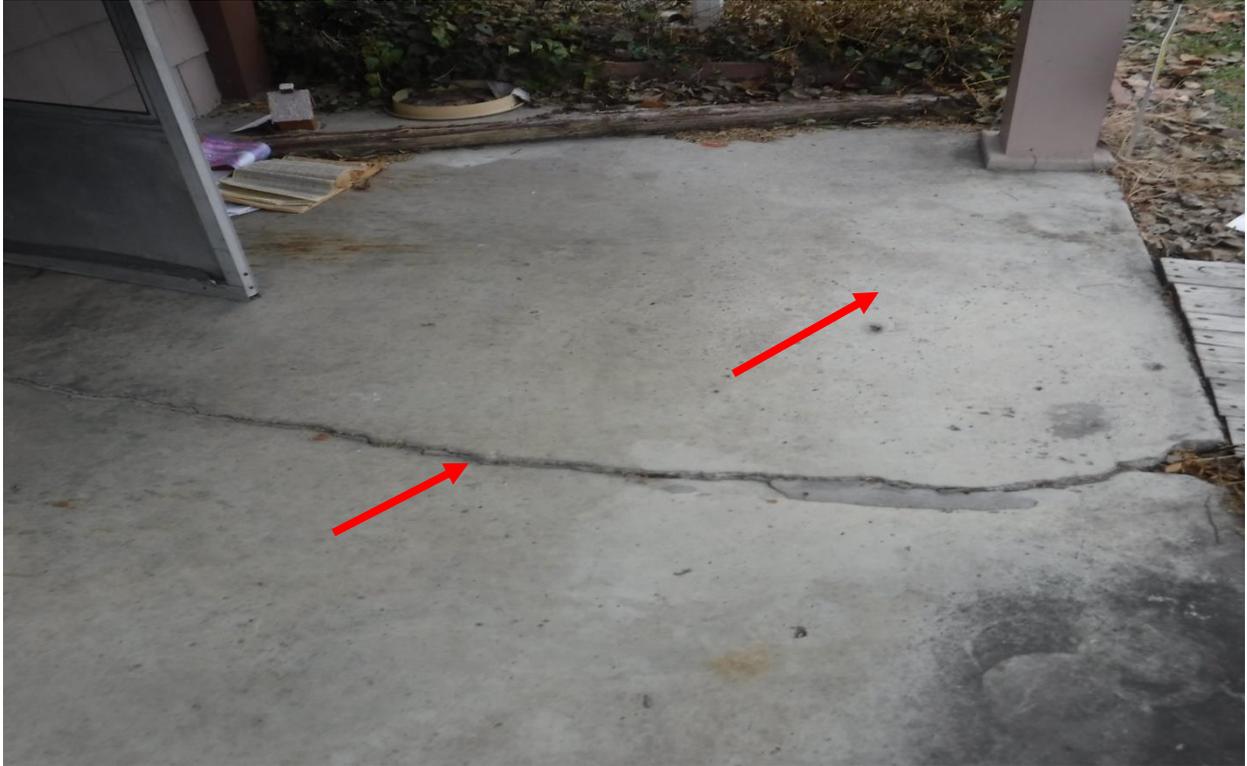
- c. The front porch piers have settled and rotated (See Photo #3). This has caused issues to the framing above. The porch foundation will have to be replaced.

Photo #3: Settlement and Crack of Porch Slab

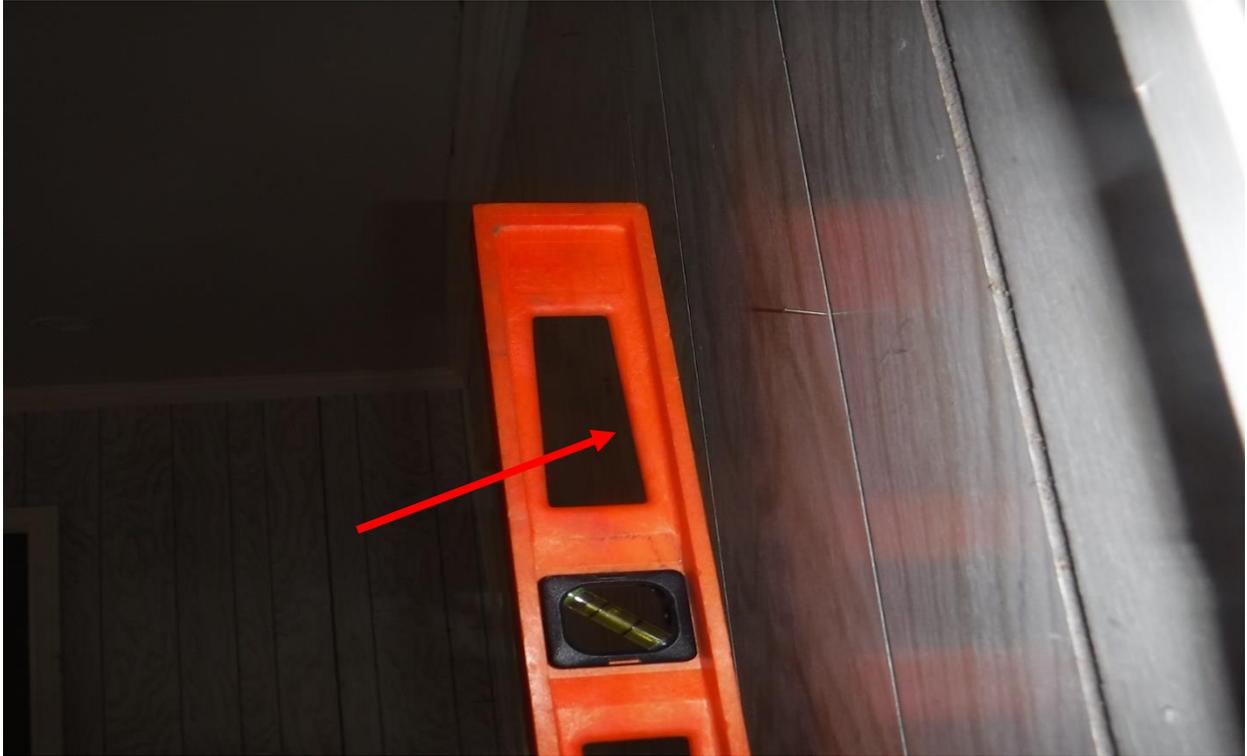
- d. The floor elevation was measured throughout with a liquid high-precision altimeter "zip level" to compare the floor elevation for flatness. This is important to check because in some situations floors can settle, due to varying causes, usually stemming from soil settlement in parts or entirely throughout foundations. These floor measurements showed the floor diaphragm to be drastically outside the normal, acceptable tolerances of 1" of vertical displacement to every 20' lateral feet of distance. From the back to the front of the structure, the foundation has settled approx. 10-1/2" in approx. 45ft. This 5x the allowable limit and is causing issues due to the issues noted above with the floor frame structure, support framing and site/crawl space drainage. This has even caused the house walls to rotate (See Photo #4).

Photo #4: Wall out of Plumb

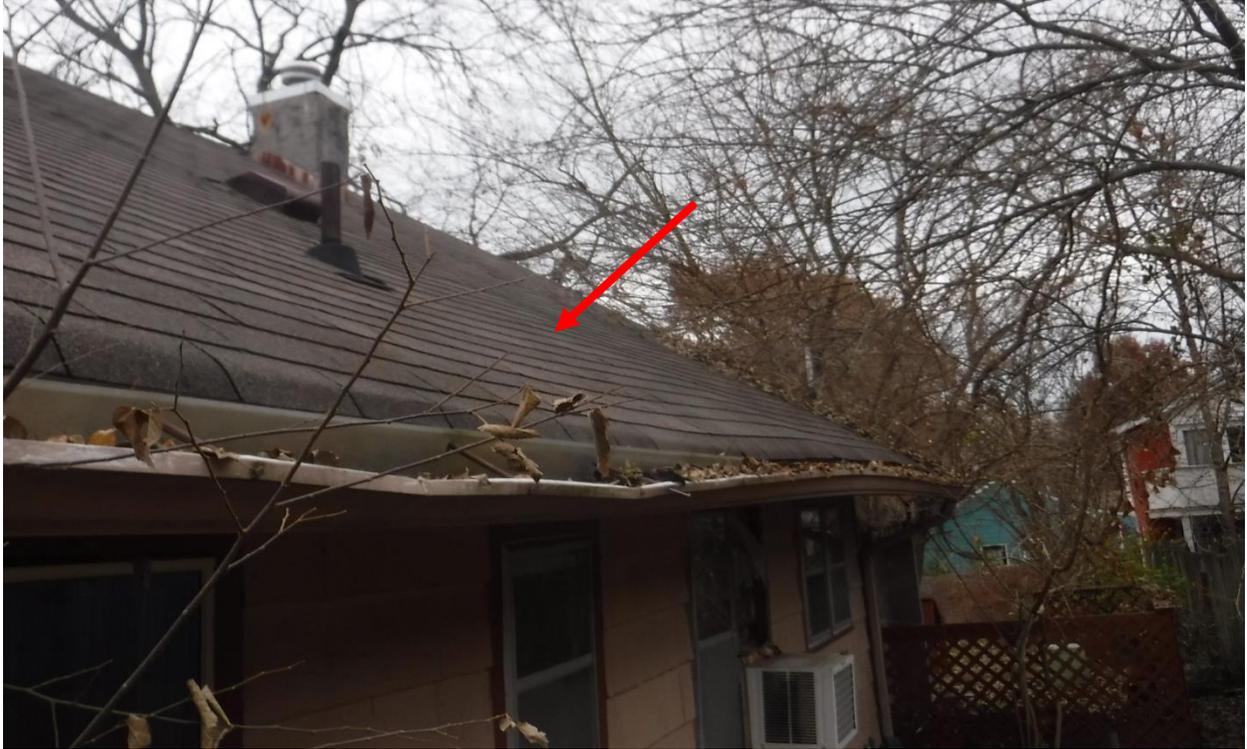
- e. There is severe bowing of the roof (See Photo #5). The attic was not visible due to accessibility restraints; however, the rafters are clearly overstressed and will have to be repaired or replaced. The roof sheathing is most likely needing replacement.

Photo #5: Roof Bowing

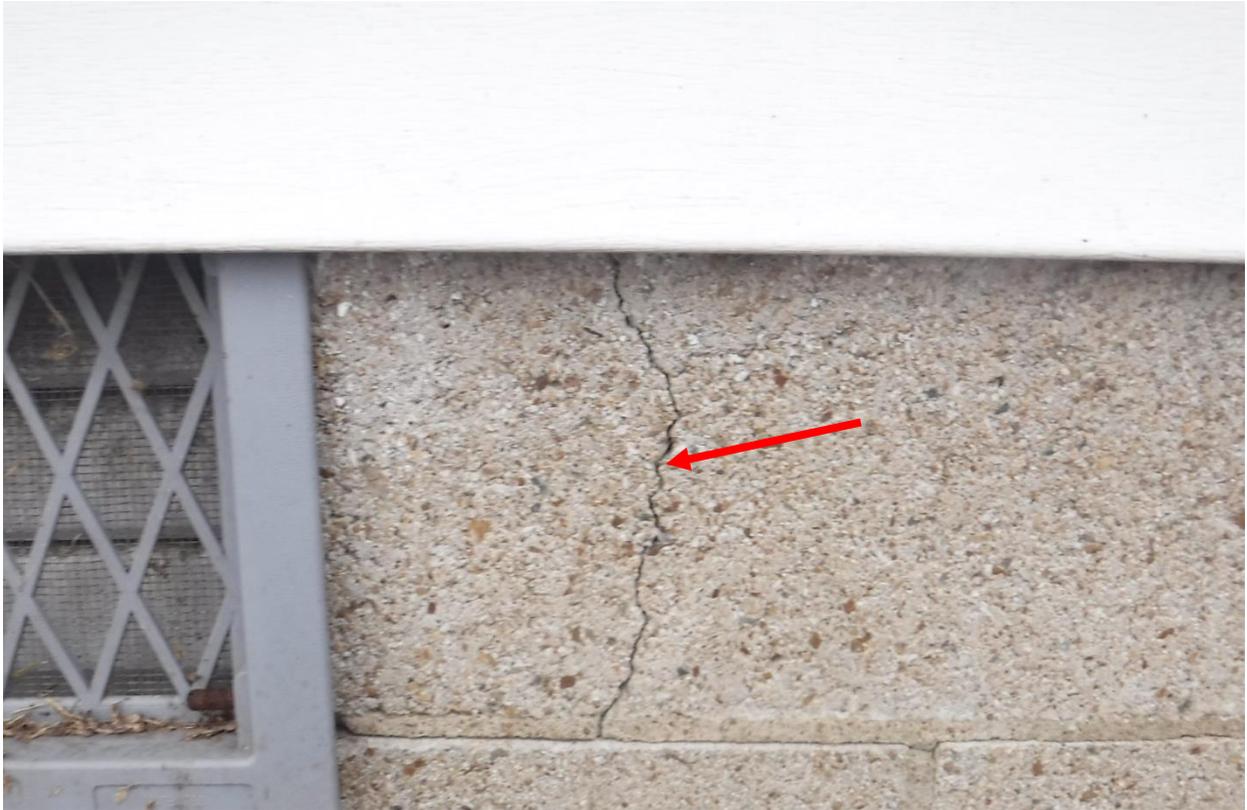
- f. There were multiple settlement cracks through the foundation (See Photo #6). Previous cracks have been patched; however, new cracks have formed showing

continual movement of the foundation. This settlement had caused structural damage to the foundation. These cracks will have to be repaired.

Photo #6: Cracking in Foundation

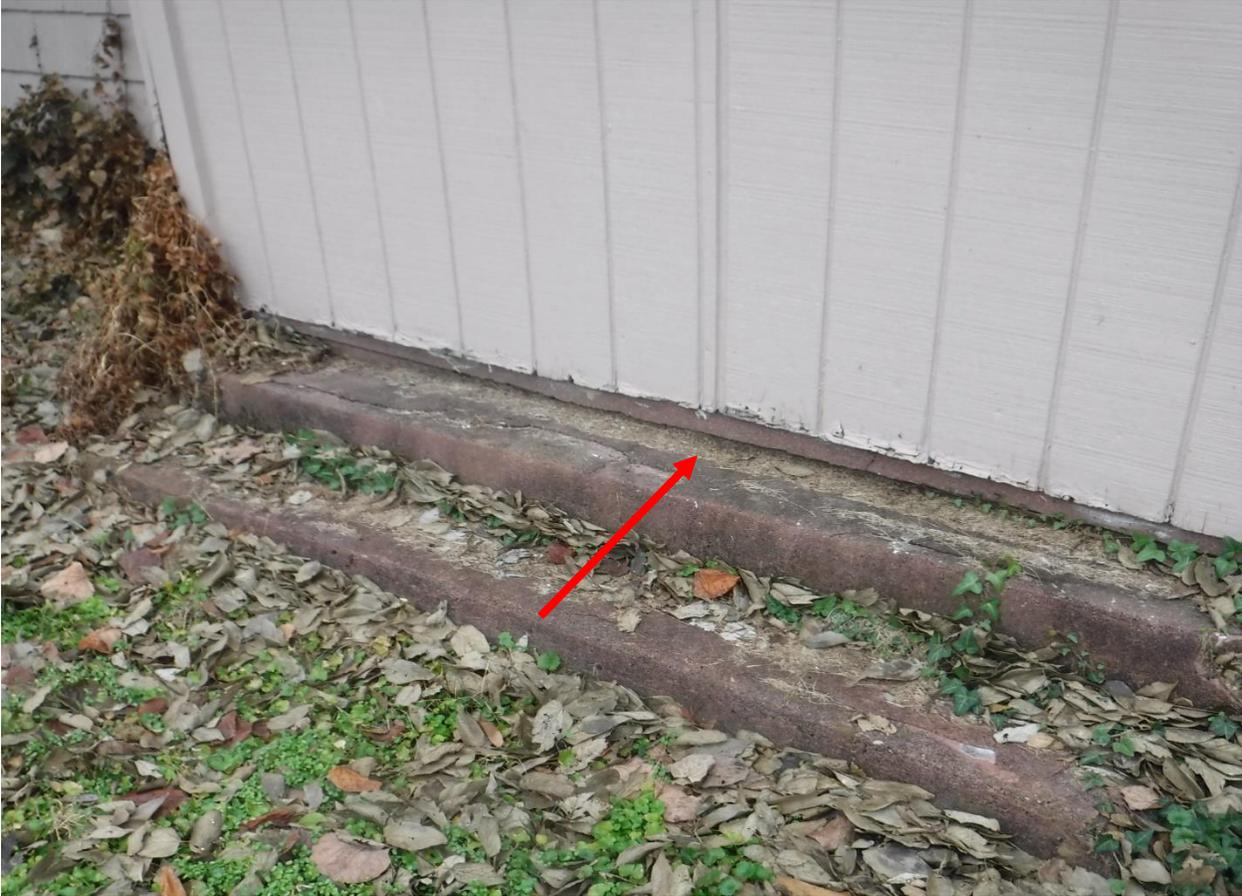
g. The addition on the side of the house is a previous concrete porch (See Photo #7). This foundation is not suitable to support a structure and will need to be replaced.

Photo #7: Side Addition on Concrete Porch:

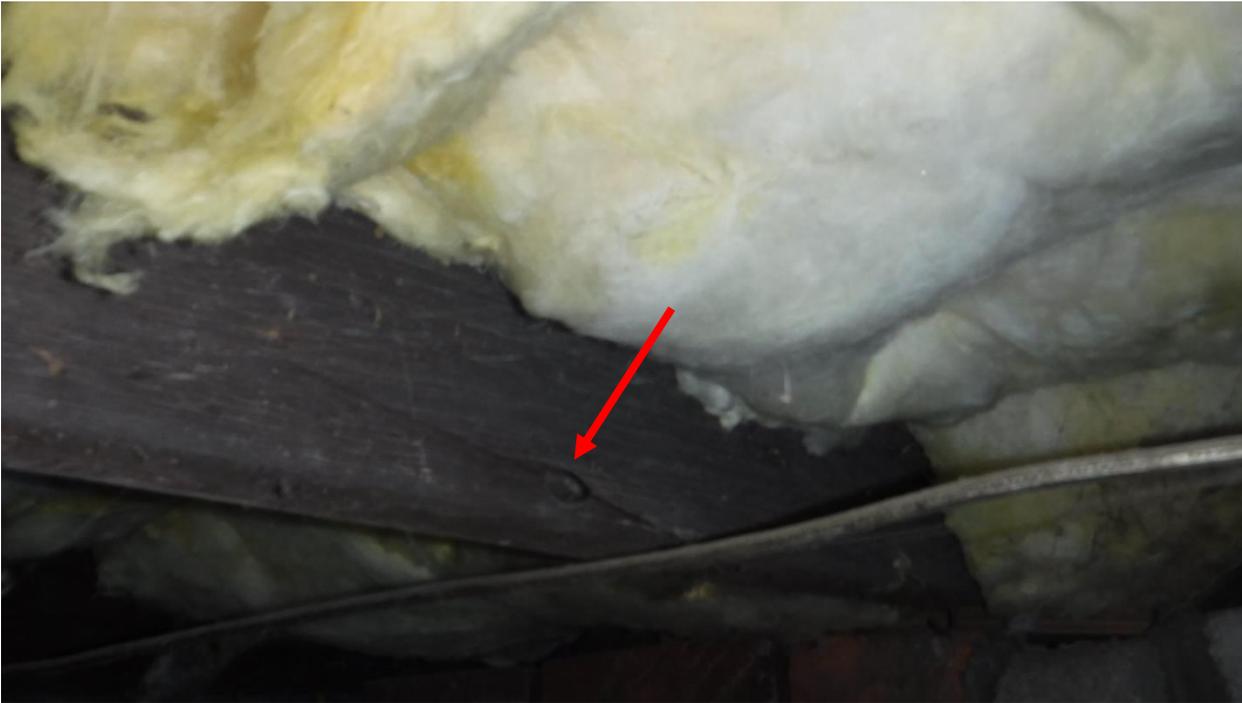
h. There is dry rot and damaged to the existing framing (See Photo #8). These damages weaken the framing and can cause it to fail. This framing will have to be repaired or replaced.

Photo #8: Framing Damage

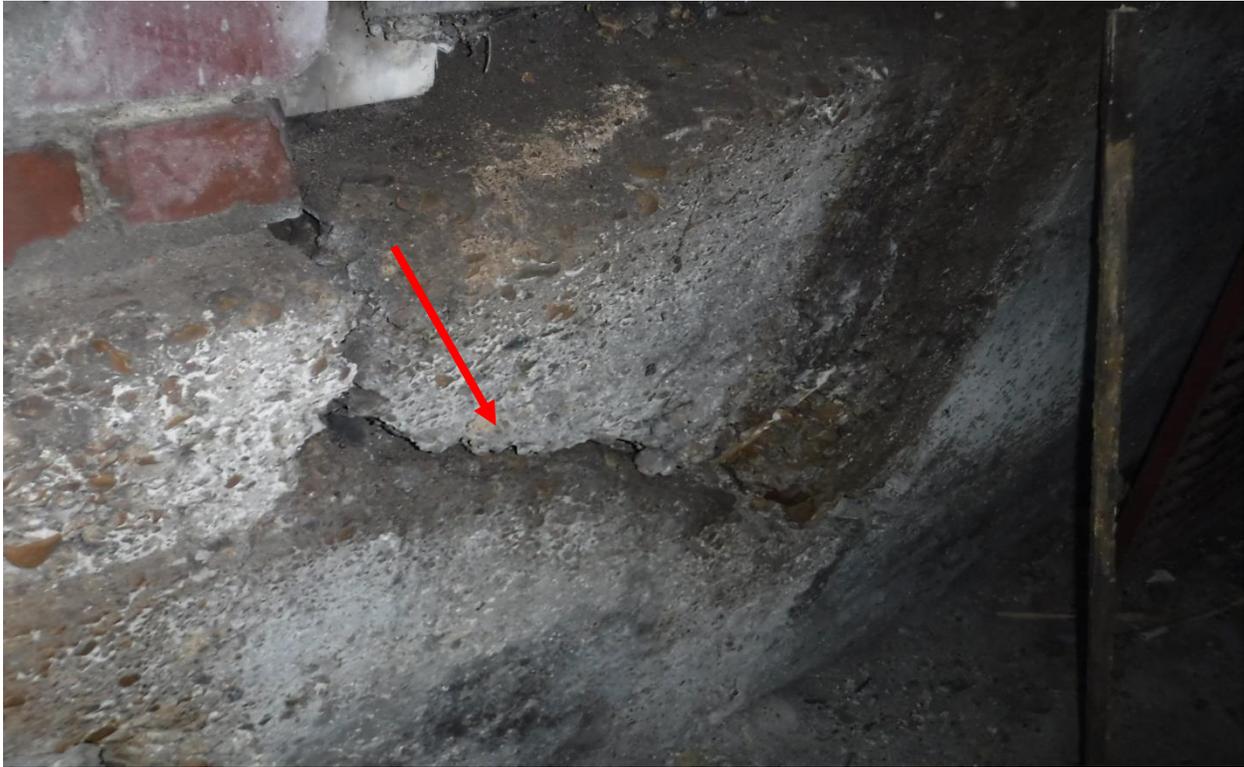
i. There are large cracks in the retaining walls (See Photo #9). These walls are under-designed and overstressed and the cracking is a result of this. The wall will need to be repaired or replaced.

Photo #9: Retaining Wall Cracking

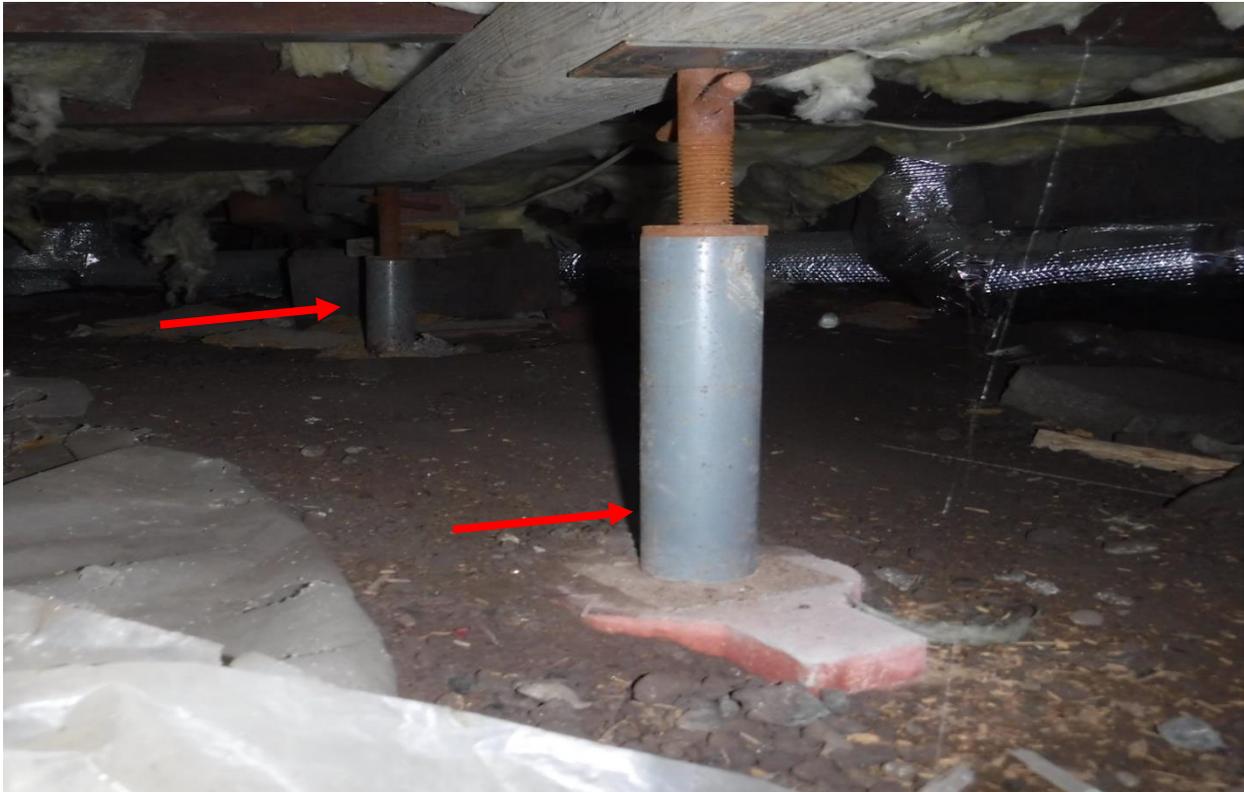
j. Temporary support posts and piers were installed throughout the crawl space to support the flooring (See Photo #10). These supports; however, were not engineered, do not meet code requirements, and because of this, they are settling, rotating and showing signs of damage. These supports will have to be replaced.

Photo #10: Temporary Floor Supports

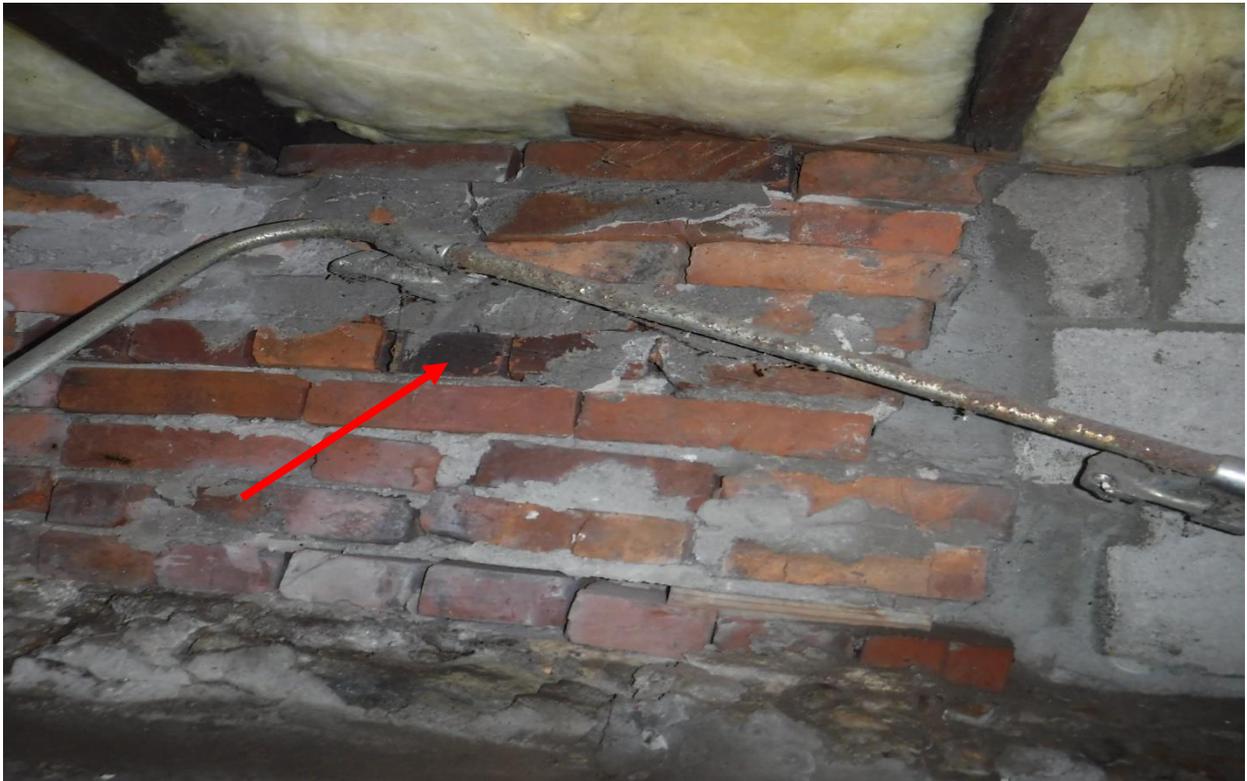
k. There are a few visible areas where the original foundation had settled and is badly damaged (See Photo #11). This foundation is not suitable to support a structure and will need to be replaced.

Photo #11: Damaged Foundation

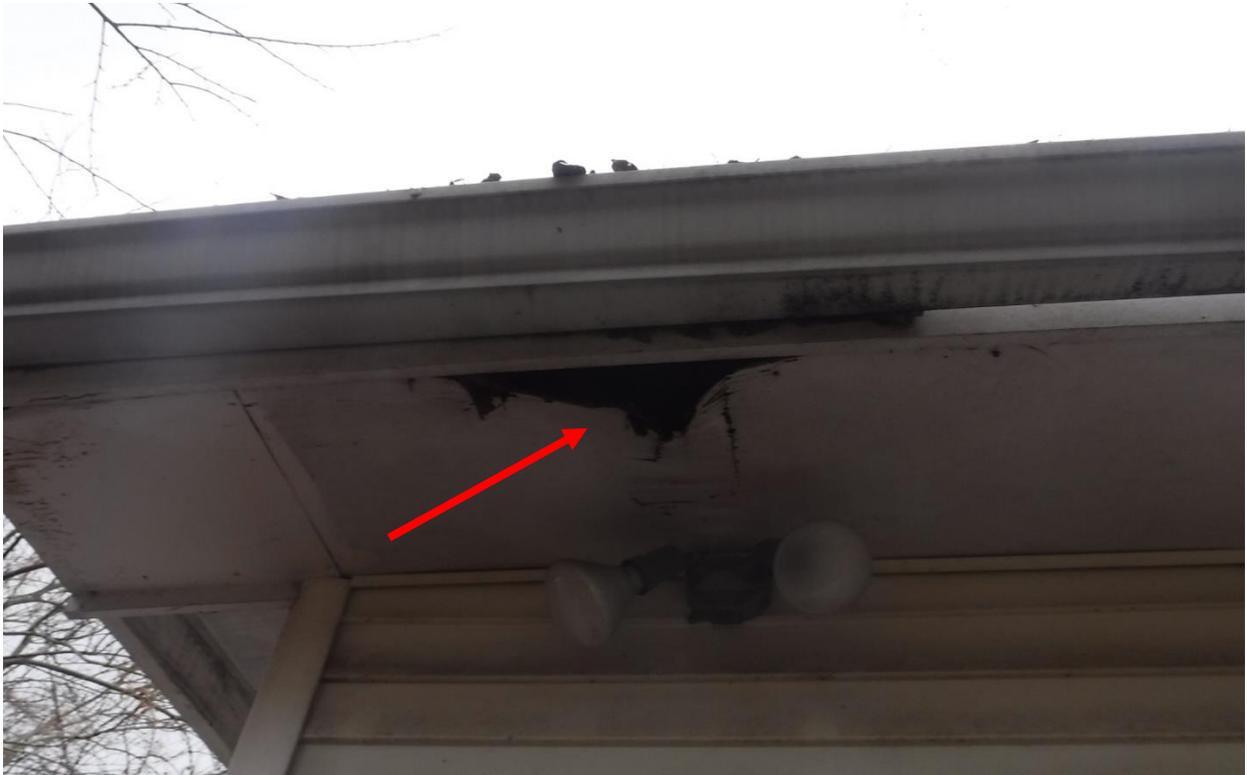
l. There are signs of roof rot and water intrusion at the rear addition (See Photos #12 and #13). The roof will need to be replaced in these areas.

Photo #12: Roof Rot at Rear

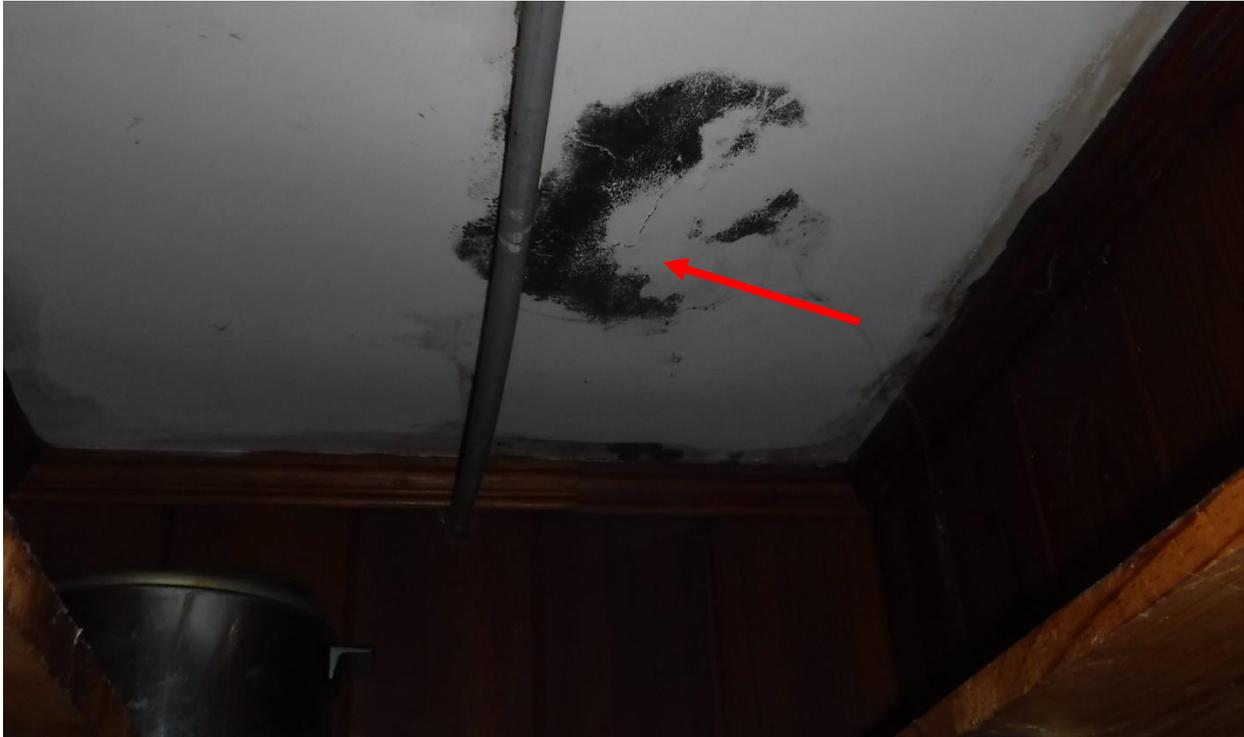
Photo #13: Ceiling Fungus at Rear
