METROPOLITAN GOVERNMENT OF NASHVILLE AND DAVIDSON COUNTY

STAFF RECOMMENDATION
215 Broadway
March 18, 2020

Application: New Construction - Violation
District: Broadway Historic Preservation Zoning Overlay
Council District: 19
Base Zoning: DTC
Map and Parcel Number: 093 06 4 043.00
Applicant: Broadway Hotel, LLC
Project Lead: Jenny Warren, jenny.warren@nashville.gov

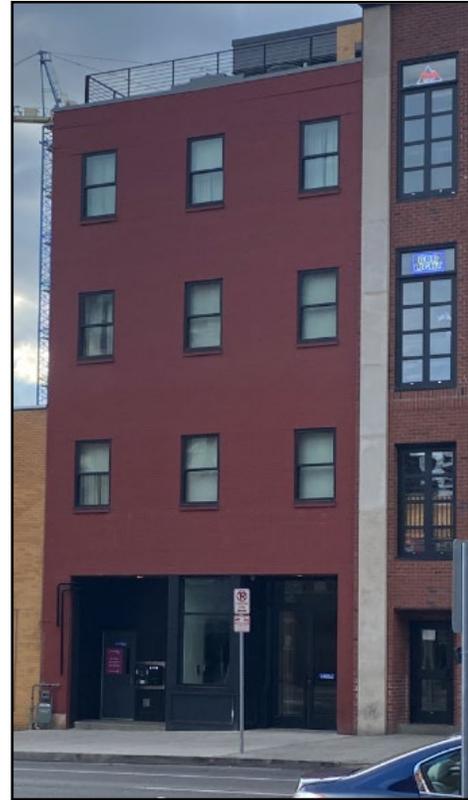
The original storefront was replaced at some point prior to the overlay. In 2014, MHZC approved changes to this storefront in conjunction with permits for the Moxy Hotel. The storefront was altered as a part of the Moxy rehabilitation, but the final storefront design does not match the permits. An ATM has also been installed in the front of the building on the left side.

Figure 1: 215 Broadway in March 2020

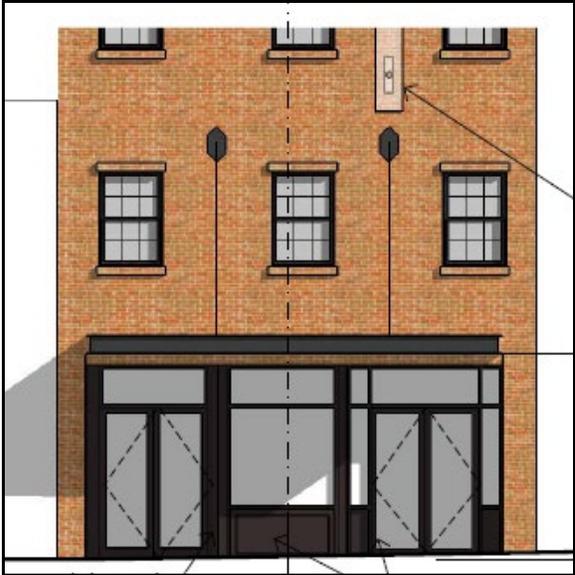
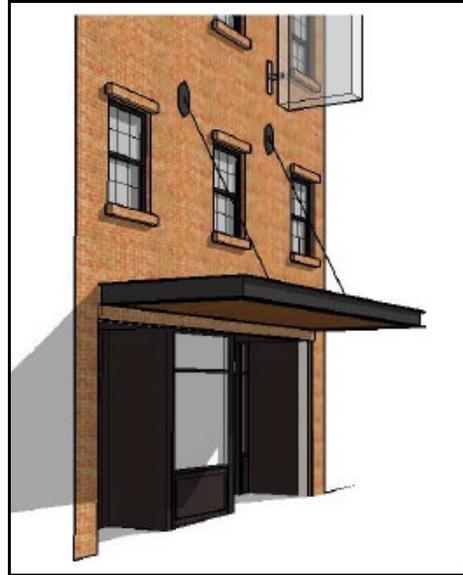
In 2014, a permit was issued for the Moxy Hotel, which included alterations to the façade of 215 Broadway. Permit #201400341 shows a storefront with a projecting central bay and recessed double doors with transoms on either side (Figures 2 &3). This was constructed as per the permitted plan on the right side, with full-light doors, and in the central bay. However, the left side was not built out according to the permitted plans (Figure 4). Instead of installing double glass doors with a transom, a solid wall was constructed with two nearly solid doors and no transom. An ATM was also installed here.

Figures 2 & 3: Storefront as approved in 2014

Staff recommends that the doors and transom be installed into the left side of the storefront, as per the plans approved in 2014.

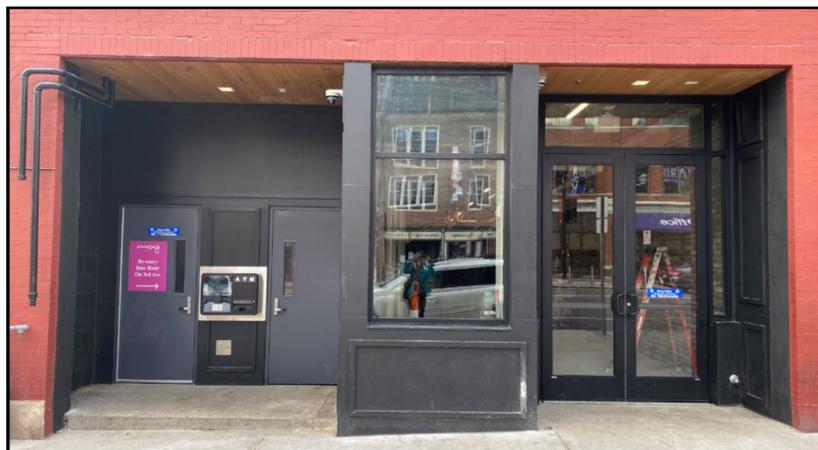
Staff finds the current configuration to be inappropriate, as it does not match the permit and does not comply with General Principles, Section II of the design guidelines which state “Replacements of street-level facades should be in keeping with the style and period of the building.” The lack of transparency on the left side, including the solid transom, the nearly solid doors and the ATM (further discussed below) are not typical of a historic primary façade on Broadway.

The ATM at 215 Broadway is installed in the wall and is one foot, eleven inches tall (1’11”) and about two feet, seven inches (2’7”) wide. It is internally illuminated.

Figures 4: Storefront as currently configured.

two-story buildings with walls that extend the full width of the lot, store-front windows and upper-level punched-openings. The ATM is not appropriate in terms of height, scale, setback, rhythm, materials, texture or details.

In addition to not meeting the design guidelines for new construction, the ATM does not meet the policy the Commission established in 2004 that only allows for ATMs inside a building, where it would not be reviewed, or “in an alcove not on the primary facade.” This ATM is in a recessed primary entry rather than an “alcove,” and it is located along Broadway, one of the most highly visible streets in the district. The Moxy Hotel occupies the property today and operates out of this historic building and a second building behind it, which faces onto 3rd Avenue, South. While the Moxy has their primary entrance on 3rd Avenue, Broadway is still the primary façade for this historic building. Therefore, an ATM along this primary façade is not appropriate.

Staff recommends disapproval of the current storefront configuration including the ATM, finding that it does not meet Section II of the design guidelines for rehabilitation, Section III of the design guidelines for new construction and the MHZC policy for ATMs. Staff suggests that the doors and transoms be installed into the left side of the storefront, as per the plans approved in 2014 and the ATM be removed within the next 60 days.
