STAFF RECOMMENDATION

703 Shelby Avenue

August 19, 2020

Description of Project: The request is to paint the historic brick.

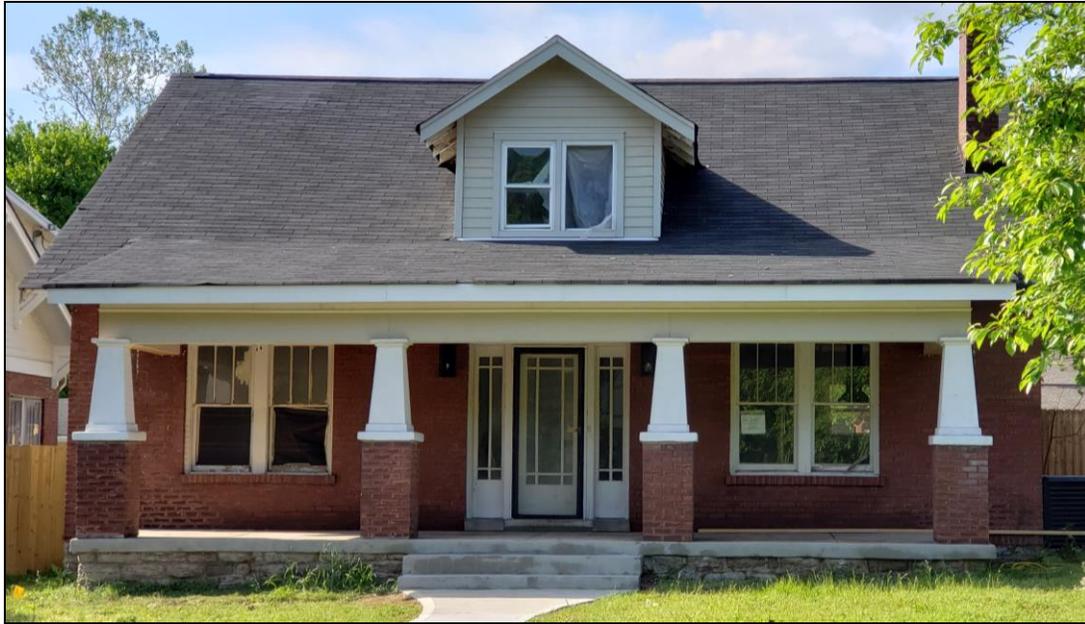
Figure 1. 703 Shelby Avenue, April 2020.

Background: The house located at 703 Shelby Avenue is a c. 1920 brick bungalow that contributes to the historic character of the Edgefield Historic Preservation Zoning Overlay district. A rear dormer addition was permitted administratively in October 2019 (HCP 2019060604).

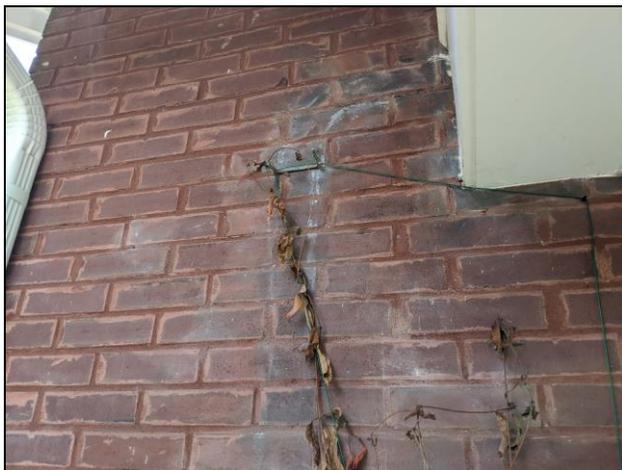
Painting of Masonry: The applicant has requested to paint the historic brick in order to cover existing stains as well as brick and mortar in need of repair. The stained areas are located near the front corners of the house and appear to be where the gutters were previously located (Figures 2 and 3).

Figure 2. Staining to the left of the front porch.

Recommendation: Staff recommends disapproval of the request to paint the brick, finding that the project does not meet Section II.B.5.c of the *Edgefield Historic Zoning District: Handbook and Design Guidelines* for when it is appropriate to paint brick. Staff recommends that the mortar be repointed and the masonry be repaired as needed using products and methods appropriate for historic masonry to prevent further damage.

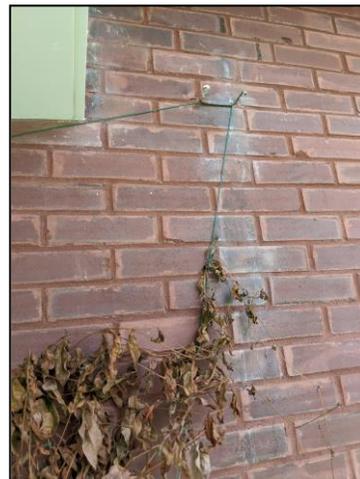
Figure 3. Staining to the right of the front porch.

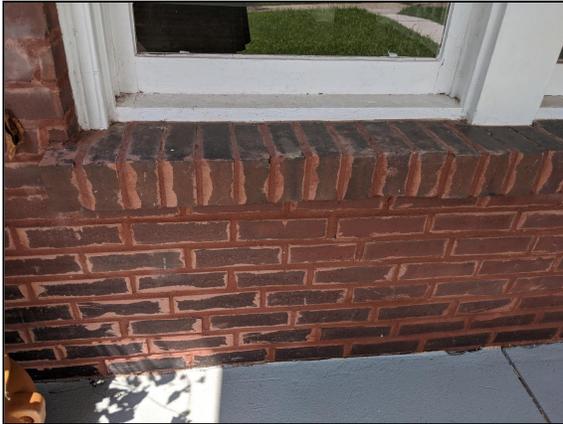
Figure 4. Front wall under porch roof.

The owner has suggested that the brick may have previously been painted or stained, but staff's inspection of the brick was unable to conclude that that is the case with the exception of the rear wall that was painted more recently without a permit. Some of the bricks appear either to have been damaged or worn down by recent or previous cleaning attempts or to have been stained by mortar in previous repointing efforts (Figures 4 and 5). (Also see Attachment B for more photos.) Staff also observed some individual brick that need repair. The owner has attempted to clean the brick using paint thinner, acetone, a wire brush, and multiple power washes, which are not effective or appropriate methods for cleaning historic brick.

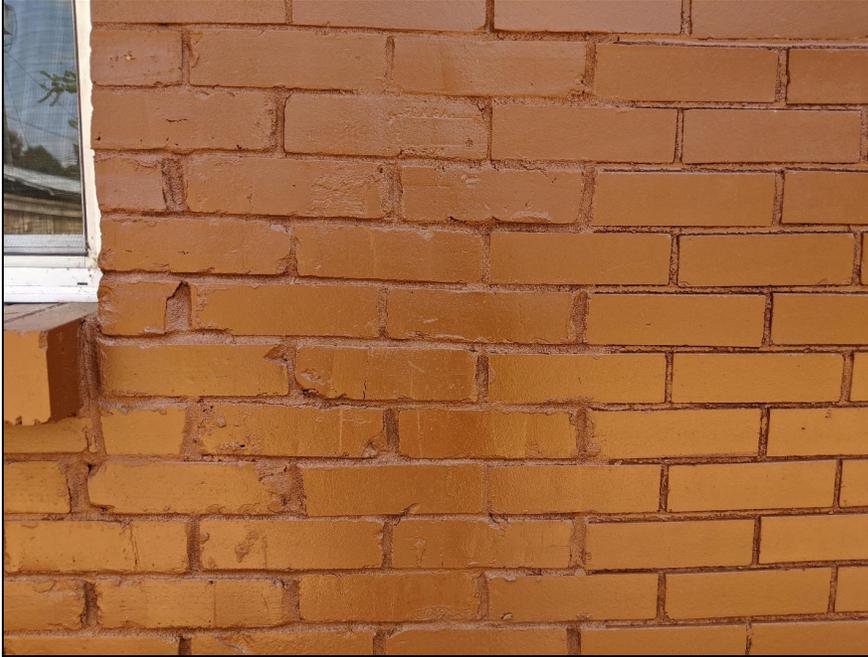
As stated previously, the rear façade has recently been painted without a preservation permit (Figure 6). While painting the brick does not meet the design guidelines, staff finds that leaving the rear wall painted could be appropriate since the rear façade is not visible from the street.

Figure 6. Recently painted rear façade.
