## **Operations Monitoring Report**

**Third Quarter FY22**

**Prepared by:**

**April 29, 2022**

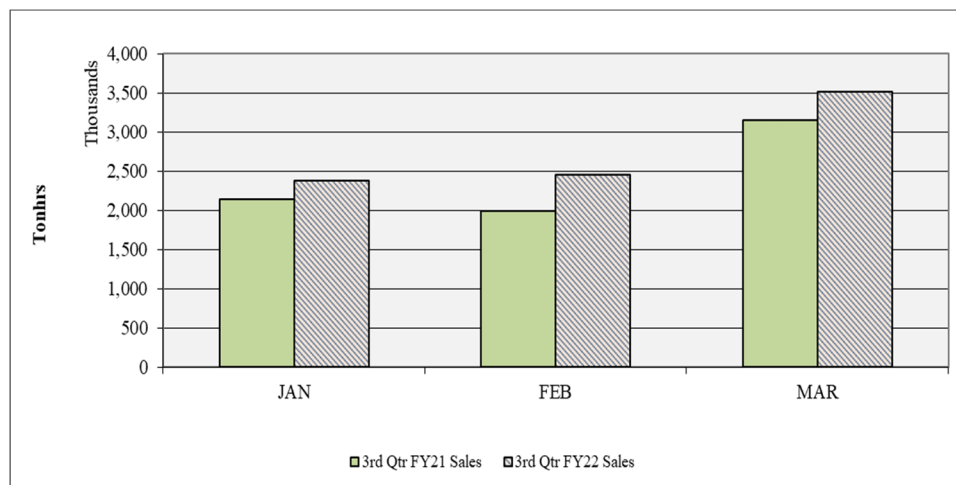
**Figure 1. Chilled Water Sales Comparison**

A comparison for the Third Quarter chilled water sales is shown in Figure 1. This data reflects a 14.7% increase in sales for the current quarter over the same quarter of the previous fiscal year.

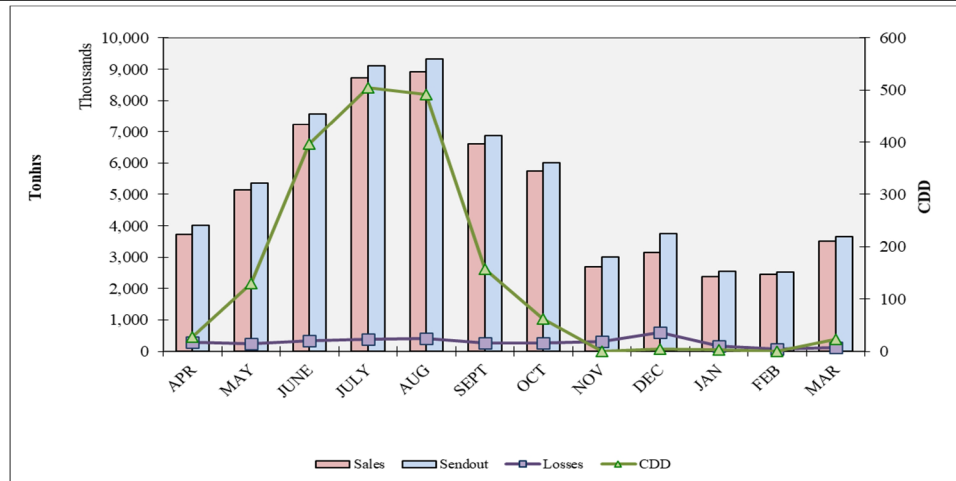
**Figure 2. Chilled Water Sales, Sendout, Losses and CDD for the Previous Twelve Months**

Figure 2 shows the chilled water sales, sendout and losses for the previous twelve months. The losses on this figure are defined as the difference in tonhrs per month between the recorded sendout and sales values and represent the total energy loss for chilled water in the EDS. The number of cooling degree days per month are also tracked for comparison.

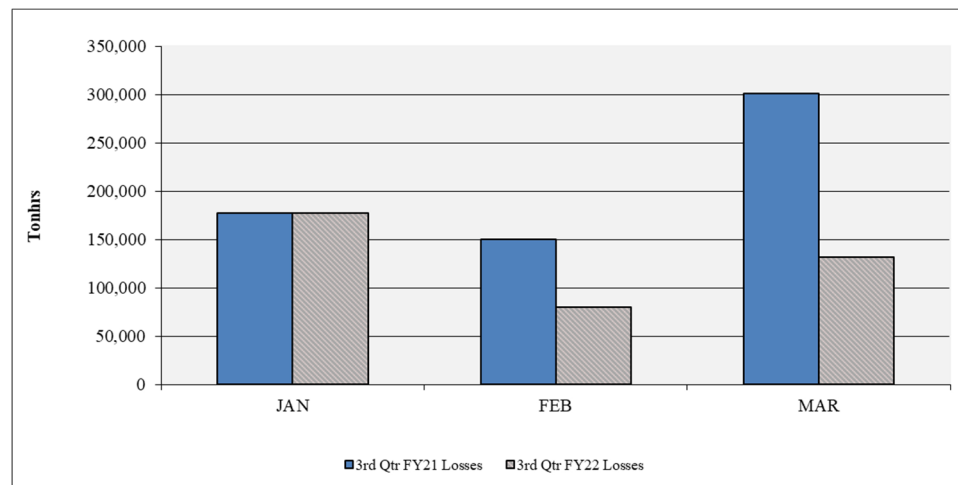
**Figure 3. Chilled Water System Loss Comparison**

A comparison of the total chilled water energy losses in the EDS for the Third Quarter is shown in Figure 3. These losses are the difference in chilled water sendout and sales.

The EDS make-up increased by 10.2% over the previous Third Quarter. However, a leak was found and repaired in January on 3<sup>rd</sup> Ave North near where a repair had previously been made. The make-up dropped dramatically after the repairs were made and have remained relatively constant since that time, although there were occasional increases in make-up due to repairs made by customers at their buildings. The average daily make-up for February and March were 5,714 and 5,871 gallons per day, respectively. These values compare to 15,929 and 24,452 gallons per day, respectively, for February and March 2021.

Another leak is still suspected on 5<sup>th</sup> Ave N, but previous efforts to locate the actual source of the leak have been unsuccessful. CES and TEG are continuing to monitor the EDS make-up and investigate any potential leaks. If the specific location of an additional leak is discovered, DES will address the issue promptly.

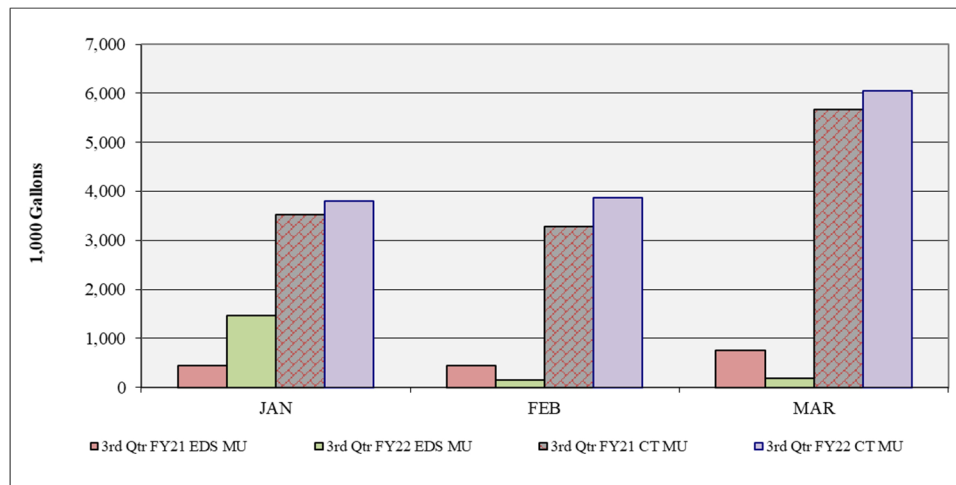
**Figure 4. Chilled Water System City Water Usage Comparison**

The make-up to the cooling towers increased 9.8% over the previous Third Quarter. The water usage in the cooling towers is typically proportional to the consumption of chilled water and should vary with chilled water sales. The number of cycles of concentration in the condensing water circuit decreased 7.2%; this decrease in cycles of concentration equates to an increase in cooling tower blowdown that requires additional make-up water to the cooling towers. The total chiller plant water use increased 8.6% over the Third Quarter FY21. The overall city water make-up comparison for the chilled water system Third Quarter is shown in Figure 4.

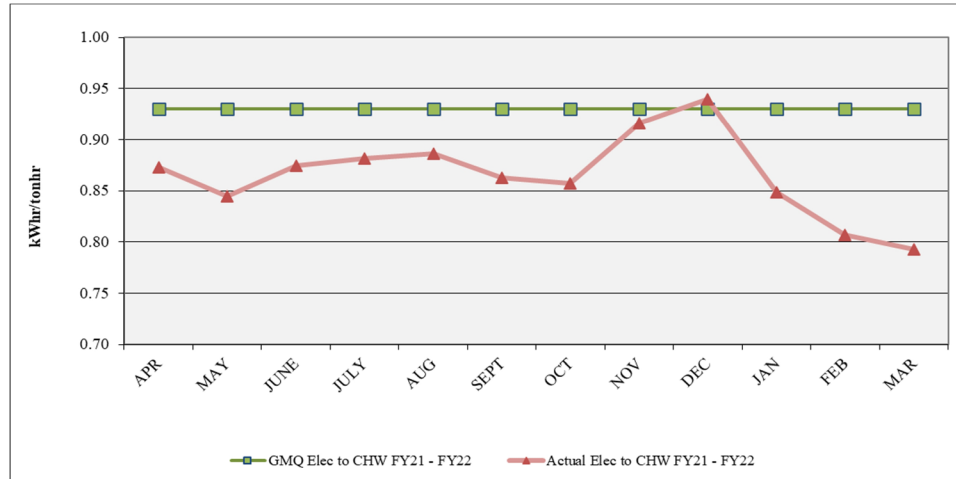
**Figure 5. Chiller Plant Electric Performance Guarantee Comparison for the Previous Twelve Months**

The performance of the chilled water aspect of the EGF is presented by the following two charts, Figures 5 and 6, for the previous twelve months. The System Performance Guarantee levels as described in Amendment 2 of the ARMA were not consistently achieved for the chilled water-water conversion for FY22 until after the leak was repaired in the EDS in January 2021. CES has met the chilled water-electric guarantee for all but one month of the fiscal year.

The chilled water allocation of the electric consumption falls under the GMQ limit of 0.93 kWhr per tonhr for the current quarter on average with only one excursion reported for the current fiscal year. The electric usage per unit of sales decreased 9.8% over the previous Third Quarter – a marked improvement over 2021.

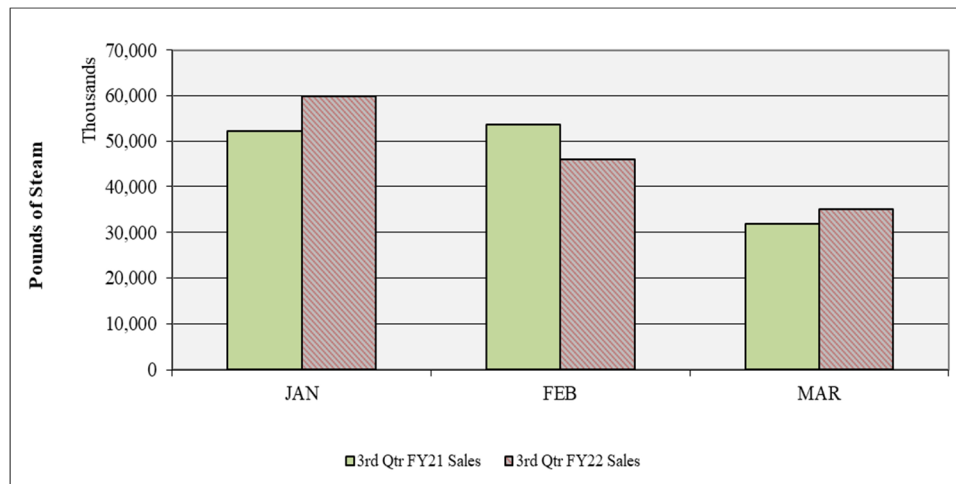
**Figure 7. Steam Sales Comparison**

The steam sendout increased by approximately 0.9% over the previous Third Quarter (FY21), and the sales increased by approximately 2.4%. The Quarter experienced a 4.1% increase in the number of heating degree days. The steam system losses decreased 14.3%, and the relative amount of condensate return decreased 1.9%. A comparison for the Third Quarter steam sales is shown in Figure 7.

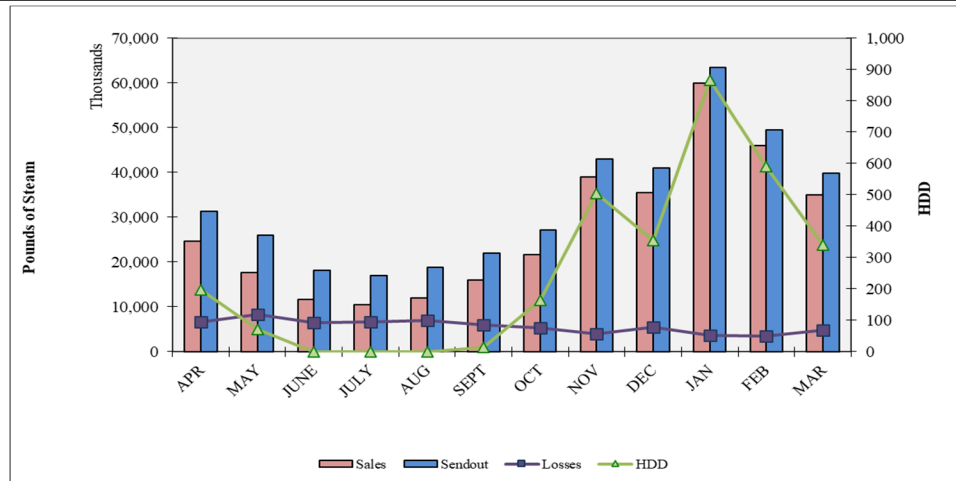
**Figure 8. Steam Sales, Sendout, Losses and HDD for the Previous Twelve Months**

Figure 8 shows the steam sales, sendout and losses for the previous twelve months. The losses on this figure are defined as the difference in pounds per month between the recorded sendout and sales values and represent the total mass loss in the EDS between the EGF and the customer meters.

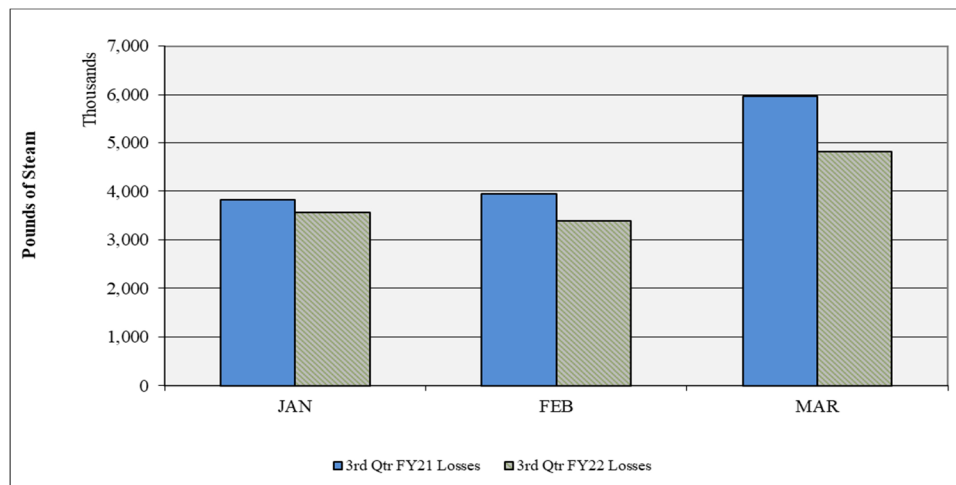
**Figure 9. Steam System Losses**

A comparison of the total steam mass losses in the EDS for the Third Quarter is shown in Figure 9. The mass loss is caused by the heat loss in the EDS between the EGF and the customer meters, resulting in a mass loss at steam traps. Faulty traps, steam leaks or meter error could also be a contributing cause of these losses. Whenever steam sales decrease from the previous quarter, the percent of system losses can be expected to increase since most of these losses are based on a near constant heat loss of the system.

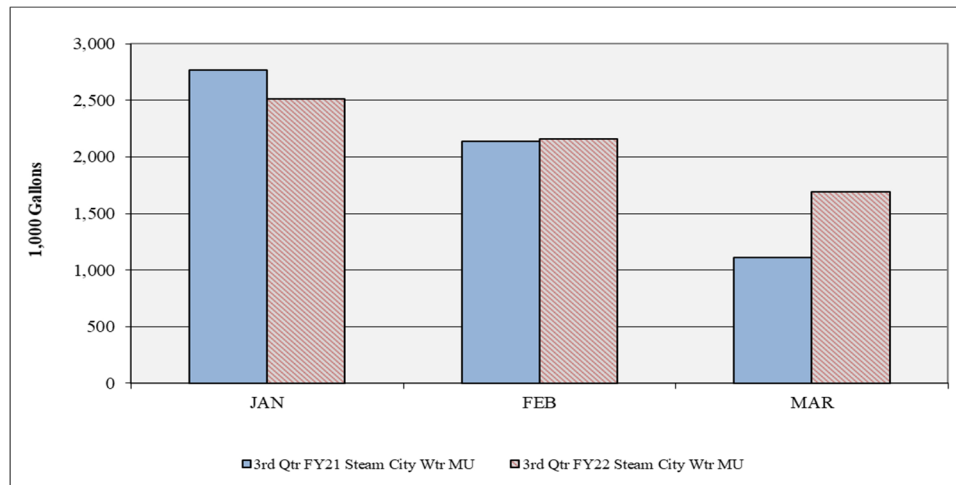
**Figure 10. Steam System City Water Make-up Comparison**

The amount of city water make-up (MU) to the steam system consists of the loss in mass between the EGF and the customers, in the condensate return from the

customers to the EGF and losses at the EGF. The corresponding data for steam system make-up is shown in the comparison of Third Quarter data in Figure 10.

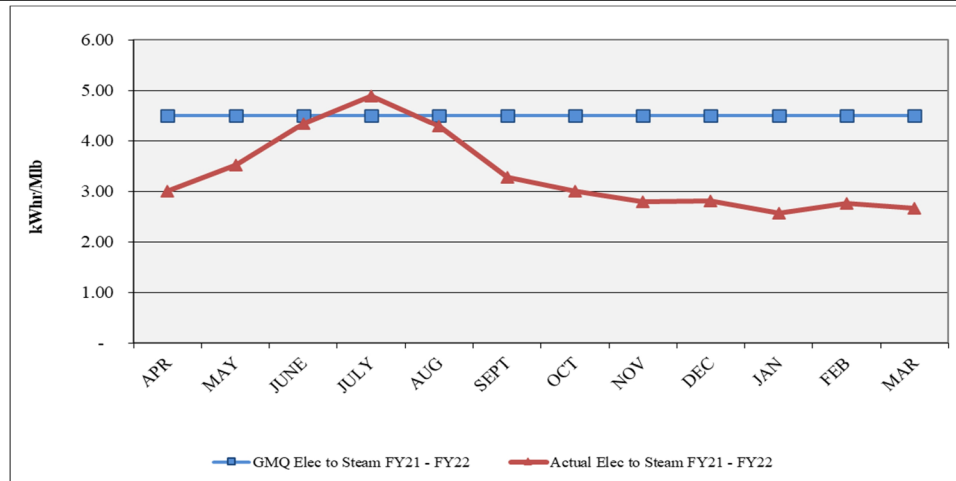
**Figure 11. Steam Plant Electric Performance Guarantee for the Previous Twelve Months**

The steam plant electric consumption for the current quarter was 1.8% higher in FY22 than in FY21. The steam-to-electric conversion factor decreased 2.2% over the same period. The monthly steam-to-electric conversion factors, along with the guaranteed values, are shown in Figure 11.

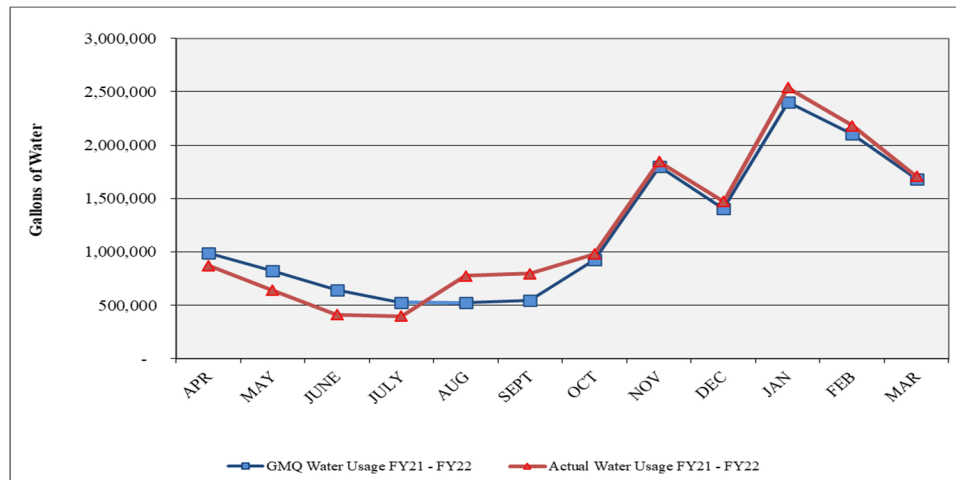
**Figure 12. Steam Plant Water Performance Guarantee for the Previous Twelve Months**

The water consumption for the steam plant increased 5.8% this quarter as compared to the previous Third Quarter due to a decrease in the amount of condensate returned during the quarter. Figure 12 shows the comparison between the actual and guaranteed steam-to-water usages for each month. The excursions above the guaranteed values in August and September are believed to be caused by a faulty meter that was replaced in September.

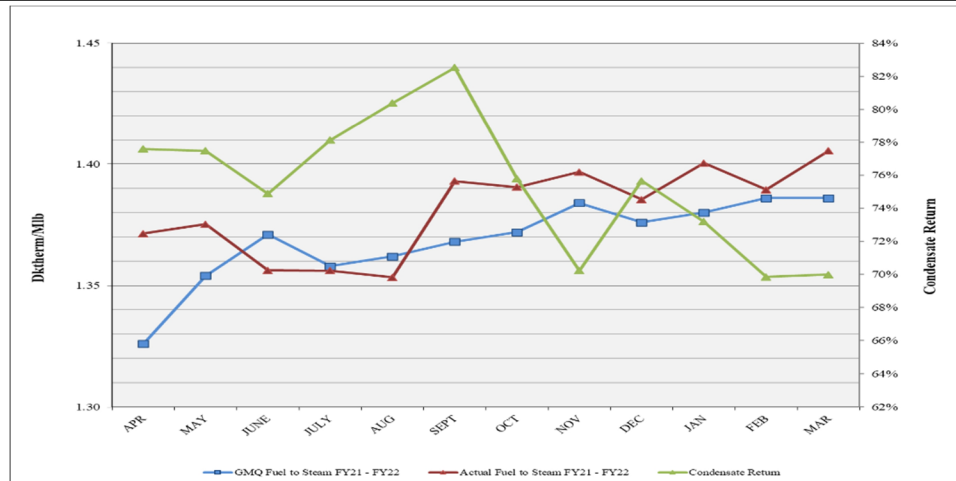
**Figure 13. Steam Plant Fuel Performance Guarantee for the Previous Twelve Months**

The performance of the steam system of the EGF is presented by the following three charts, Figures 11, 12 and 13. The steam fuel conversion factor exceeded the guaranteed values for the months of September, October, November, and December, January, February, and March; however, the differences between the actual and guaranteed values were small. The steam electric conversion factor was exceeded in July but was not exceeded in subsequent months. TEG monitors CES's performance regularly and will continue to report any non-compliance in the EGF's operation. The steam water conversion factor exceeded the guaranteed values in every month of FY22 except July. The faulty meter at the EGF was replaced in September.

The fuel consumption per unit of steam sendout remained approximately the same as in the previous Third Quarter. As shown in Figure 13, the performance guarantee was met in July and August but was not met for the remaining months of FY22. The relative amount of condensate return is shown on this graph to reflect the influence that the condensate return has on the plant efficiency.
