5246 Brick Church Pike Culvert Replacement

Existing Conditions

Proposed Conditions

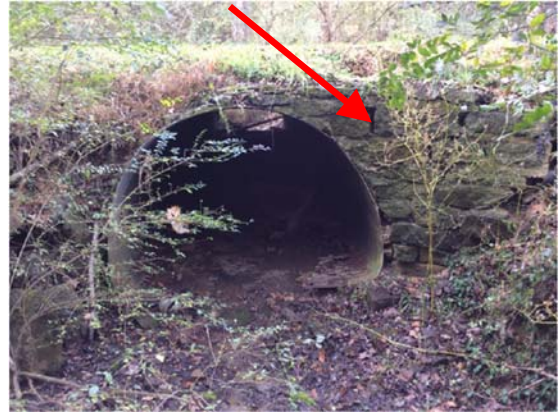
Pike. The existing culvert consists of a 33' long 72"x56" CMP with stone headwalls. There is an area of pavement settlement that has since been patched. The corrugated metal pipe has 100% section loss throughout the pipe invert. The stone headwalls have missing stones and mortar loss. The headwalls have started to fail. Additionally, there is evidence of ponding and sediment deposit at the outlet.

Failing Headwall

The proposed culvert construction will include a 14.5'x5' reinforced concrete slab bridge, the installation of guardrail, roadway reconstruction, and site restoration to ensure proper functionality. Due to the depth and width of construction, the road will need to be closed to through traffic throughout the duration of the project. The project has been scheduled while school is out for summer in order to have the least impact on the community.

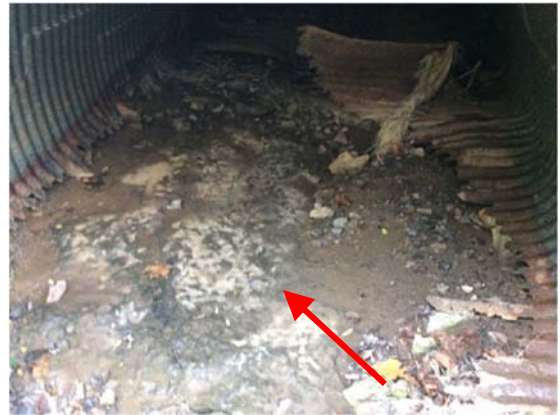
100% Section Loss throughout Invert

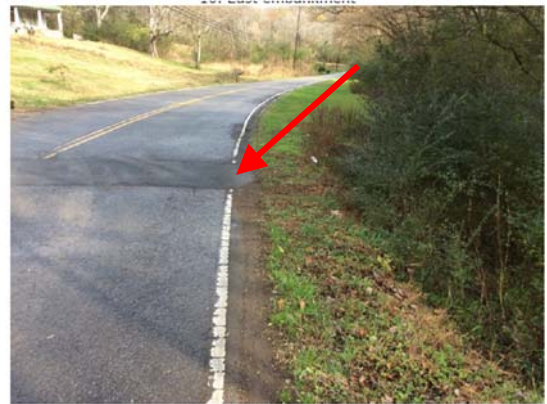
Patched Roadway Settlement
