7425 Harper Road Culvert Replacement

Existing Conditions

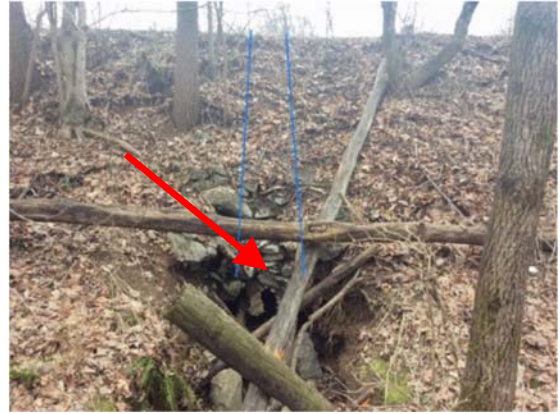
Obstructed Outlet w/ Downed Trees

The proposed culvert construction will include an 18" RCP with reinforced concrete headwalls as well as the installation of erosion control measures, roadway reconstruction, and site restoration. The project will require a road closure through the duration of the project due to depth of excavation and the narrow roadway prevents the contractor from safely maintaining a lane of traffic.

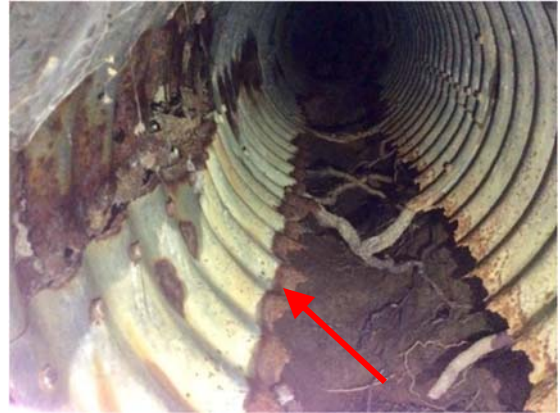
100% Section Loss throughout Invert

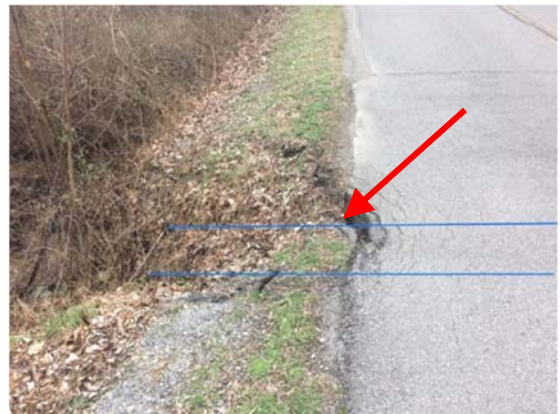
Pavement Failure/Settlement
