4578 Little Marrowbone Road Culvert Replacement

Existing Conditions

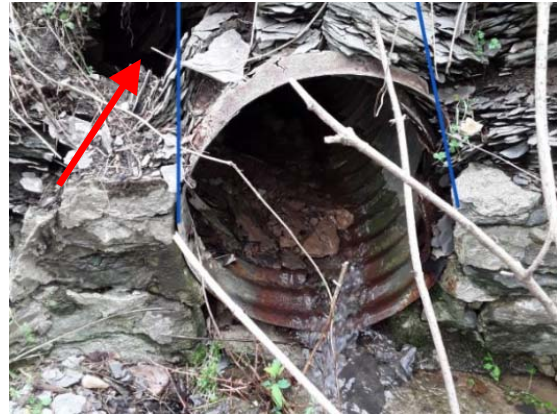
The culvert structure consists of a 31' long 24" CMP culvert with a natural stone masonry headwall at the outlet located approximately 302' east of the featured address, 4578 Little Marrowbone Road. The corrugated metal pipe shows severe section loss throughout the pipe leading to a void of up to 1.5' deep by 2' wide running under most of the pipe. The outlet headwall shows mortar loss in the joints and brittle shale rock is stacked over the headwall and failing to support the road embankment. The road is cracking and sagging atop the culvert due to the void below the pipe which has been partially patched before.

Failing Outlet Headwall w/ Erosion

The proposed culvert construction will include a 24" RCP with reinforced concrete headwalls, roadway reconstruction, and site restoration to ensure proper functionality. The project shall be completed under intermittent lane closures. Both lanes of traffic will be open at the end of each workday and access to all properties shall be maintained throughout the project duration.

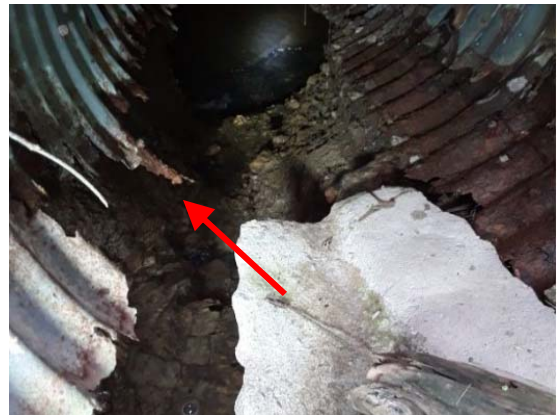
100% Section Loss through Invert

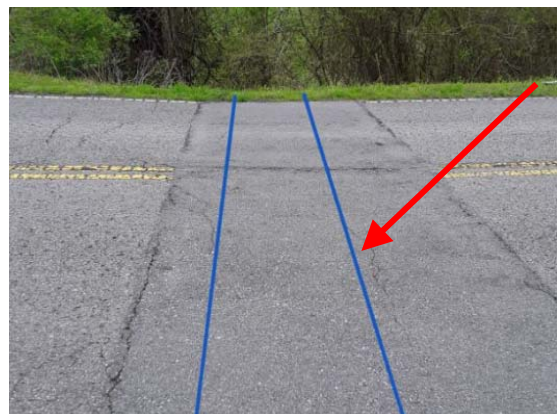
Patched Roadway Settlement/Failure
