3940 Taz Hyde Road Culvert Replacement

Existing Conditions

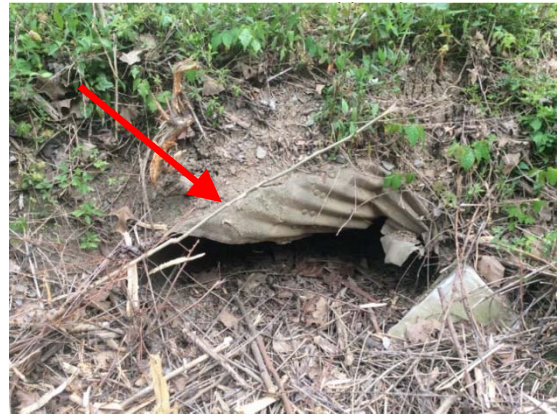
Crushed Inlet

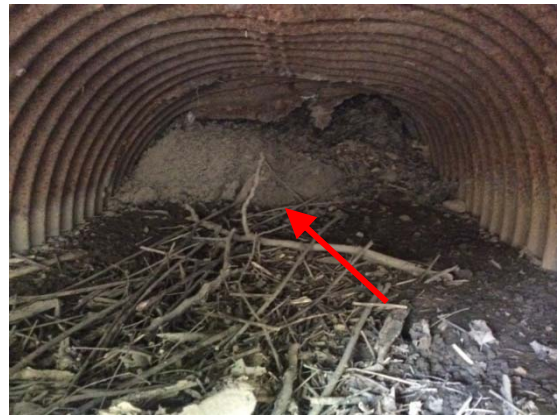
Collapsed CMP

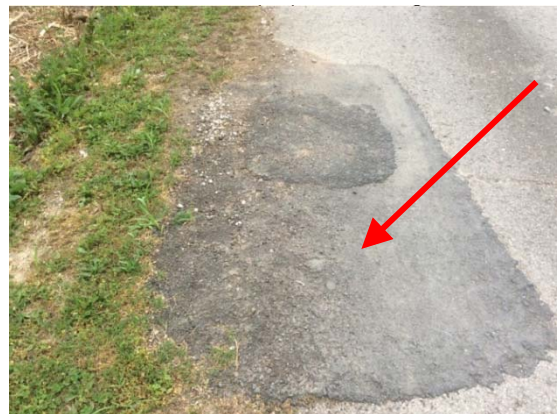
Patched Roadway Settlement/Failure
