5776 Lickton Pike Culvert Replacement

Existing Conditions

Proposed Conditions

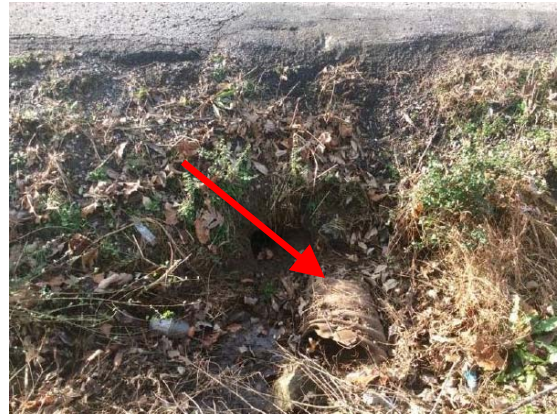
The existing culvert consists of a 25' long 18" CMP. There are areas of pavement settlement adjacent to the culvert inlet and outlet. The corrugated metal pipe has areas of 100% section loss, and the pipe has collapsed under the road. Additionally, the pipe has been crushed at the inlet.

Crushed Pipe Inlet

The proposed culvert construction will include an 18" reinforced concrete pipe, reinforced concrete headwalls, roadway reconstruction, and site restoration to ensure proper functionality. Due to a 12" Water Main conflict, the first two weeks of construction will be dedicated to the vertical adjustment of the Water Main. Additionally, due to the depth of excavation, the narrow travel lanes, and maintaining traffic through the construction, the project duration will be approximately 6 weeks.

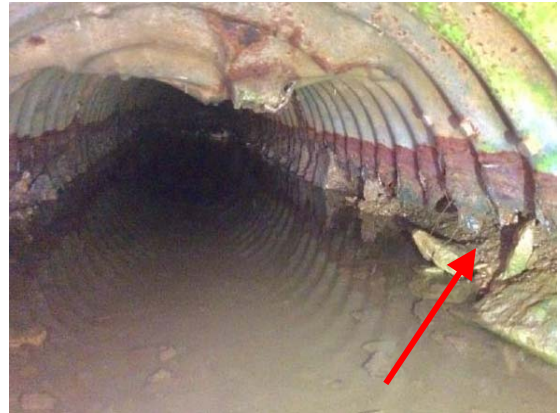
Section Loss & Corrosion

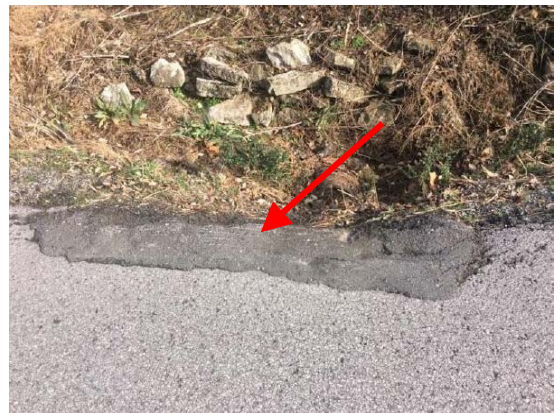
Roadway Settlement
