# 2064 Shaw Road Culvert Replacement

## Existing Conditions

## Proposed Conditions

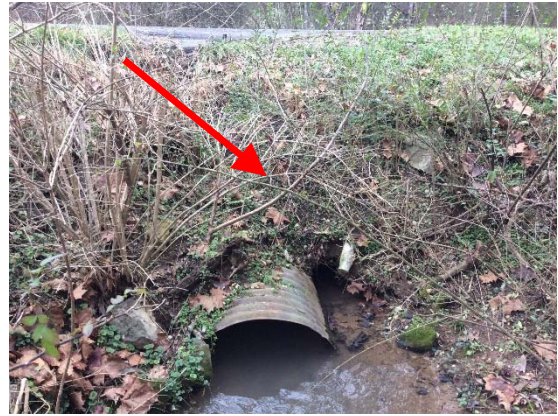
**Embankment Destabilization**

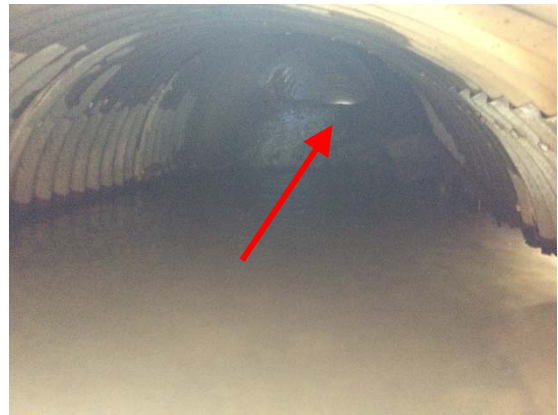
**Seam Separation & Pipe Collapse**

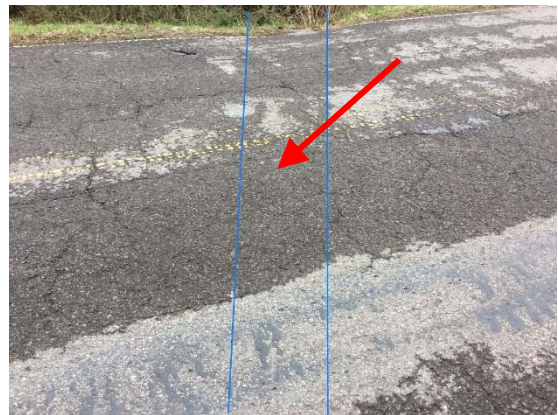
**Roadway Settlement**
