# 322 Bonnaridge Drive Culvert Replacement

## Existing Conditions

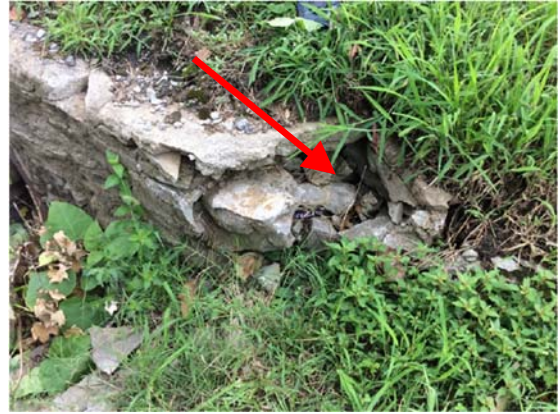
**Failing Inlet Headwall**

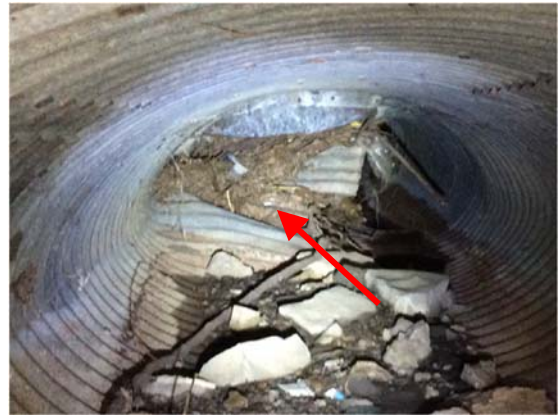
**Pipe Collapse**

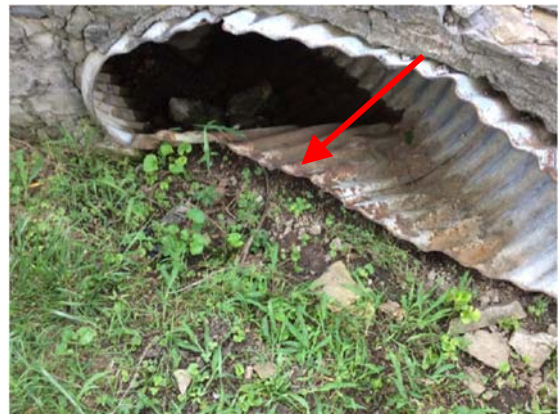
**Deformed Pipe @ Outlet**
