4884 Brick Church Pike Culvert Replacement

Existing Conditions

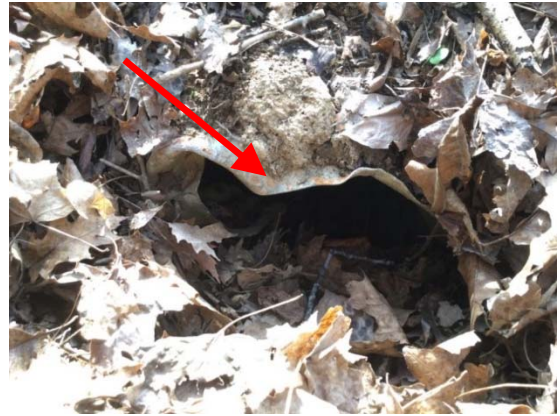
Crushed Pipe Inlet

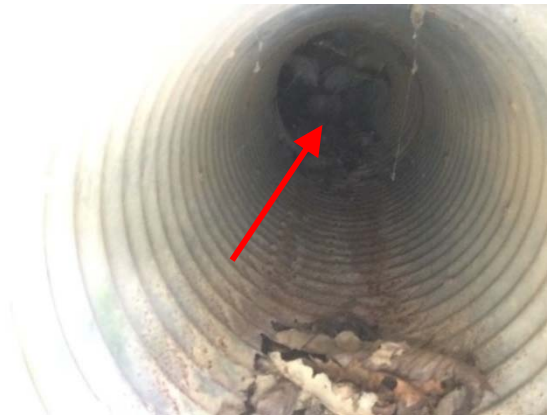
The culvert structure consists of a 42' long 18" CMP culvert with stone masonry headwall at the outfall located approximately 35' south of the featured address, 4884 Brick Church Pike. The corrugated metal pipe exhibits various corrosive holes throughout the culvert with heavy layers of rust. Additionally, the culvert appears to be collapsing at approximately 15' in from the outlet. The inlet shows a sediment blockage of approximately 90% and the outlet headwall exhibits some heavy mortar loss with missing stones.

Section Loss & Pipe Collapse

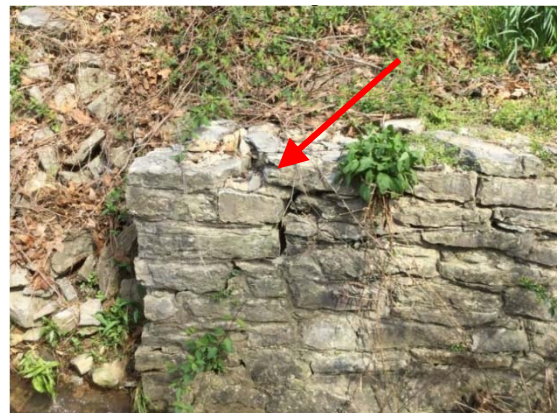
Failing Headwall
