5357 John Hagar Road Culvert Replacement

Existing Conditions

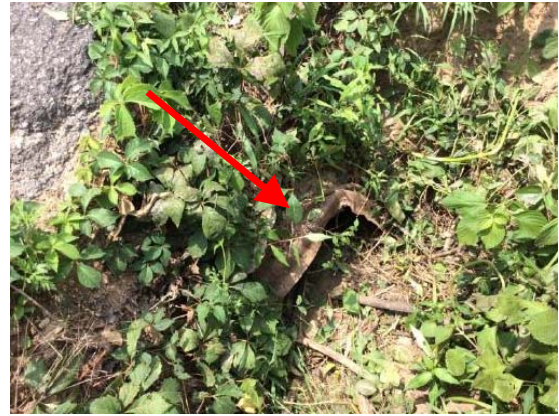
The culvert inlets are located approximately 60' west of the feature address, 5357 John Hagar Road. The existing culvert consists of two 25' long 24" CMP with no headwalls. The pavement over the culvert has area transverse and longitudinal cracks that typically measure 1/8" wide as well as areas of pavement settlement. The corrugated metal pipes show heavy corrosion. The east pipe has collapsed under the roadway and the west pipe has partially collapsed with heavy sediment buildup. Additionally, the culvert inlet and outlet have been crushed and are partially buried.

Crushed Culvert Inlet

The proposed culvert construction will include the installation of a 38"x24" reinforced concrete pipe, reinforced concrete headwalls, roadway reconstruction, and site restoration to ensure proper functionality.

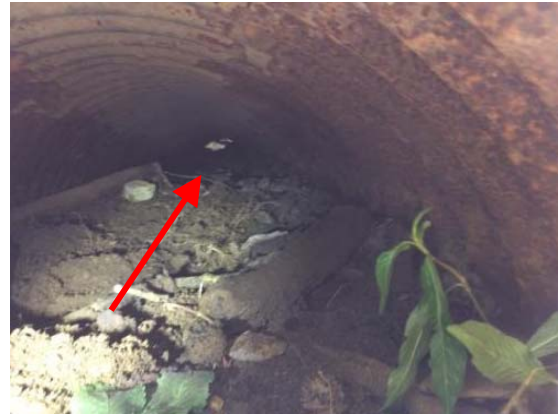
Partial Pipe Collapse w/ Heavy Corrosion

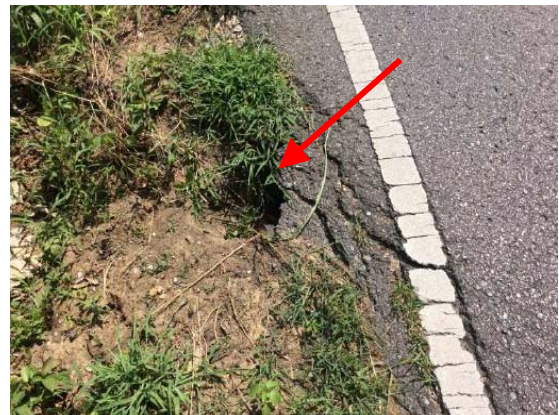
Shoulder Settlement
