Heath Road @ Hwy 70 Culvert Rehabilitation

Existing Conditions

Proposed Conditions

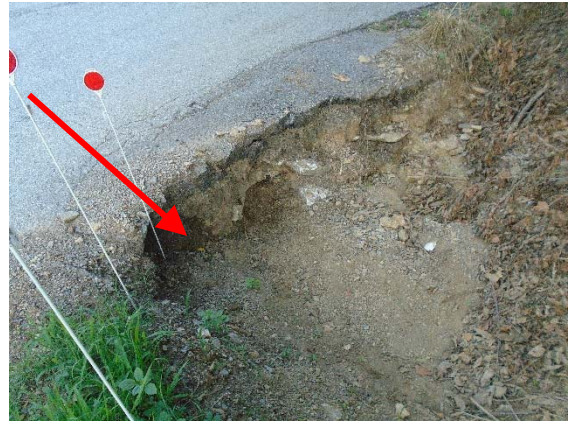
Culvert Inlet w/ Roadway Washout

In order to rehabilitate the culvert, we will be lining the corrugated metal pipe (CMP) with a ridged polymer liner, removing vegetation from the culvert features, regrade the upstream channel, and installing a reinforced concrete headwall at the inlet. This will structurally rehabilitate the culvert and give additional service life to the asset. Additionally, by using a trenchless construction method, we will be reducing the impact and duration of the project to the residence and commuters.

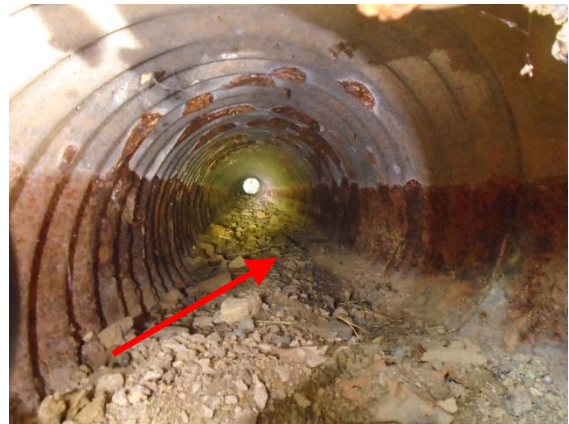
Heavy Corrosion w/ Areas of Section Loss
