# Facility Condition Assessment

April 3, 2017

## Nissan Stadium

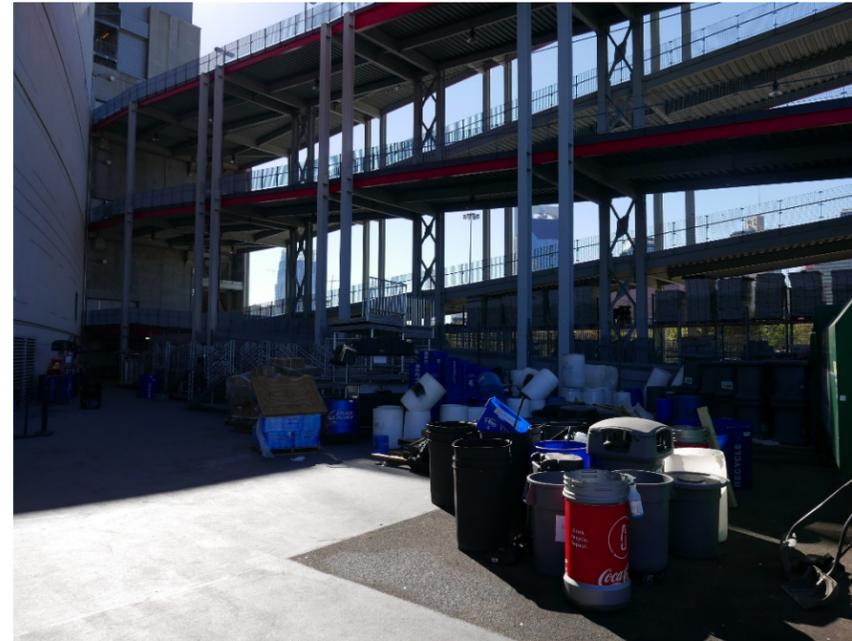
One way the lack of building storage at the field level manifests itself is with the existence of a “boneyard” in the shadow of the northwest pedestrian exit ramp. This is general building storage that would better be placed out of sight of guests. While screened at eye level, the boneyard is fully visible to guests using the ramp.

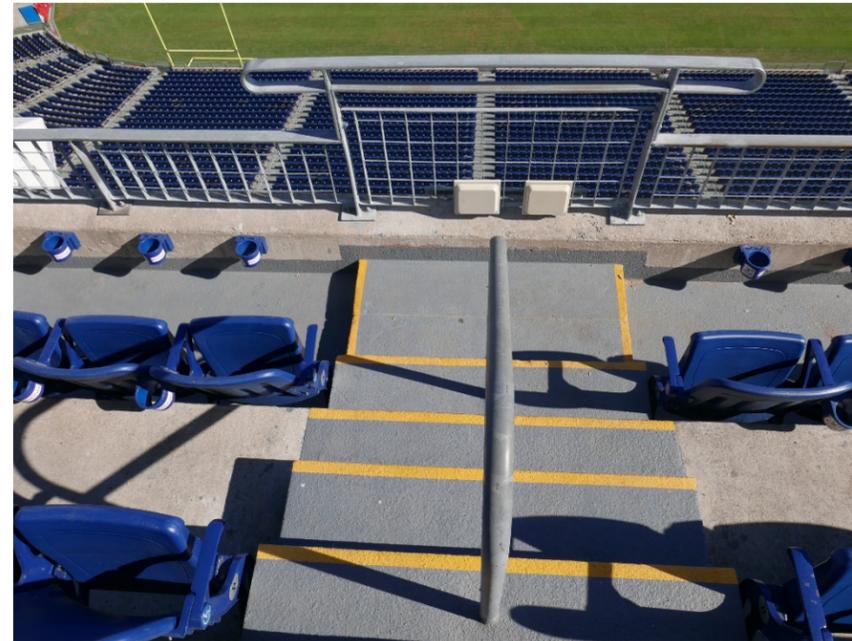
The design of some handrail/guardrail conditions at the upper seating bowl is problematic, as such conditions often are next to vomitory stairs and similarly complex geometry. While there is no inexpensive fix, greater use of tempered glass in lieu of fabricated metal railings in these areas can improve compromised sightlines for seats affected by these conditions.

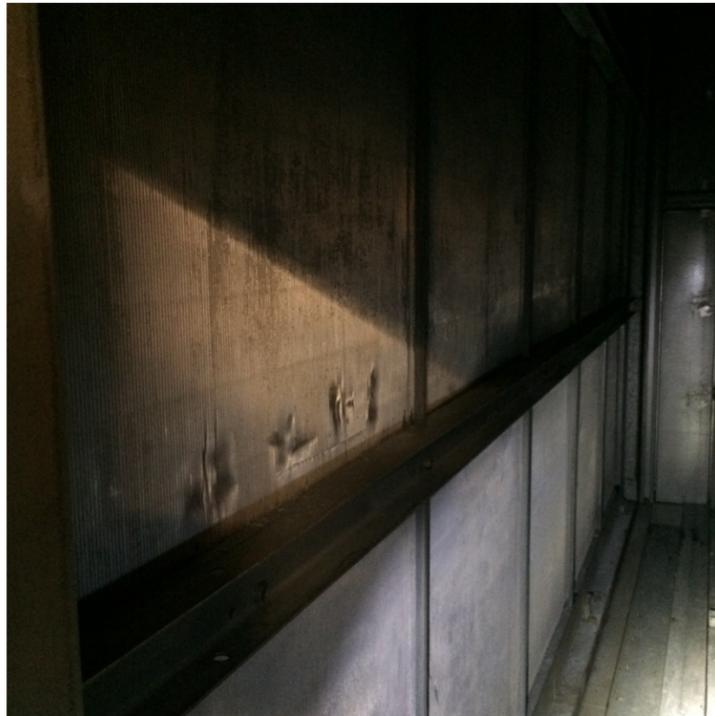
Club AHU Cooling Coil

The club level air handlers and their associated components appear to be in generally good condition considering their age and runtime. However, one of the air handlers apparently has a leak in the condensate drain pan that is getting onto the floor. The air handler on Level 3 Sector B has a buckled, return air mixing box plenum due to a restriction within the ductwork at one point in time. While this is not a replacement issue, it should be reviewed and confirmed there is no leakage of airflow through the buckled seam. The coils are original to the unit and need to be cleaned. The unit with the leak may require replacement of the coil in the immediate future due to rust spreading up the coil.

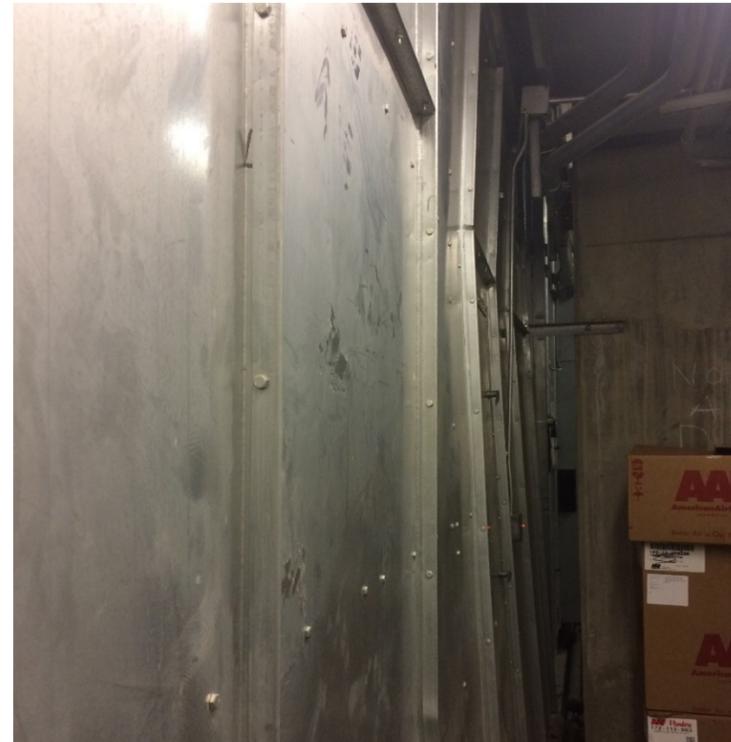
Club AHU Buckled Return Plenum

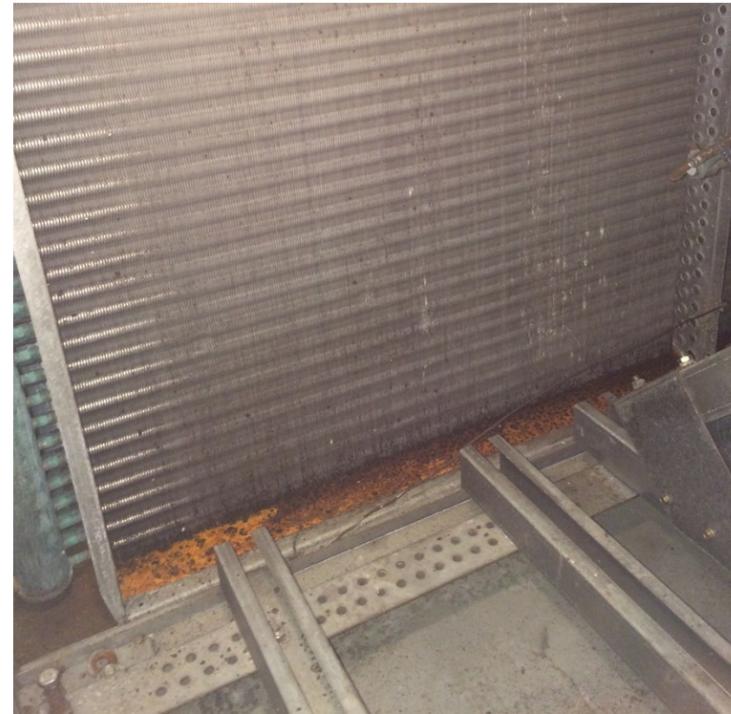
The air handlers serving the locker rooms are units that have a high percentage of outside air, ranging from 50-70% outside air. These units do not appear to have a UV antimicrobial coil protection or an energy recovery device. A large percentage of utility costs are associated with conditioning outside air. Because the facility utilizes electric resistance reheat, this energy consumption is only exacerbated.

*Air Handling Cooling Coil with Biological Growth*

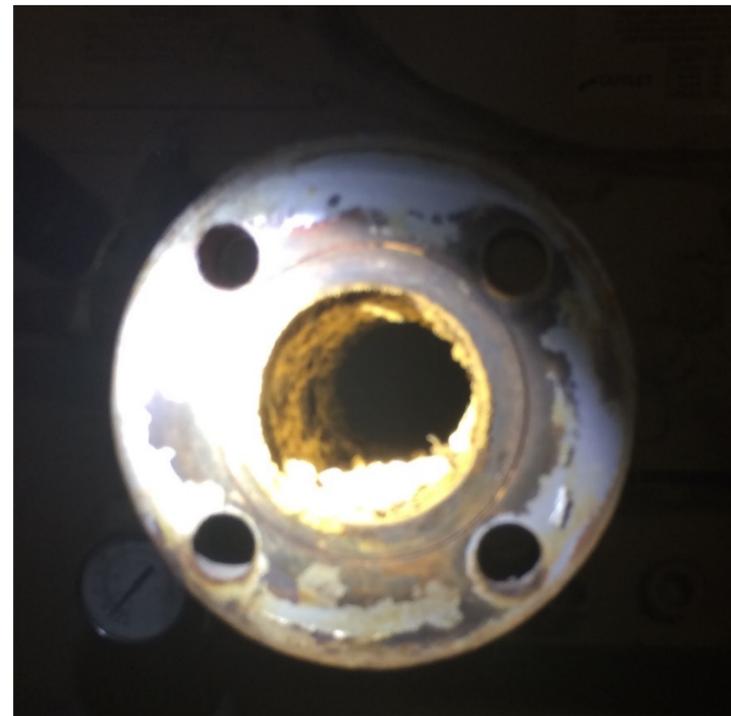
*Inside Chilled Water Pipe with Corrosion*

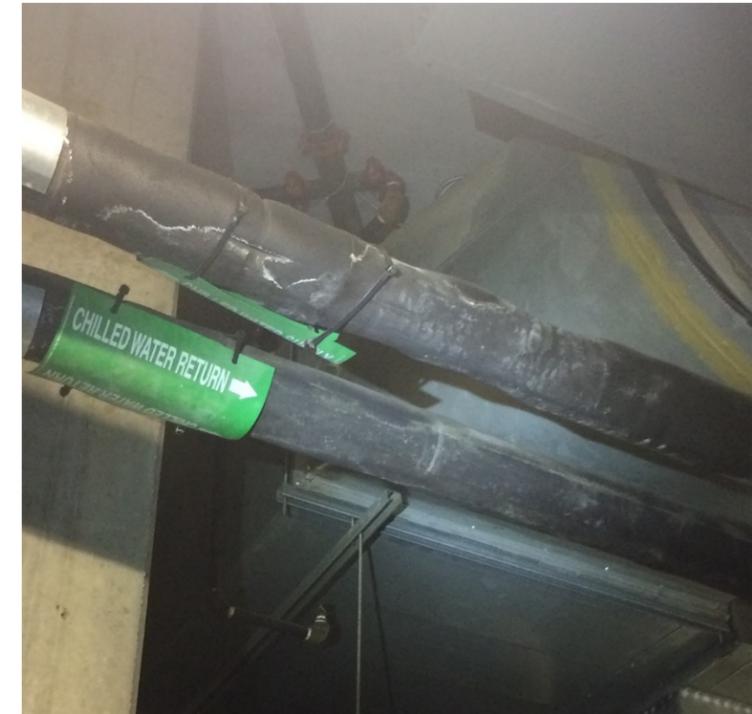
The chilled water insulation is showing signs of water damage in certain areas of the facility. Most of the chilled water piping serving the facility is insulated with a closed cell, fiber-free elastomeric thermal insulation.

*Chilled Water Insulation*

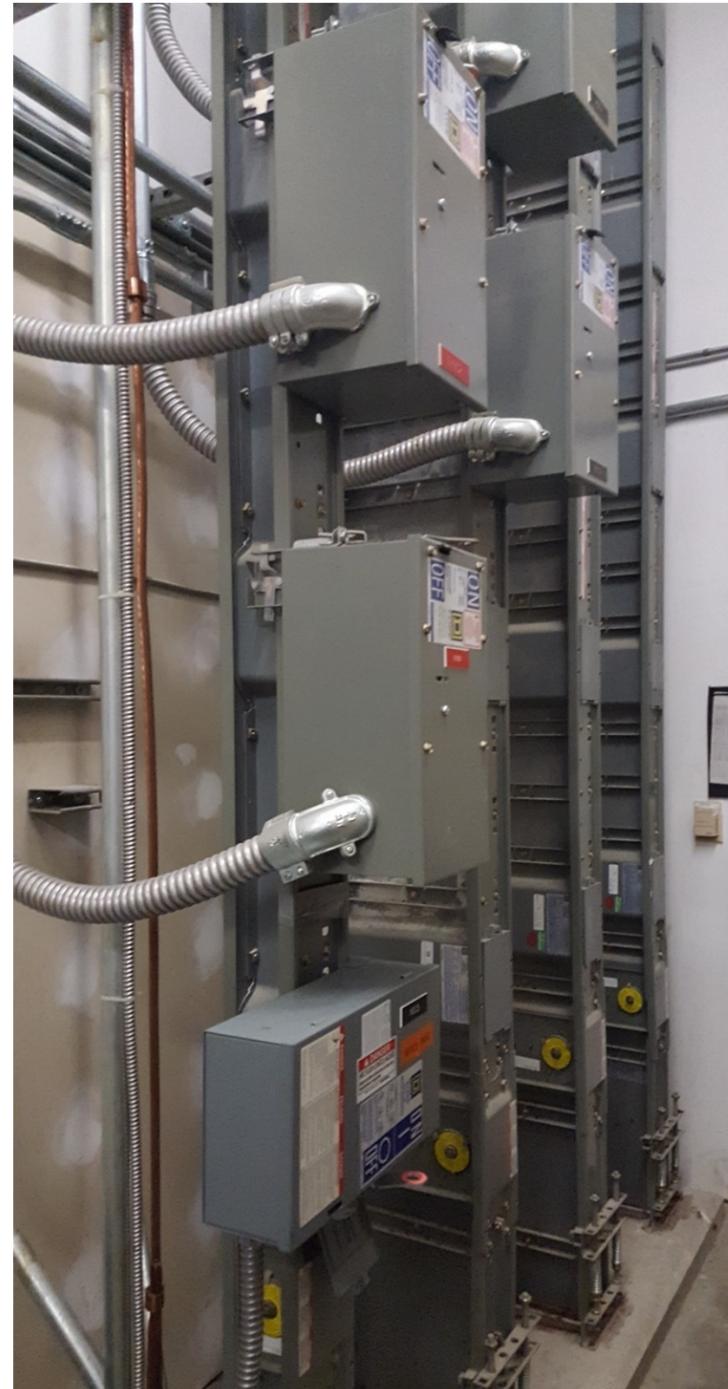
The riser electrical rooms on the upper concourse were extremely dusty at the time of the walk-through.

*Bus Duct Risers*

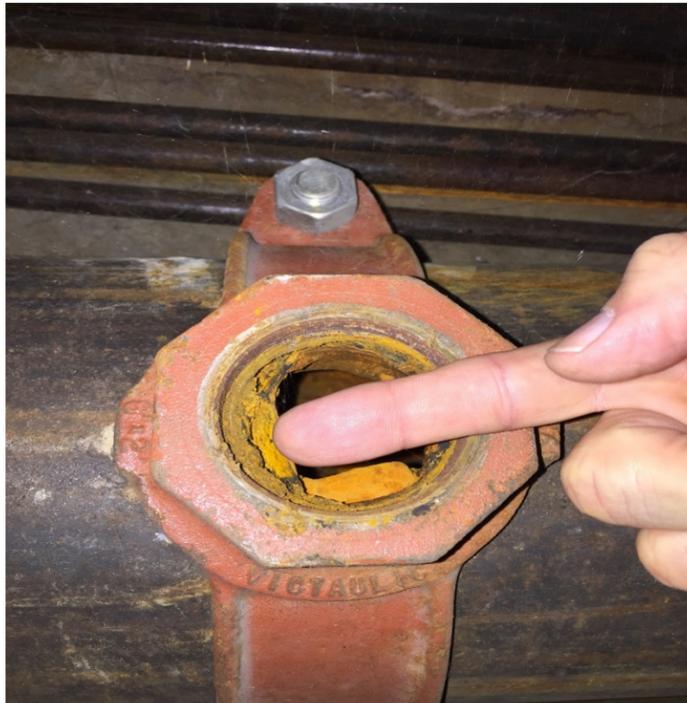
*Interior Pipe Corrosion*

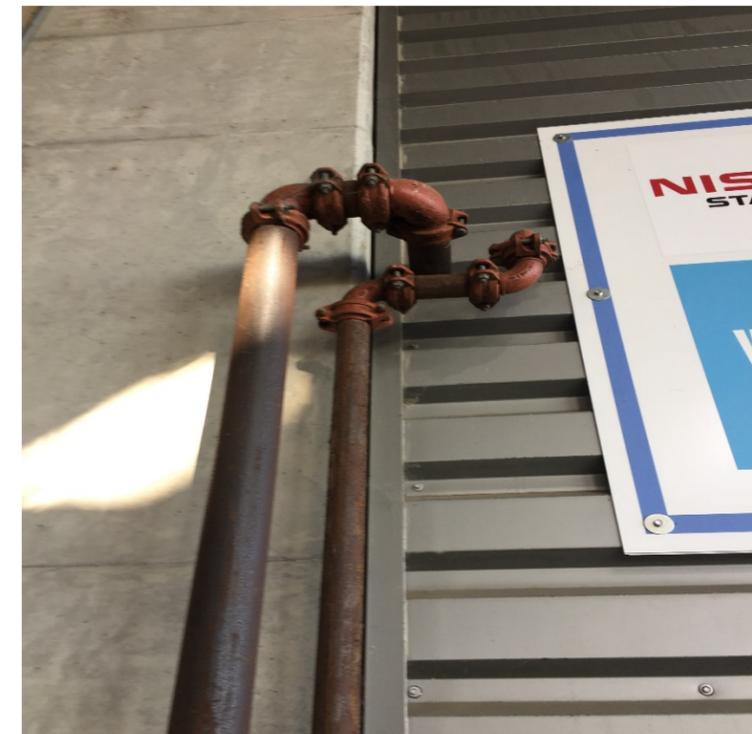
*Rust on Exterior Dry Pipe System Piping*

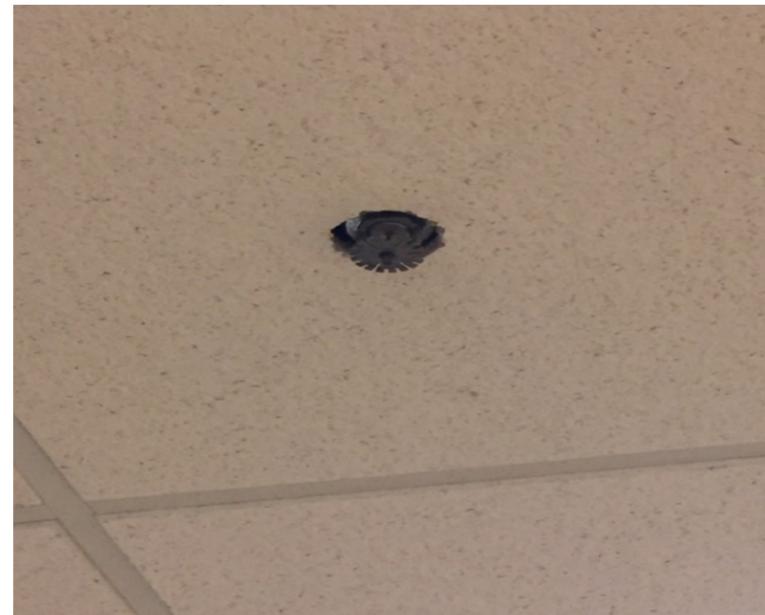
We noted that interior sprinkler head trim rings were missing in a few locations.

*Interior Automatic Sprinkler Head Missing Trim*

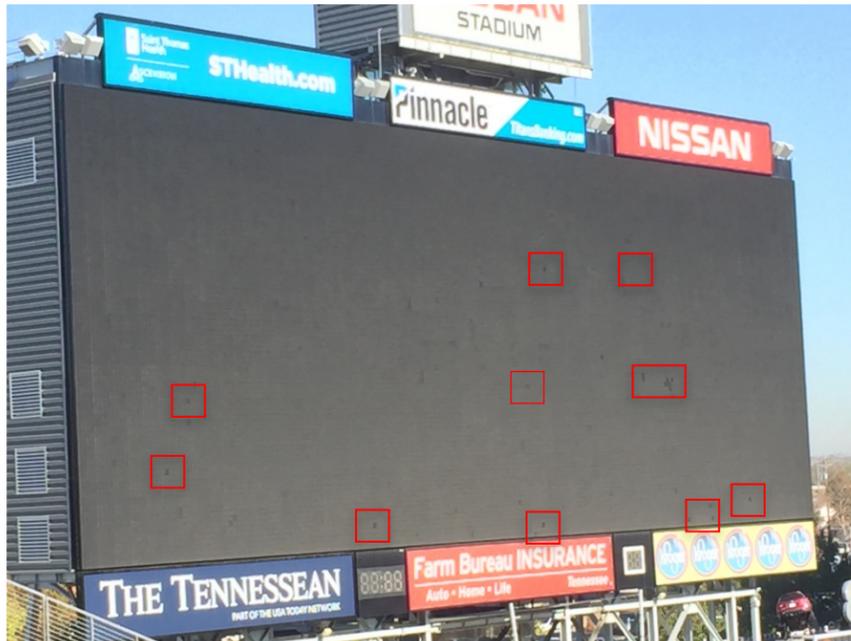
- There are issues with the uniformity between modules as highlighted below on the North display.

North Display

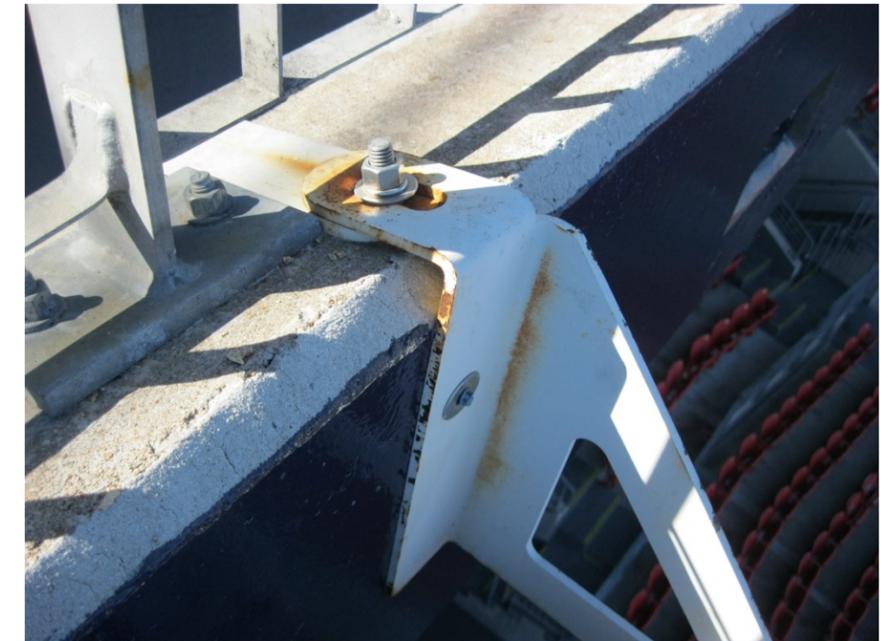
Existing speaker bracket showing rust

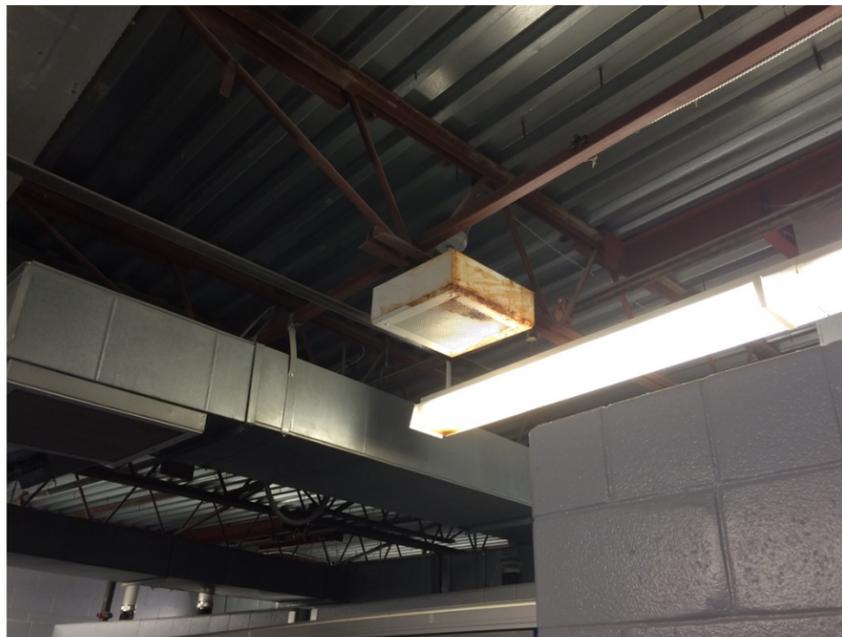
*Existing restroom rusted speaker*

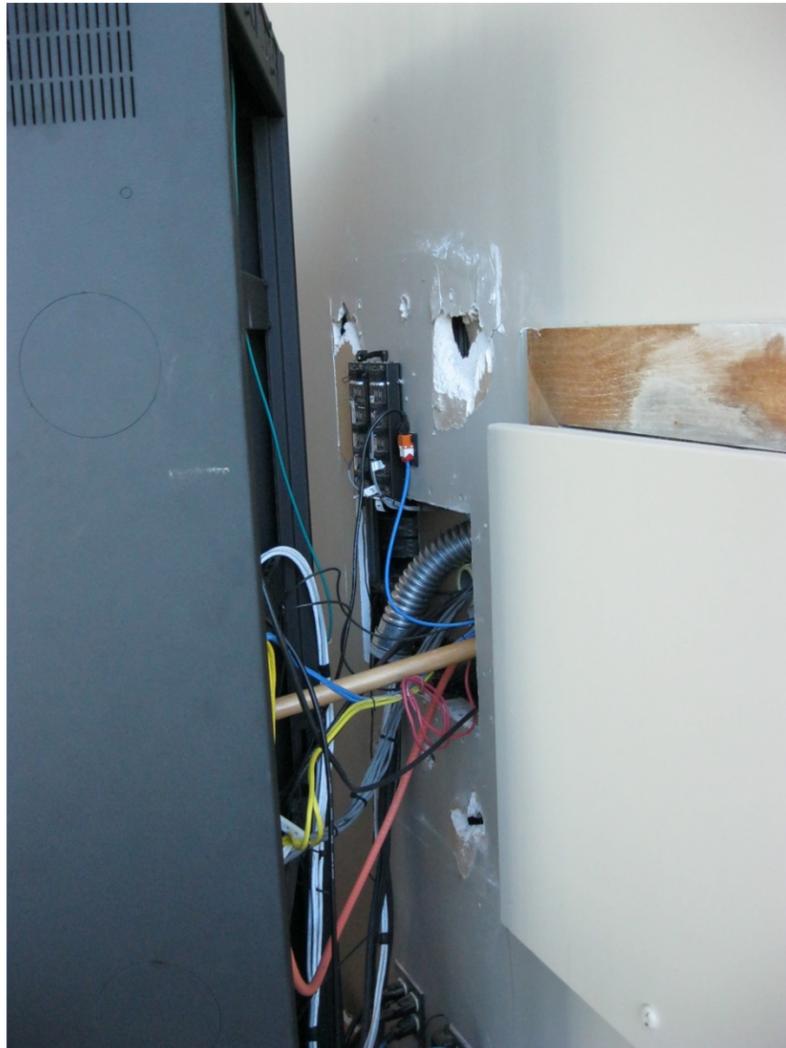
Poor installation workmanship at club AV rack

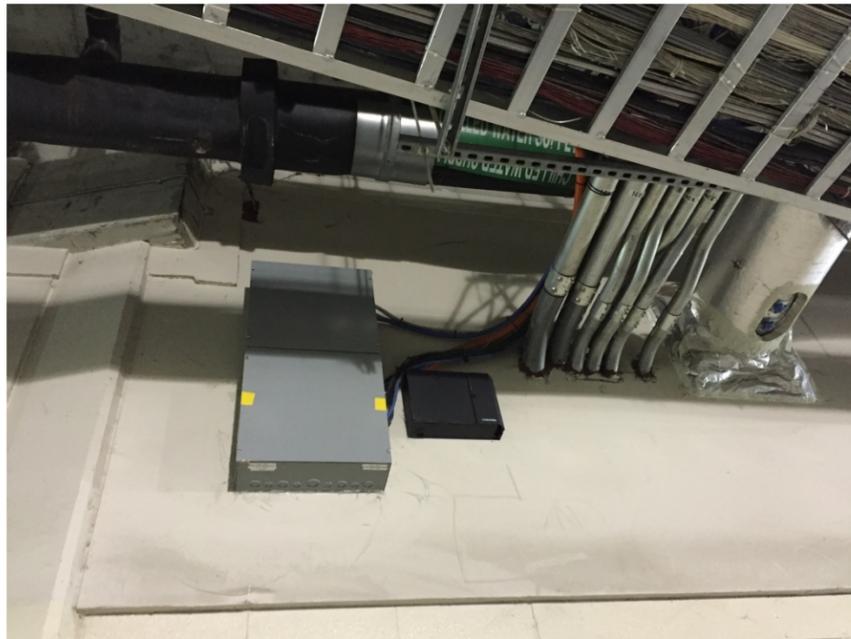
Splice point for damaged cable

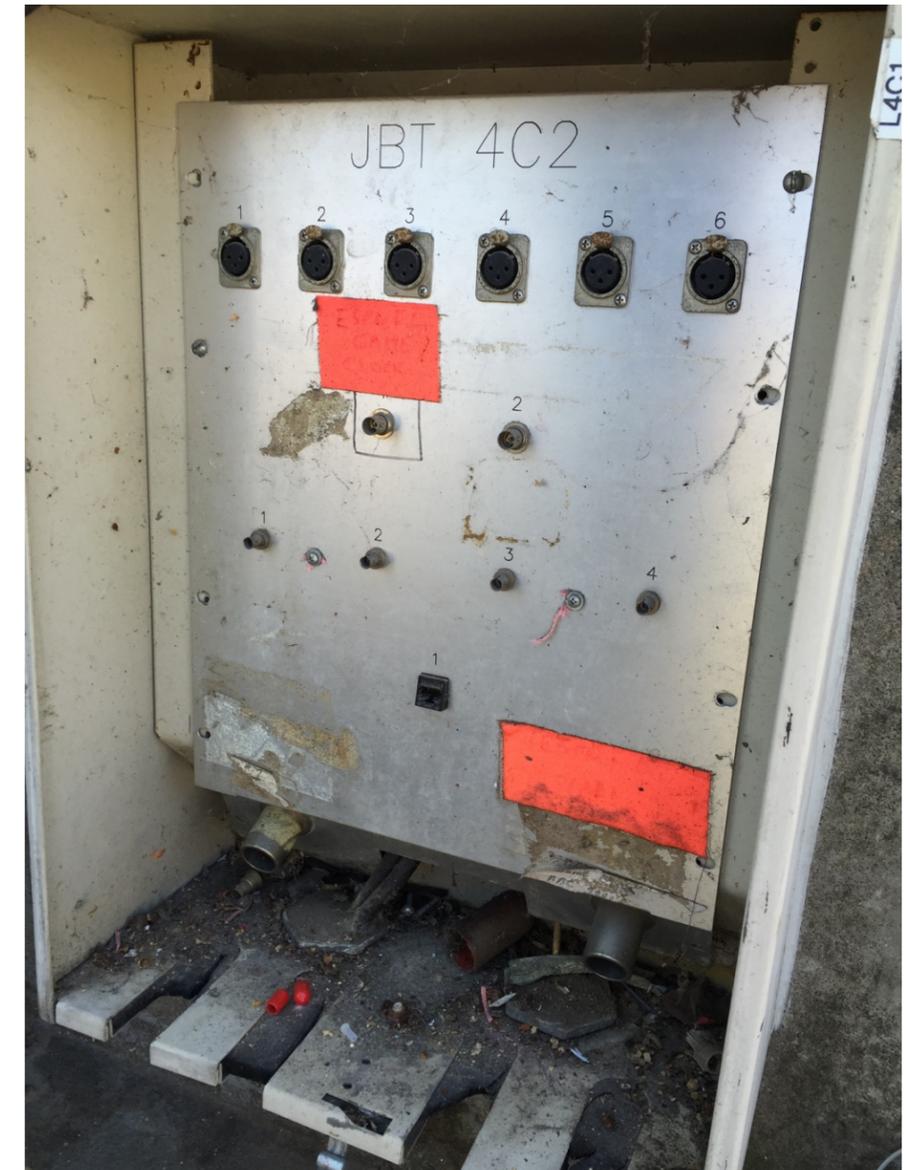
Damaged and Corroded Broadcast Box Panel (Typical of most)

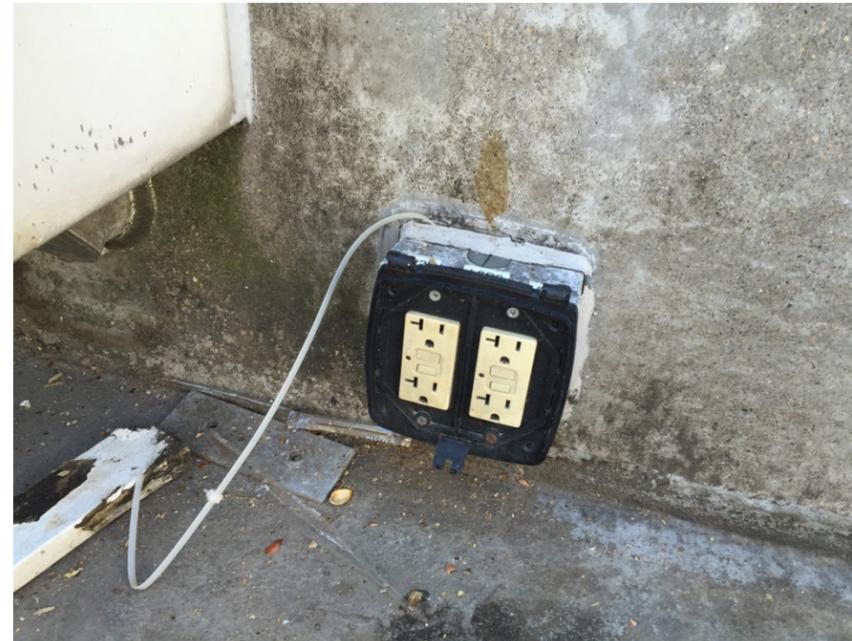
Non-weatherized outlet subject to standing water

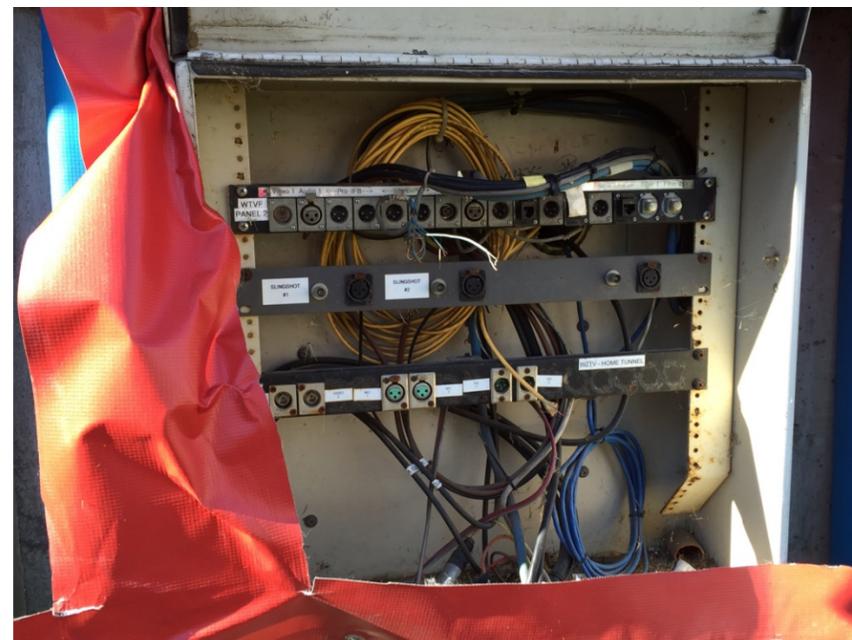
Rusted and corroded coax and audio connections in corroded connection box

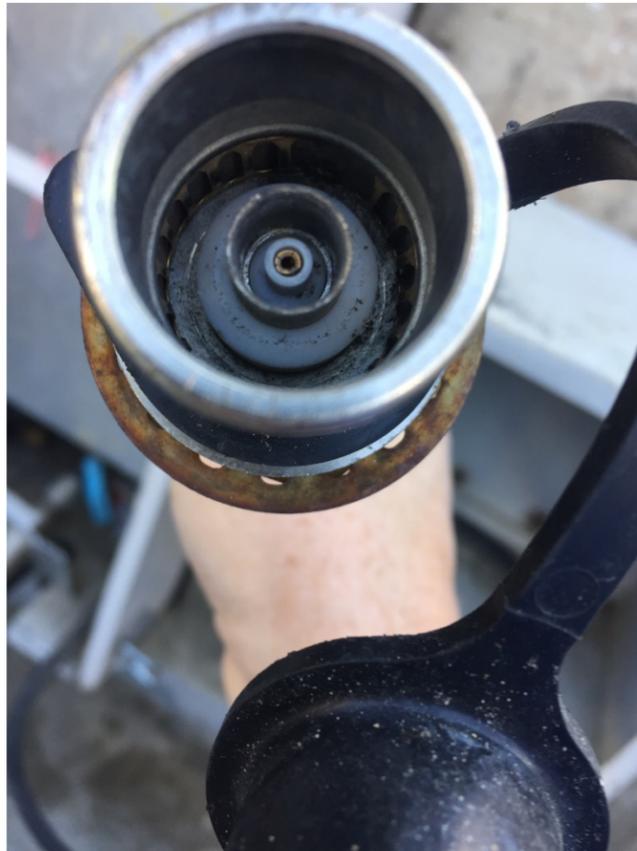
Same connector with corrosion in interior

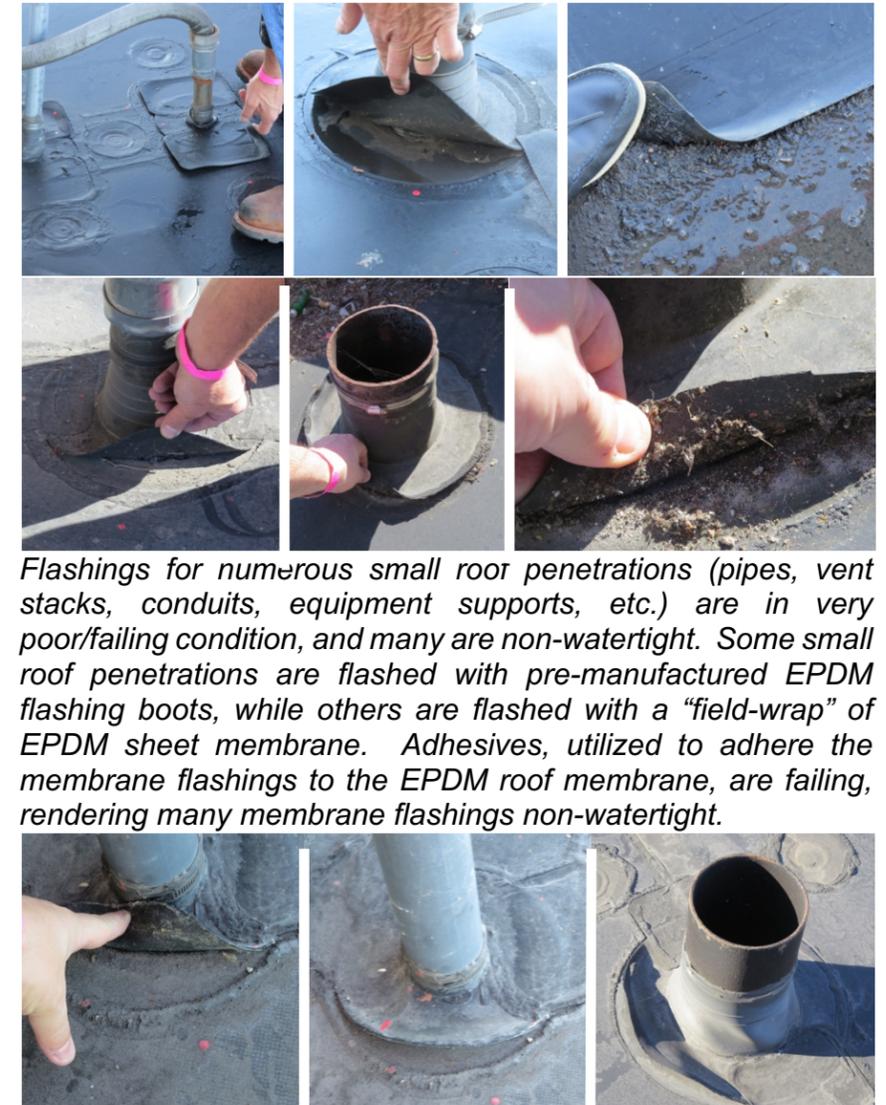
*Flashings for numerous small roof penetrations (pipes, vent stacks, conduits, equipment supports, etc.) are in very poor/failing condition, and many are non-watertight. Some small roof penetrations are flashed with pre-manufactured EPDM flashing boots, while others are flashed with a “field-wrap” of EPDM sheet membrane. Adhesives, utilized to adhere the membrane flashings to the EPDM roof membrane, are failing, rendering many membrane flashings non-watertight.*

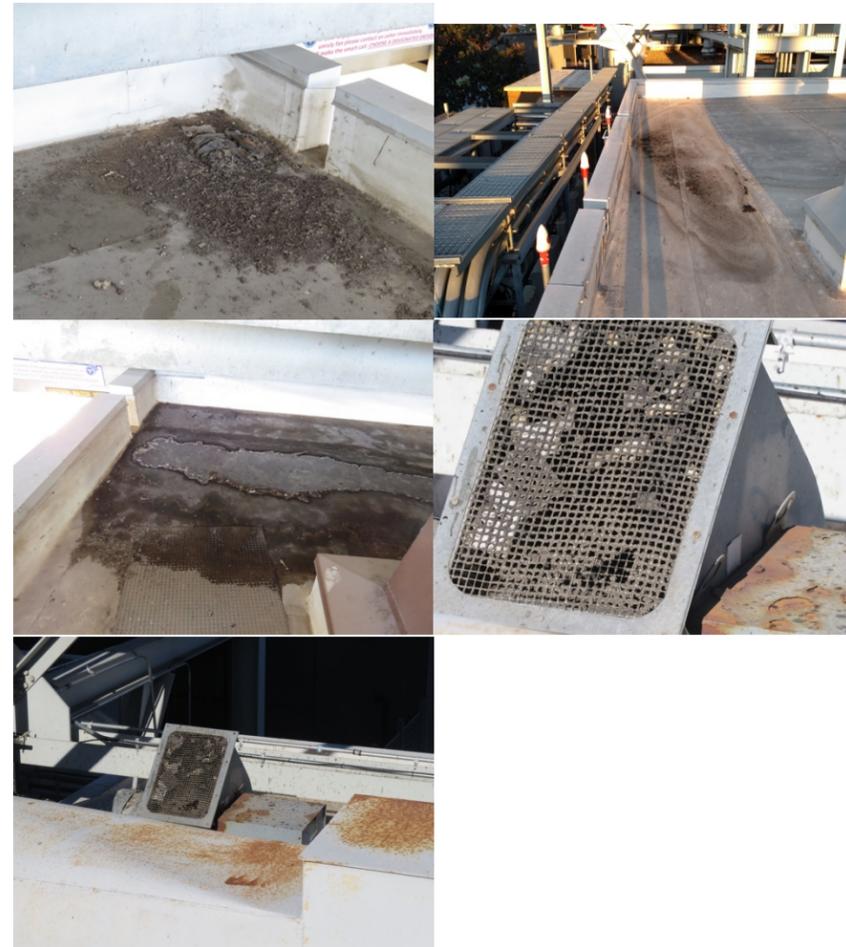
*Debris and grease/oil deposited from rooftop exhaust fans/vents onto the roof surface can cause hazardous conditions to persons walking/working on the roof, and may potentially cause damage to the single-ply roof membrane (four photos, above). Some small areas of roof appear to retain (“pond”) water on the roof surface (photos below left and far below left). Although the roofs were dry at the time of our inspection, water stains/silt deposits on roof surfaces are an indication of areas that retain water. At least one open/non-watertight lap seam was noted on the PVC/TPO-covered roof areas (below right). This was the only such condition noted during our inspection of the roofs.*

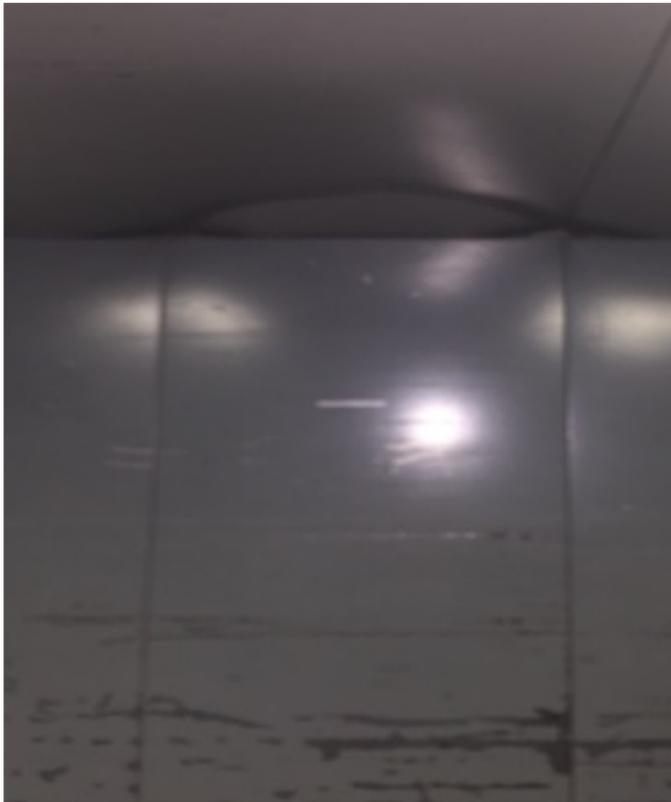
*Damaged Interior Ceiling on Freight #4*

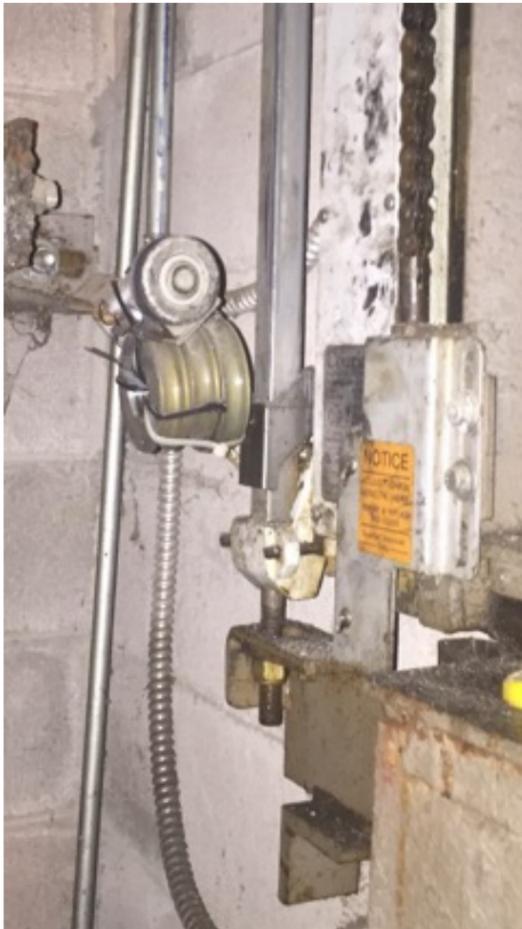
Field Engineered Gate Switch in need of Repair

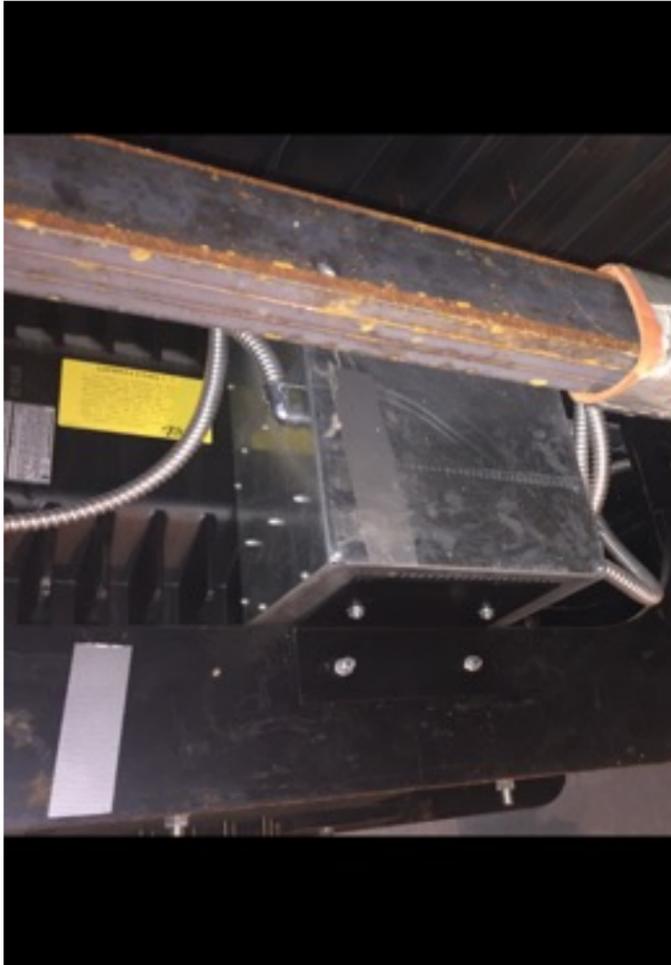
*Typical Rust on Equipment in Overhead on Express Cars*

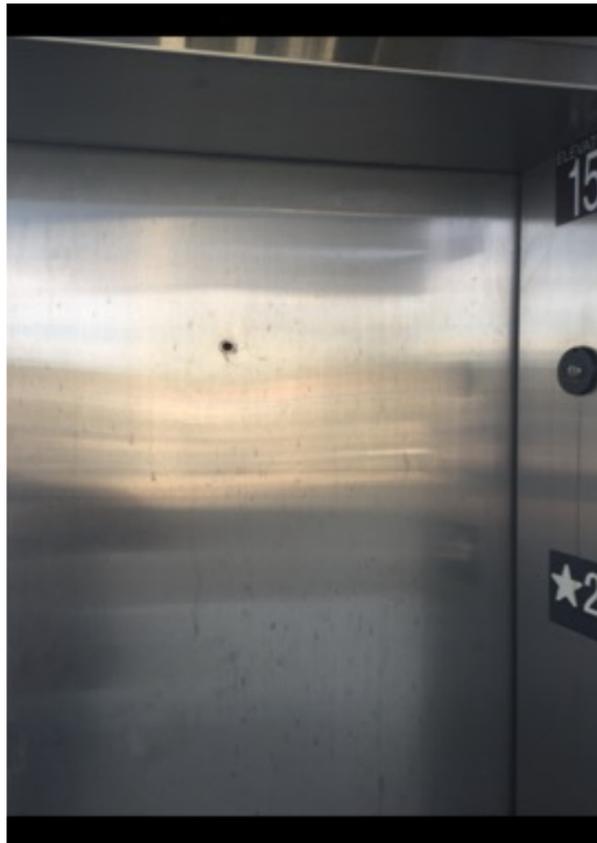
*Weather Damaged Hall Door Entrances on Express Units*

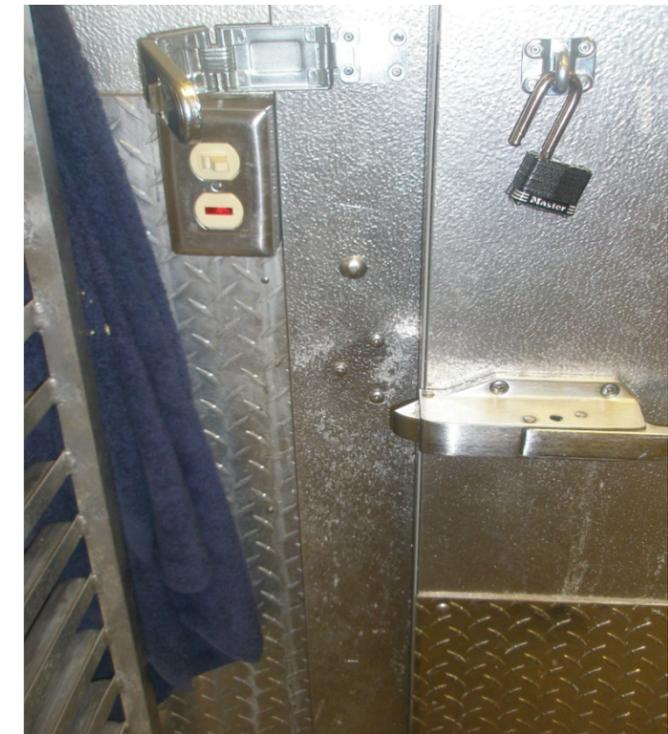
*Door Handle on Walk In Cooler is Damaged*

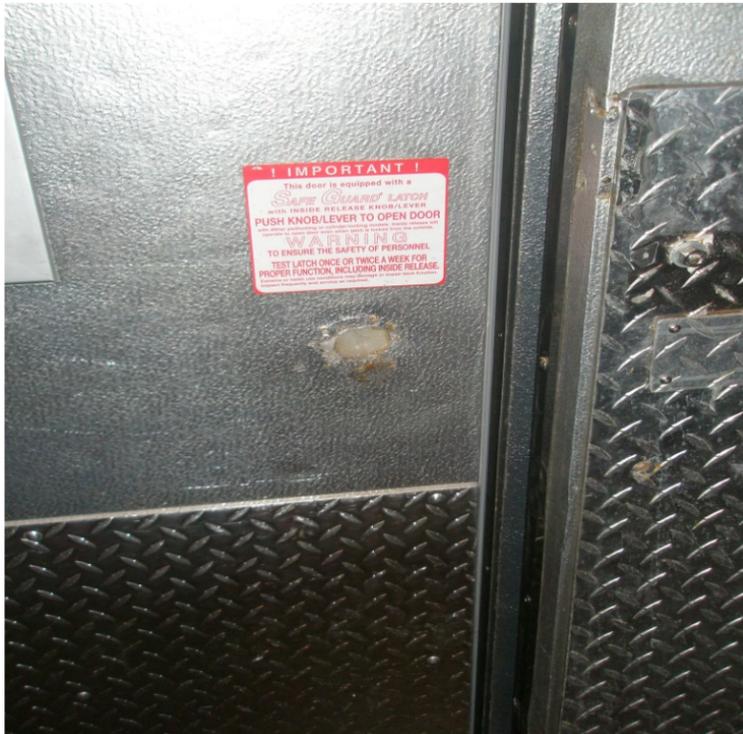
*Missing Door hardware on Cooler*

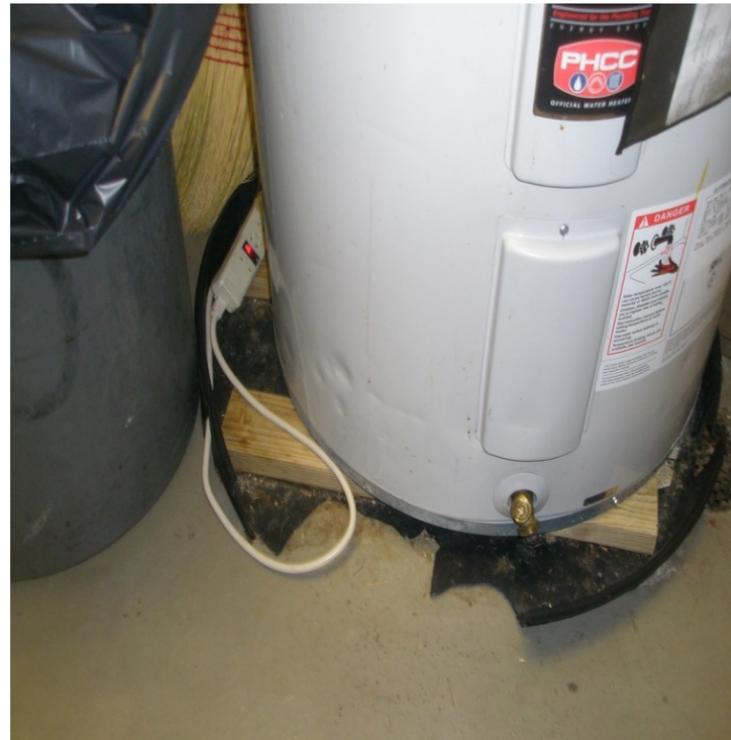
*Non-code compliant stand for hot water heater*
