# 232 W Marthona Road Culvert Replacement

## Existing Conditions

## Proposed Conditions

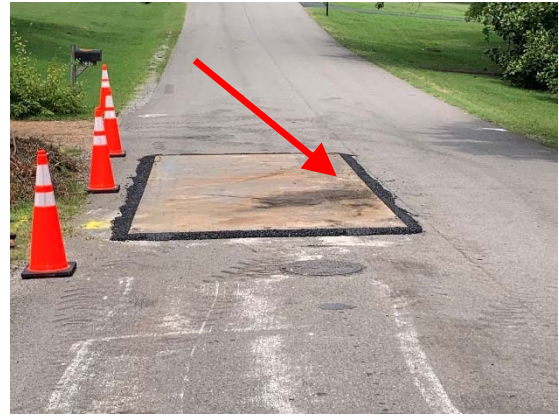
The culvert structure consists of a 37' long 49"x33" CMP culvert located approximately 20' south of the feature address, 232 West Marthona Road. There is an area of roadway failure near the inlet that has since been mitigated with the installation of a steel roadway plate. The corrugated metal pipe shows areas of corrosion with 100% section loss. Additionally, there is an area of seam separation with roadway backfill infiltration at the location of roadway failure. The inlet and outlet headwalls are beginning to fail with areas of missing stone and mortar loss.

**Roadway Failure w/ Steel Road Plate**

The proposed culvert replacement will include replacing the CMP Culvert with a Reinforced Concrete Box Bridge, Reinforced Concrete Wingwalls, Roadway Reconstruction, and Site Restoration.

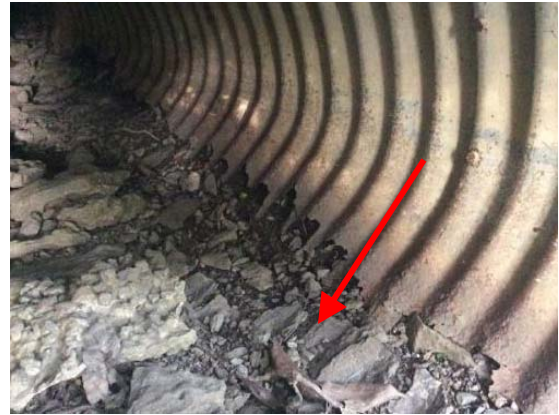
**100% Section Loss Along Pipe Invert**

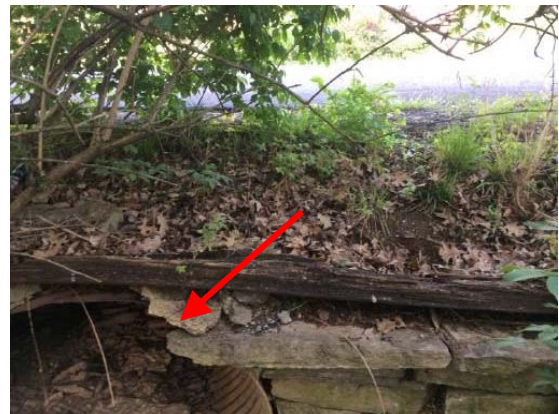
**Failing Outlet Headwall**
