442 Ewing Lane Culvert Replacement

Existing Conditions

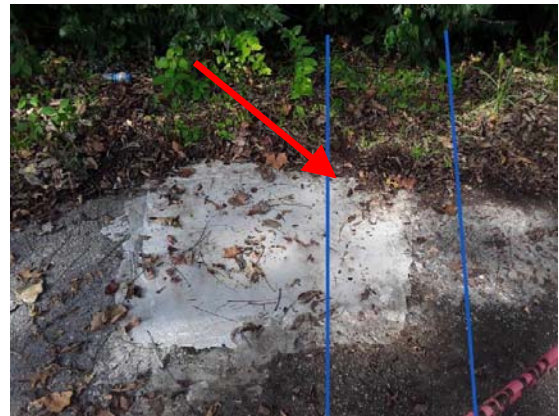
The culvert inlet is located adjacent to the feature address, 442 Ewing Lane. The existing culvert consists of a 36' long 18" CMP with no headwalls. The corrugated metal pipe shows mild surface corrosion with isolated areas of 100% section loss. A section of the pipe had collapsed under the roadway causing roadway failure. The pipe was temporarily patched and the hole in the roadway was secured with flowable fill. The inlet and outlet are partially buried due to sediment buildup. The pavement has settled and there are areas of large transverse cracks.

Patched Roadway Failure

The proposed culvert replacement will include the installation of an 18" reinforced concrete pipe and reinforced concrete headwalls as well as site restoration and roadway reconstruction.

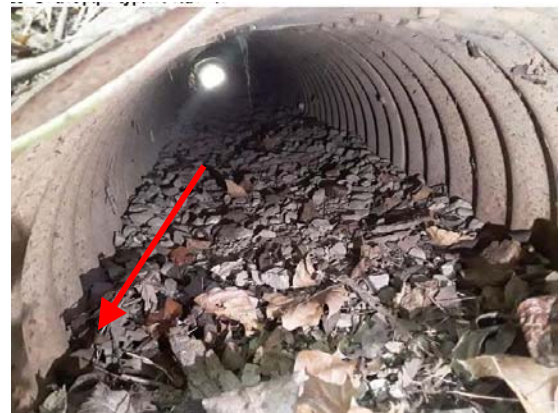
100% Section Loss

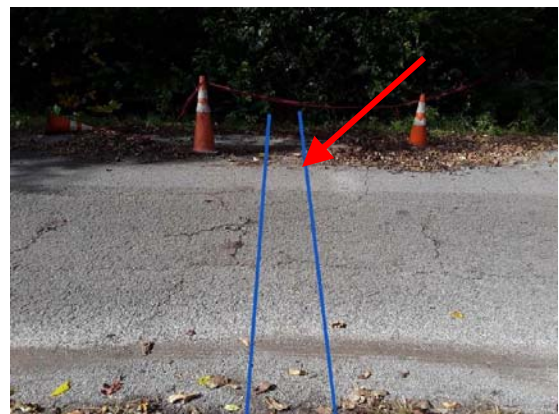
Roadway Settlement
