2310 Antioch Pike Culvert Rehabilitation

Existing Conditions

Proposed Conditions

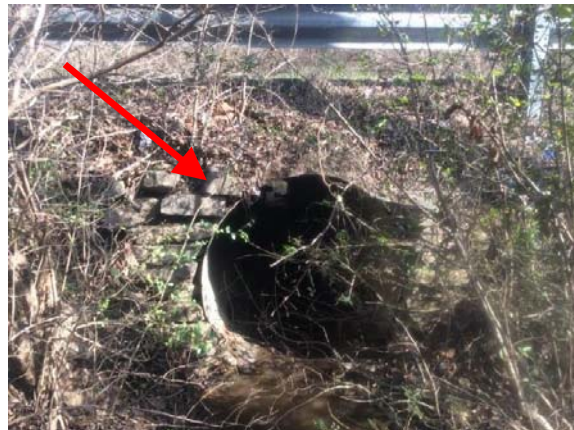
The culvert structure consists of a 34.5' long 48" CMP culvert located adjacent to the feature address, 2310 Antioch Pike. The outlet headwall has failed and is threatening to destabilize the embankment. The corrugated metal pipe has areas of heavy surface corrosion along the invert with areas of section loss, and minor seam separation.

Headwall Failure w/ Steel Road Plate

The proposed culvert rehabilitation will include isolating the upstream and downstream channels, installing a cementitious lining through the CMP, and reinforced concrete headwalls at the inlet and outlet as well as site restoration and minor roadway reconstruction.

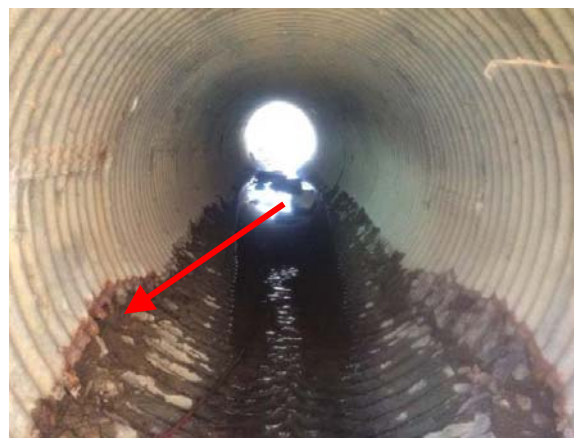
Section Loss
