3007 Lakeland Drive Culvert Replacement

Existing Conditions

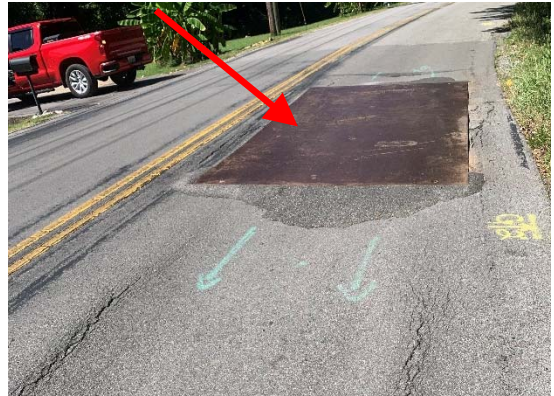
The subject culvert is located in a residential area with Light traffic volume, 30 mph speed limit and two 11.5' wide lane conveying traffic in the east and west directions. The culvert is located approximately 10' east of the featured address, 3007 Lakeland Drive. The culvert consists of a 41' long 18" CMP with a catch basin and area drain at the outlet. The pavement at the approaches and over the culvert has settled and a steel road plate has been installed. The CMP has 100% section loss, pipe deformation, seam separation, and debris buildup throughout.

Roadway Settlement w/ Steel Road Plate

The proposed culvert replacement will include replacing the existing 18" CMP, installing an 18" reinforced concrete pipe (RCP), reinforced concrete inlet headwall, and tie into the existing outlet catch basin as well as site restoration and roadway reconstruction. The culvert replacement will also require the vertical adjustment of a water main.

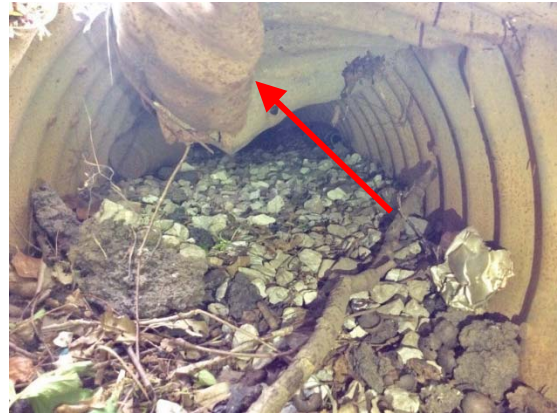
Pipe Deformation & Sediment Buildup
