# 4861 Little Marrowbone Road #1 Culvert Replacement

## Existing Conditions

# 4861 Little Marrowbone Road #2 Culvert Replacement

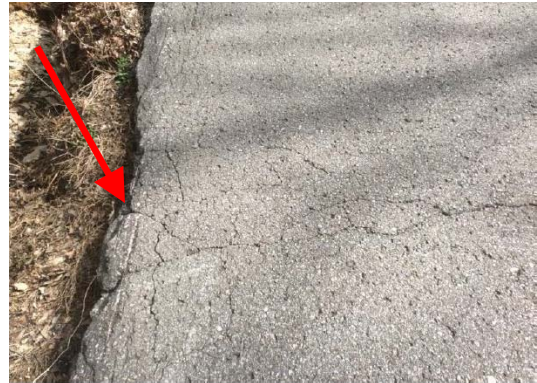
The culvert inlet is located approximately 340' east of the featured address, 4861 Little Marrowbone Road. The culvert consists of a 30" corrugated metal pipe (CMP) with stone a headwall at the outlet. The outlet headwall has missing stones/mortar loss and has begun to destabilize. The pavement over the culvert has transverse and longitudinal cracks as well as an area of shoulder failure at the culvert inlet. The CMP exhibits 100% section loss due to corrosion along the CMP inverts. The downstream channel is holding water due to a lack of fall.

**Roadway/Shoulder Settlement**

The proposed culvert replacement will include the installation of a 30' long 30" RCP culvert with reinforced concrete headwalls. The installation of channel and embankment protection as well as site restoration and roadway reconstruction.

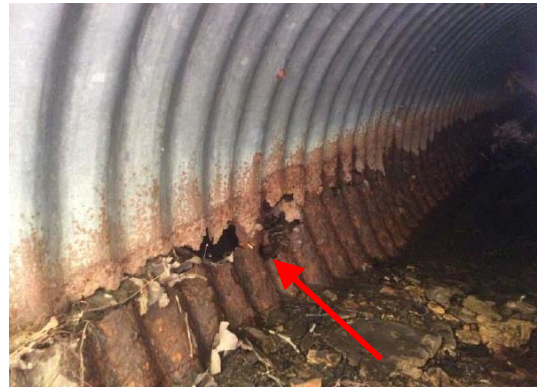
**Section Loss**

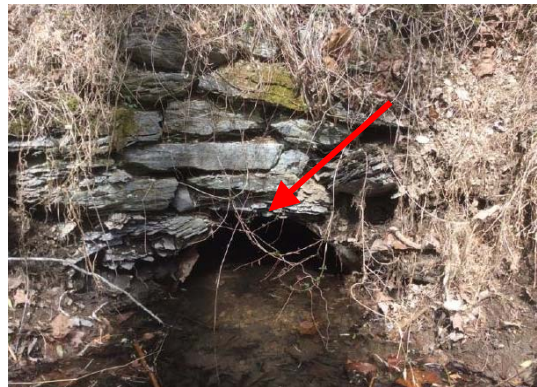
**Outlet Headwall Destabilization**

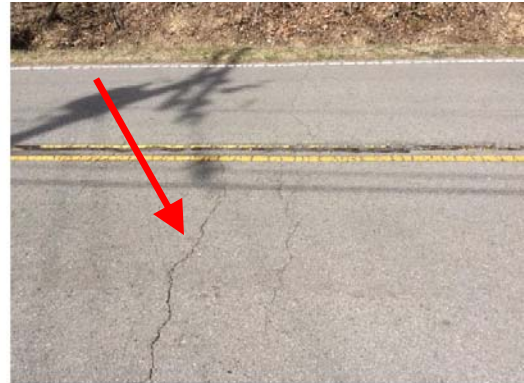
The culvert inlet is located approximately 15' east of the featured address, 4861 Little Marrowbone Road. The culvert consists of a 24" corrugated metal pipe (CMP) at the inlet and transitions into a 24" reinforced concrete pipe somewhere under the road. There is a stone headwall at the inlet with missing stones and mortar loss. The pavement over the culvert has transverse and longitudinal cracks. The CMP has heavy surface corrosion, section loss, and the pipe has collapsed under the road. The RCP has cracking at the joints. There is sediment buildup throughout the pipe. Additionally, the pipe was not visible throughout its length due to the sediment buildup and/or due to a section of the CMP that has collapsed under the roadway.

**Roadway Settlement**

The proposed culvert replacement will include the installation of a 46' long 38"x24" HERCP culvert with reinforced concrete headwalls. The installation of channel and embankment protection as well as site restoration and roadway reconstruction.

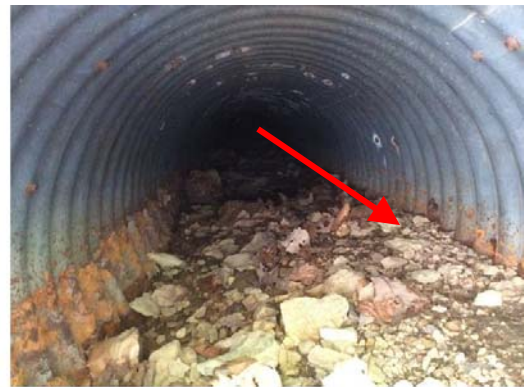
**Section Loss**

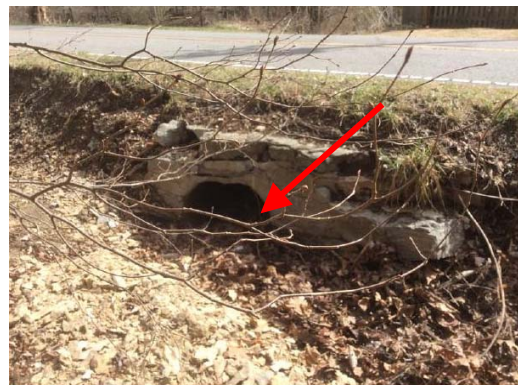
**Inlet Headwall Destabilization**
