4969 Tranham Road Culvert Replacement

Existing Conditions

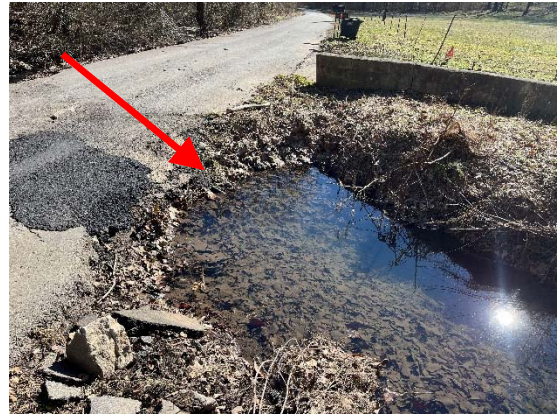
Buried Culvert Inlet

The proposed culvert construction will include two 30"x19" reinforced concrete pipes, reinforced concrete headwalls, roadway reconstruction, and site restoration to ensure proper functionality.

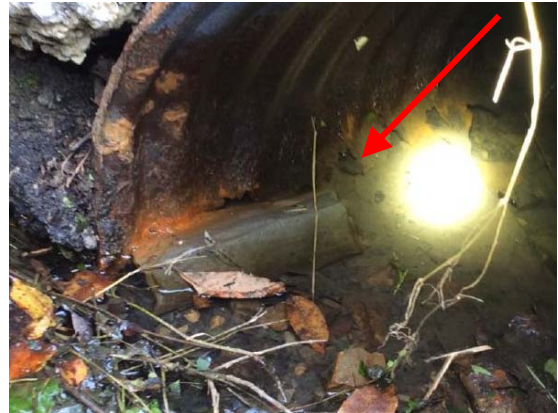
Section Loss & Pipe Collapse

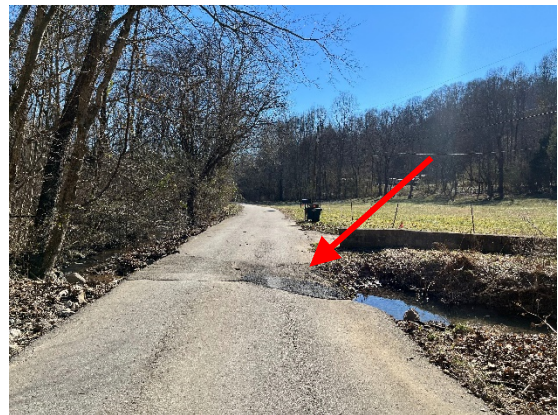
Pavement Settlement/Failure
