5304 Flagstone Drive Culvert Rehabilitation

Existing Conditions

Proposed Conditions

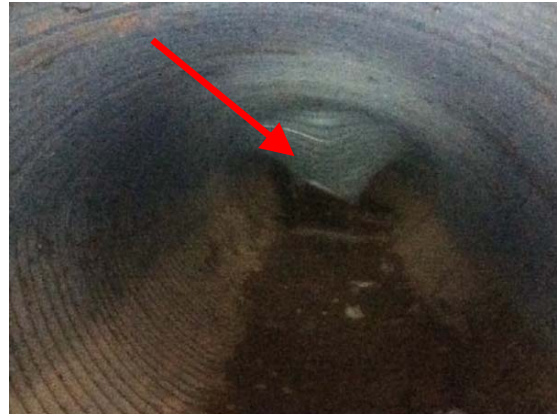
The culvert structure consists of a 54.5' long 41"x29" CMP culvert with reinforced concrete headwalls. The culvert is located adjacent to the feature address, 5304 Flagstone Drive. The concrete headwalls have light cracking and discoloration. The corrugated metal pipe has an area of partial pipe collapse with minor sediment buildup.

Partial Pipe Collapse

The culvert rehabilitation will consist of repairing the section of partial pipe collapse, clearing all sediment/debris from the pipe, lining the pipe to increase the service life, and repairing the cracks in the concrete headwall.

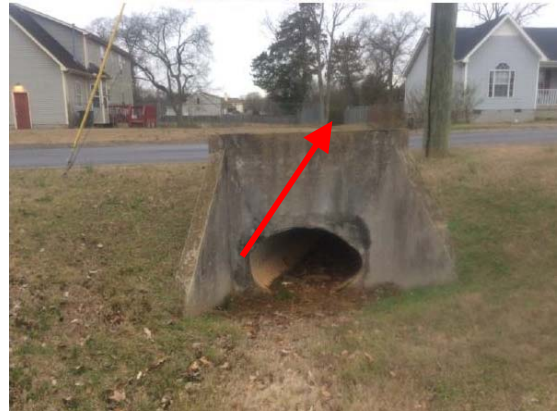
Inlet Headwall
